Repairing Standard Enforcement Order Ordered by the First-tier Tribunal for Scotland (Housing and Property Chamber)

Chamber Ref: FTS/HPC/RT/24/0448

9 Cruden Terrace, Lockerbie, DG11 2HY being the subjects registered in the Land Register of Scotland under title number DMF32911 ('The Property')

Statement of Decision of the First-tier Tribunal for Scotland (Housing and Property Chamber) under Section 24 (1) of the Housing (Scotland) Act 2006.

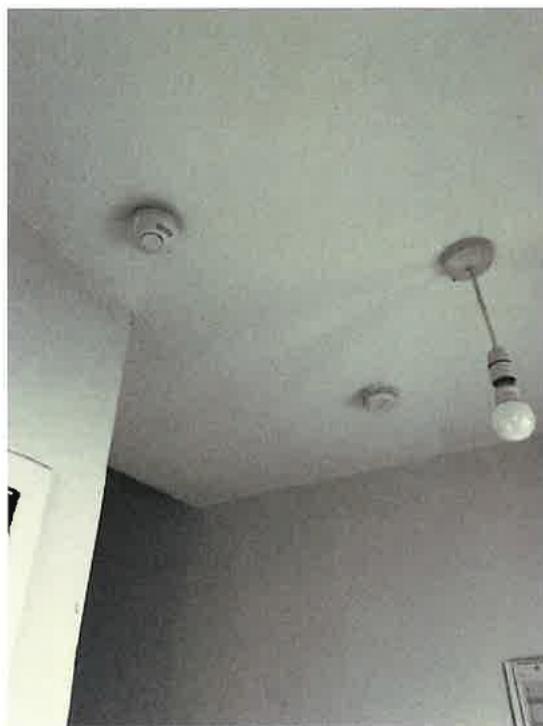
A smoke alarm had been installed but it was not interlinked.

Photograph 2: Downstairs hallway: smoke detectors

- 3.2 One functioning smoke alarm in every circulation space, such as hallways and landings.
 - 3.3 One heat alarm in every kitchen and
 - 3.4 All alarms should be interlinked and the installation should comply with the regulations.

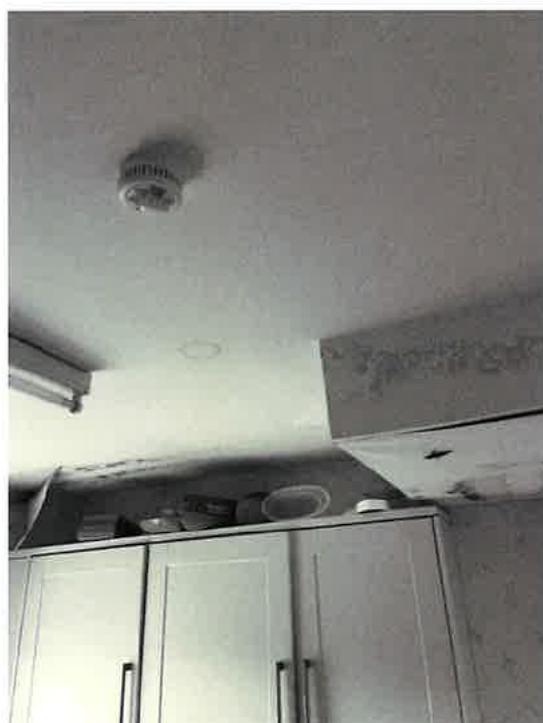
A heat detector had been installed but it was not interlinked.

Photograph 3: Kitchen: heat detector

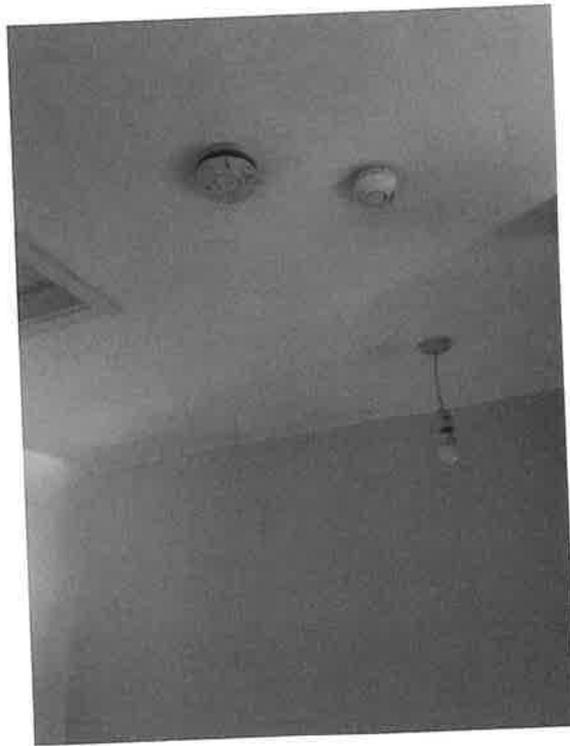
Smoke alarms had been installed but were not interlinked.

Photograph 4: Landing: smoke detectors

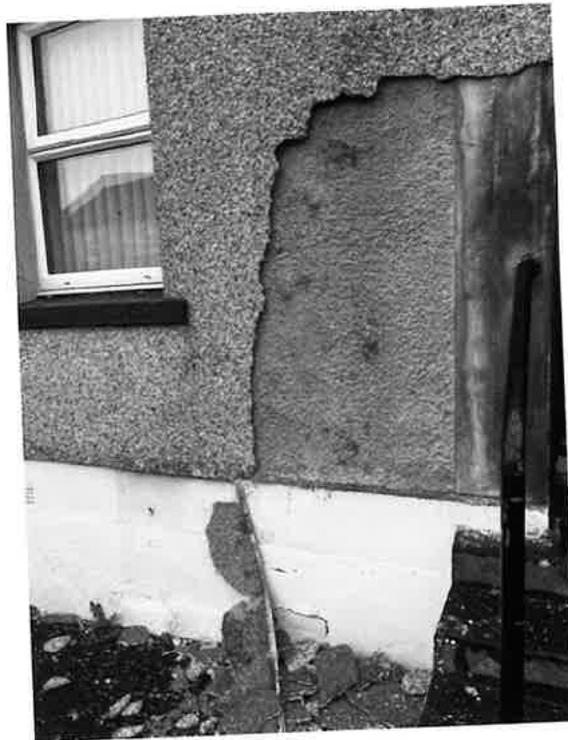
The external rendering near the front door of the Property had fallen off leaving a bare patch of the external wall. A section of the remaining rendering at the front of the Property was loose. There is a gap of approximately 25 mm between the loose rendering and the wall.

6.2.3 Rendering had fallen off the front external wall of the Property.

Photograph 5: Front elevation: missing rendering

7. Repair the defective and missing render to the front external wall of the Property to render it in a reasonable state of repair.
8. Repair the dislodged roof slates to render them in a reasonable state of repair.

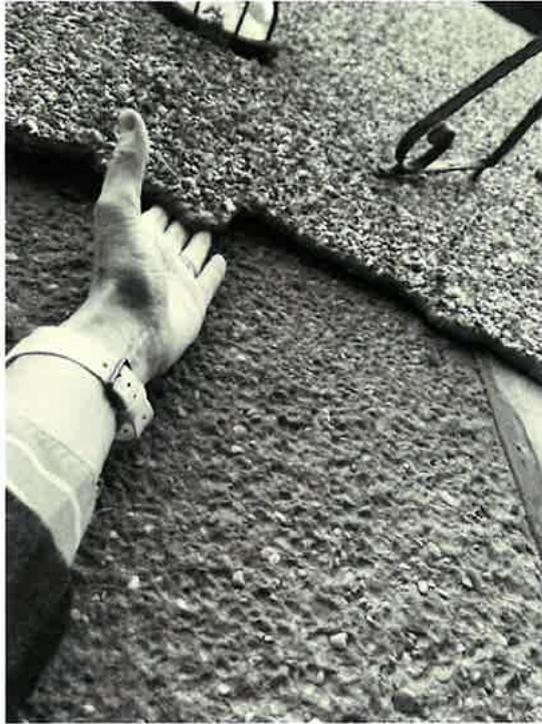
6.2.4 The Rendering to the front external wall of the Property was loose and there was a gap of approximately 25mm between the rendering and the external wall where it was loose.

Photograph 6: Front elevation: gap beneath outer layer of rendering

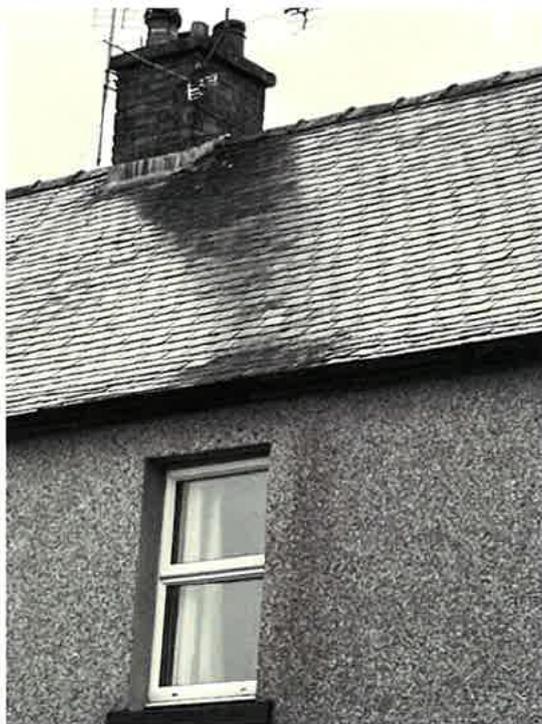
Several roof slates to the front of the Property were dislodged.

6.2.5 A number of roof slates at the front of the roof are dislodged.

Photograph 7: Front elevation: Raised and uneven slates above window of bedroom 3

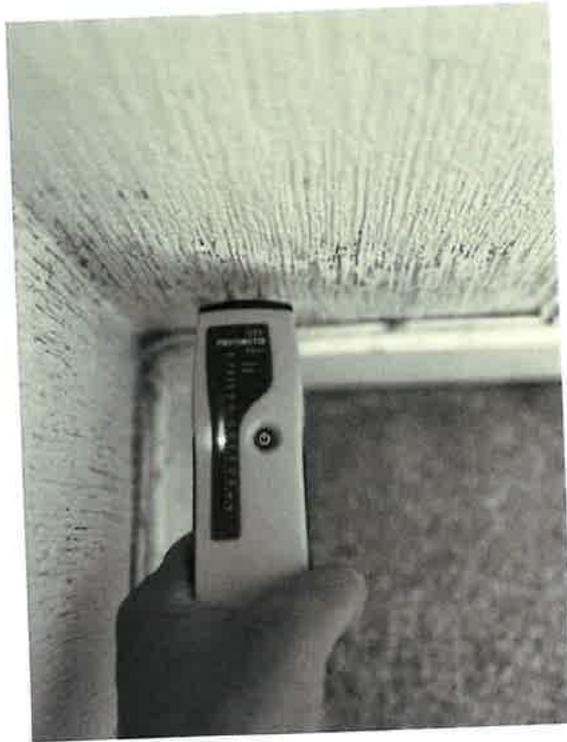
Mrs Hesp tested this area with a damp meter and amber damp readings were obtained indicating low levels of damp.

6.2.10 There is damp in the external wall of the living room.

Photograph 8: Living room: front wall: damp content raised

11. Repair the damp to the external wall of the living room to render it water tight.

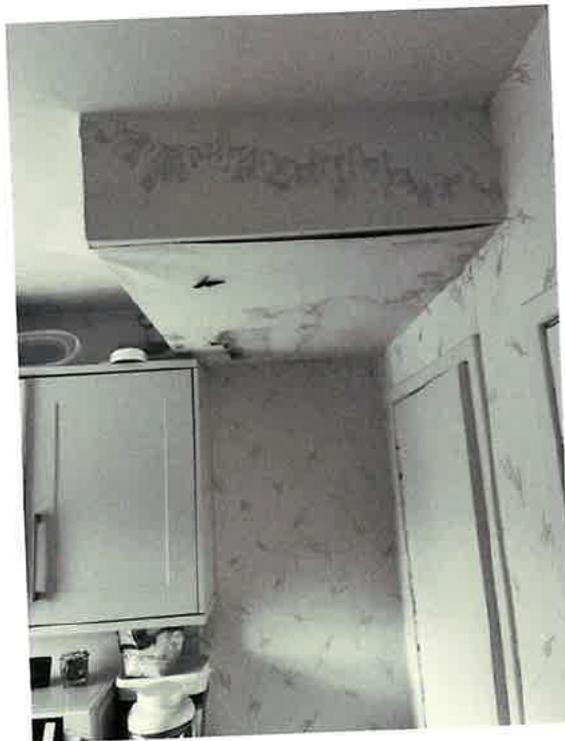
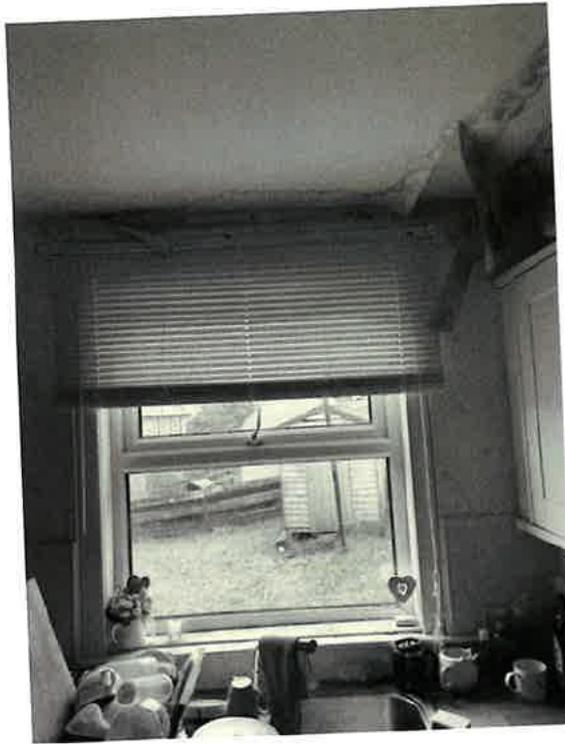
Water damage to the décor of the kitchen ceiling was apparent. Mrs Hesp tested this area with a damp meter and green damp readings were obtained indicating that the area was not damp.

6.2.8 Sections of kitchen ceiling were stained and the decoration was loose.

The Tribunal determine that wallpaper on the ceiling of the kitchen is a fixture and the fact that it is peeling away from the ceiling results in it not being in a reasonable state of repair.

Photograph 9: Kitchen: ceiling - staining and bubbling to wallpaper

Photograph 10: Kitchen: ceiling - staining and bubbling to wallpaper

5. Repair the electric shower pull cord to render it in proper working order.
6. Repair the stained and loose wallpaper on the kitchen ceiling to render it in a reasonable state of repair.

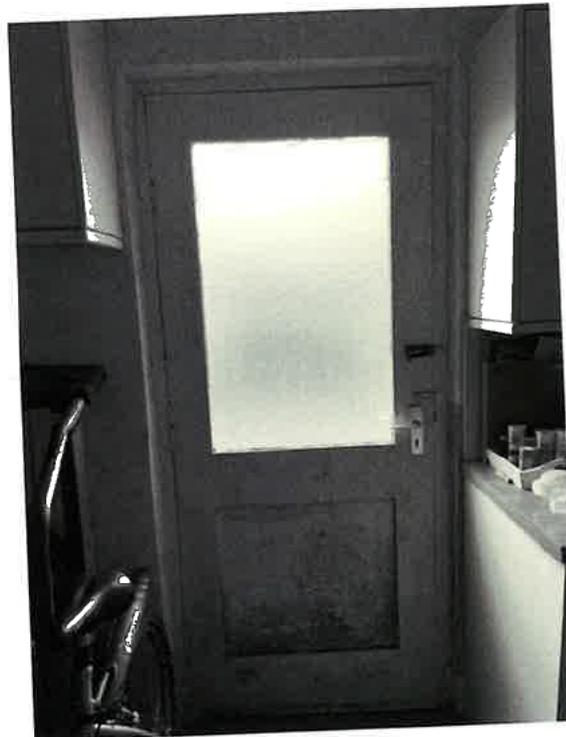
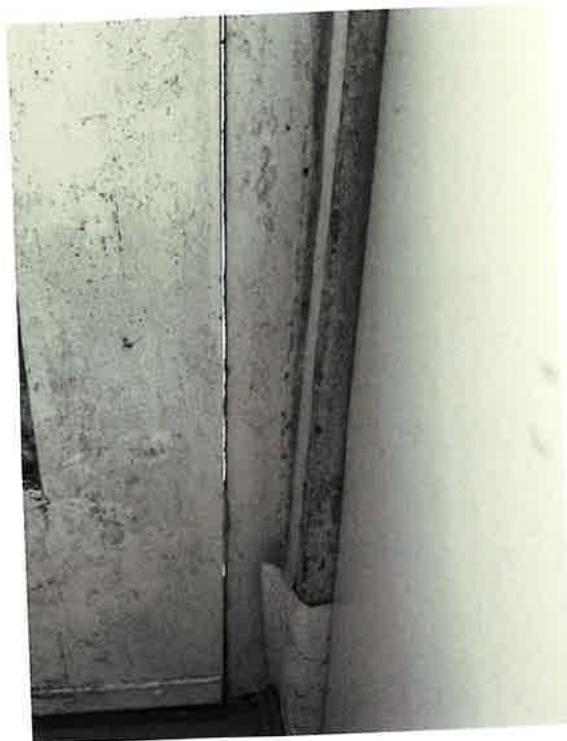
There was evidence of dark staining to the door consistent with mould. Mrs Hesp tested the door and adjacent frame with a damp meter and green damp readings were obtained indicating that the door was not damp.

The back door was ill fitting and daylight was visible between the door and the door frame.

6.2.9 Light is visible between the back door and the door frame when the door is closed.

Photograph 11: Kitchen: back door

Photograph 12: Kitchen: back door

9. Repair the front door and surround of the Property to render it wind and water tight.
10. Repair the back door and surround of the Property to render it wind and water tight.

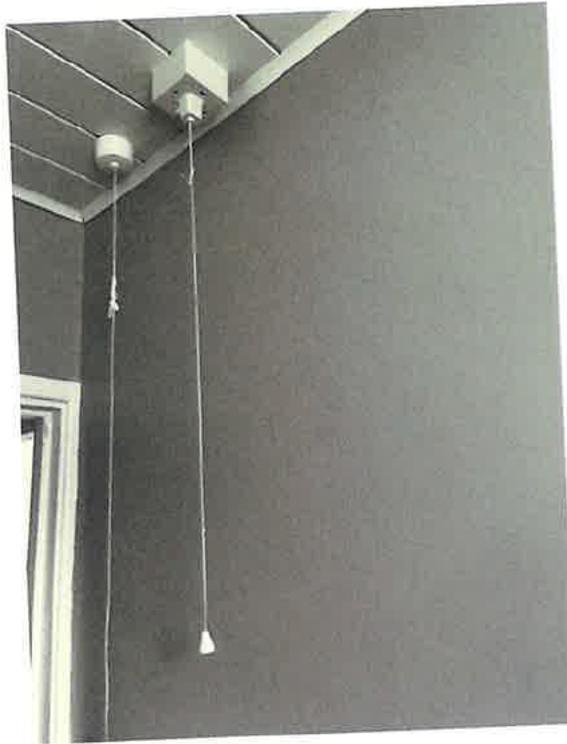
It was not possible to turn off the shower pullcord.

6.2.12 The shower cord cannot be turned off.

Photograph 14: Bathroom: Shower power switch

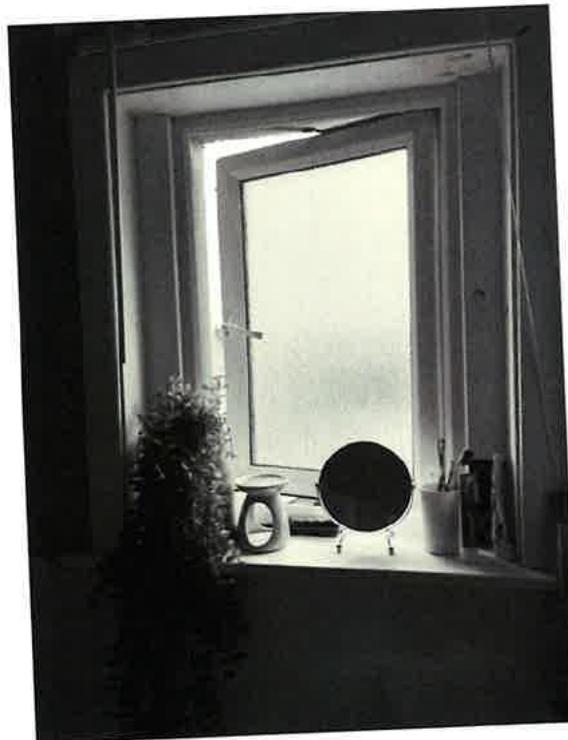
As stated in the complaint, there is no mechanical extractor fan but the window in the bathroom opens.

Photograph 15: Bathroom: Window

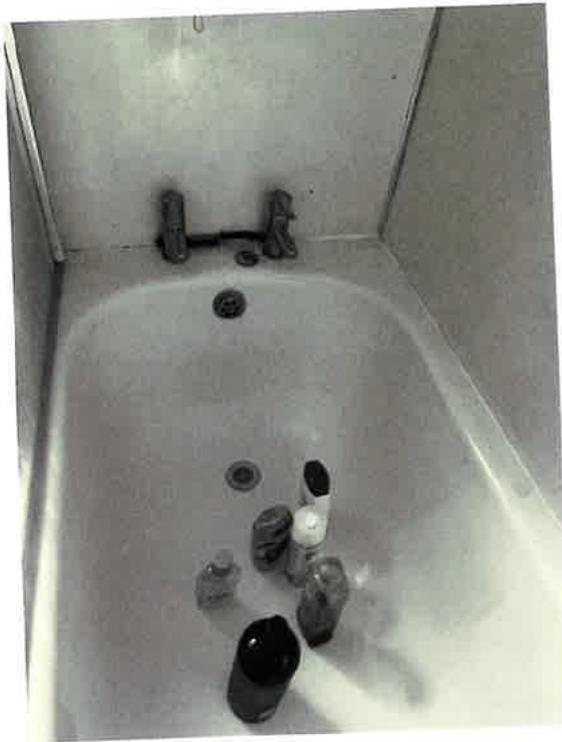
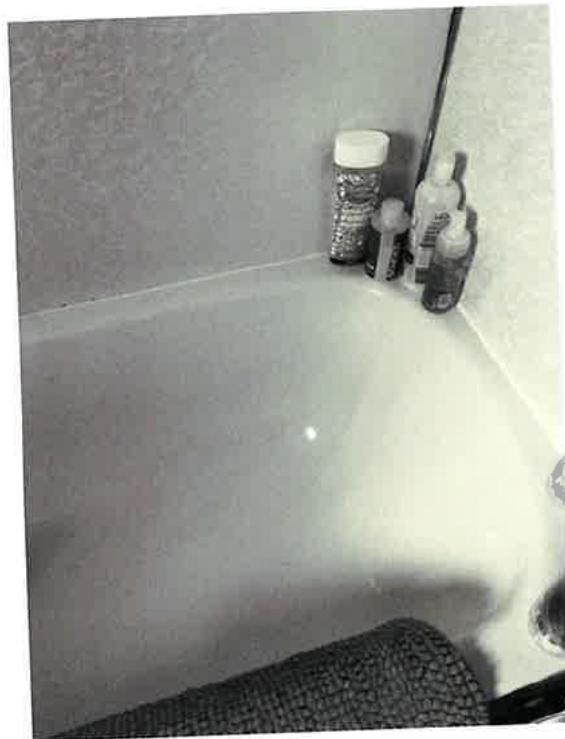
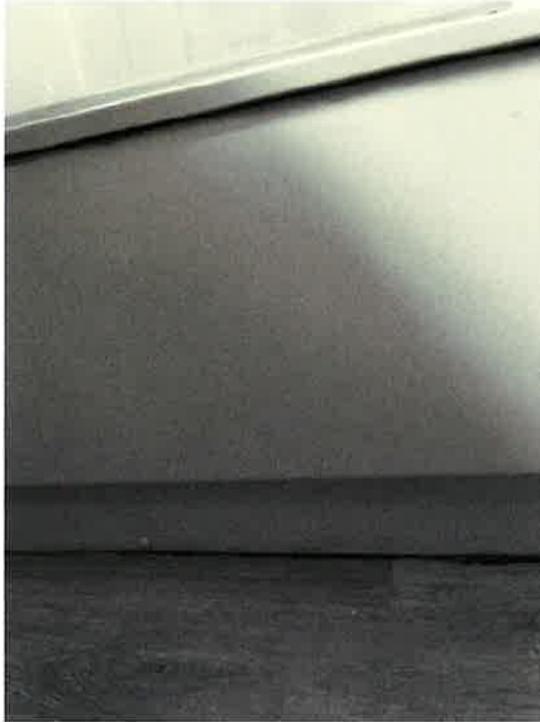
No movement of the bath was detected at the inspection.

Photograph 16: Bathroom: Bath

Photograph 17: Bathroom: Bath

Photograph 18: Bathroom: Bath panel

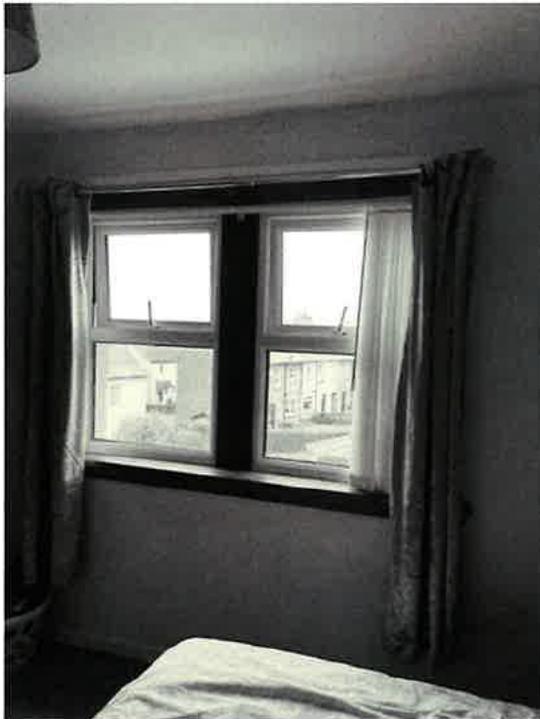
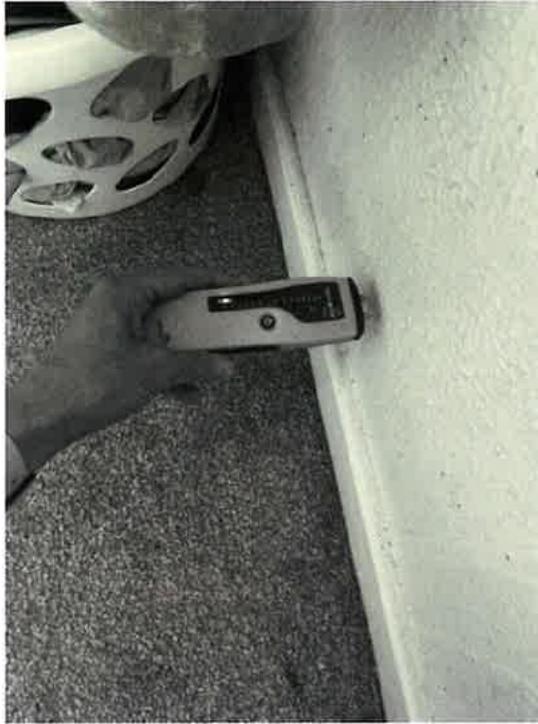
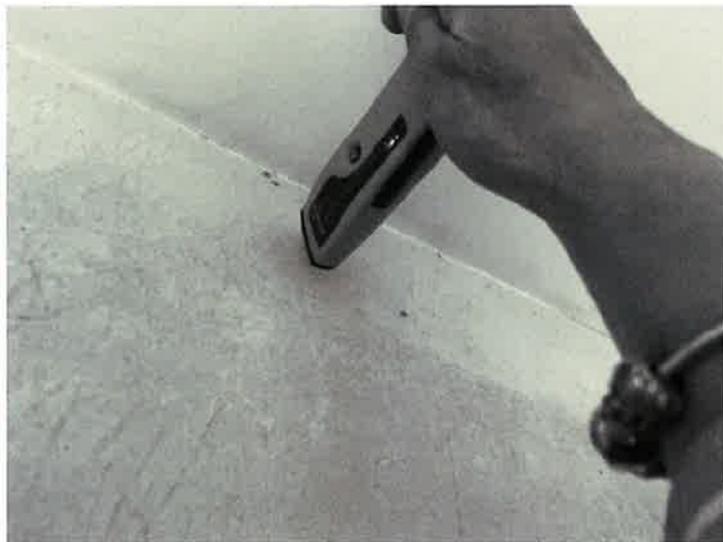
There was evidence of mould high upon the bedroom wall. Mrs Hesp tested the bedroom wall with a damp meter and green damp readings were obtained indicating that the wall was not damp.

Photograph 19: Bedroom 1: Staining to ceiling and wall

Photograph 20: Bedroom 1: Damp meter reading to wall

Photograph 21: Bedroom 1: Damp meter reading to wall

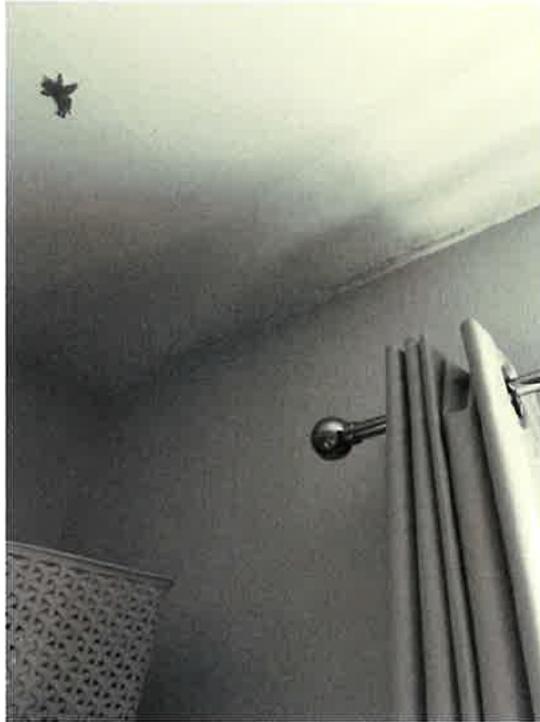
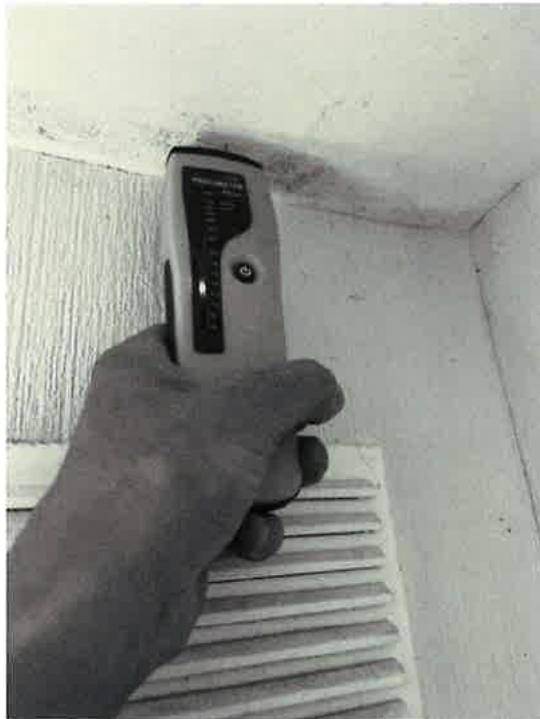
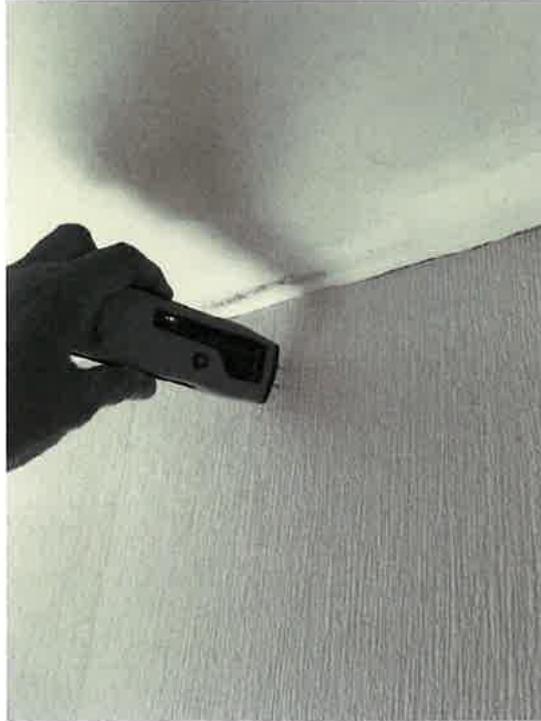
There was evidence of damp staining to the bedroom wall and ceiling. Mrs Hesp tested the bedroom wall and ceiling with a damp meter and green damp readings were obtained indicating that the wall was not damp.

Photograph 22: Bedroom 2: Staining to ceiling

Photograph 23: Bedroom 2: Damp meter reading to ceiling

Photograph 24: Bedroom 2: Damp meter reading to wall

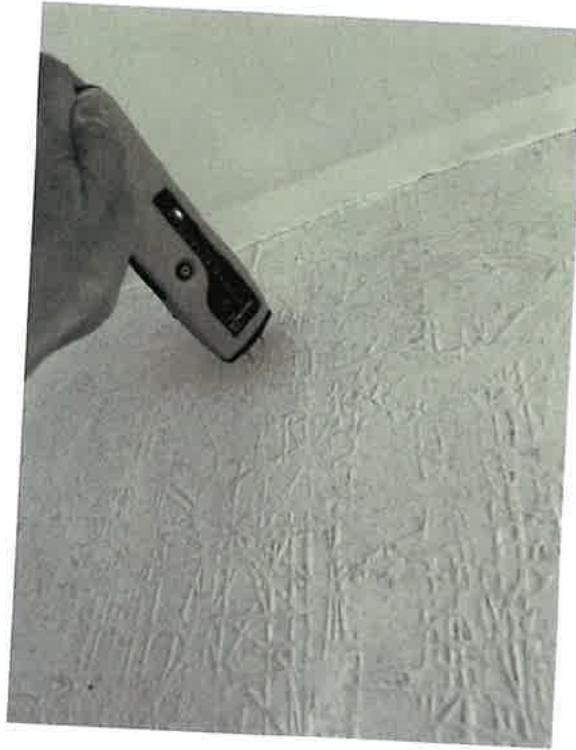
There was evidence of damp staining to the bedroom wall. Mrs Hesp tested the bedroom wall with a damp meter and green damp readings were obtained indicating that the wall was not damp.

Photograph 26: Bedroom 3: Damp meter reading to wall
