**First-tier Tribunal for Scotland (Housing and Property Chamber)**

**STATEMENT OF DECISION: Housing (Scotland) Act 2006 Section 24 (1)**

**Chamber Ref: FTS/HPC/RT/23/4600**

**11D Galvelmore Street, Crieff, Perthshire PH7 4BY  
("The Property")**

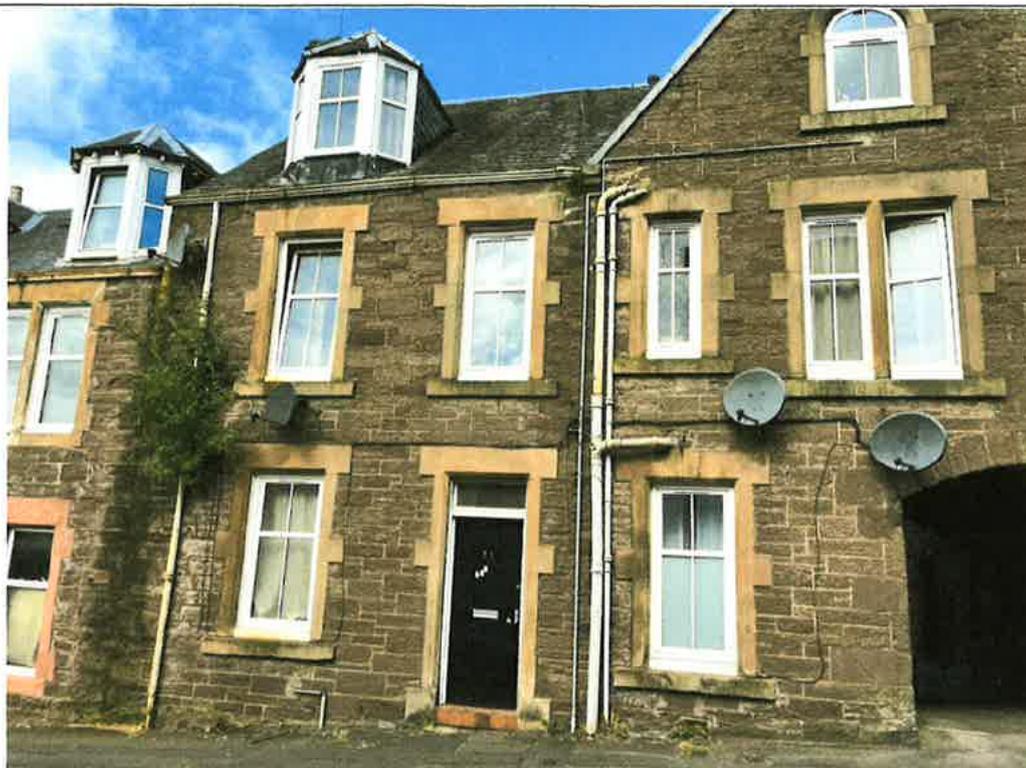
Front

Significant vegetation growth could be seen on the front wall and rear stacks.

A damp stain on the front wall indicates that rainwater has been overflowing from the old guttering and has been for a long time. Viewed from a window above, the guttering could be seen to be choked.

12. There is significant vegetation growth on the front wall and rear stacks. Pointing is soft, loose and open in various places.

14. A damp stain on the front wall indicates that rainwater has been overflowing from the old guttering and has been for a long time. Viewed from a window above, the guttering could be seen to be choked.

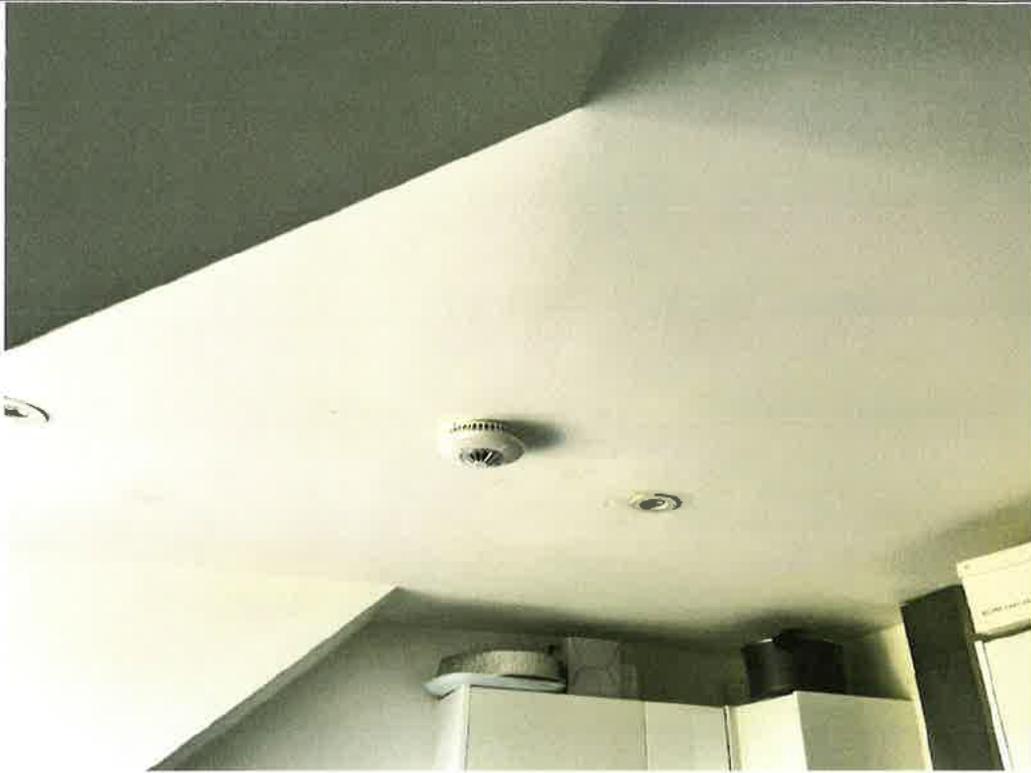
Heat detector

Internally there are many stains on walls and ceilings indicating extensive rainwater penetration including directly around the heat detector and light fitting in the kitchen. Most were dry on inspection, including in the kitchen but high instrumental moisture meter readings in the bedrooms indicated that there is still significant dampness in the property.

17. The internal front door to the flat has no draughtproofing.
18. Internally there are many stains on walls and ceilings indicating extensive rainwater penetration including directly around the heat detector and light fitting in the kitchen. Most were dry on inspection, including in the kitchen but high instrumental moisture meter readings in the bedrooms indicated that there is still significant dampness in the property.

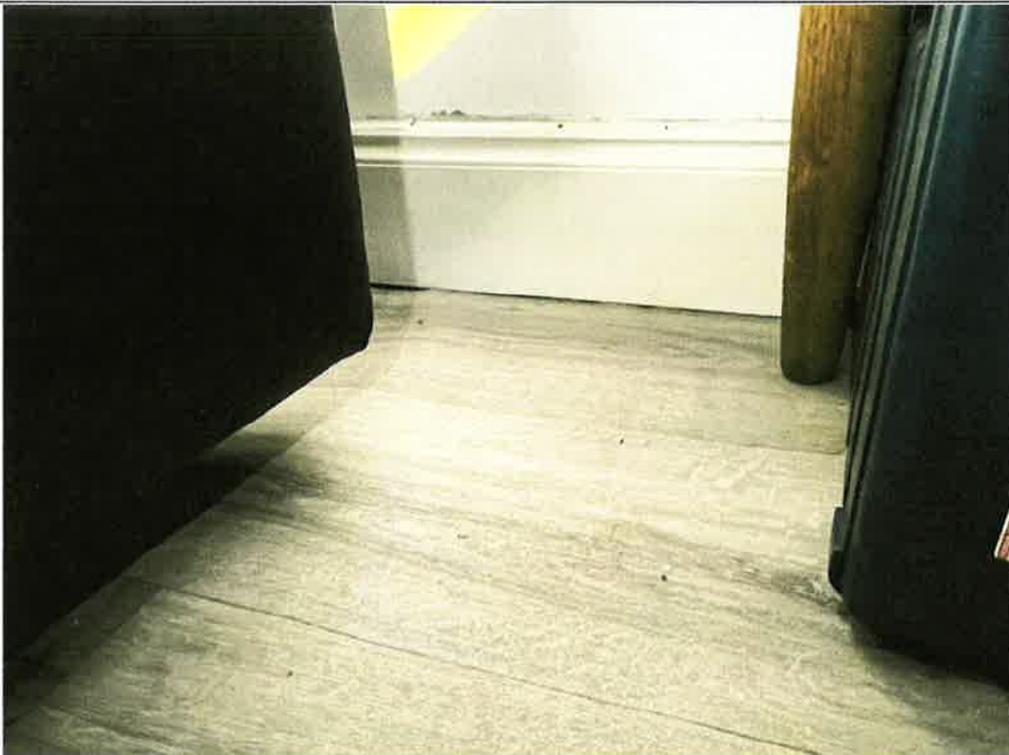
A small gap could be seen below the skirting board in the kitchen.

Gap below the skirting in the kitchen

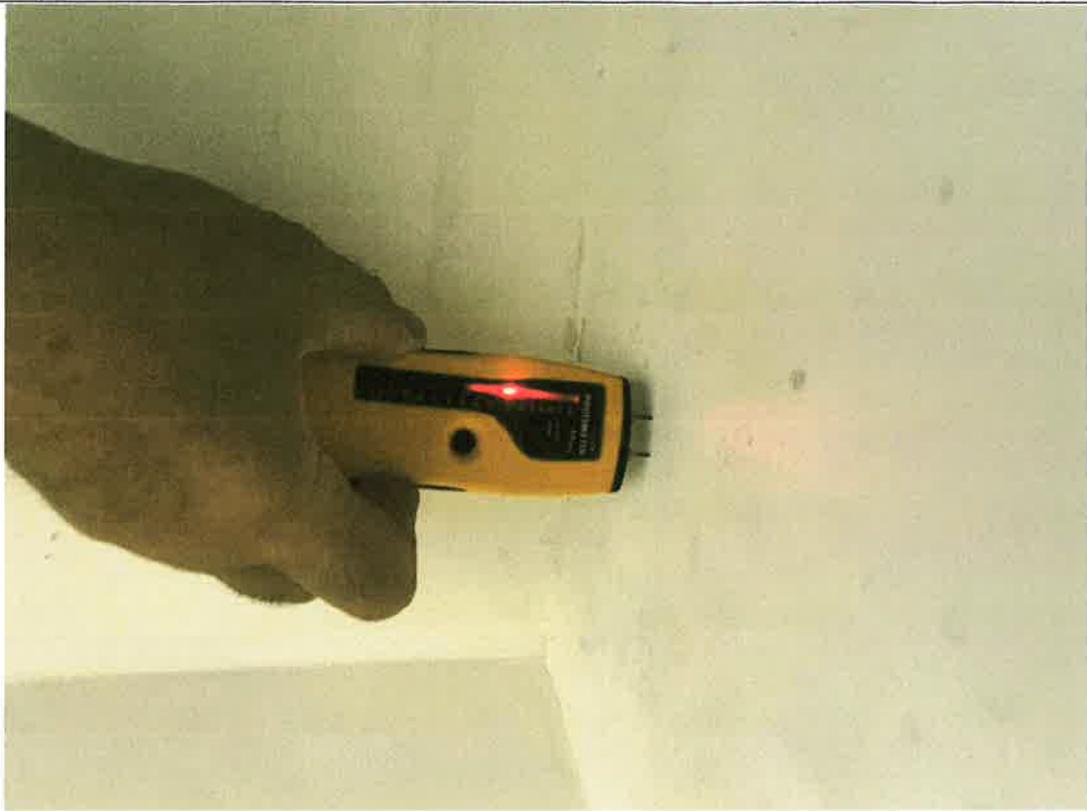
Dampness in the front bedroom

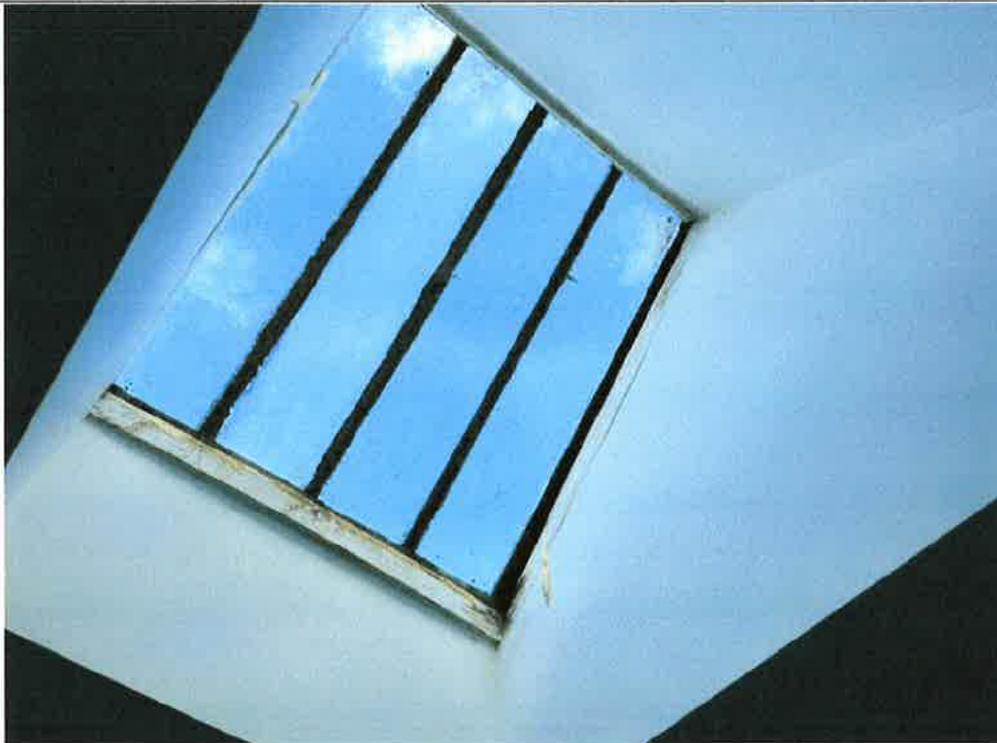
There is an old metal framed single glazed skylight above the landing. This is rusting and there are signs of rainwater and/or condensation below.

19. There is an old metal framed single glazed skylight above the landing. This is rusting and there are signs of rainwater and/or condensation below.
20. A small gap could be seen below the skirting board in the kitchen.

Signs of dampness below the skylight window

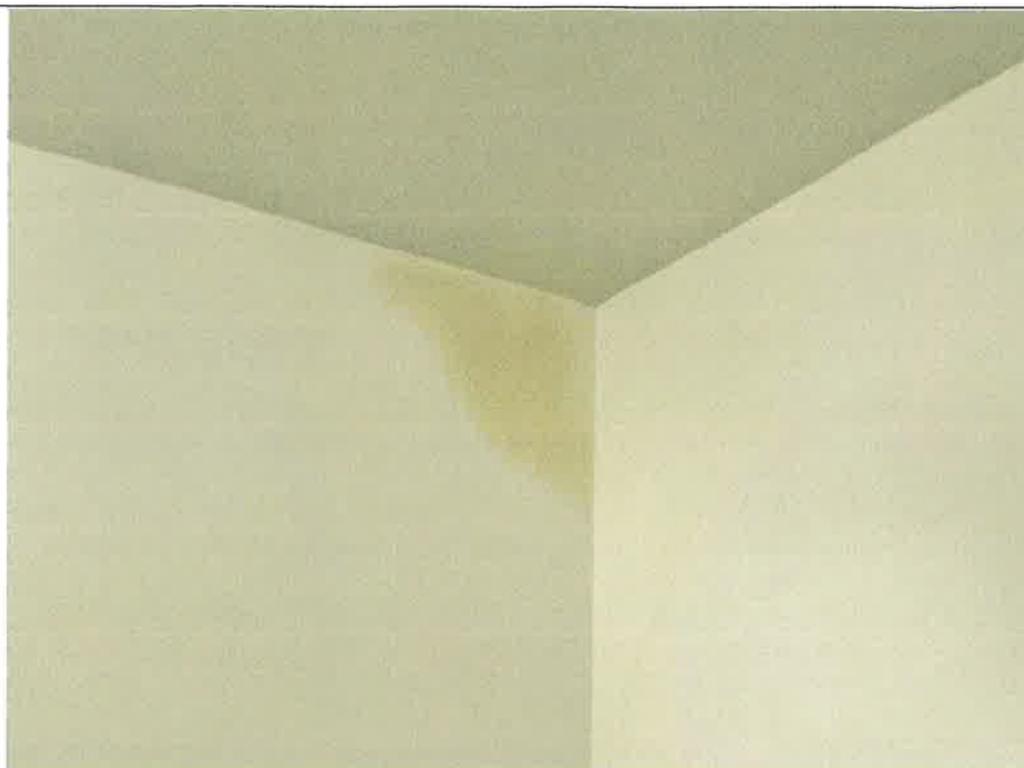
Damp stain in the rear bedroom....

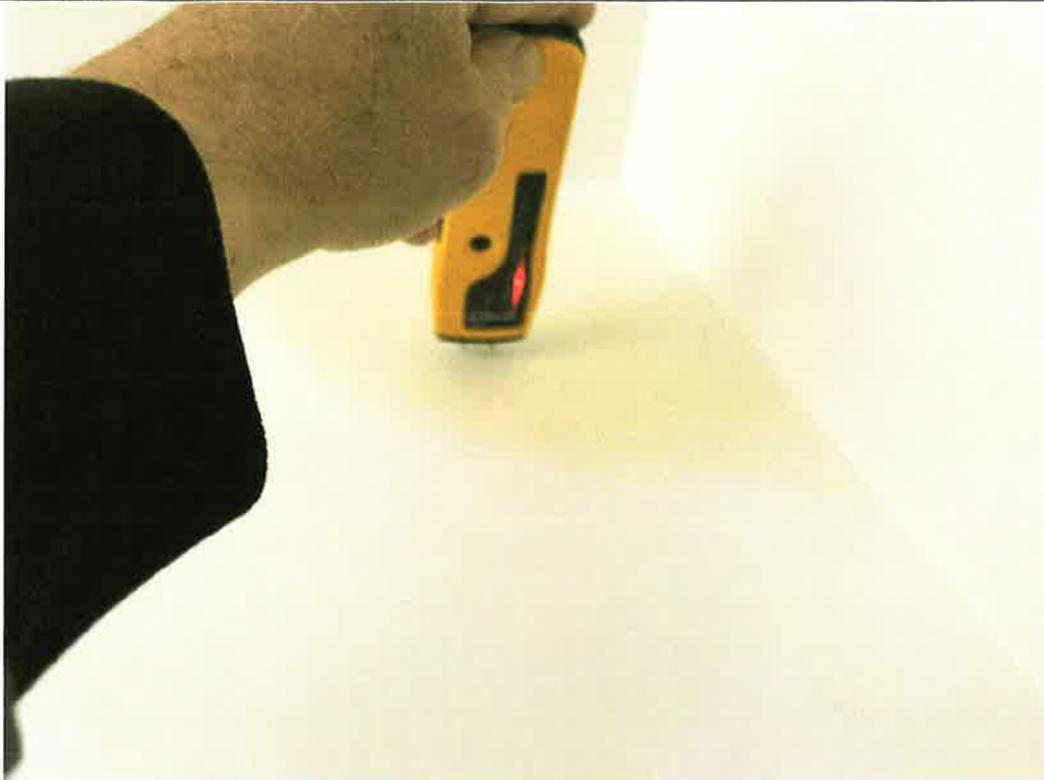
...registering high damp readings

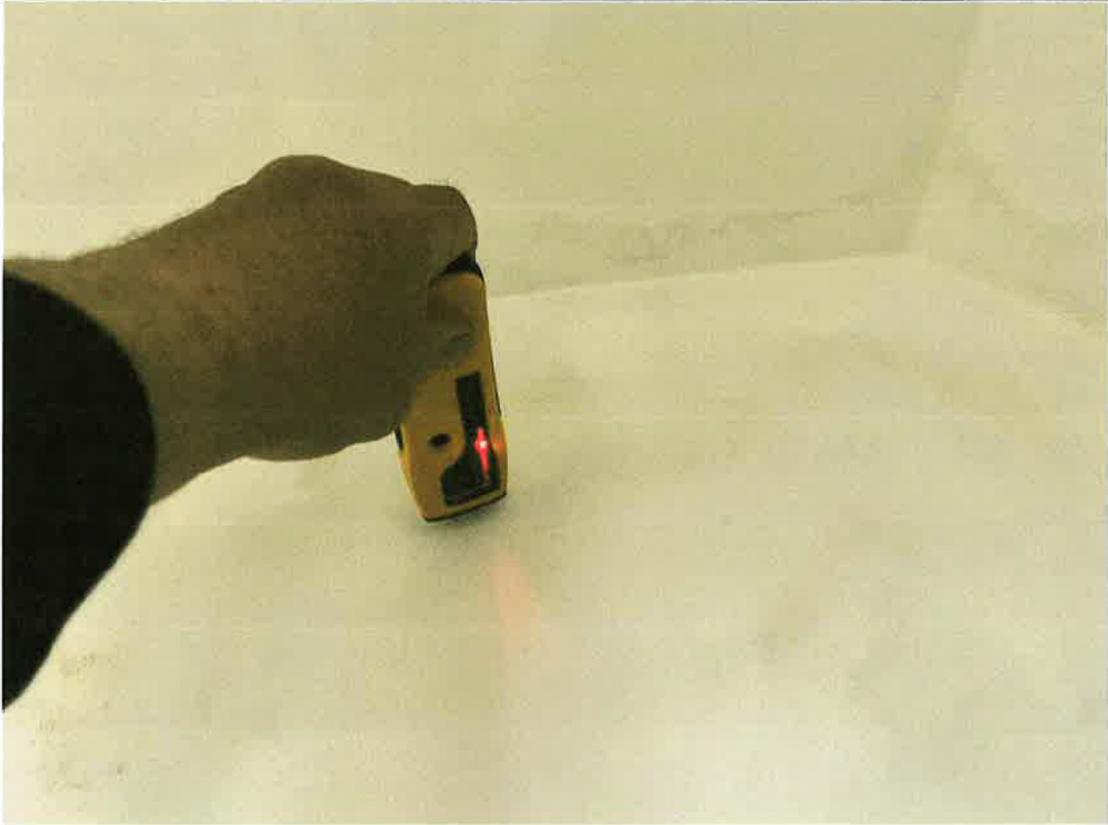
Many stains and high damp readings in bedroom cupboard

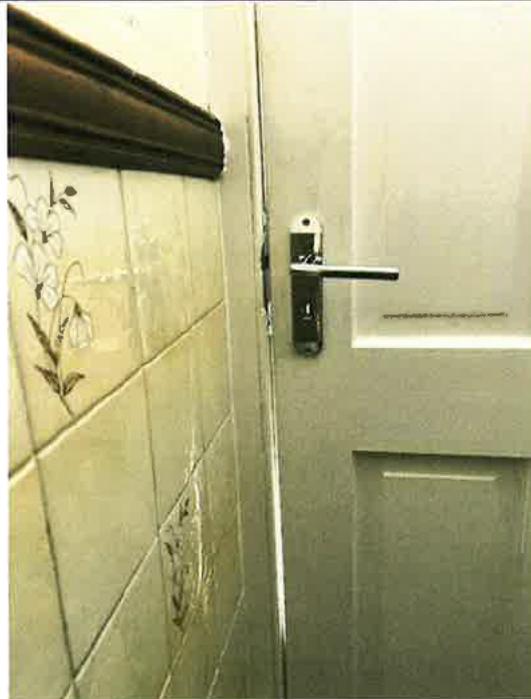
The internal front door to the flat has no draughtproofing.

No draughtproofing on the front door

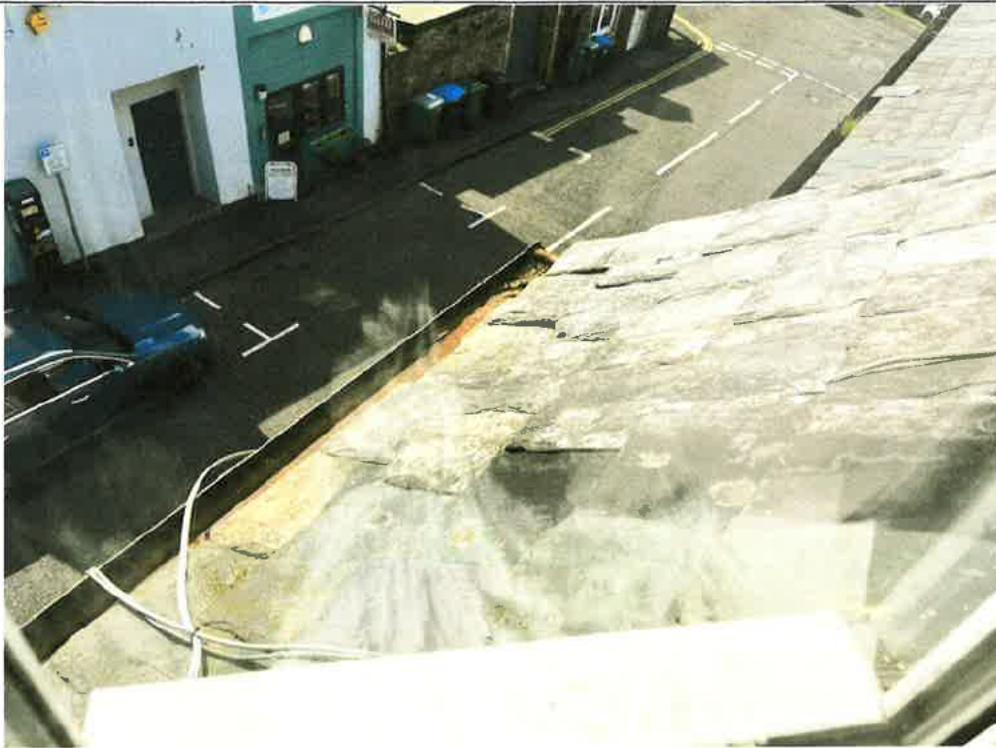
Rainwater gutters were also choked and poorly aligned at the rear of the property.

Choked guttering

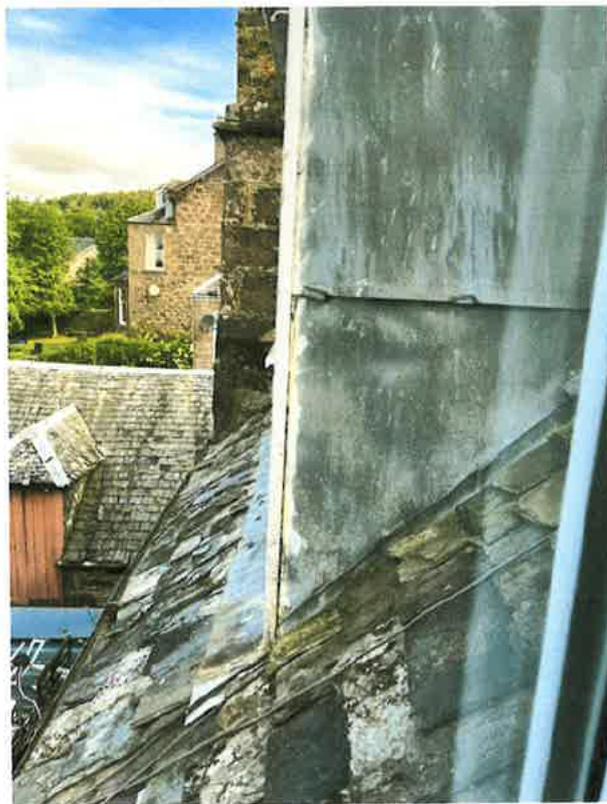
Part of the rear roof

There are various indications that the roof is "nail sick" – many replaced slates of different ages and size, some held in place by lead strips, cracked and chipped slates, uneven-ness, debris of broken slates in the gutters.

16. There are various indications that the roof is "nail sick" with many replaced slates of different ages and size, some held in place by lead strips, there are also cracked, chipped and uneven slates, with debris of broken slates in the gutters.
