First-tier Tribunal for Scotland (Housing and Property Chamber)

Determination: Housing (Scotland) Act 2006: Sections 26 and 27

106 Carron Place, Irvine, North Ayrshire, KA12 9NE, registered in the Land Register of Scotland under title number AYR13282 (“the Property”)

Case Reference FTS/HPC/RP/25/1678

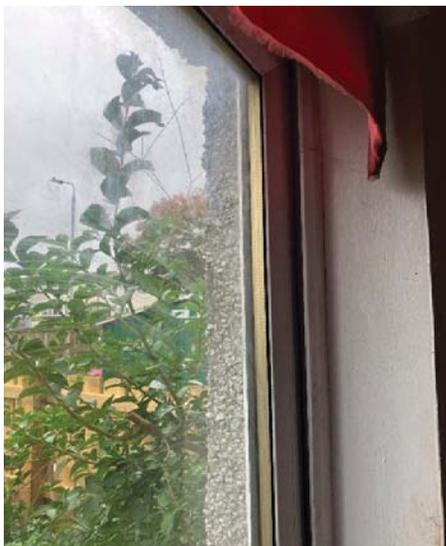
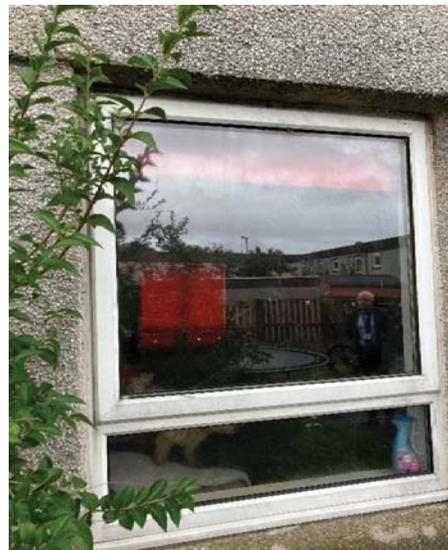
- 13. The top right- hand corner of the living room window fails to close properly, leaving a considerable gap.
- 14. There was no evidence of a leaking radiator in the living room.

Living room window – internal

Living room window – external

As viewed from within, the top right-hand corner of the living room window fails to close properly, leaving a considerable gap. This was confirmed when viewed externally. **Repairs are necessary** although the closing mechanism was functional.

47.1 The Landlord is to repair or replace the defective living room window and ensure that it is in a reasonable state of repair, in proper working order and wind and watertight.

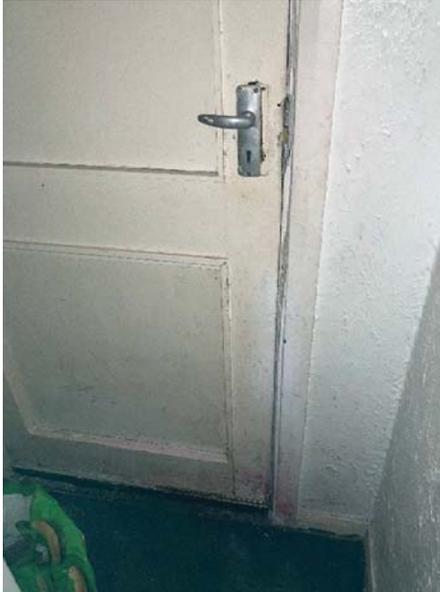
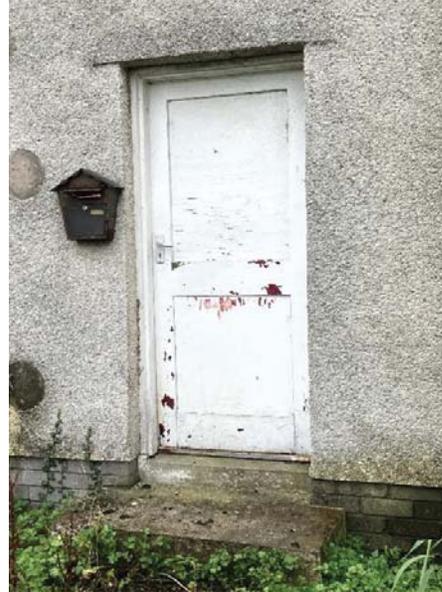
- 17. There was no key available for the front door. There is a gap between the door and the door frame.
- 18. There is a sag in the hall ceiling which is cosmetic and there is no evidence of it being caused by water damage.

“Front door” from hallway.

“Front door” viewed externally

When viewed internally from the hallway there is a small although visible gap and clear daylight is evident between the door and door frame. As viewed from the garden the door appears functional although recent maintenance and decoration has been neglected. **Repairs are necessary** to render the door wind and watertight.

47.4 The Landlord is to repair or renew the front door and or surrounding frame, of the Property to ensure that it is functioning and is wind and watertight.

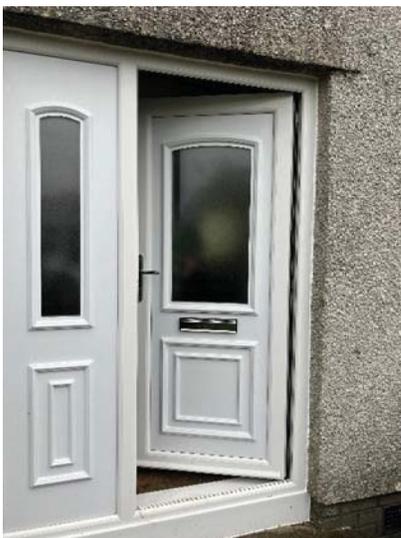
“Rear door”. Recently renewed and fully functional

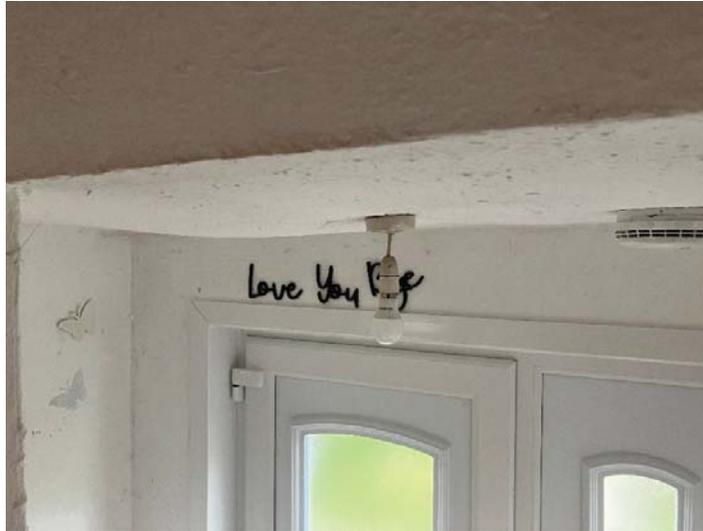
Hall ceiling as viewed from internal stairs

There is a noticeable "sag" in the ceiling which is not considered significant in terms of the repairing standard nor the result of any obvious water damage

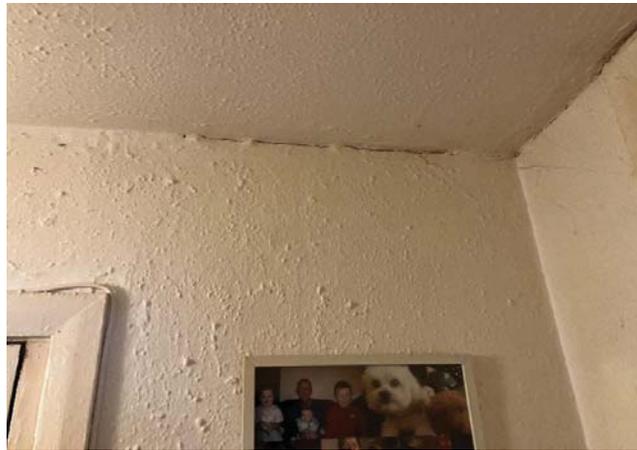
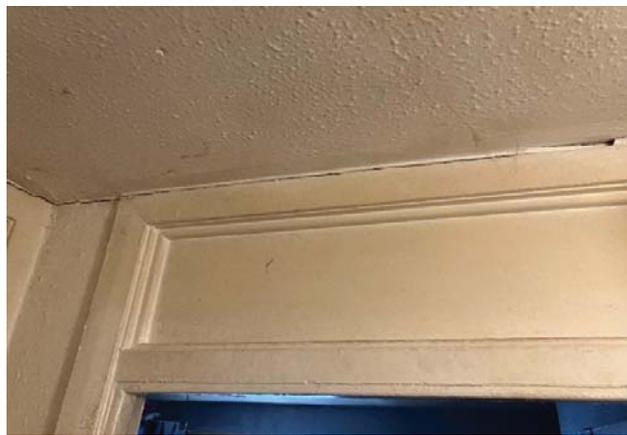
Landing ceiling

Minor separation and shrinkage cracking is evident on the upper landing at the junction of internal wall heads and ceiling. This is not considered structurally significant in terms of the repairing standard.

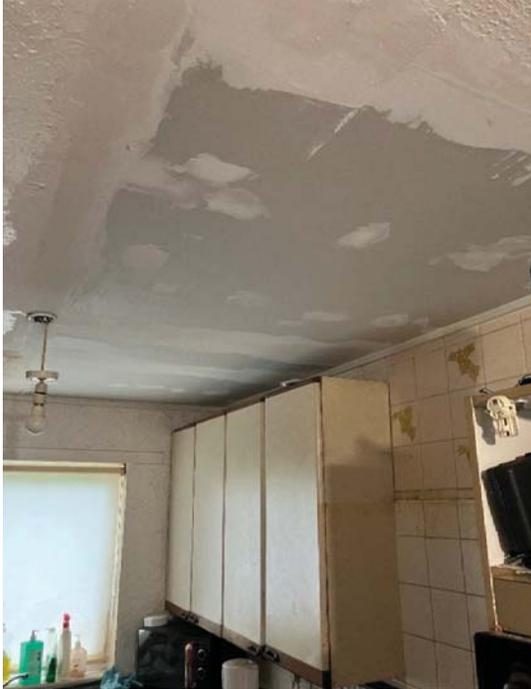
Kitchen ceiling

A section of the kitchen ceiling has been replaced and renewed in plasterboard. It remains undecorated.

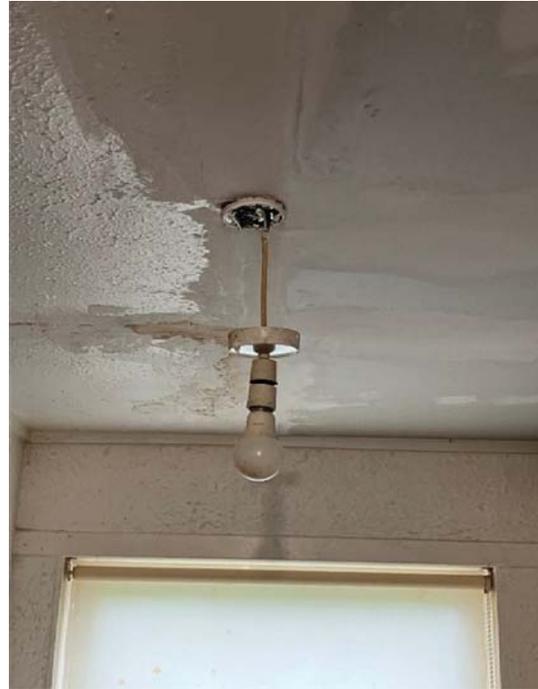
21. There is a suspended light pendant in the kitchen which is not properly secured.
22. The kitchen worktops and cupboards display evidence of significant wear and tear which reflects their age. There is cosmetic damage but they remain functional.

Suspended light pendant kitchen ceiling

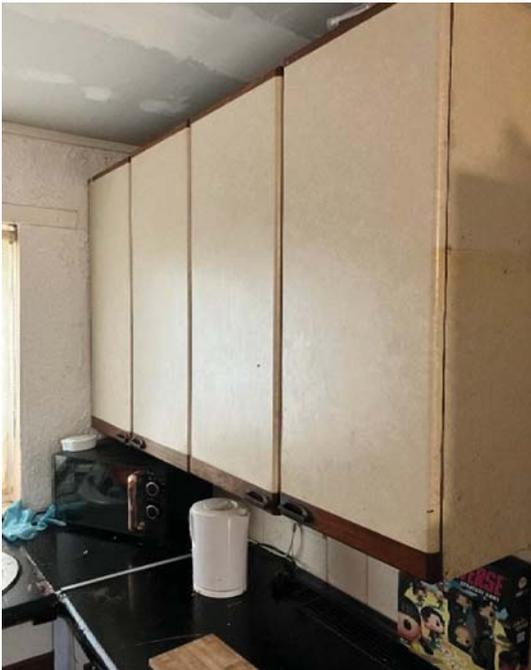
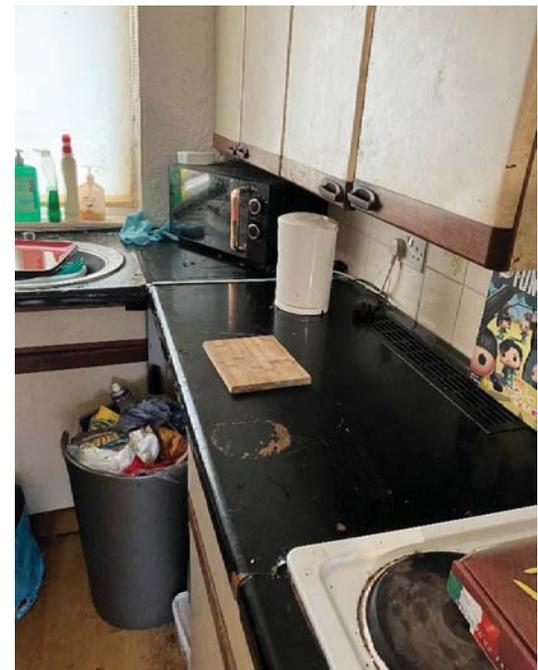
Kitchen cupboards

Kitchen worktops

Both the kitchen cupboards and worktops display evidence of significant wear and tear reflecting their age. They would benefit from refurbishment or replacement although remain functional.

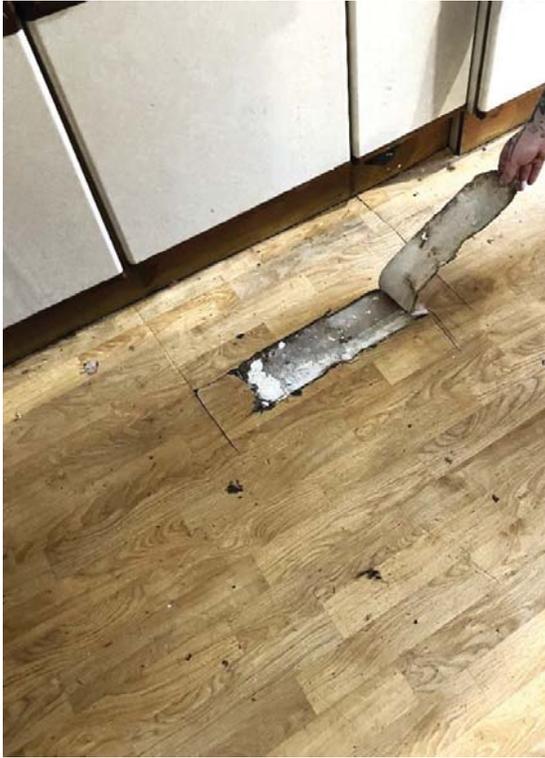
Floor covering in kitchen

The linoleum floor covering, represents a trip hazard and is in **need of significant repair or replacement**

47.5 The Landlord is to repair or replace the kitchen floor covering and ensure that no part of it constitutes a trip hazard.

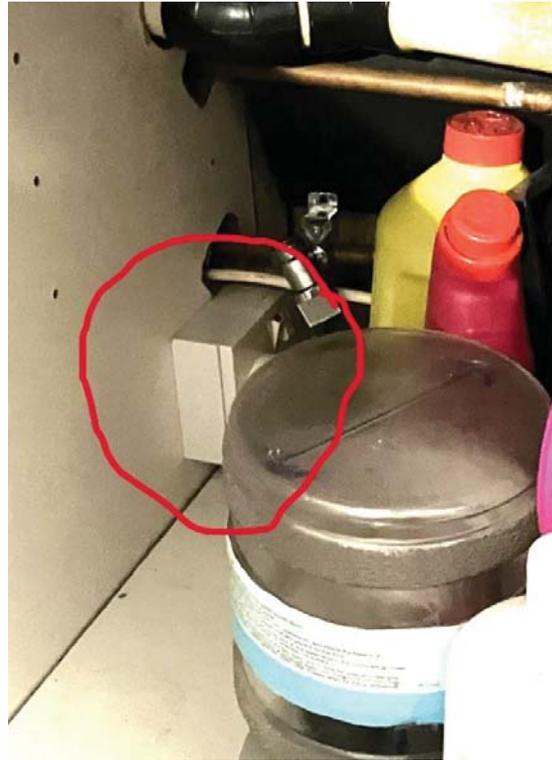
Under sink electrical socket

There is, immediately below pipework in the under-sink cupboard, an electrical power point. (See "EICR").

Several items raised in the application and noted during the inspection warrant **further investigation** notably in the kitchen and “bedroom back 1” where there are actual or alleged electrical defects affecting power point sockets and light fittings.

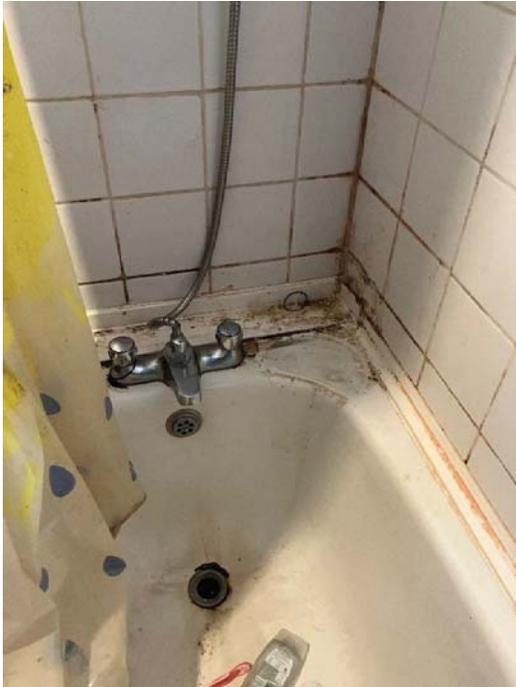
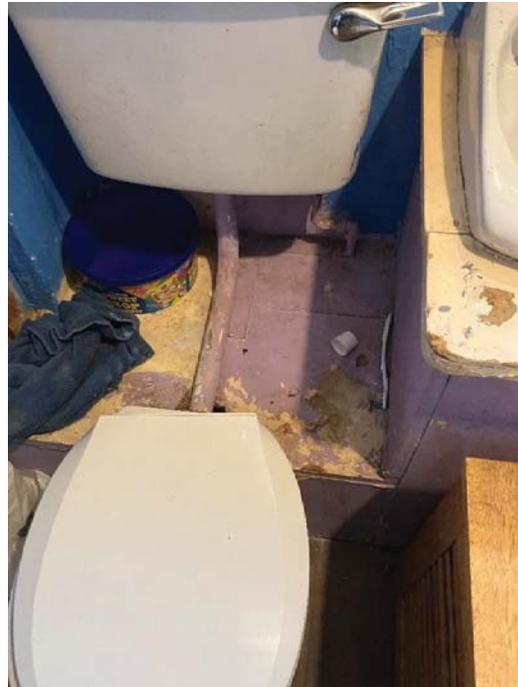
Bath rim and seal

Area next to "sink" and WC

The area surrounding the bath/shower attachment adjacent to the internal walls has been sealed. It displays considerable evidence of mould although the surrounding bath/shower seal appears to be functioning satisfactorily. Staining from previous water "spillage" is evident at the area between the wash hand basin (sink) and WC

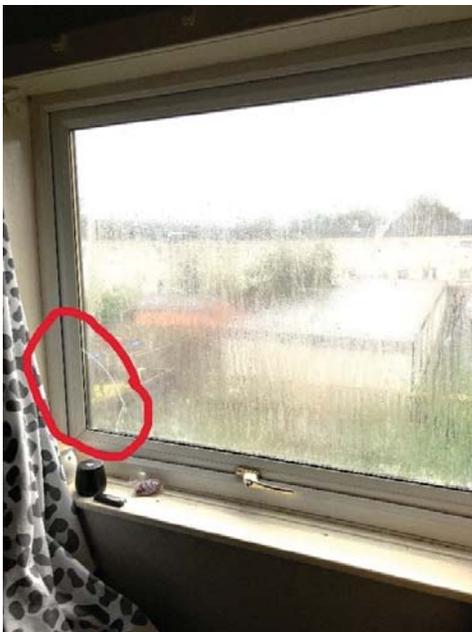
Cracked window pane

The bedroom window closing mechanism is functional although the double glazed panel is cracked/broken at the bottom left corner as viewed from within. **It is in need of repair or replacement**

47.6 The Landlord is to repair the window pane in back bedroom 1.

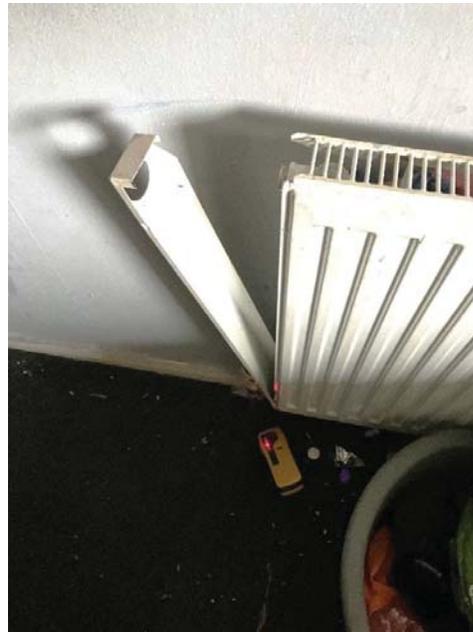
Broken and leaking radiator

The side panel of the radiator is broken and there is a leak at the valve confirmed by damp readings at the carpet below. **The radiator and valve are in need of repair.**

47.7 The Landlord is to repair the radiator in back bedroom 1.

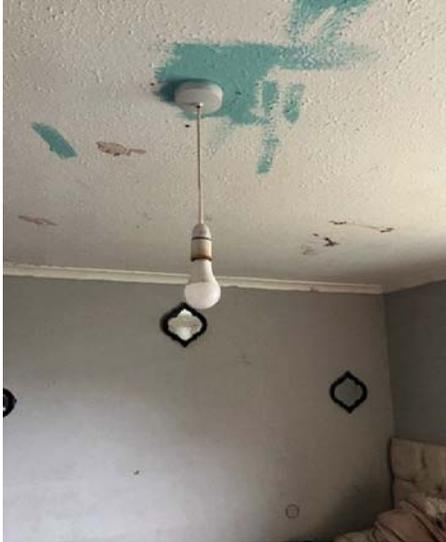
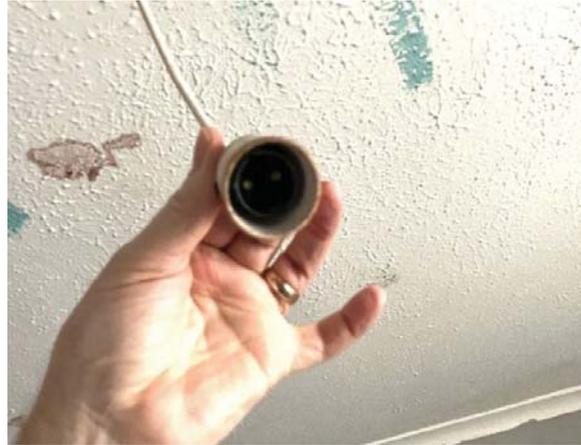
Ceiling light pendant

Light pendant "bulb socket"

The ceiling light is defective. The photographs illustrate that it is not operational when the switch is in the "on" position and there is what may be "singeing" at the bulb socket.

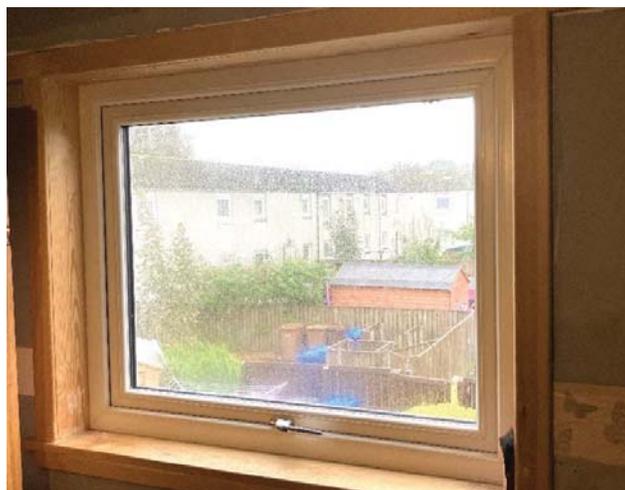
The back bedroom window has been renewed and is fully functional

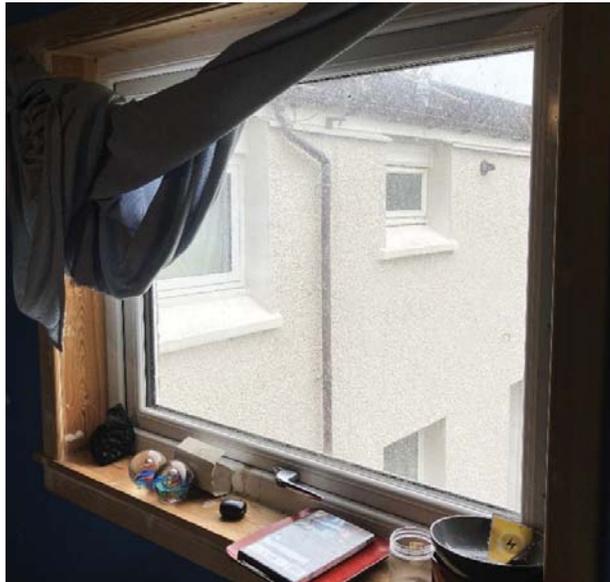
Front bedroom window

The front bedroom window has been renewed. No detailed inspection was possible as full access could not be gained to the room. The current tenant confirmed that it was fully functional.
