**First-tier Tribunal for Scotland (Housing and Property Chamber)**

**Repairing Standard Enforcement Order (RSEO): Housing (Scotland) Act 2006  
Section 24**

**108 Cumbrae Drive, Motherwell, ML1 3LJ ("the Property")**

### Pre-hearing inspection summary and Schedule of Photographs

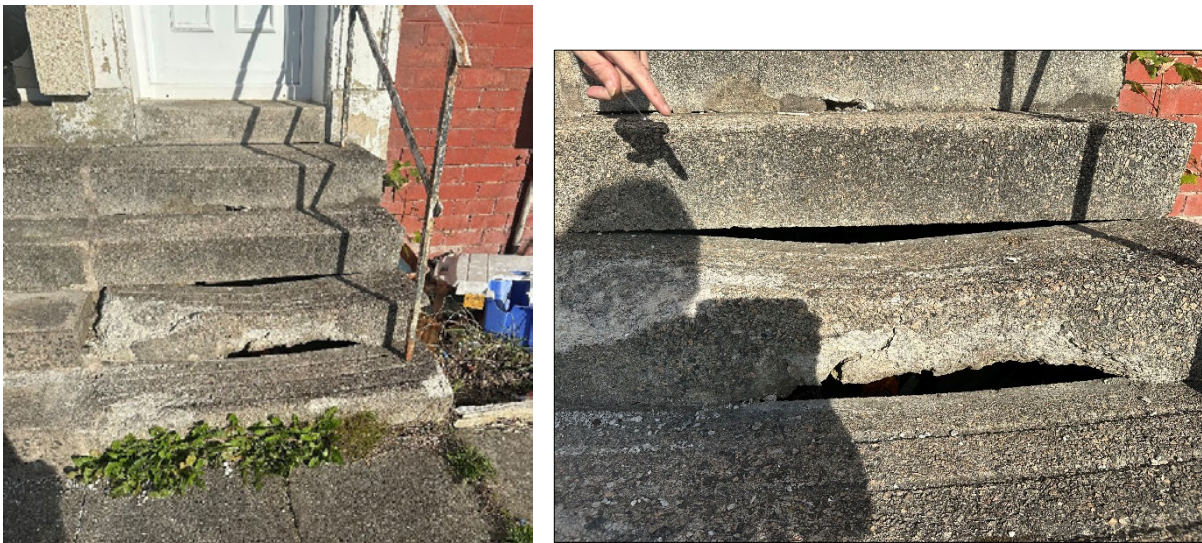
#### **External stairs**

- 11.1 The front steps were uneven, particularly the edges of the first step and middle and edges of the second step. There was a large gap at the base of the riser of the second step and a smaller gap at the base of the riser of the third, which presented potential tripping hazards.

External concrete stairs are badly damaged and weathered. The second step has failed and is potentially dangerous.

- b) Front steps: To instruct a suitably qualified contractor to repair or replace the front steps to the Property to provide a means of entrance and egress from the Property that is even, secure, and free of trip-hazards;

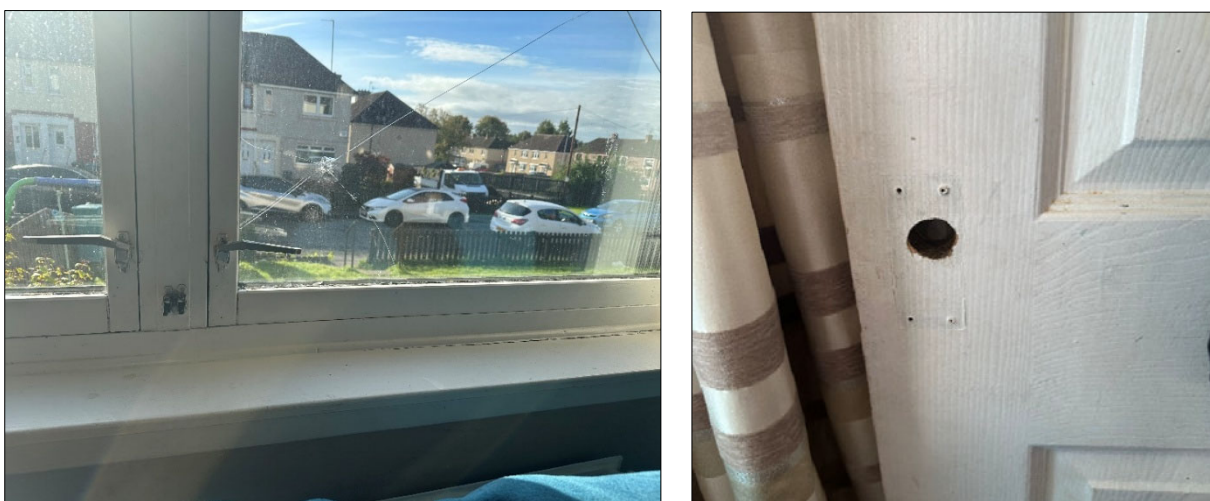
#### **Lounge**

- 11.2 The door handle to the living-room door was missing.
  - 11.3 In the double-glazed window to the living room, the leftmost outer pane (when viewed from exterior) was badly cracked, showing evidence of two impact points. The Tenant stated that a report had been made to the police about local youths causing the damage by throwing stones.

Living room window – double glazed window panel has a large external crack.  
Internal lounge door handles are missing.

- d) Broken front lower window: To instruct a suitably qualified contractor to repair or replace the broken front living room window;
- e) Upper rear bedroom window: To instruct a suitably qualified contractor to repair or replace the window and/or frame so that the window closes flush and securely within its frame;

- f) Living-room door handle: To instruct a contractor to replace the missing door handle to the living room door;
- g) Kitchen cabinets: To instruct contractors to undertake work:

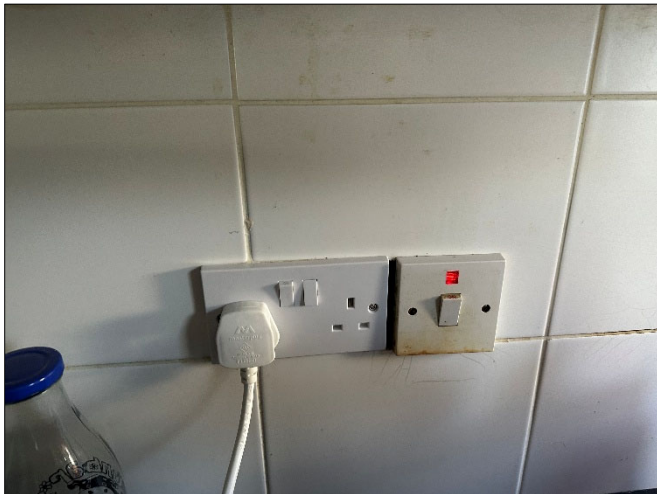
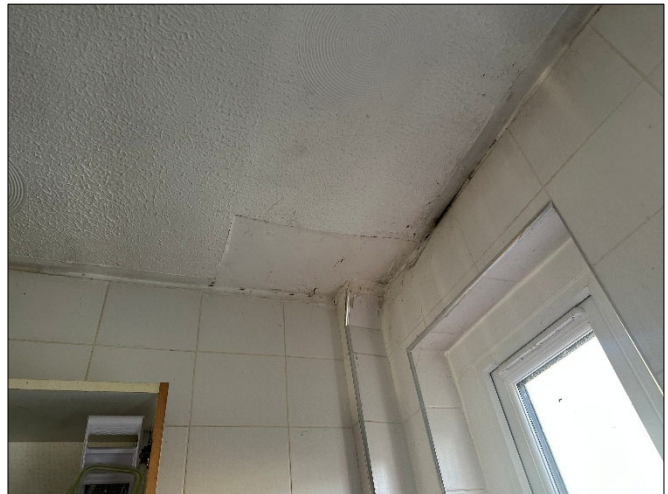
- 11.4 In the kitchen, the Tenant directed us to an isolator switch in the kitchen that was used to operate the washing machine. She explained that, due to various issues, she had not used it recently but had recently been informed by the Landlord's electrician that the switch was working. She had attempted use the plug (underneath the work surface) the prior weekend but it did not operate. She currently required to plug the washing machine into one of the other plugs above the work surface.

Double socket has been replaced however the tenant advised the isolator switch is not working and the washing machine has to be plugged into the new double socket above worktop. A section of ceiling has been patched and a slight bow was noted however no evidence of water ingress was visible.

- iii. To instruct a suitably qualified contractor to inspect and, as necessary, repair or replace the isolator switch for the washing machine in the Property's kitchen;

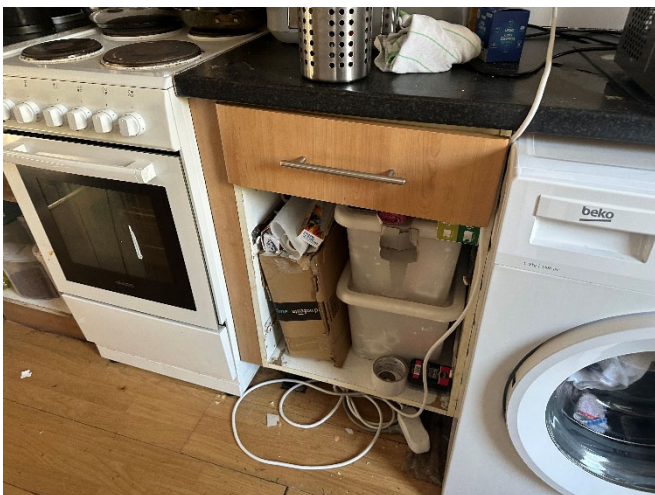
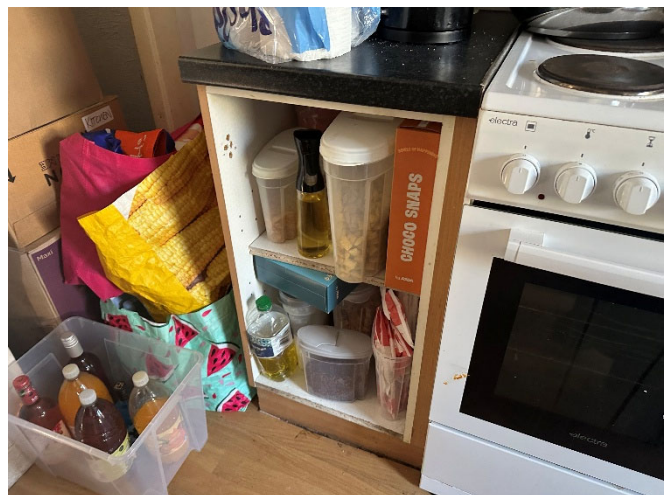
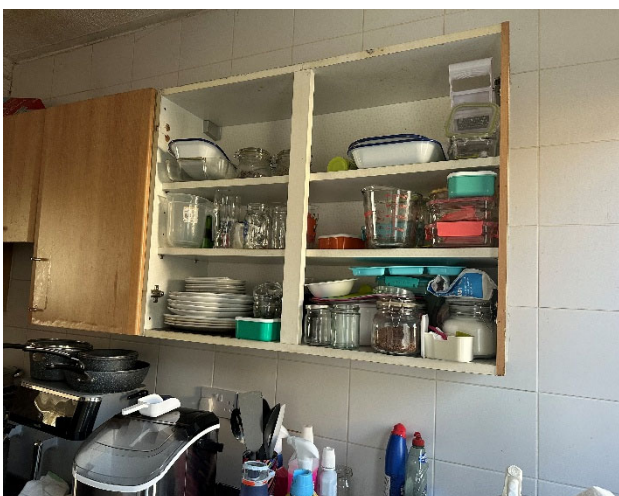
- 11.5 In the kitchen we noted three cabinets missing their front doors, one cabinet that appeared to be missing drawers and drawer fronts, and one door which was missing a handle.

Kitchen cabinets are missing doors and one unit is missing 3 drawers.

- i. To replace: the missing three doors; the three missing drawers; and any handles missing on existing doors; or
  - ii. In the alternative, to fit new cabinets, drawers and doors within the kitchen, so as to provide an equivalent food preparation area and areas for storage.

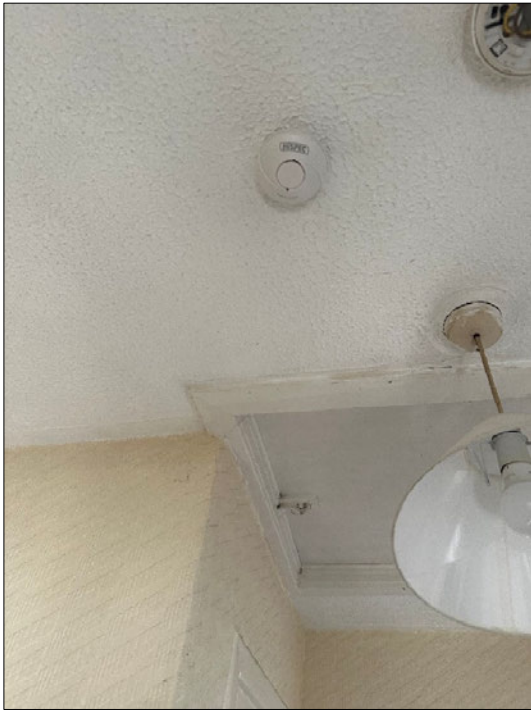
## **Fire detection**

Inter linked smoke and heat detectors have been fitted and test and found to be in good working order.

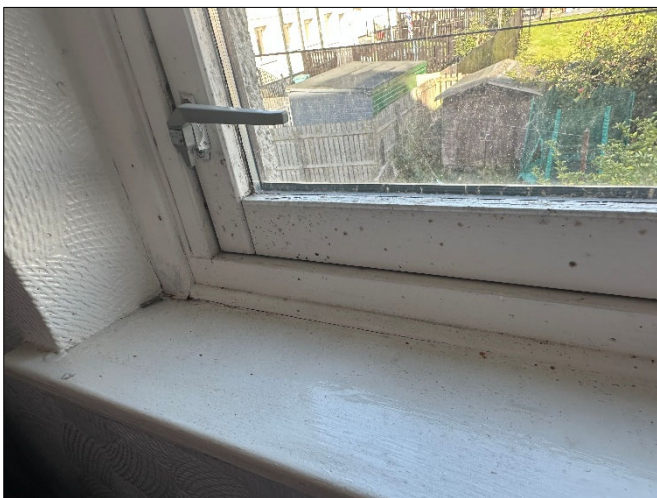
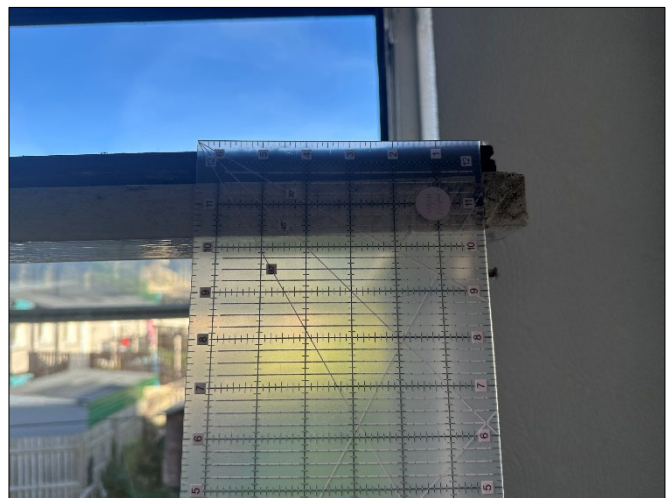
## **Rear Bedroom**

- 11.6 In the upper rear bedroom, we observed that the window was unable to close fully, due to the window and/or the frame being warped.
- 11.7 In regard to the Tenant's reports of damp and mould in the lower rear bedroom and upper rear bedroom (the latter directly being direct above the former), we observed:

The timber framed double glazed window unit was inspected and was found to be swollen and warped.

All windows have been fitted with trickle ventilation, however it was noted during the inspection all vents have been painted over and no longer open to allow background ventilation.

- c) Damp and mould:
  - i. To instruct contractors to undertake work to repair or replace the existing trickle vents in all windows of the Property;
  - ii. To instruct contractors to investigate and, as necessary, undertake work to repair or replace, the vent between the lower bedroom and living area;

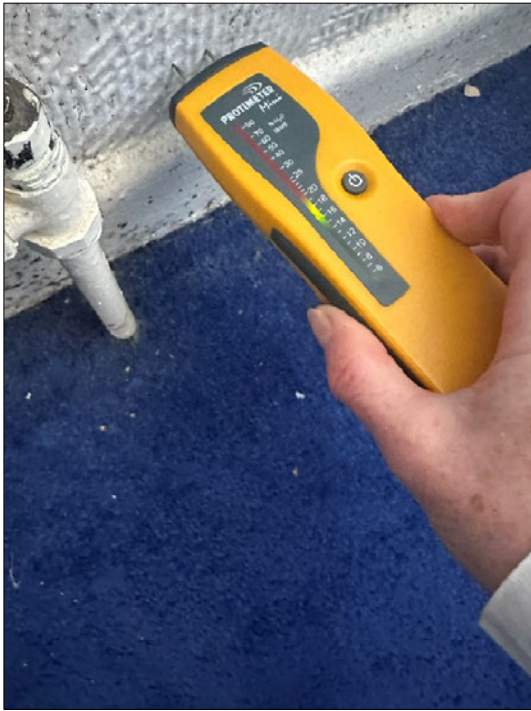
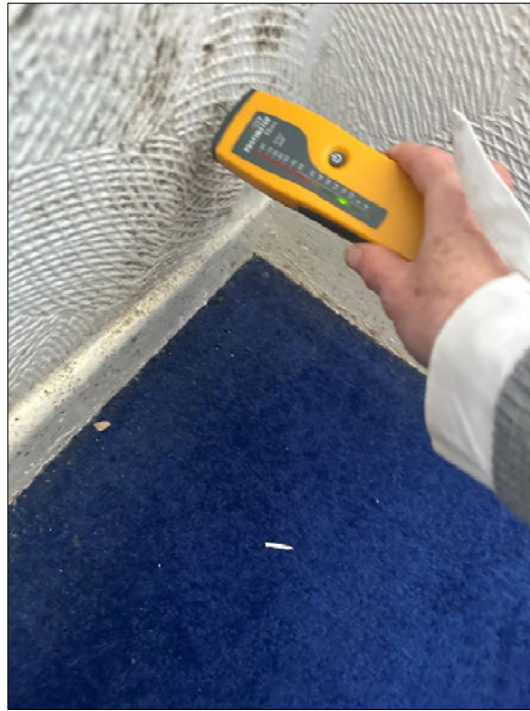
## **Rear Bedroom Cont**

- 11.7.2 In the upper bedroom, evidence of black mould spotting on the window sill and lower window frame, as well as on that portion of the wall to the lower right of the window (viewed from within the room). Damp meter readings were taken and found moderate readings in that portion of the wall to the lower right of the window and high normal to the lower left.

Slight mould was noted below window, all readings within high normal range.

- iii. To instruct a suitably qualified specialist to inspect the Property (and in particular the lower and upper rear bedrooms and the exterior walls thereto) to examine for the presence of damp and mould, and to report on any recommended interior or exterior works to remedy or mitigate against damp and mould in the Property;

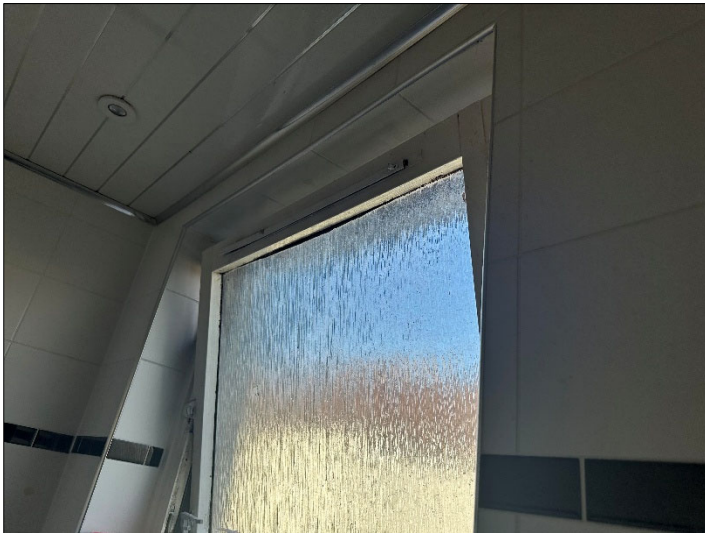
## **Bathroom**

- 11.7.3.3 The bathroom, adjacent to the upper rear bedroom, had no mechanical ventilation and, due to the blocked trickle vent, could only be externally ventilated by opening the window (the window being found wedged open during our inspection).

No mechanical ventilation fitted to the bathroom, and the window was wedged open during inspection.

Trickle ventilation was fitted to window however it was painted over and inoperable.

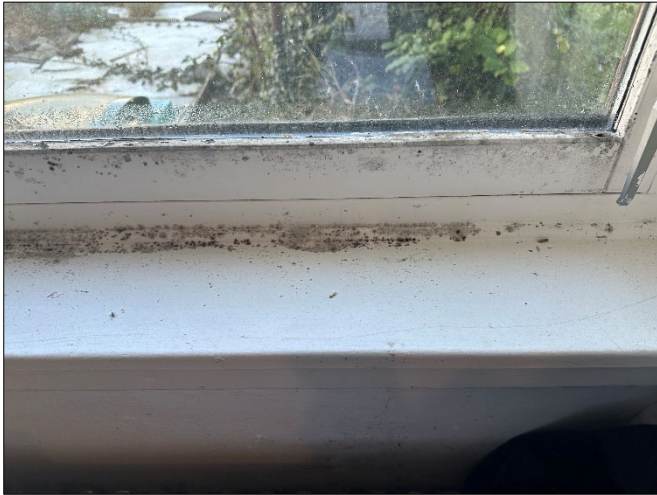
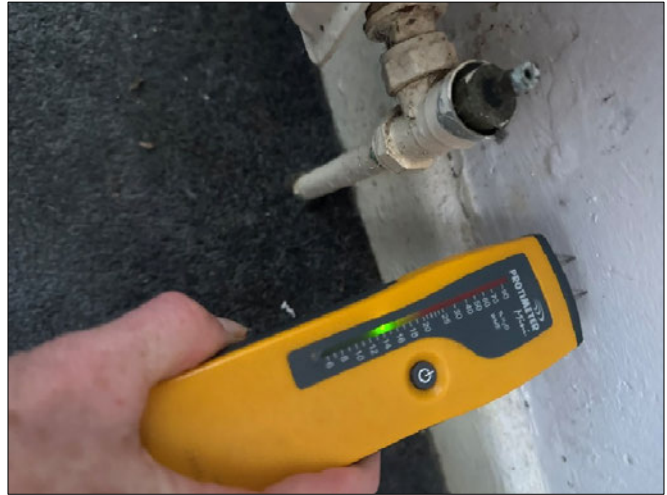
### Ground floor rear bedroom

- 11.7.1 In the lower bedroom, evidence of black mould spotting on the window sill and lower window frame. Damp meter readings were taken and found high normal or moderate readings in that portion of the wall to the lower right of the window (viewed from within the room) and high normal to the lower left.

Evidence of mould noted at window and back wall. Moisture reading within high normal range.

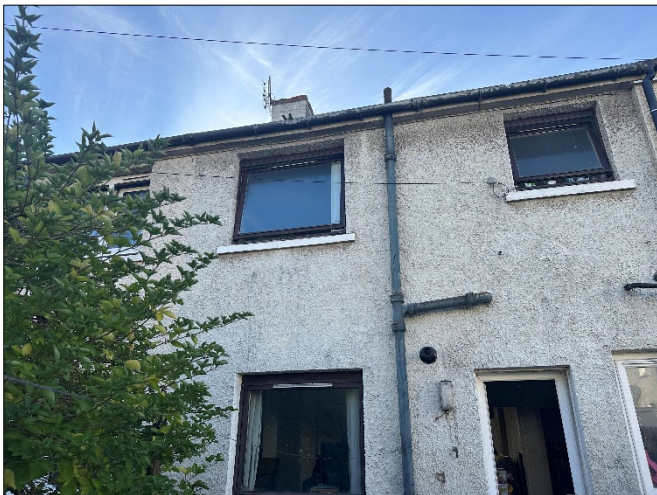
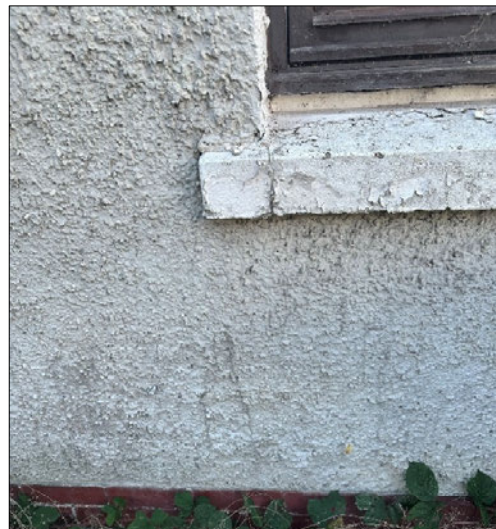
### External rear elevation

- 11.7.3.4 The tumble dryer in the upper landing was a condensing dryer so had no hose to vent it externally.
    - 11.7.3.5 The exterior walls at the rear bedrooms showed some sign of water damage to the exterior sills, and some slight cracking to the roughcasting.

- 11.7.3.6 There was some vegetation visible in the guttering above the rear bedrooms.
12. We were informed by the Tenant of the following issues that had been materially resolved in the months prior to the inspection, though which had aspects requiring consideration at the inspection or Hearing:

Some cracking was noted above ground floor bedroom and an area of vegetation was visible at the gutter. Cracking was also visible at the ground floor bedroom windowsill.
