**Statement of Decision of the First-tier Tribunal for Scotland (Housing and Property Chamber) under Section 24 (1) of the Housing (Scotland) Act 2006.**

**Tribunal Ref: HPC/RP/25/2433**

**Property: 5 Firwood Road, Newton Means, Glasgow G77 5PX**

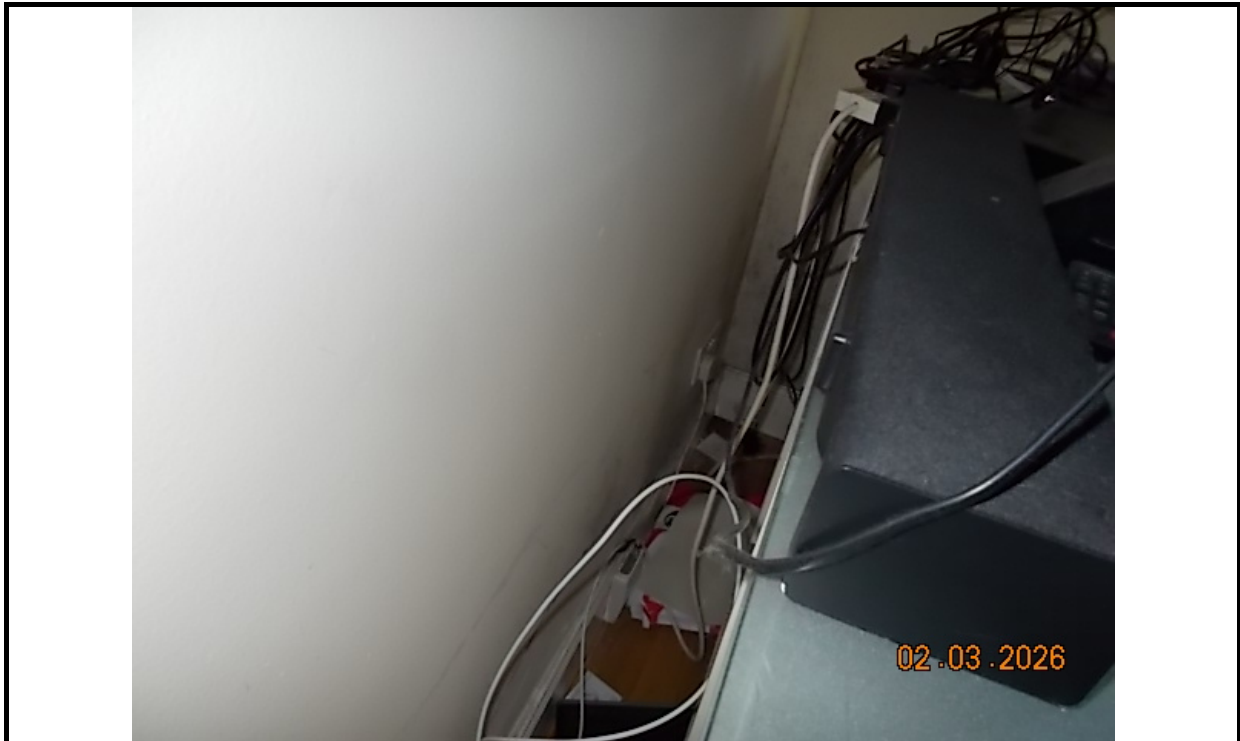
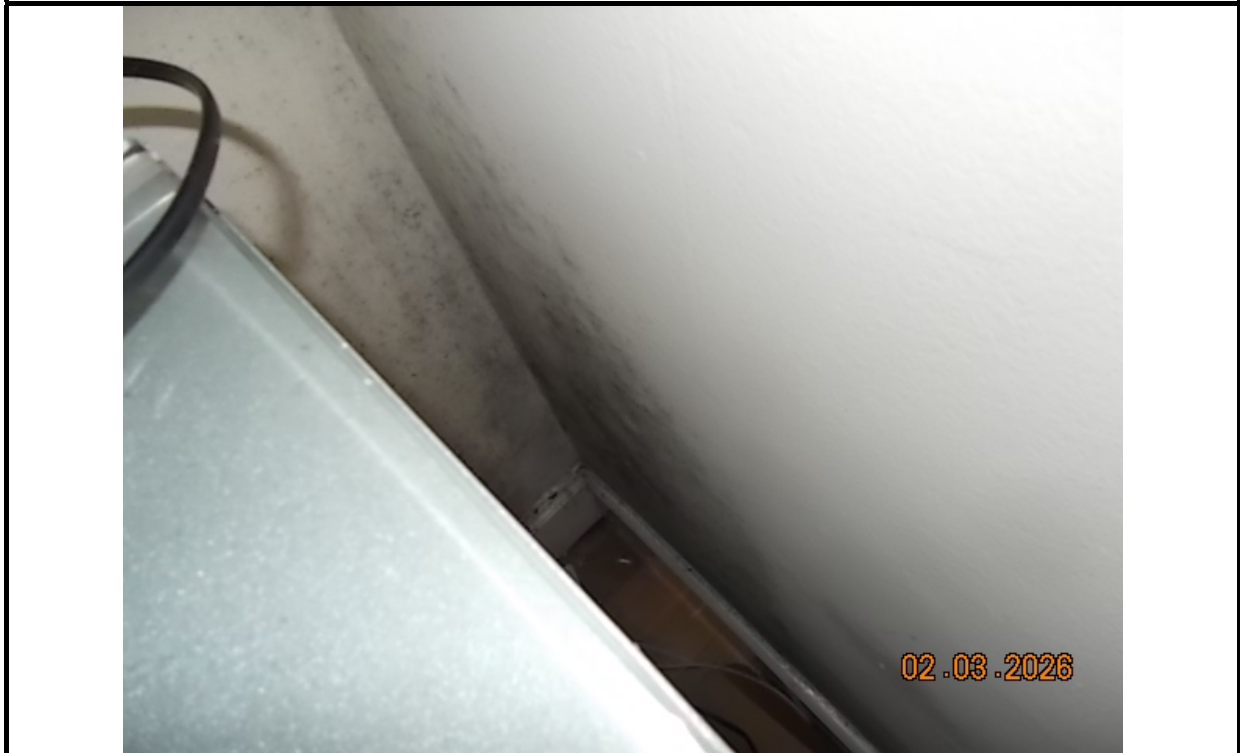
- i. Living Room – mould growth was present at lower levels behind furniture on the outer walls. Condensation was noted on the inside of windows and around window frames.

A Peter Cox report submitted to the Tribunal supports the view that the mould is likely to be due to condensation as a result of heating and ventilation strategies, these being exacerbated by heat loss due to limited insulation.

1. Living Room behind TV

2. Living Room behind TV

Solutions to the problem may include increasing ventilation to extract warm moist air at source and to improve insulation to reduce heat loss. (The issue in relation to insulation is addressed further below)

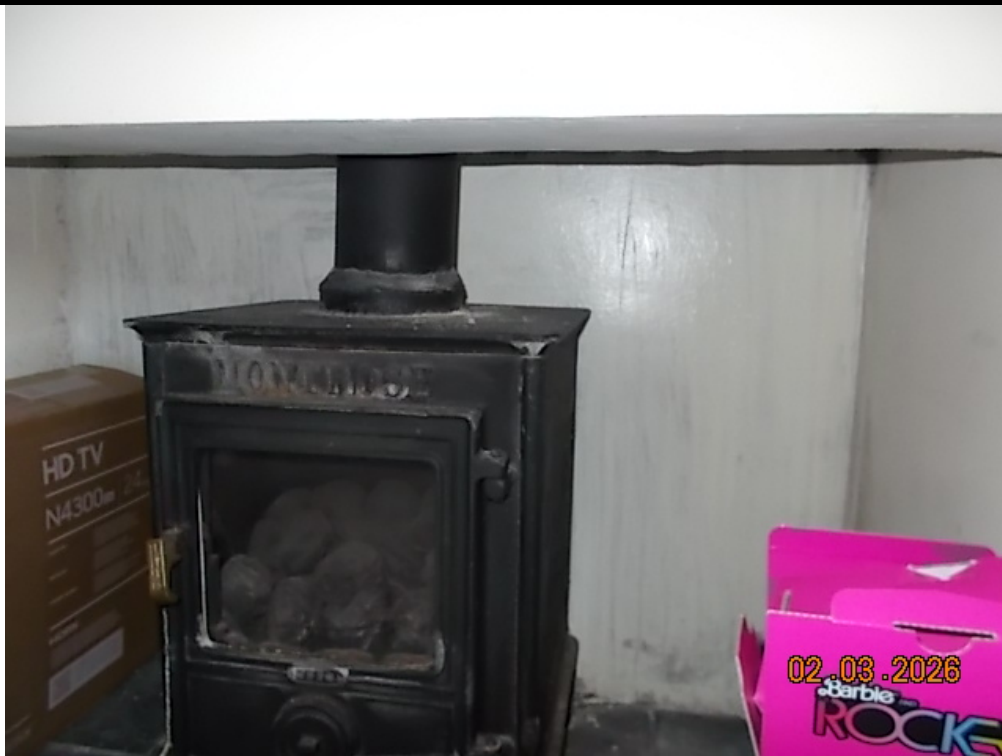
3. Living Room fireplace

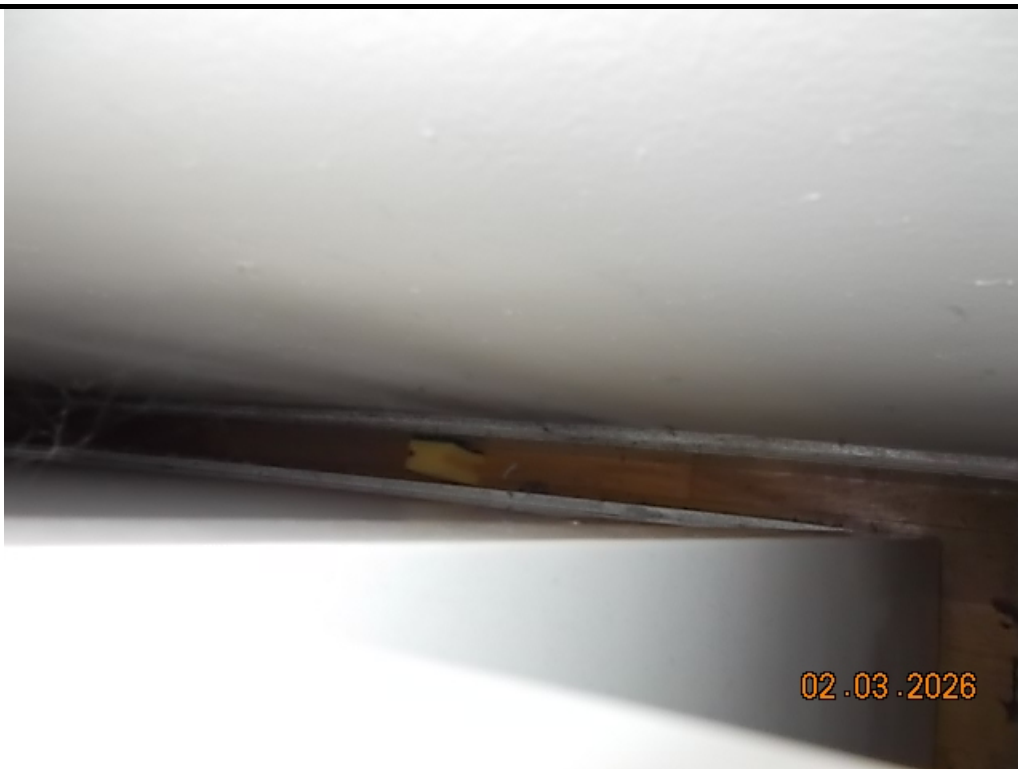
4. Living Room left of fireplace

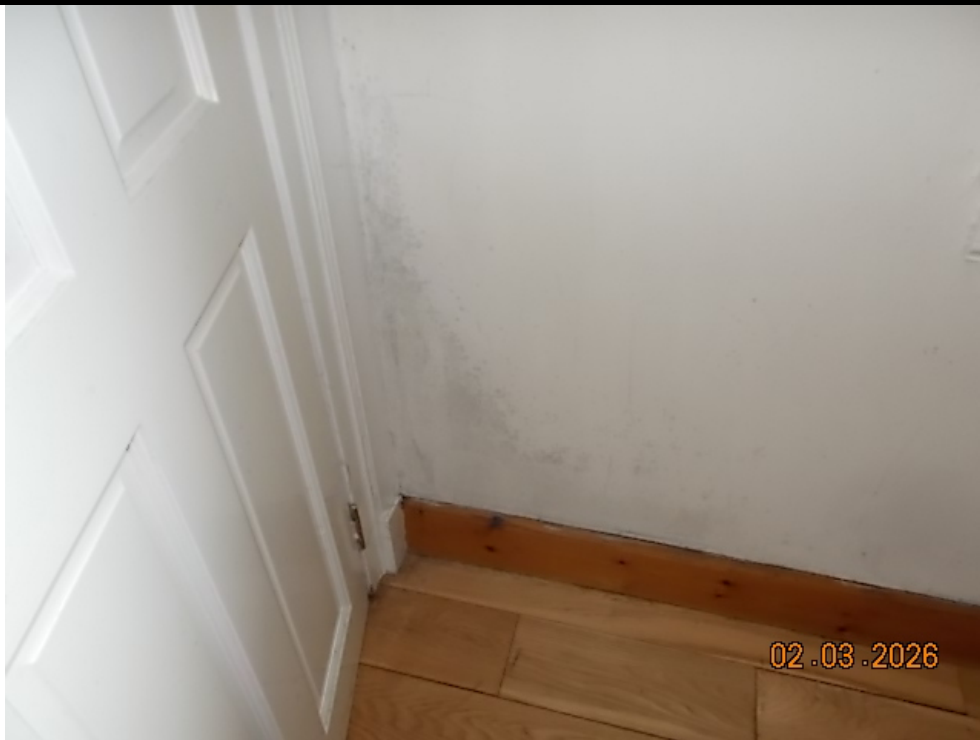
- ii. Dining Room – mould growth was noted on the outer wall at the door to the kitchen, at lower levels.
- iii. Family Bathroom – there was evidence of previous mould growth on the ceiling. There was some minor discolouration of areas of walls which were not tiled.

5. Dining Room at Door to Kitchen

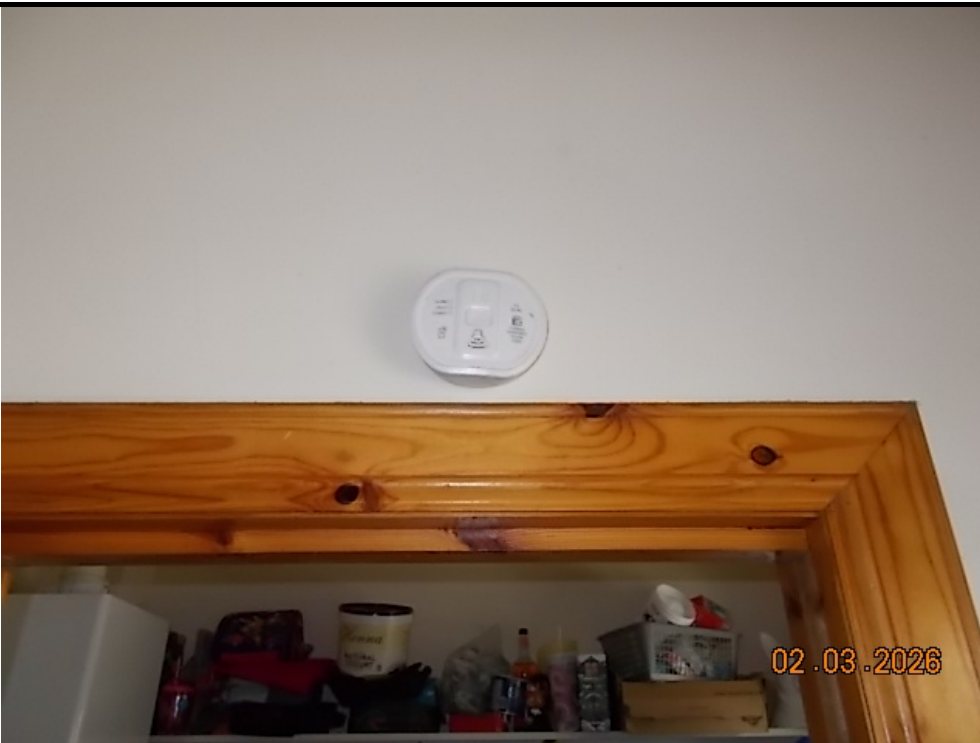
- i. While it did not form part of the application, the Tribunal noted there was an operational carbon monoxide detector and alarm. This, however, is located in kitchen rather than the utility room where the boiler is located. It should be relocated in accordance with Scottish Government statutory guidance.
- ii. The Tribunal noted there were interlinked smoke and heat alarms and that these were operational.

6. Carbon Monoxide Alarm above door from Kitchen to Utility Room

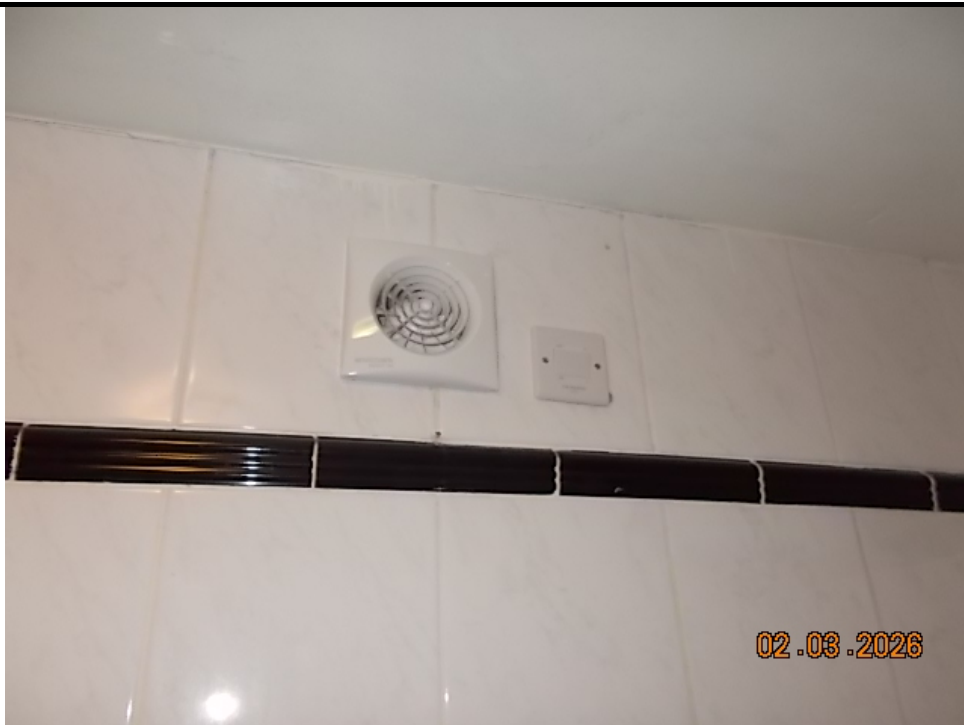
- i. The fans in the bathroom appear operational but are not very efficient.
- ii. Two fans in the kitchen do not appear to be operational. A grille is missing externally.

The Tribunal found the extractor fans within the Property to be unsatisfactory, they being either inoperative or inefficient.

8. Extract fan in family bathroom

The Respondent should instal larger, effective fans.

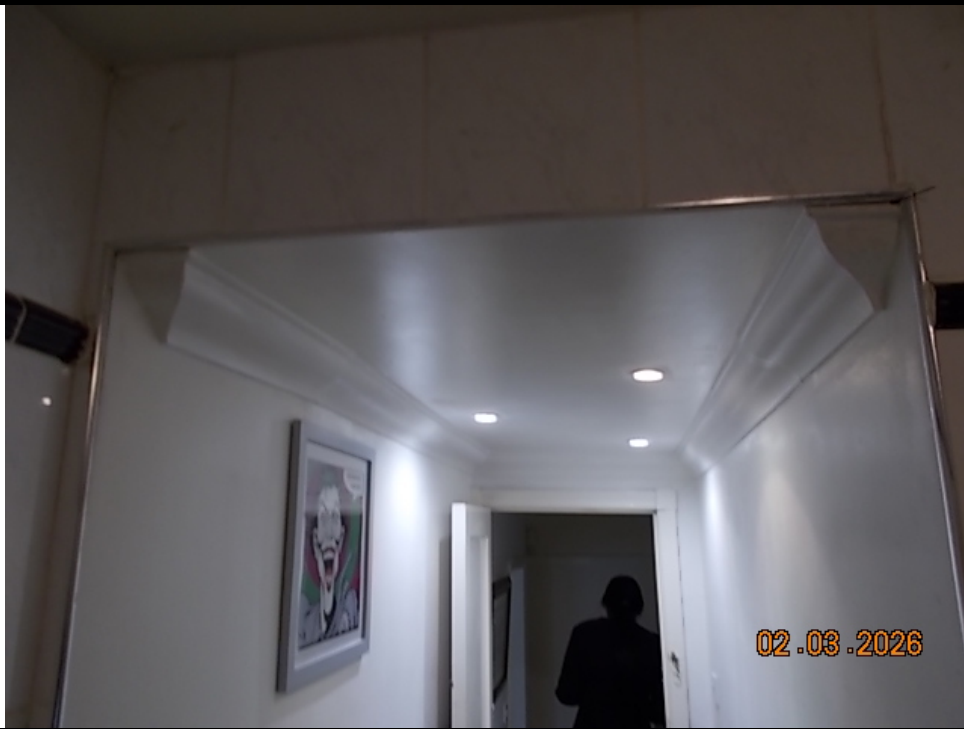
9. Redecorated ceiling to Family Bathroom

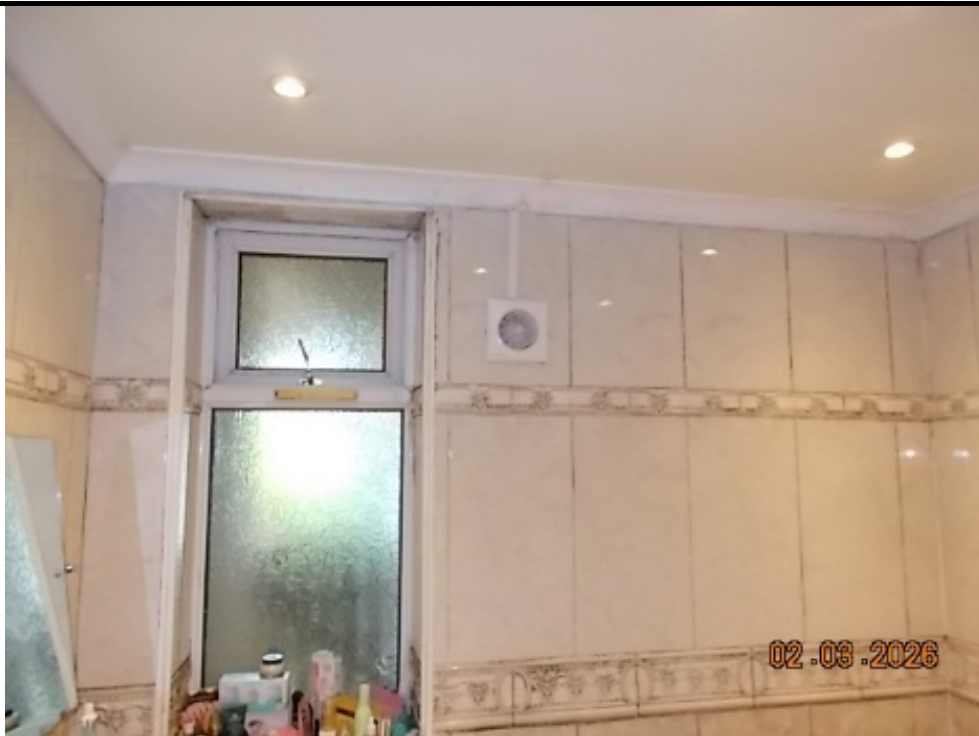
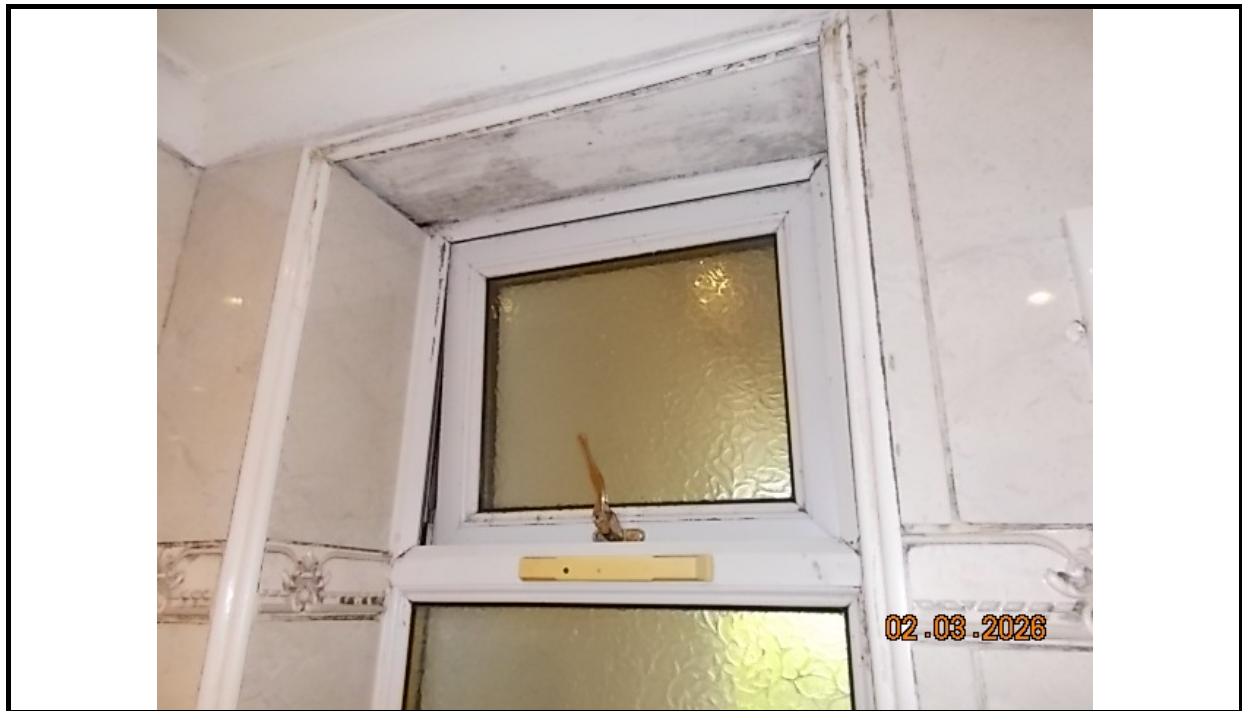
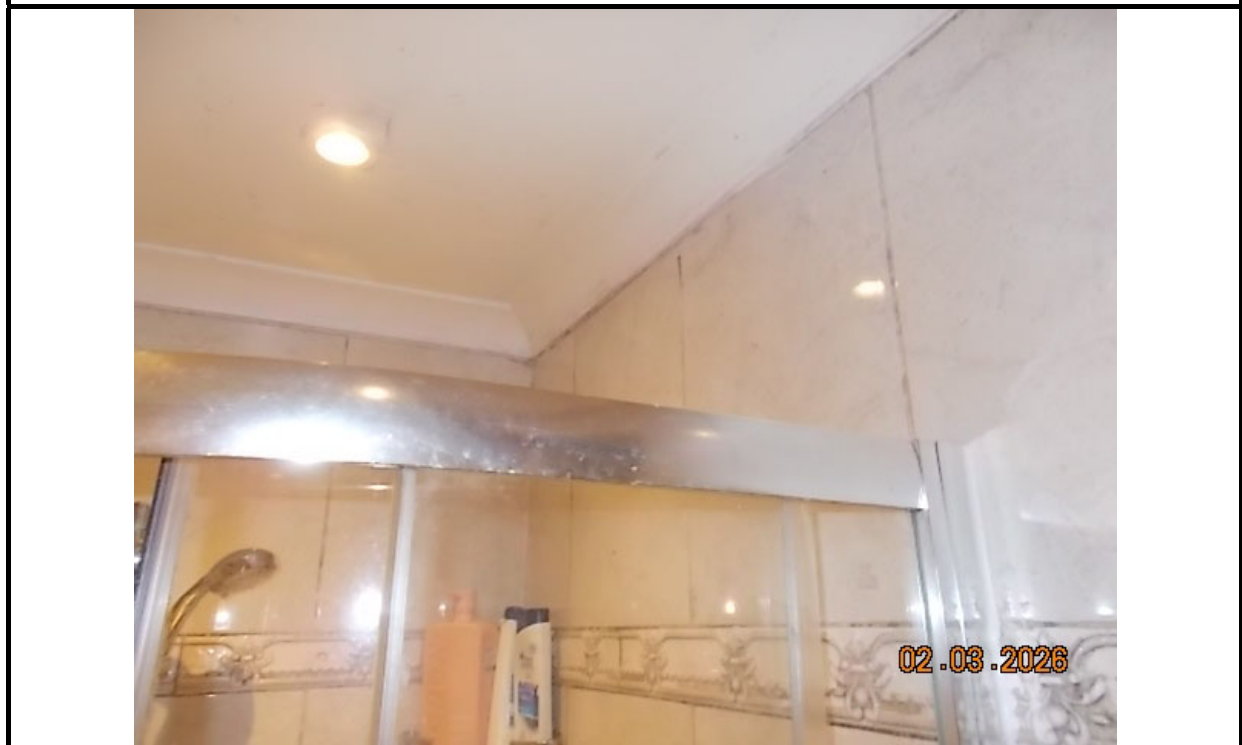
- iv. Shower Room – mould growth was noted on the ceiling and at joints of tiling on walls, particularly around the window.
- v. Rear Bedroom – mould growth was noted on the outer walls at the corner between the rear and side walls, at low level.

10. Shower Room

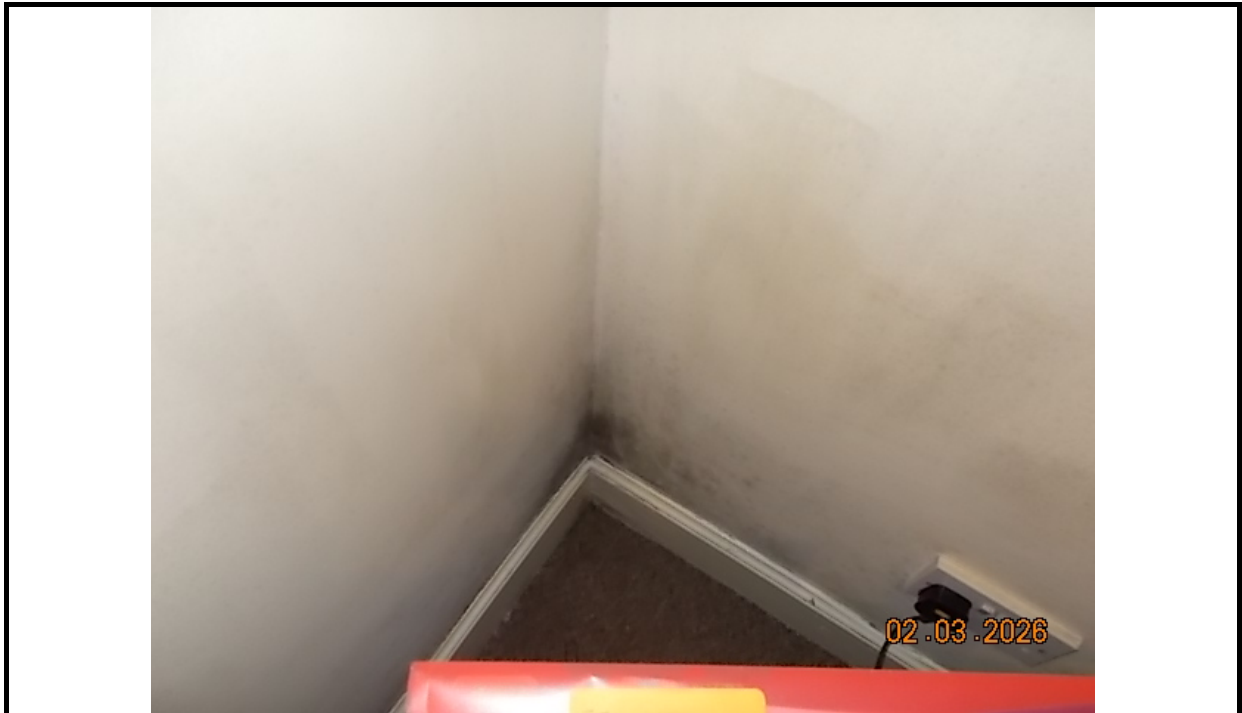
13. Rear Bedroom corner of outer walls

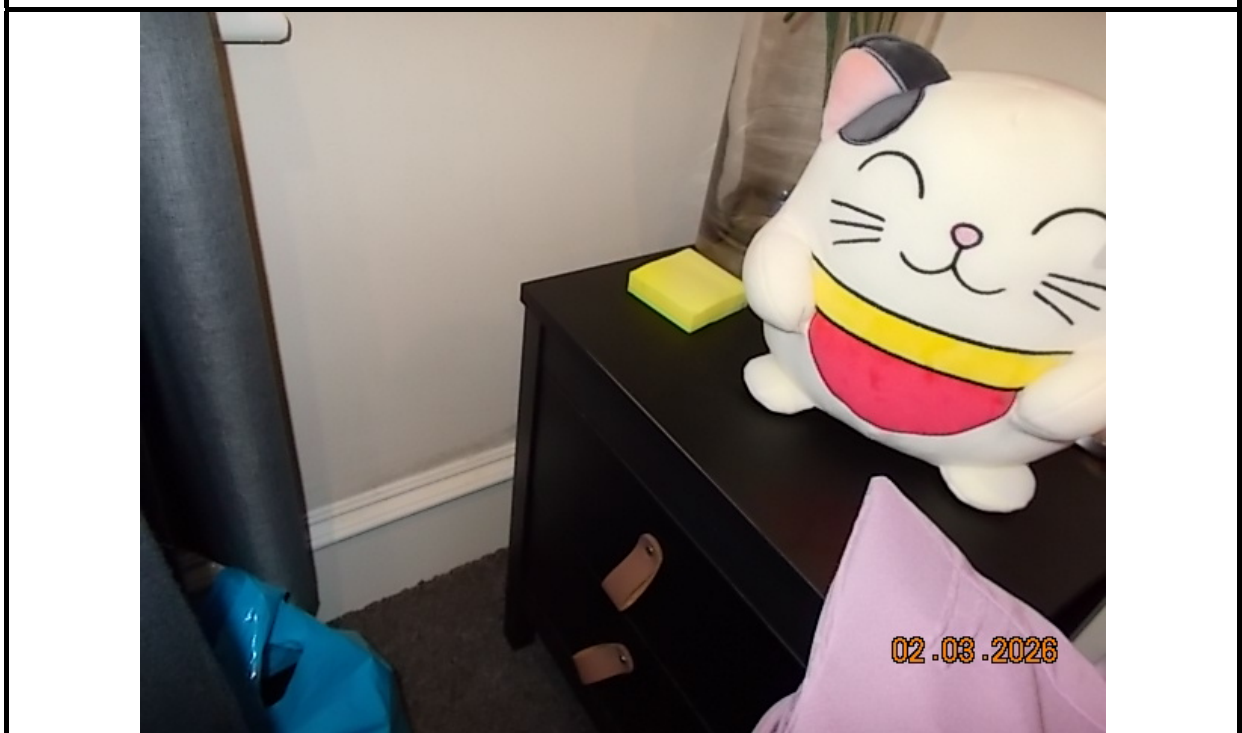
- vi. Sitting Room – no mould growth was visible.
- vii. Front Bedroom - mould growth was noted on the outer walls at the corner between the rear and side walls, at low level.

14. Front Bedroom corner of outer walls

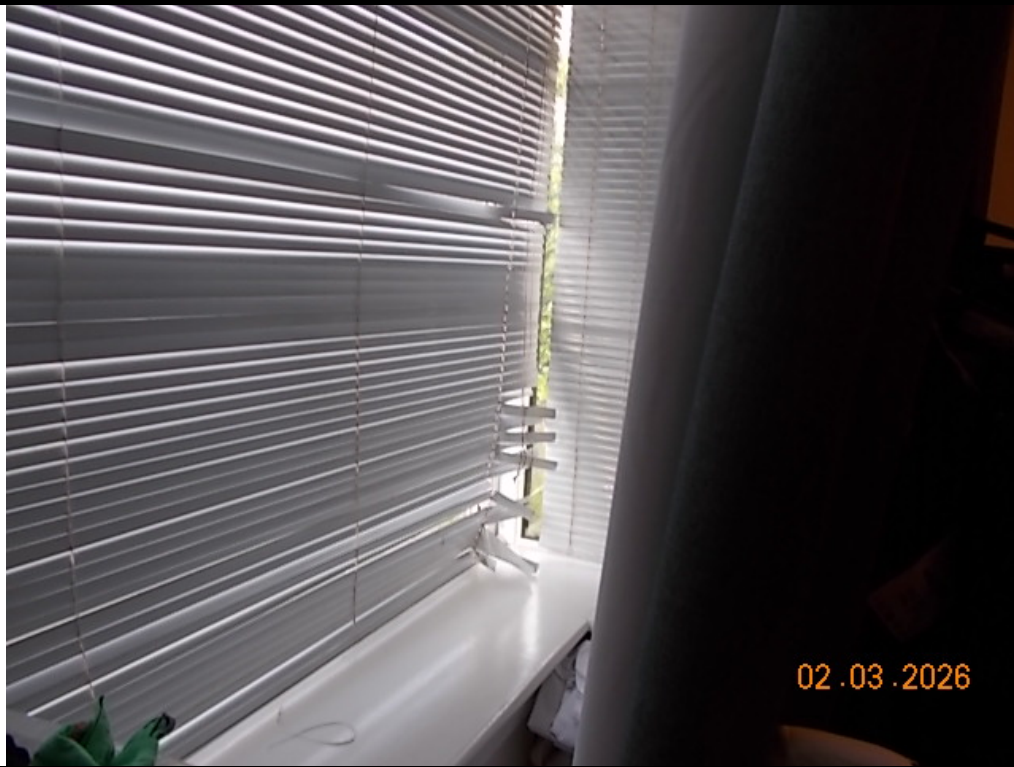
This was not obvious to the Tribunal.

The windows appeared to be satisfactory with all seals intact.

15. Window to Front Bedroom

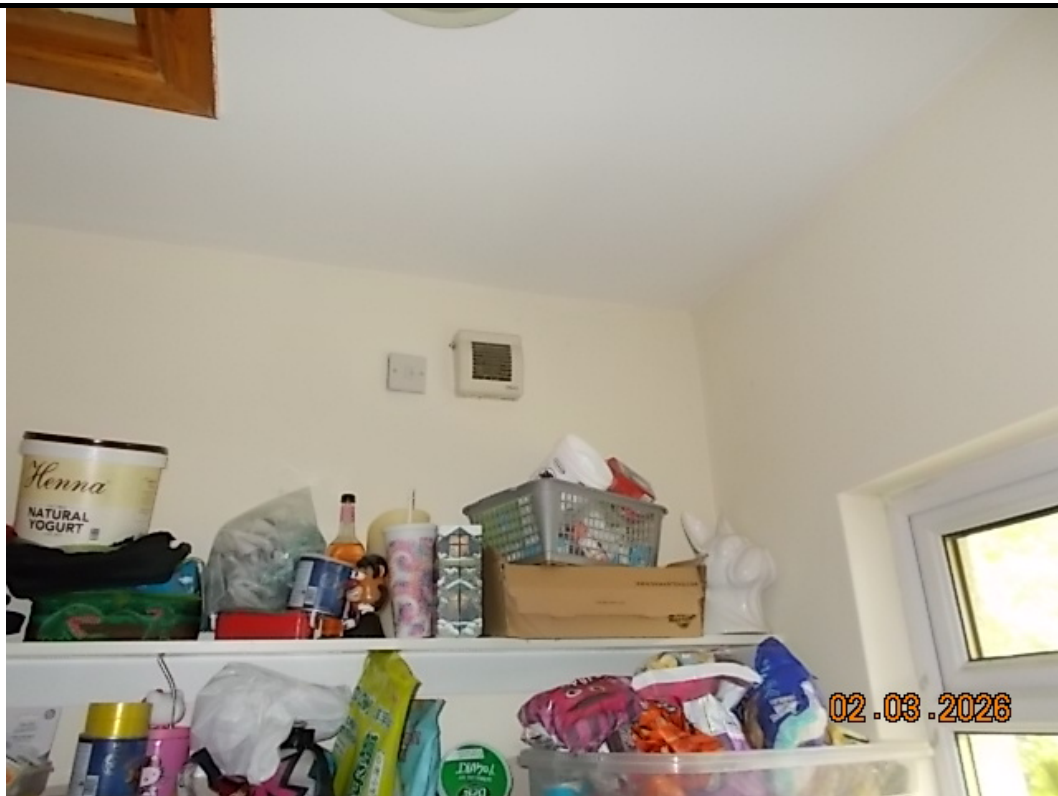
16. Extract Fan in Utility Room

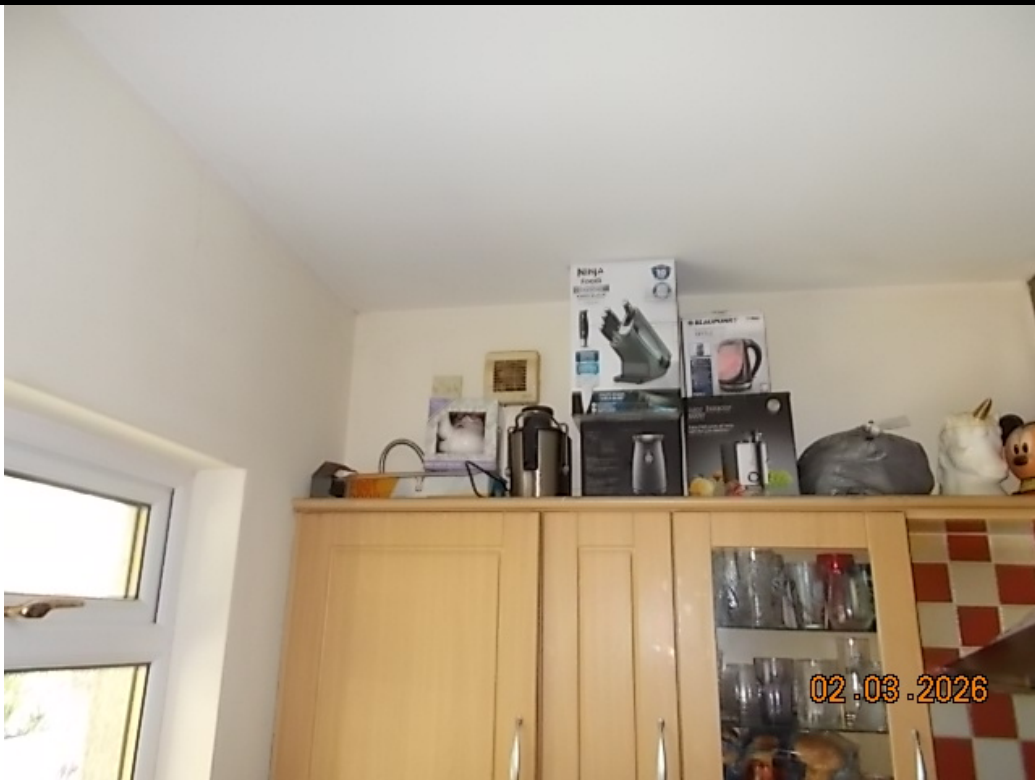
17. Extract Fan in Kitchen

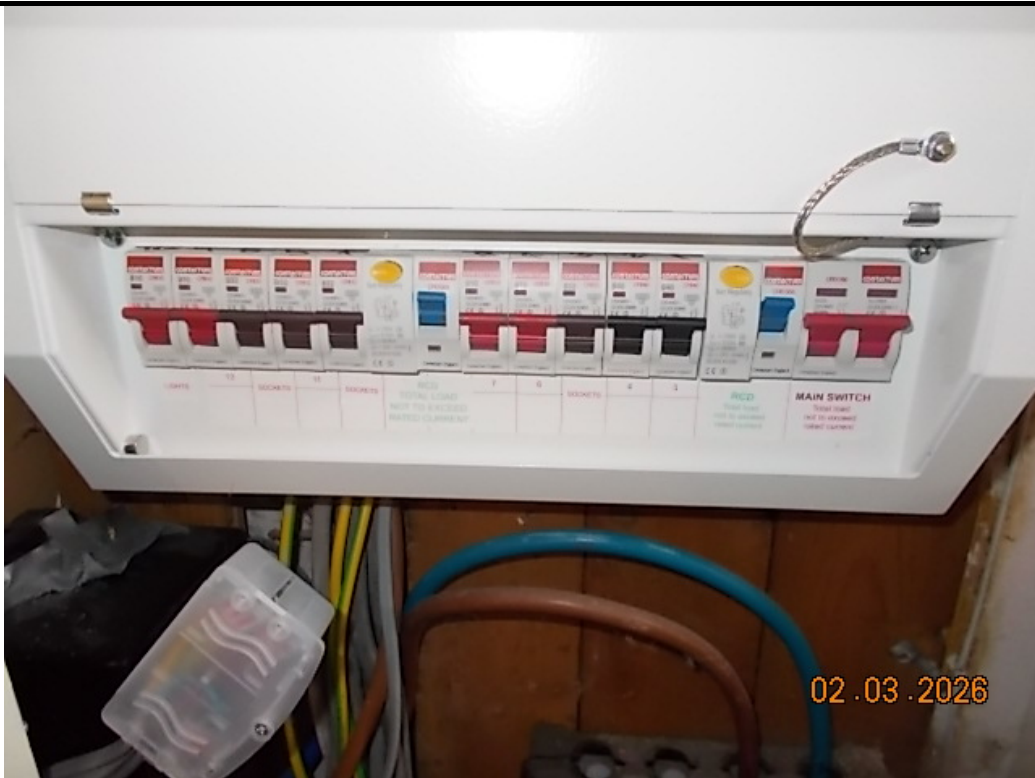
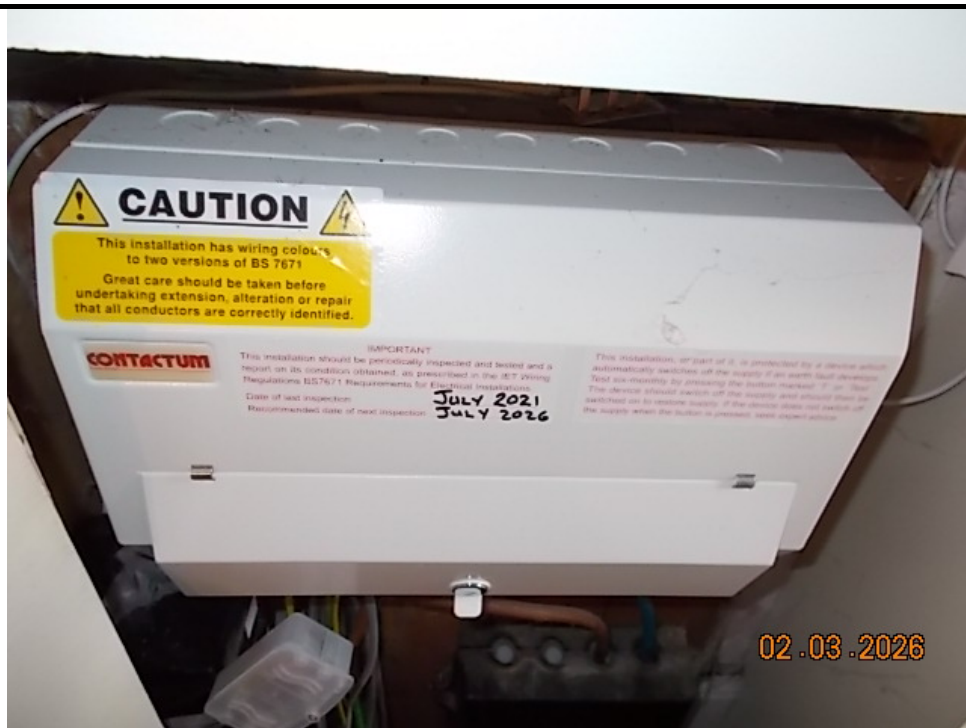
There appears to be EICR and RCD protection as required. However, as the EICR certificate expires in July 2026 the necessary work required to renew the EICR certificate will require to be done.

18. Consumer Control Unit

19. Testing record on Consumer Control Unit

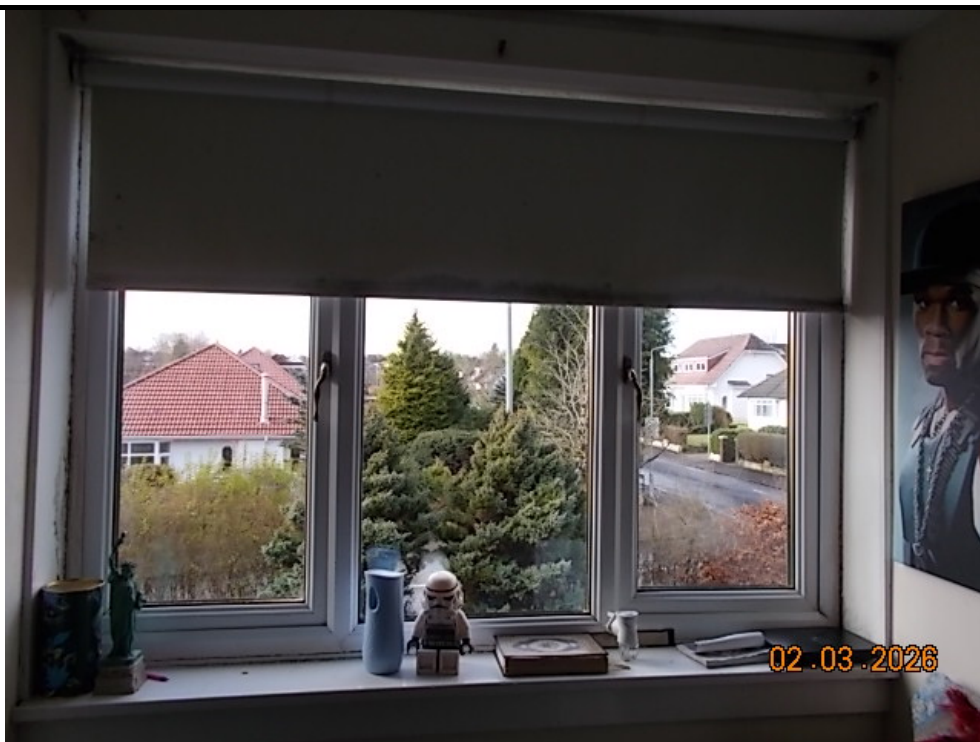
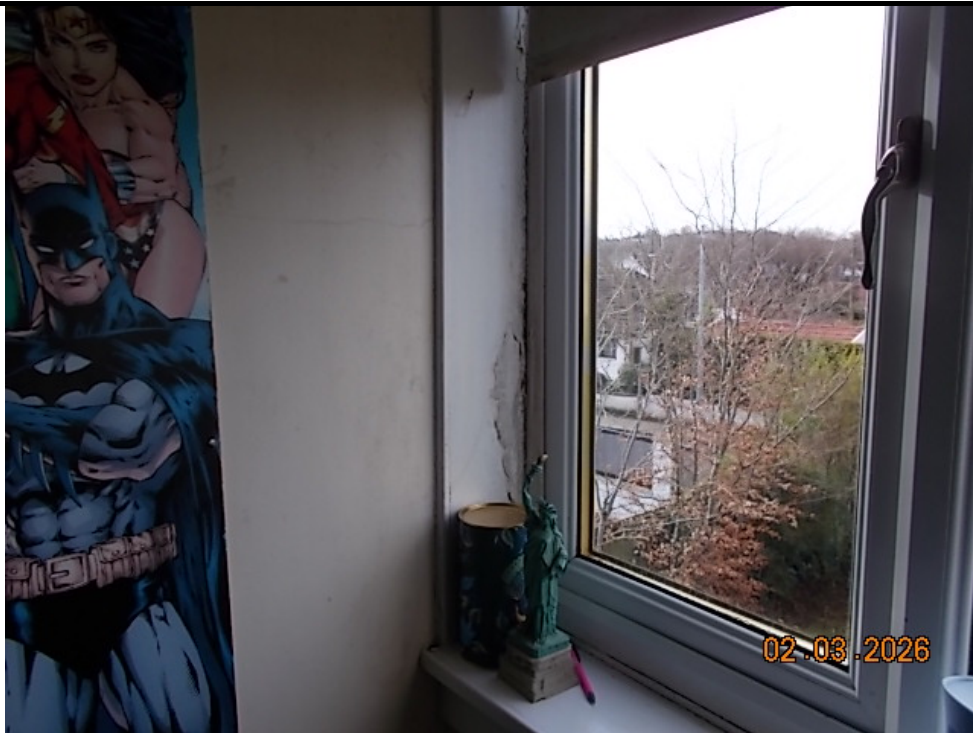
- viii. Upper floor bedroom – mould growth was noted mainly around the window.

Mould in the upper floor is likely caused by either water penetration from outside or condensation run off from windows.

The Tribunal did not find significant evidence of rising or penetrating damp. There may be damp around the upstairs bedroom window, this was not confirmed and, if damp existed it is not significant.

20. First Floor Front Bedroom window

22. First Floor Front Bedroom window

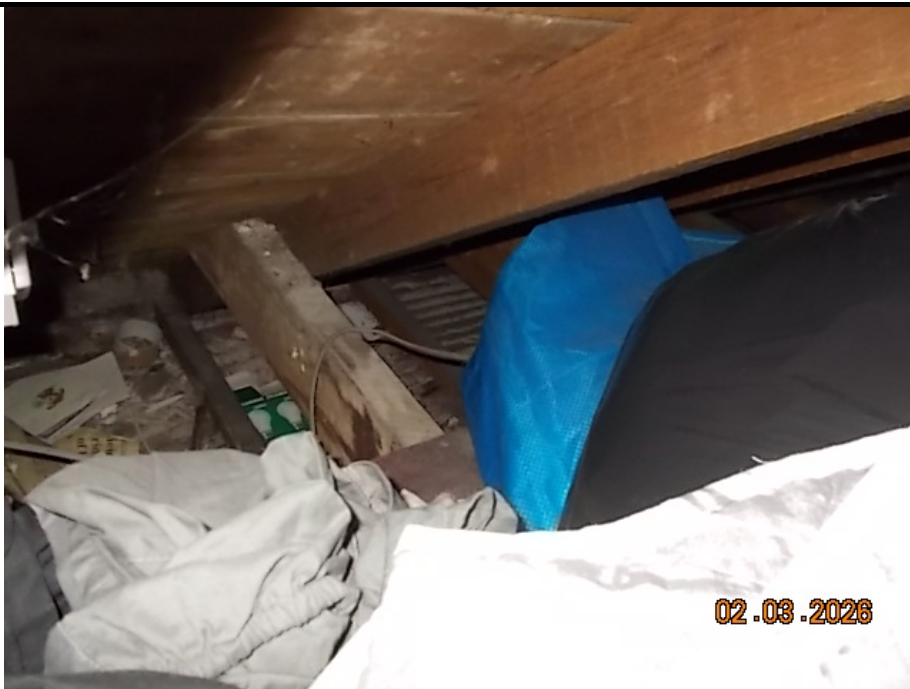
The eaves of the roof space were accessed from the stairwell of the Property. No insulation was visible.

EPC is a measure of energy efficiency. The tolerable standard (s13(1) (h) (6) of the Housing (Scotland) (Act) 2006) requires satisfactory thermal insulation. Scottish Government guidance to local authorities states satisfactory means the presence of roof void insulation. Given the Tribunal was unable to see any insulation the insulation is not satisfactory.

The Tribunal found there was no thermal insulation.

24. Eaves Roof void from Stair

Due to the layout of the Property and access to the roof space resolving the issue may be complex but it will require roof voids to be accessed and inspected to determine how much insulation can be added and where.

- a) Remove debris from the gutters of the Property.
- b) Repair, or if necessary, replace, the gutters at the Property.
- c) Instruct a suitably qualified electrician, who should be a member of Select, NECEIC or other approved body, to undertake inspection and testing of the electrical installation at the Property and to provide an Electrical Inspection Condition Report (EICR), completing any works found to be necessary
- d) Replace the extractor fans within the bathrooms and kitchen of the Property.
- e) Install thermal insulation within the roof / loft space of the Property.

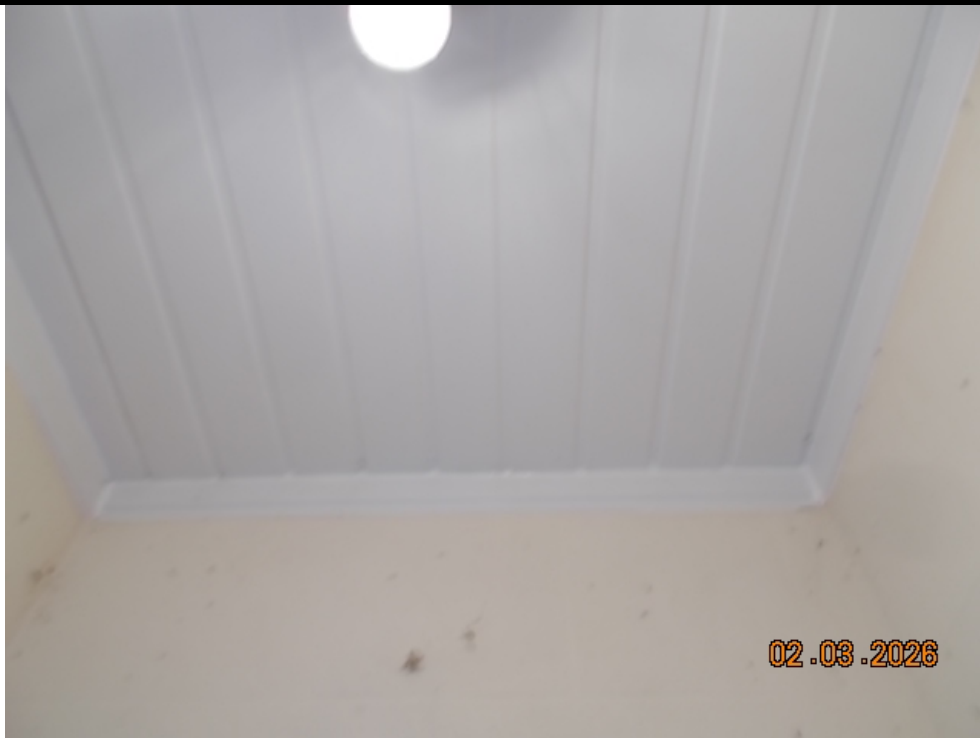
The Applicants advised that this had been repaired although they advised there was still a continuing roof leak.

There was no evidence of a roof leak in this area at time of inspection. The roof, generally, looks in reasonable condition with no widespread missing, loose or otherwise defective tiles.

25. Porch Ceiling

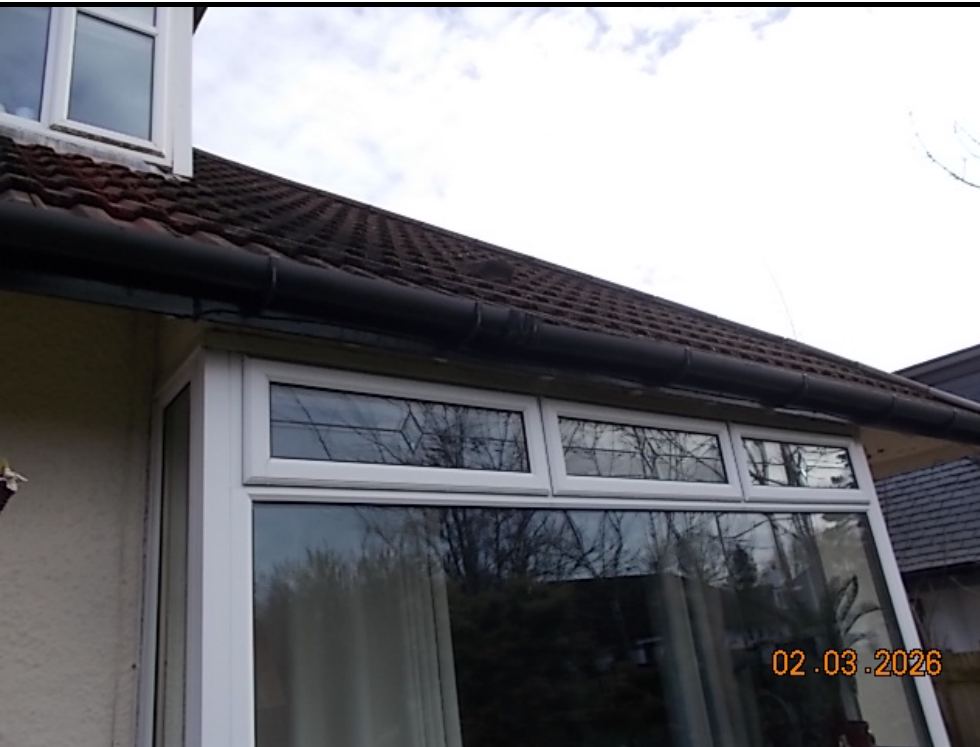
An examination of the gutters from above disclosed evidence of accumulations of debris in the gutters. An examination from below disclosed evidence of leaking joints.

The Tribunal determined that the gutters of the Property had debris within them and were leaking at various joints. Action is required to address this.

26. Front Gutter with leaking joint

The Tribunal considers that the Respondent will need to clean out gutters to clear debris and will require to check joints and to reseal or replace if required.

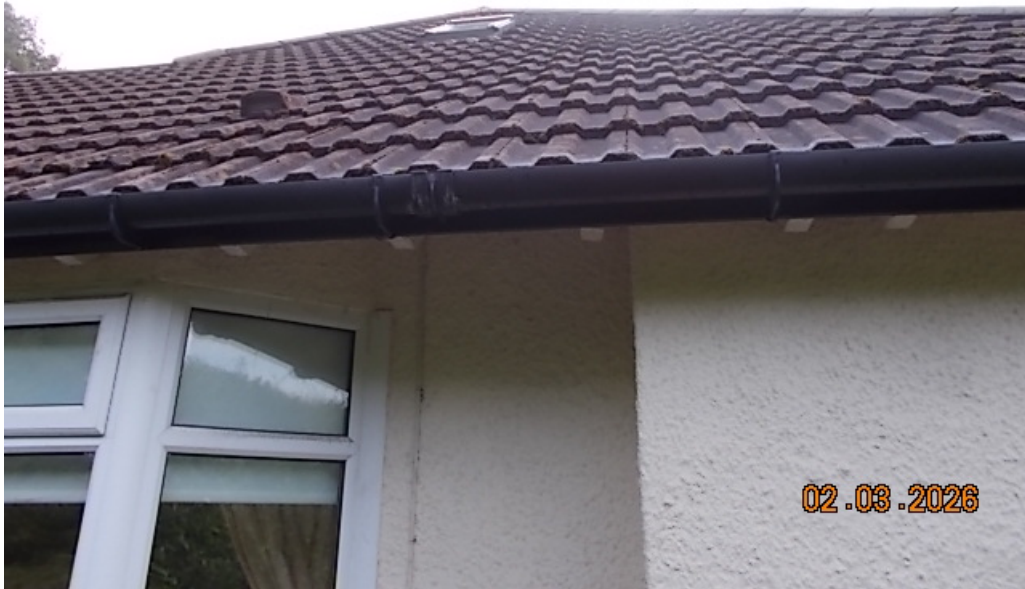
29. Side gutter with leaking joint

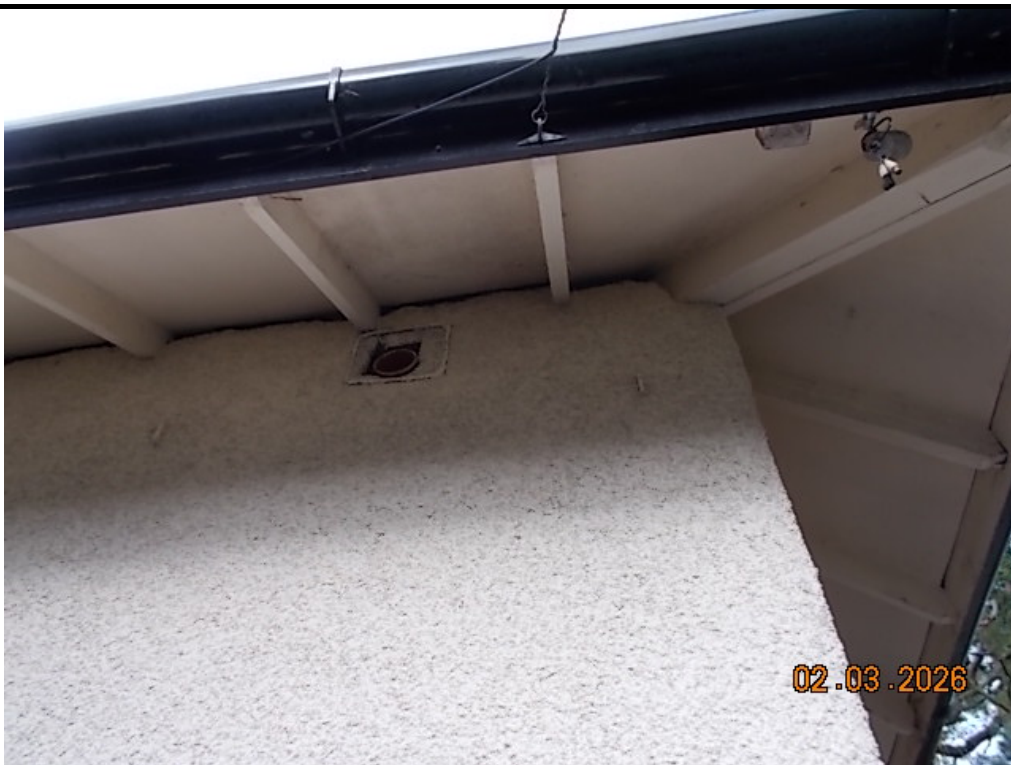
32. Kitchen extract fan external
