Statement of Decision of the First-tier Tribunal for Scotland (Housing and Property Chamber)

Case Reference Number: FTS/HPC/RP/19/2496

Re: 1/1 37 Barterholm Road, Paisley PA2 6PA (“the house”)

Schedule of Photographs taken during the
inspection by tribunal members on 29th
October 2019

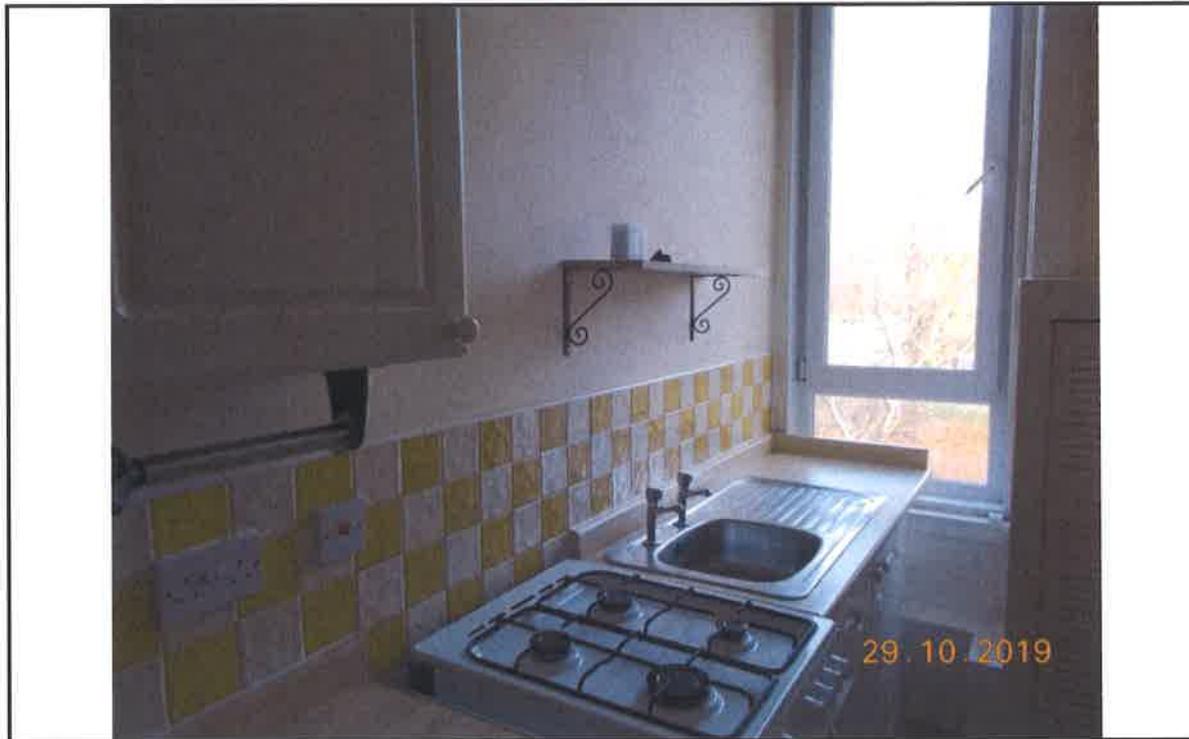
1. Kitchen Cooker

20. The tribunal observed at its inspection that there was no cooker hood installed above the gas cooker in the kitchen. The landlords told the tribunal that they were not aware of any requirement to install a cooker hood. The tribunal notes that there is no such requirement. The tribunal observed at its inspection that the tilt and turn window in the kitchen appeared to be operating correctly, and could be opened, despite the presence of a roller blind fitted at the top. The tribunal therefore determined that there were no repairing standard issues to be addressed in relation to either the ventilation for the cooker or the roller blind in the kitchen.

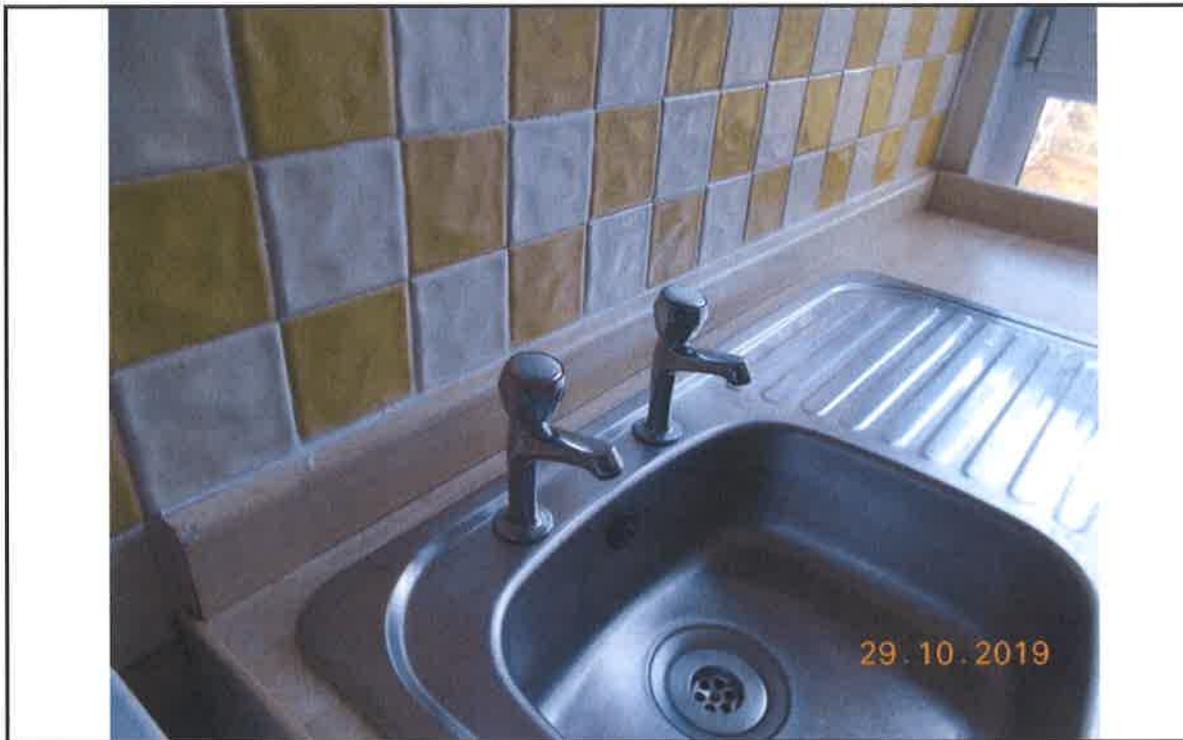
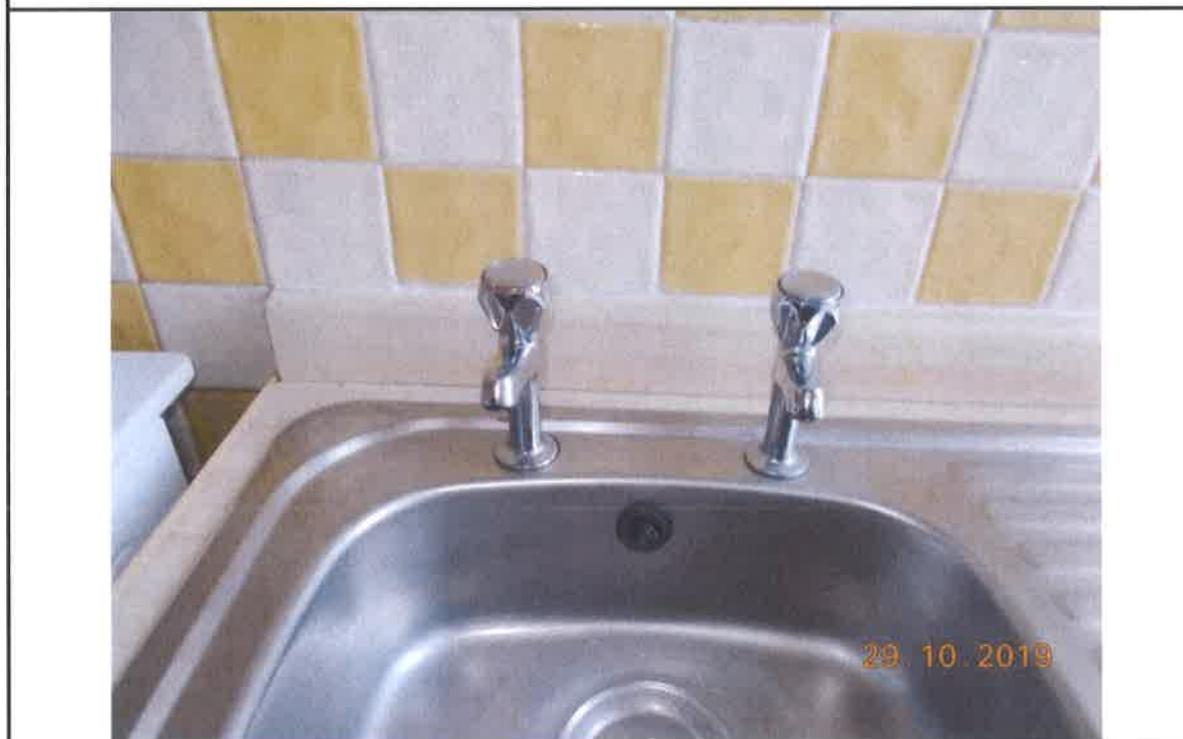
3. Seal between kitchen sink upstand and tiling and upstand and worktop

7. *Installation of water seal behind kitchen sink to prevent further water ingress down the back of the sink unit.*
25. The tribunal observed at its inspection that there was not a visible silicone seal between the kitchen sink upstand and worktop but one was in place between the upstand and tiling on the wall behind it. There was no evidence of water ingress underneath the sink. The tribunal therefore determined that the seal was therefore in a reasonable state of repair and in proper working order.

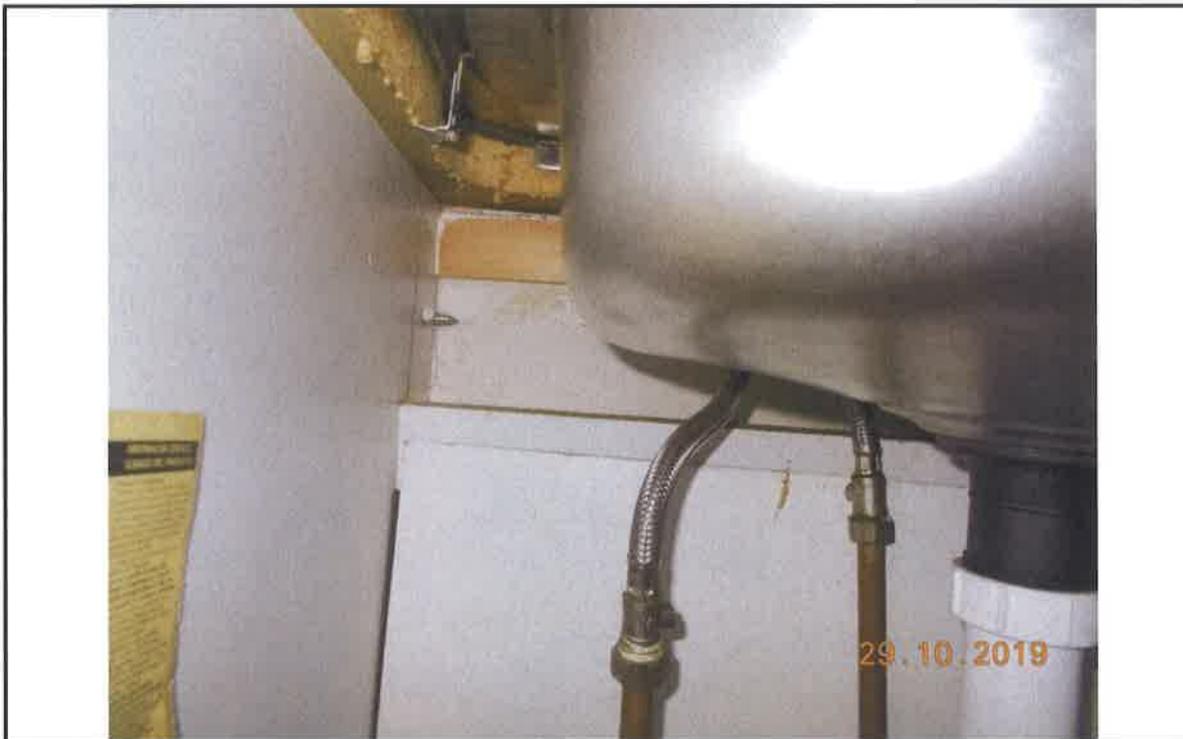
5. Area under Kitchen sink

- ix. There was no evidence of water ingress underneath the sink (photograph 5).
 - x. The kitchen door opened and closed properly, and appeared to be operating correctly, although one of the hinges appeared to be a bit loose. (photograph 6).

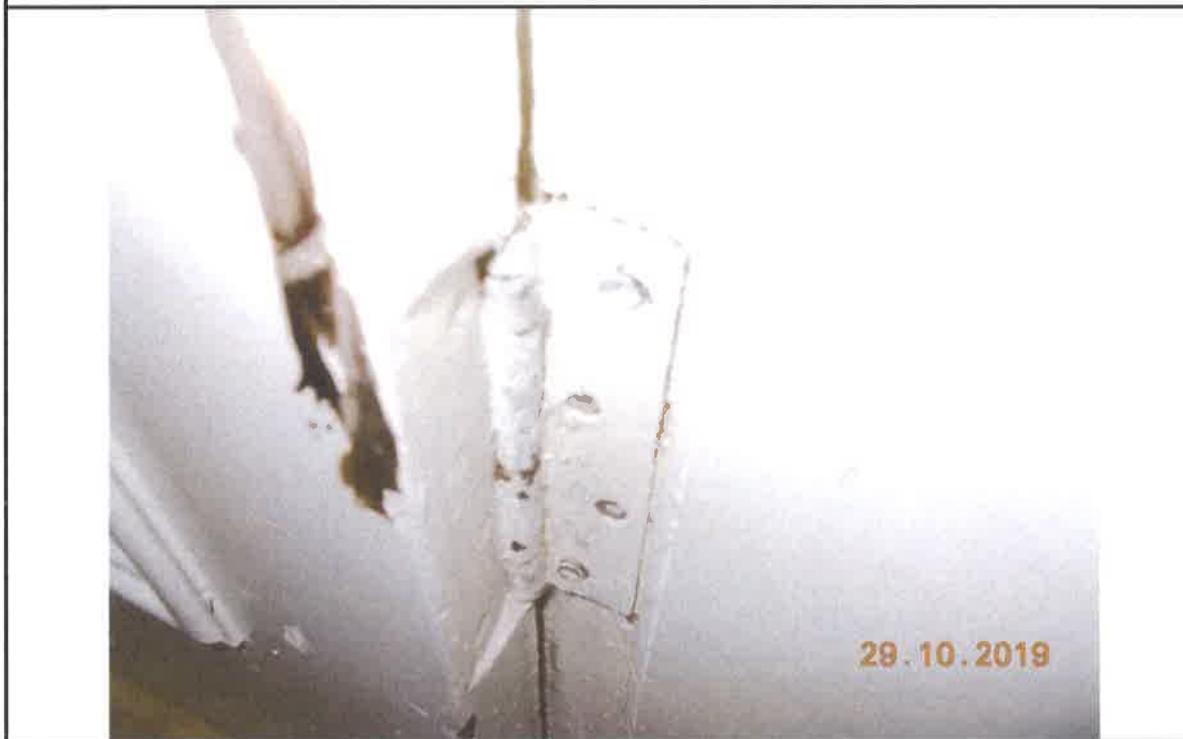
6. Kitchen door hinge

8. *Repair kitchen door and living room door- neither door can be closed.*
26. At its inspection, the tribunal found that the kitchen door opened and closed properly, and appeared to be operating correctly, although one of the hinges appeared to be a bit loose. The tribunal determined that the door was in a reasonable state of repair and in proper working order.

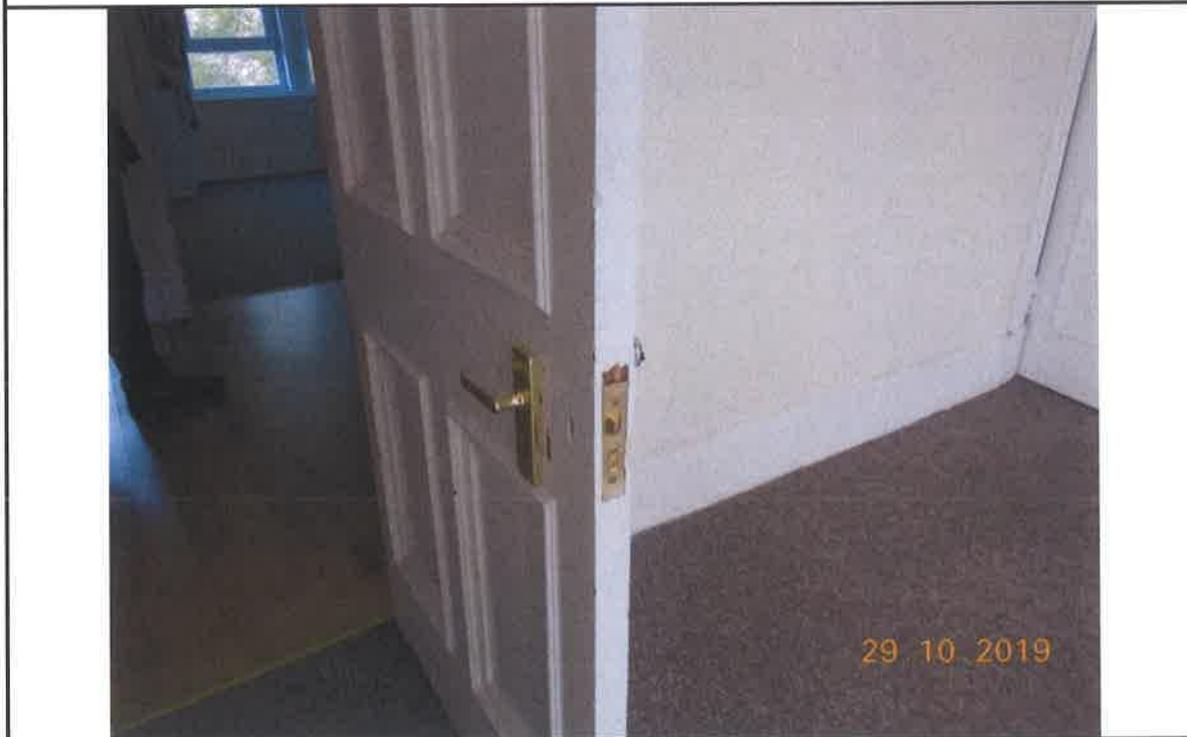
8. Living room door lock

27. The tribunal found that the living room door did not close properly. An additional catch had been fitted to the door. The lock mechanism on the door appeared to have been fitted the wrong way round, which was the reason why the door was not closing correctly.

29. The tenancy agreement explicitly stated at paragraph 19 that the tenant had a duty not to interfere with door closer mechanisms. The tribunal therefore determined that although the living room door was not closing properly, this was due to the tenant's failure to use the house in a proper manner. The landlord was not therefore in breach of the repairing standard, in terms of section 16(1)(b) of the Act.

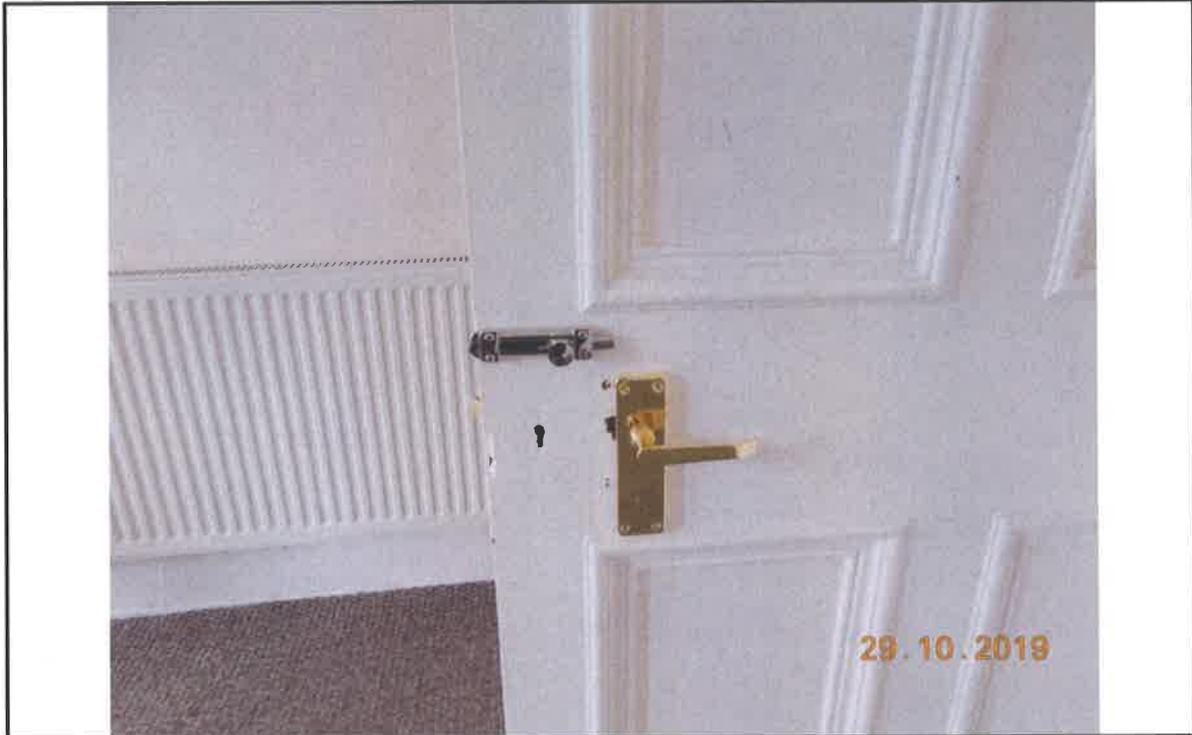
9. Living room door additional catch

28. The landlords told the tribunal at the hearing that they had been surprised to see the additional catch and the incorrectly fitted lock when they arrived for the inspection, as they had not been in the house for several months. They told the tribunal that they believed the former tenant had fitted these himself. The tribunal found the landlords to be credible and reliable witnesses, and it accepted their evidence on this point.

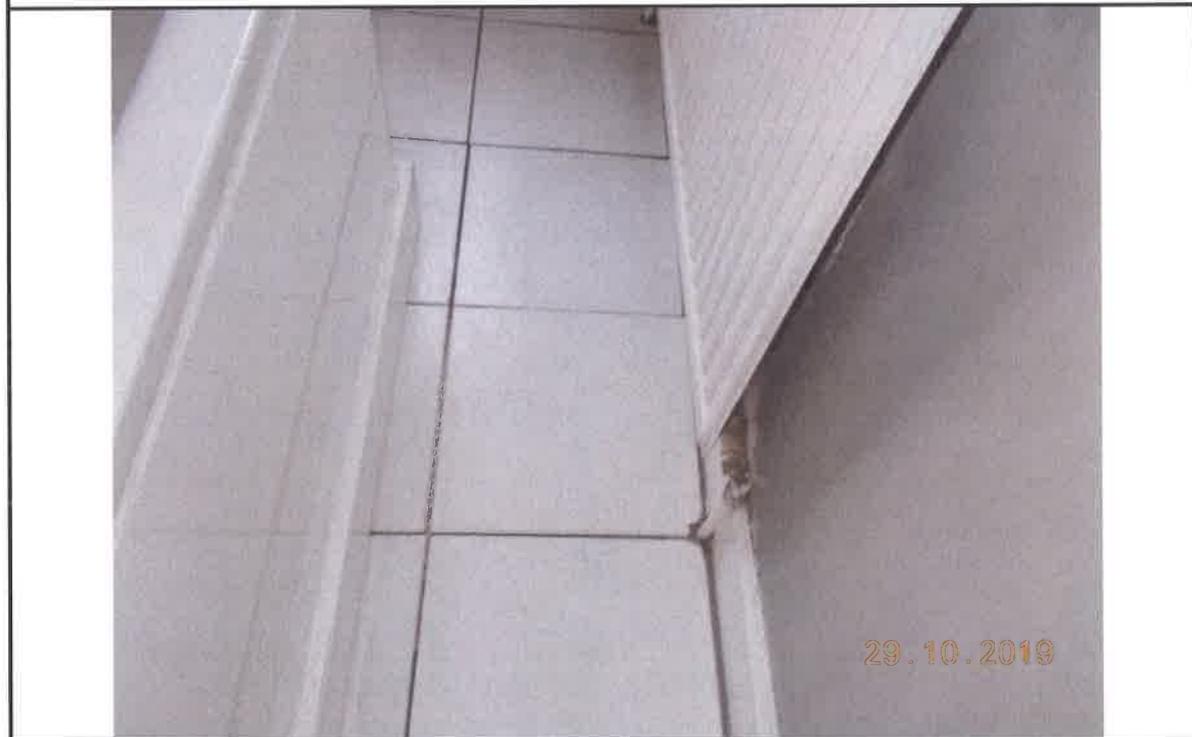
10. Floor tiling in Bathroom

19. It was not entirely clear to the tribunal exactly which tiles the former tenant was complaining about. The landlords said that they were unsure what he was referring to. The tribunal observed at its inspection that one floor tile in the bathroom moved slightly when it was walked on. Otherwise, the tribunal observed no issues with either the wall or the floor tiles in the bathroom. It therefore determined that both the wall and floor tiles in the bathroom were in a reasonable state of repair and in proper working order.

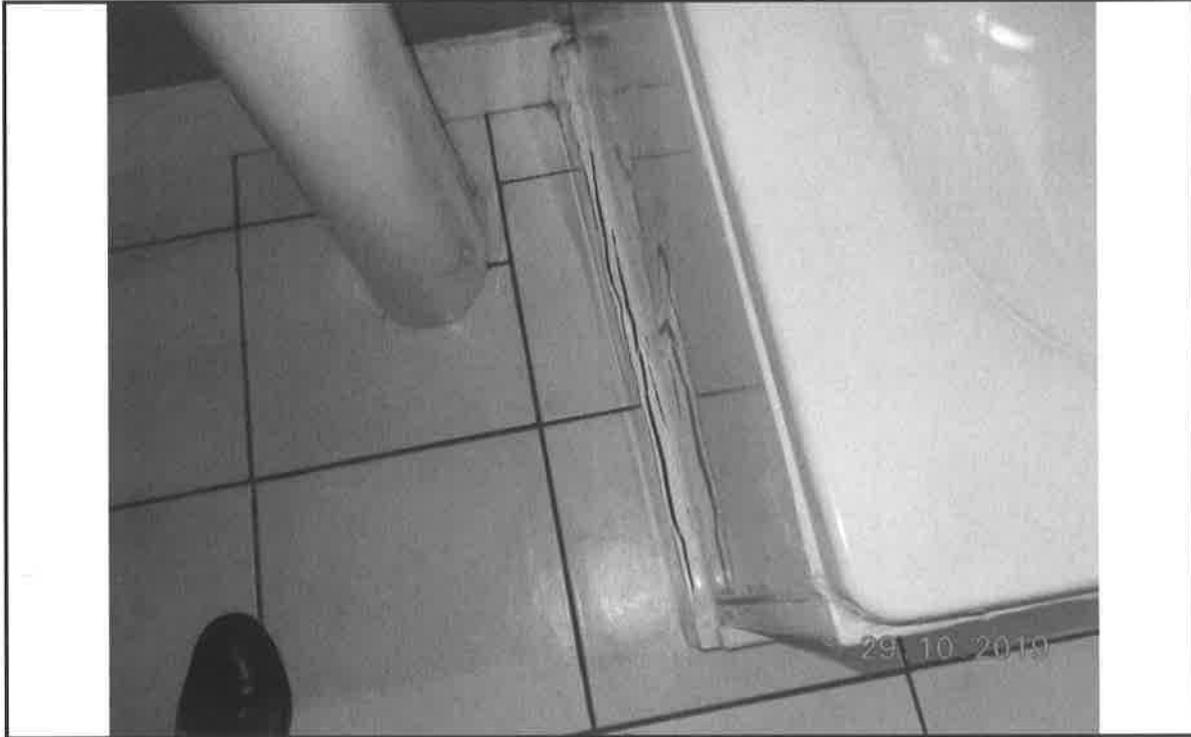
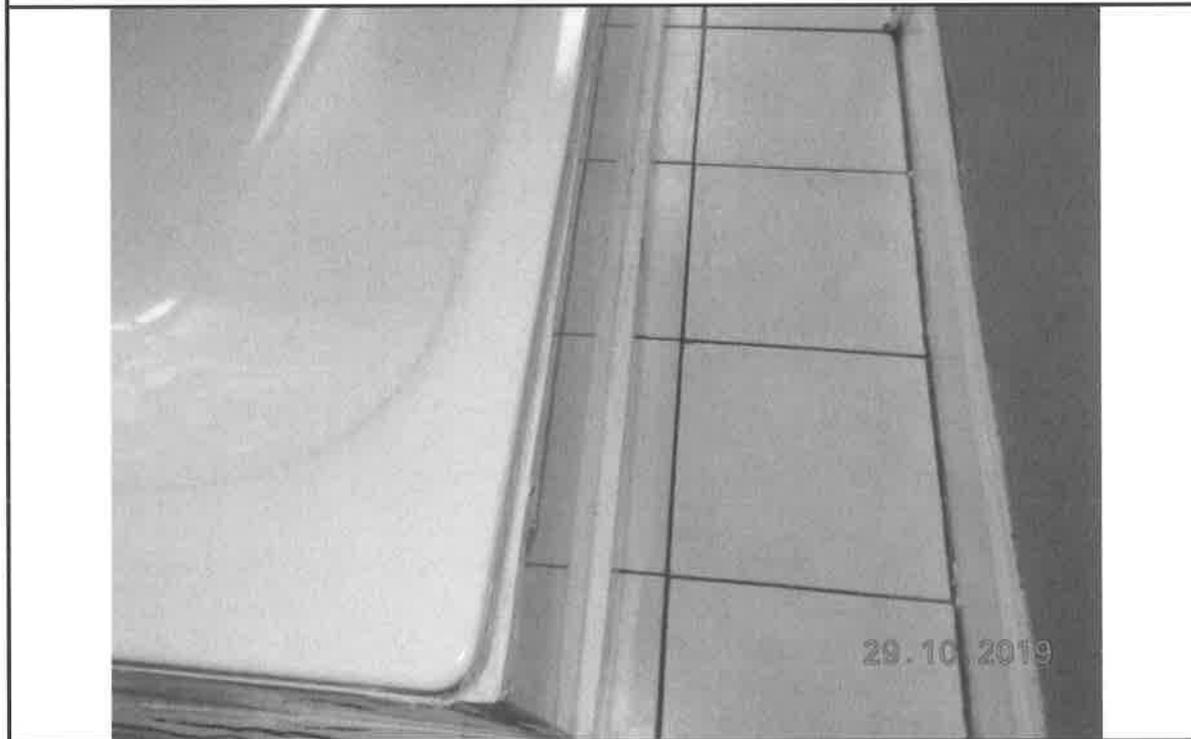
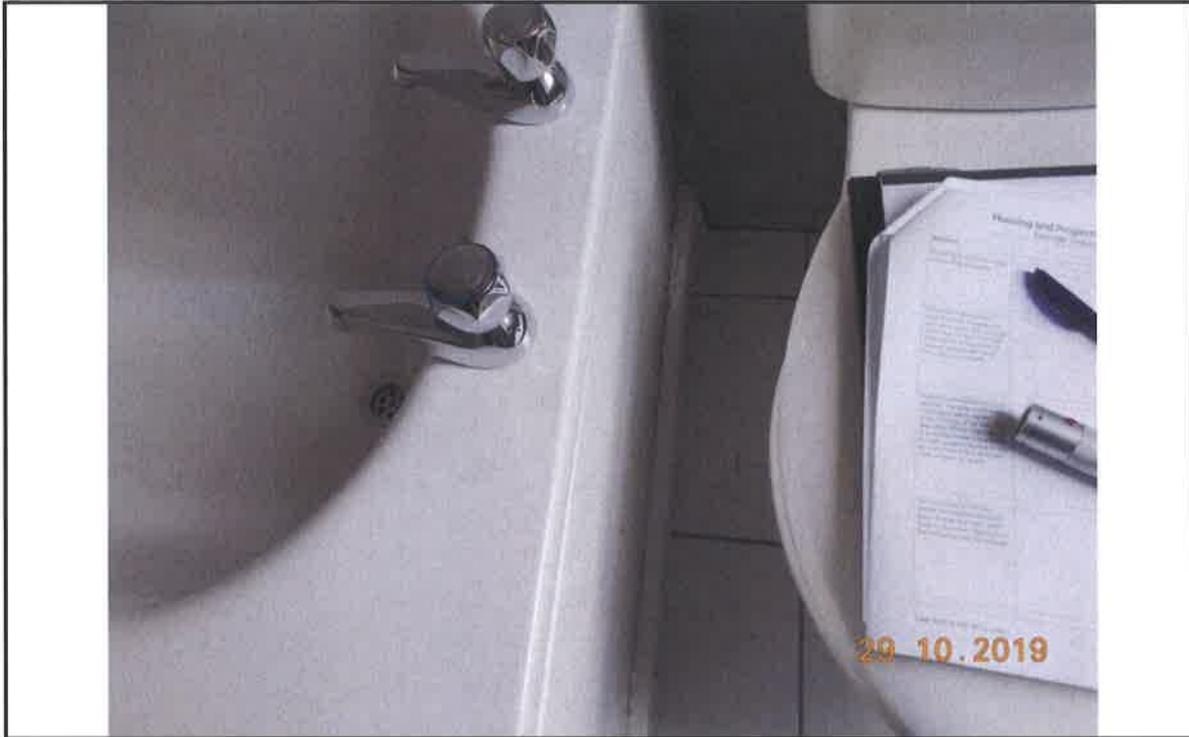
- v. There was a timber trim around the bottom of the bath. This had split slightly in some areas, but the damage appeared to be cosmetic only, and no mould was observed (photographs 11-13).

22. At its inspection, the tribunal observed that there was a timber trim around the bottom of the bath. This had split slightly in some areas, but the damage appeared to be cosmetic only, and no mould was observed. The tribunal determined that the timber trim was in a reasonable state of repair and in proper working order.

11. Timber trim round bath

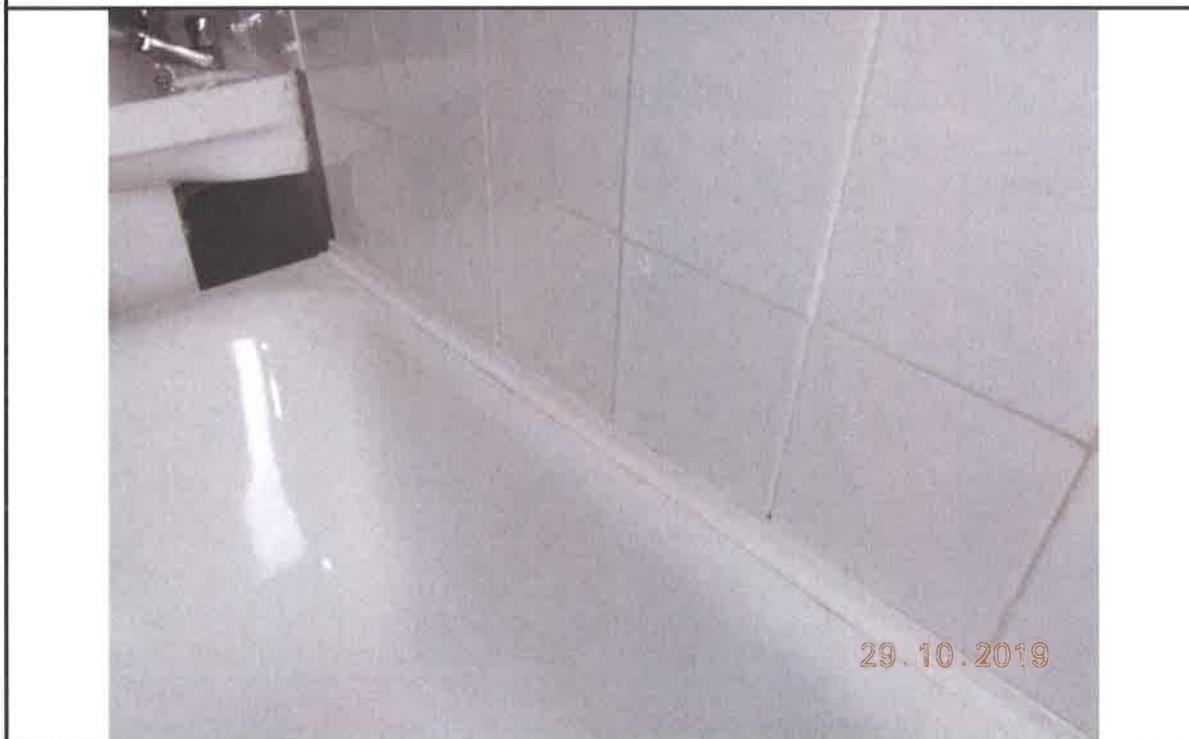
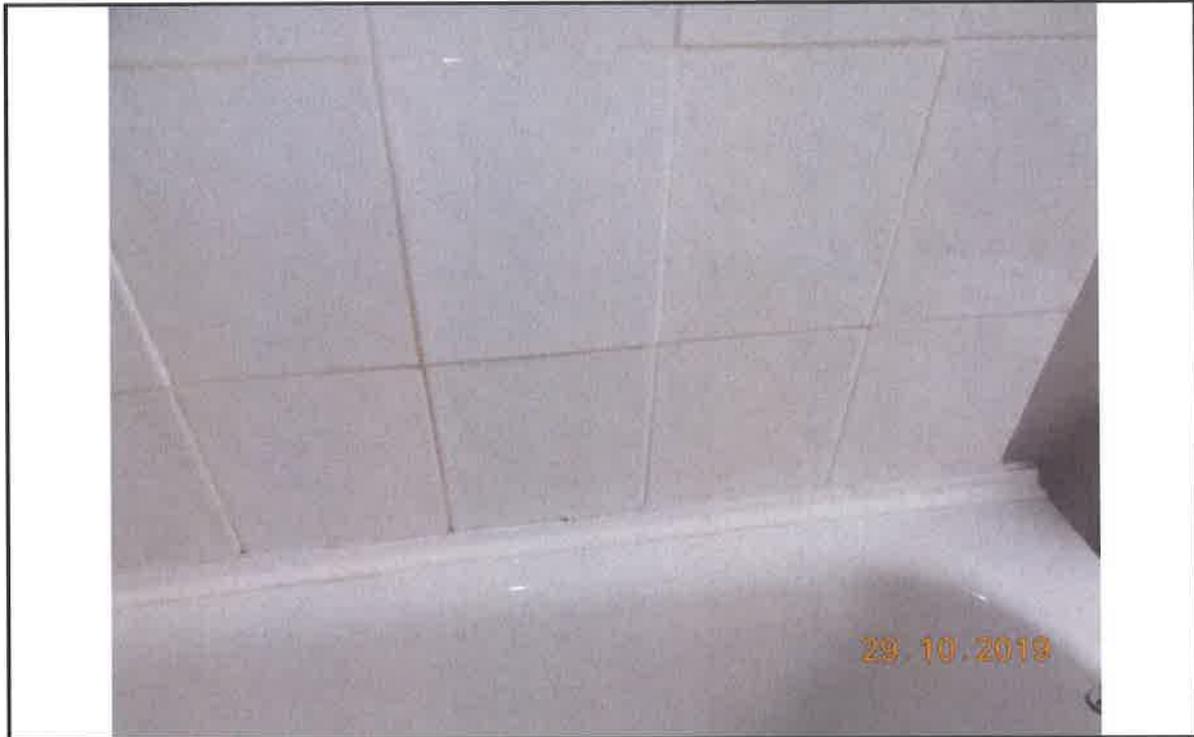
- signs of water ingress behind the bath, or of any mould. (photographs 14 and 15)
- vii. The door to the bedroom at the rear of the property was capable of being opened and closed, although the hinge at the bottom was a bit loose, leading to the door moving slightly away from the door frame at the bottom (photograph 19)

23. At its inspection, the tribunal observed that there was a plastic trim/seal along the length of the bath, between the bath and the wall tiling. A silicone seal had been added along some of the trim. While it was not possible to see underneath the bath, there were no signs of water ingress behind the bath, or of any mould. The tribunal determined that the bath seal was in a reasonable state of repair and in proper working order.

14. Seal between bath and wall tiling

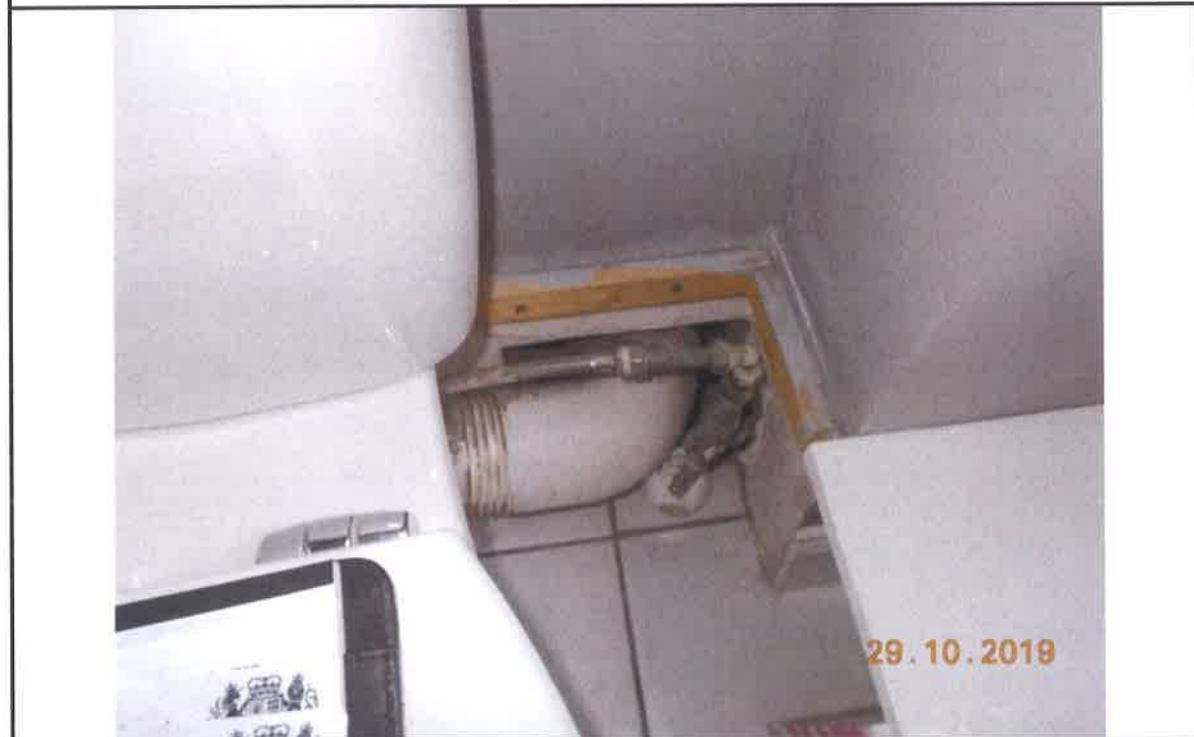
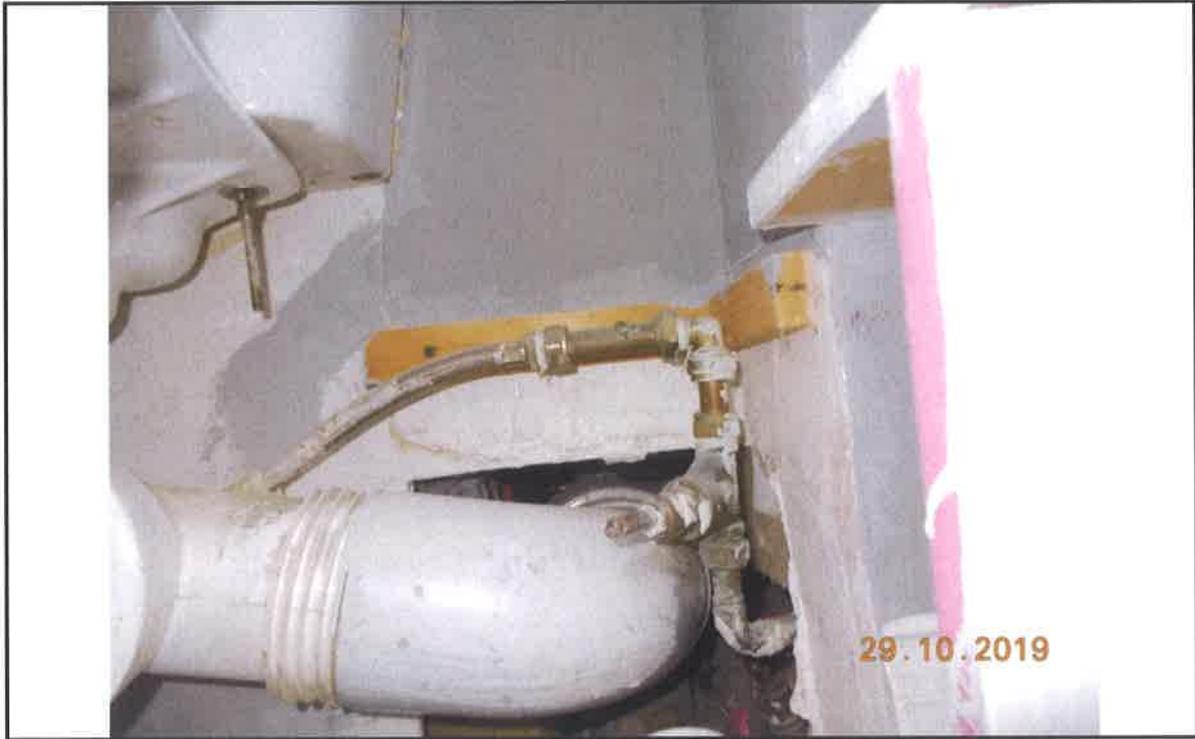
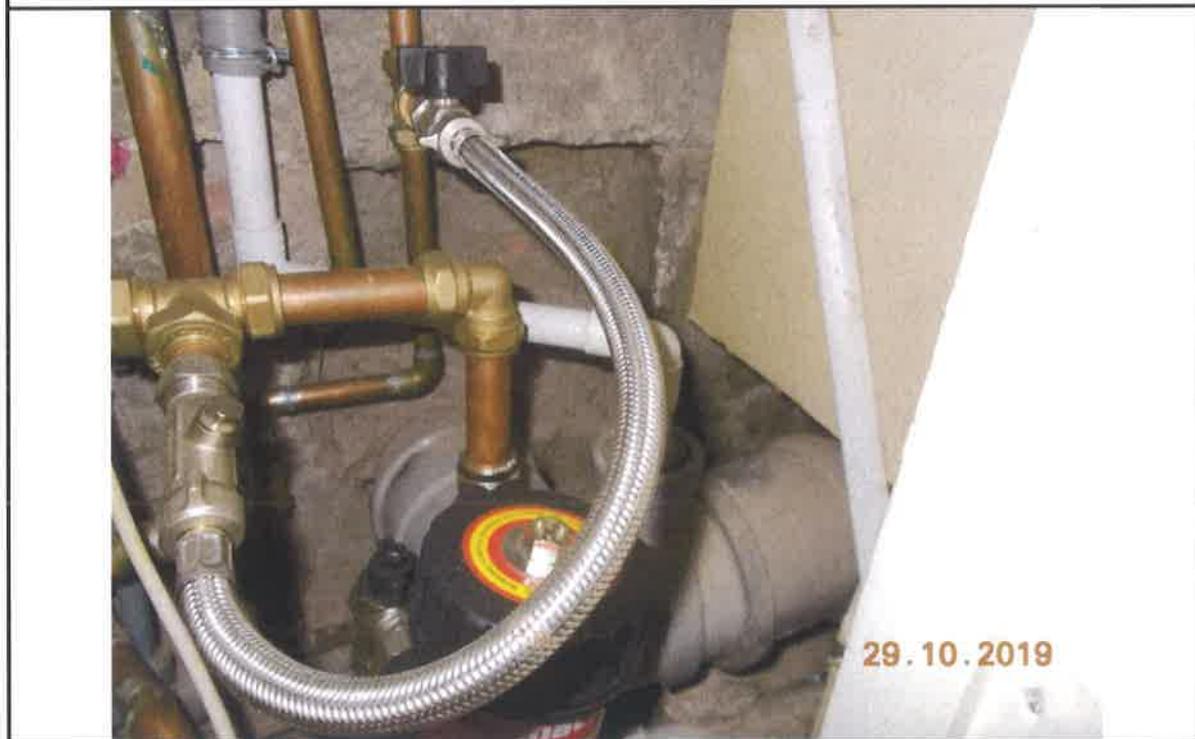
- xvi. There was a hole in the bathroom wall to the right of the toilet, which was covered by a wooden box, through which led a pipe which went through to the kitchen. There was no evidence of any leakage around the pipe, and no foul smell was apparent (photographs 16-18).

41. The tribunal observed at its inspection that there was a hole in the bathroom wall to the right of the toilet, which was covered by a wooden box, through which led a pipe which went through to the kitchen. There was no evidence of

any leakage around the pipe, and no foul smell was apparent. The tribunal did not consider that there was a repairing standard issue to be addressed.

16. Hole in Bathroom wall with Kitchen

18. Hole in Kitchen wall with Bathroom

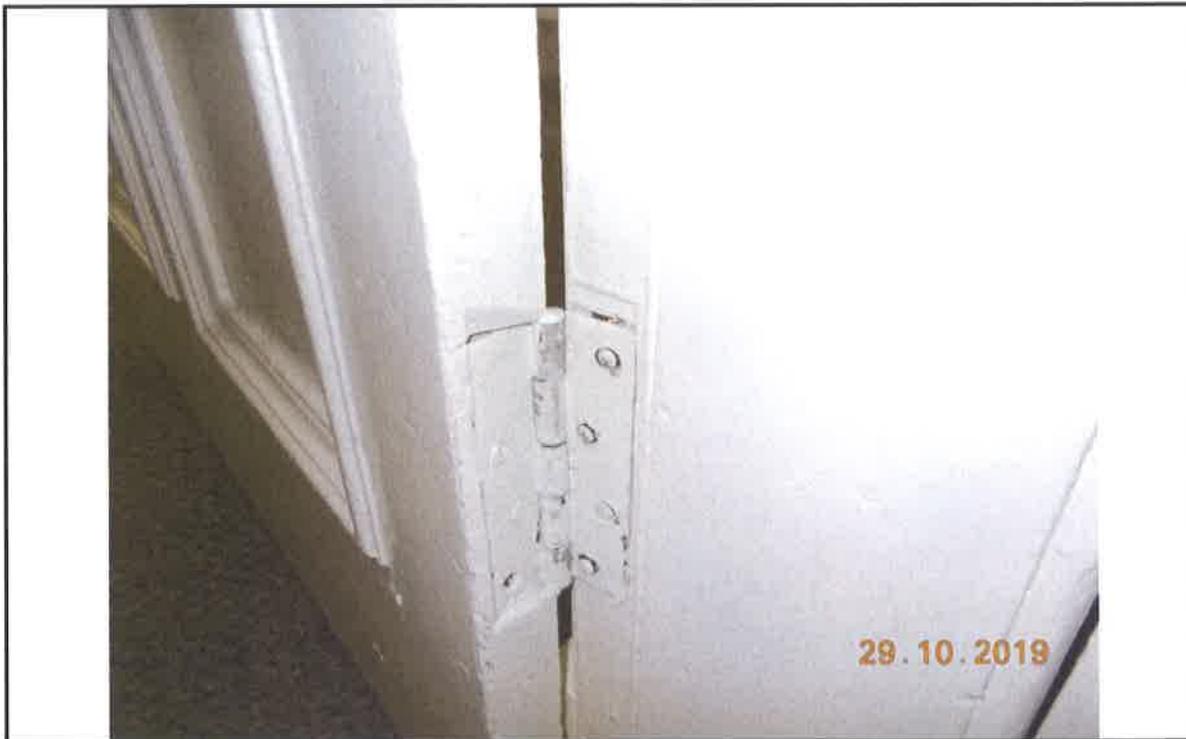
19. Hinge to Back Bedroom door

6. *Repair bottom hinge on door of back bedroom- door not opening and closing properly as the bottom of the door comes away when moving the door.*
24. The tribunal observed at its inspection that the door to the bedroom at the rear of the property was capable of being opened and closed, although the hinge at the bottom was a bit loose, leading to the door moving slightly away from the door frame at the bottom. The tribunal determined that, while the door would benefit from the hinge being tightened, it could be opened and closed, and was therefore in a reasonable state of repair and in proper working order.

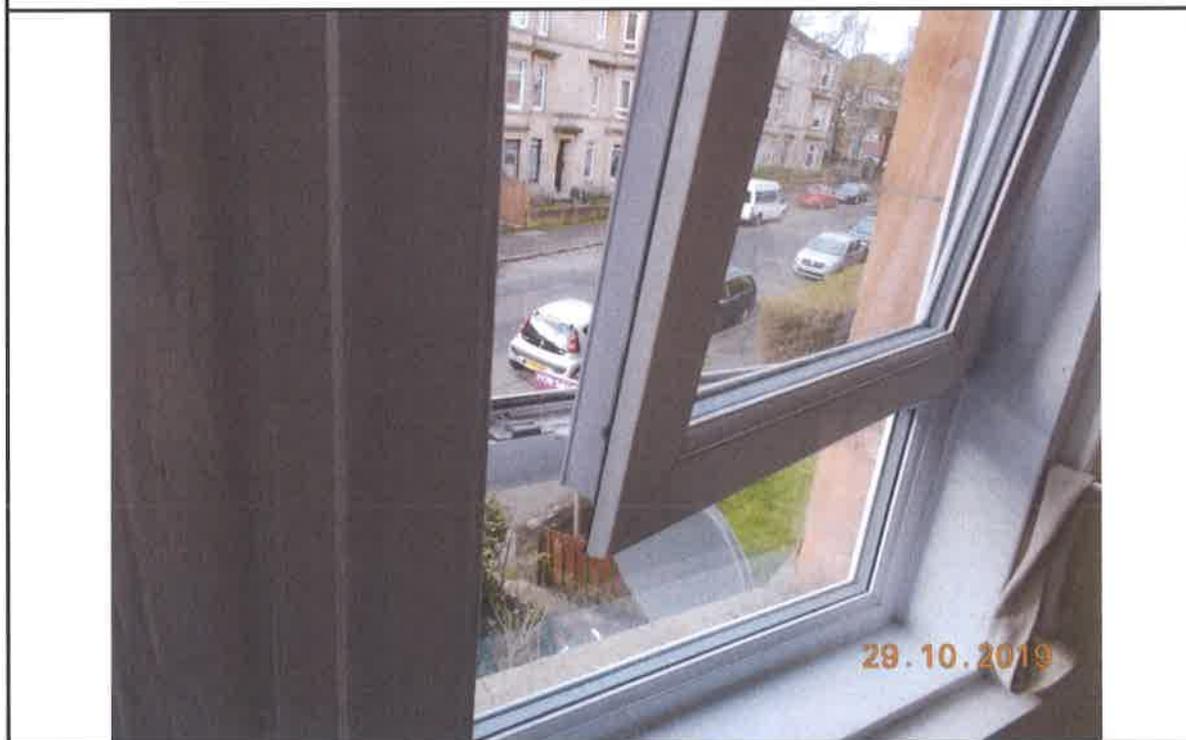
20. Living Room right hand window

- iv. On testing all of the windows in the house, the tribunal found that they were all capable of being opened and closed without excessive force. The tilt and turn mechanisms operated correctly, allowing for the windows to be cleaned from within the house, other than the right-hand bay window in the living room. That window opened and closed, but the tilt mechanism was not operating correctly (photograph 20).

21. On testing all of the windows in the house at its inspection, the tribunal found that they were all capable of being opened and closed without excessive force. The right-hand bay window in the living room opened and closed, but the tilt and turn mechanism was not operating correctly. Mr Brandon told the tribunal at the hearing that the windows were only 4-5 years old. While there was a slight issue with the right-hand living room bay window, the tribunal determined that, as all the windows could be opened and closed without excessive force, they were in a reasonable state of repair and in proper working order.

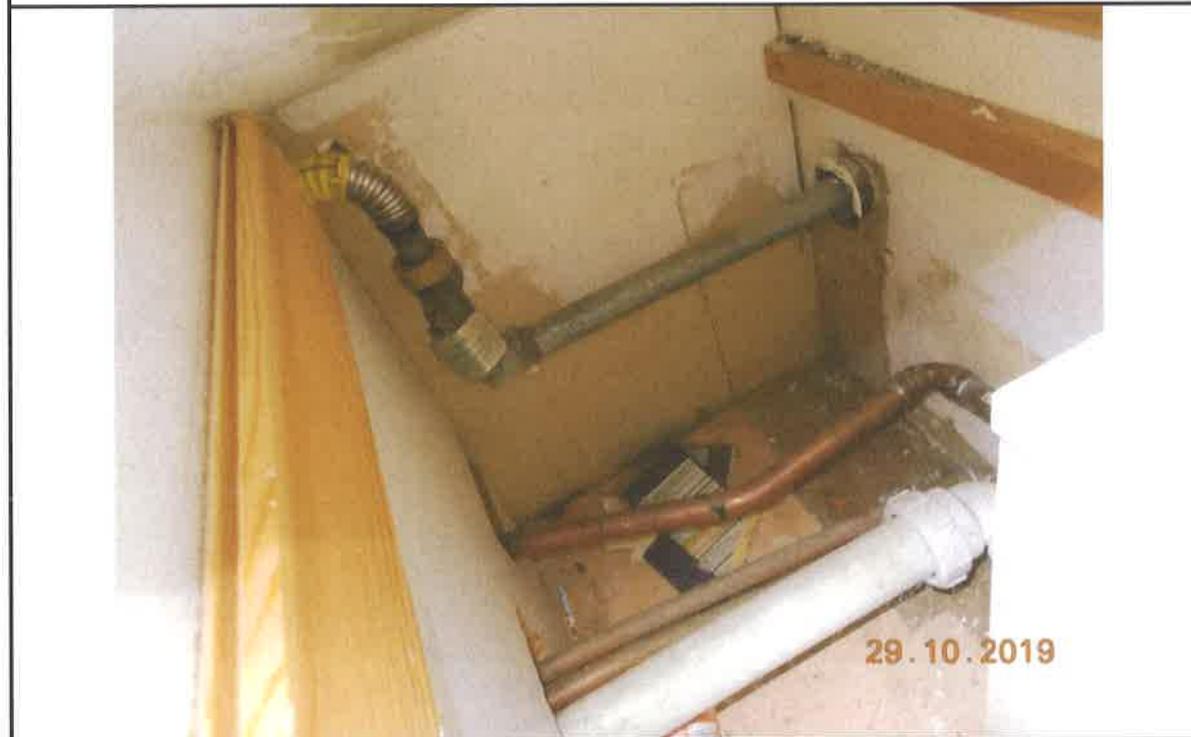
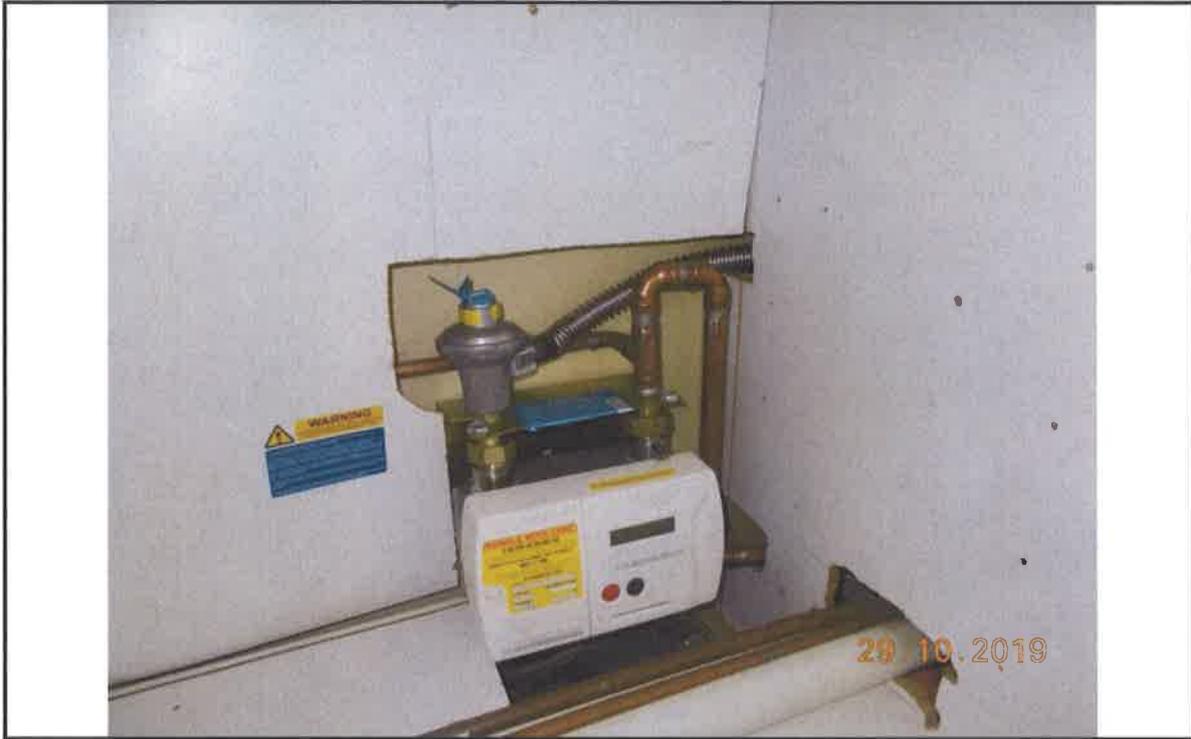
47. The former tenant's complaint was that the gas engineer had stated on the gas safety certificate that the ECV and gas meter were not easy to access. He stated in his application that the engineer had suggested that an access hatch/ panel should be cut in the side of the sink unit to allow clear access to the ECV. Again, while the engineer had stated on the certificate that the ECV and gas meter were not easy to access, this was not noted as a defect. The tribunal observed at its inspection that the gas meter was situated under the kitchen sink. The ECV on the incoming gas supply was on the other side of the cupboard underneath of the sink.

48. The tribunal noted that, while the ECV and gas meter may not be easy to access, it would be possible to access them if needed. The tribunal took the view that there was no repairing standard issue to be determined.

22. ECV on incoming main gas supply

23. Gas meter

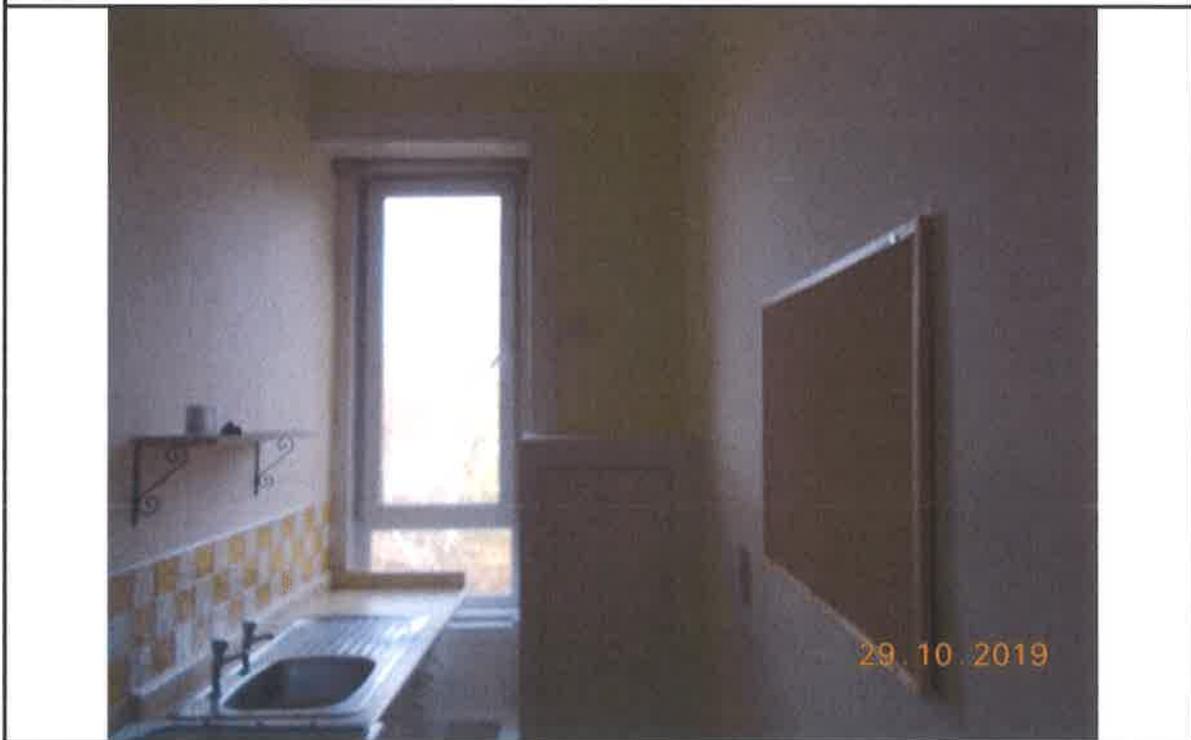
24. Carbon Monoxide Alarm

57. The tribunal observed an issue at its inspection which was not included in the tenant's application. It could not therefore make a formal determination regarding this matter, but the landlords may wish to address this. The carbon monoxide alarm in the kitchen did not appear to be correctly situated relative to the boiler (photograph 24).

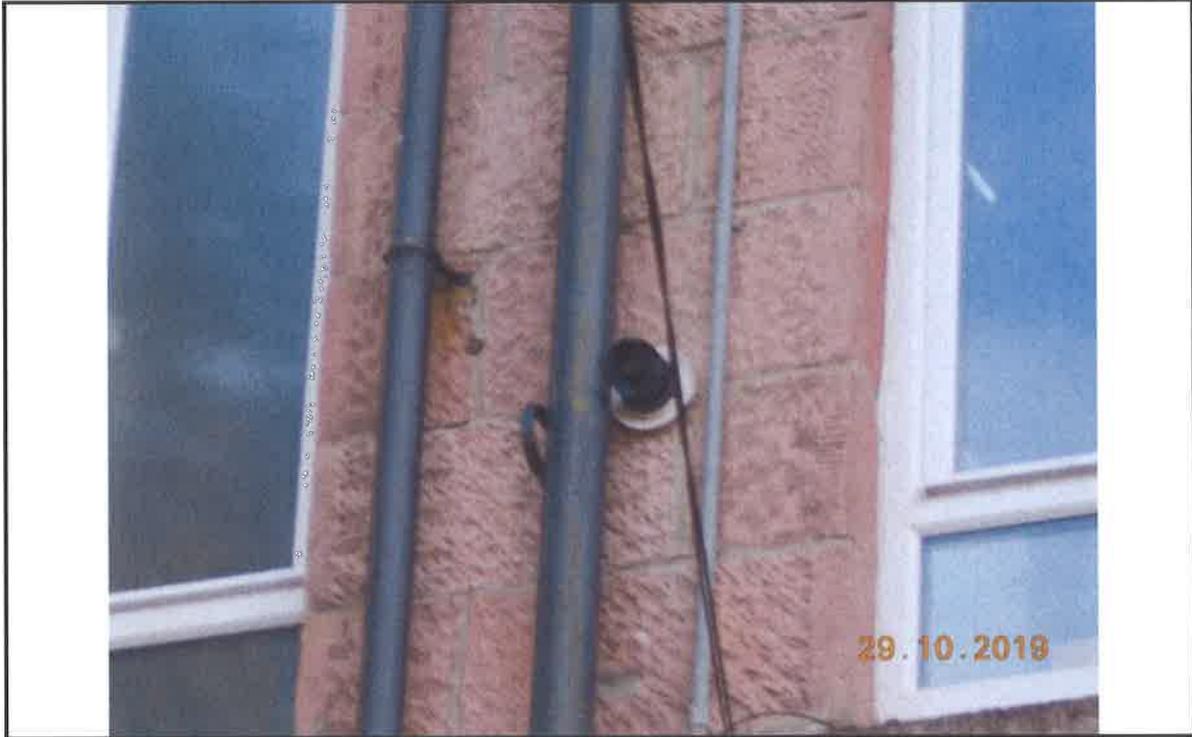
25. Flue from gas boiler

46. It was not entirely clear from the former tenant's application what this complaint specifically related to. The gas safety certificate stated: 'outside still to be filled with cement (flue)', but again this was not noted as a defect on the certificate. The tribunal assumed that this was the source of the former

tenant's complaint. It had observed at its inspection that the gas flue was sealed correctly inside the house, and that it appeared to have been sealed off properly with a cover to the outside of the property. The tribunal therefore determined that the flue was in a reasonable state of repair and in proper working order.
