Statement of Decision of the First-tier Tribunal for Scotland (Housing and Property Chamber)

Case Reference Number: FTS/HPC/RP/19/2496

Re: 1/1 37 Barterholm Road, Paisley PA2 6PA (“the house”)

Schedule of Photographs taken during the
inspection by tribunal members on 29th
October 2019

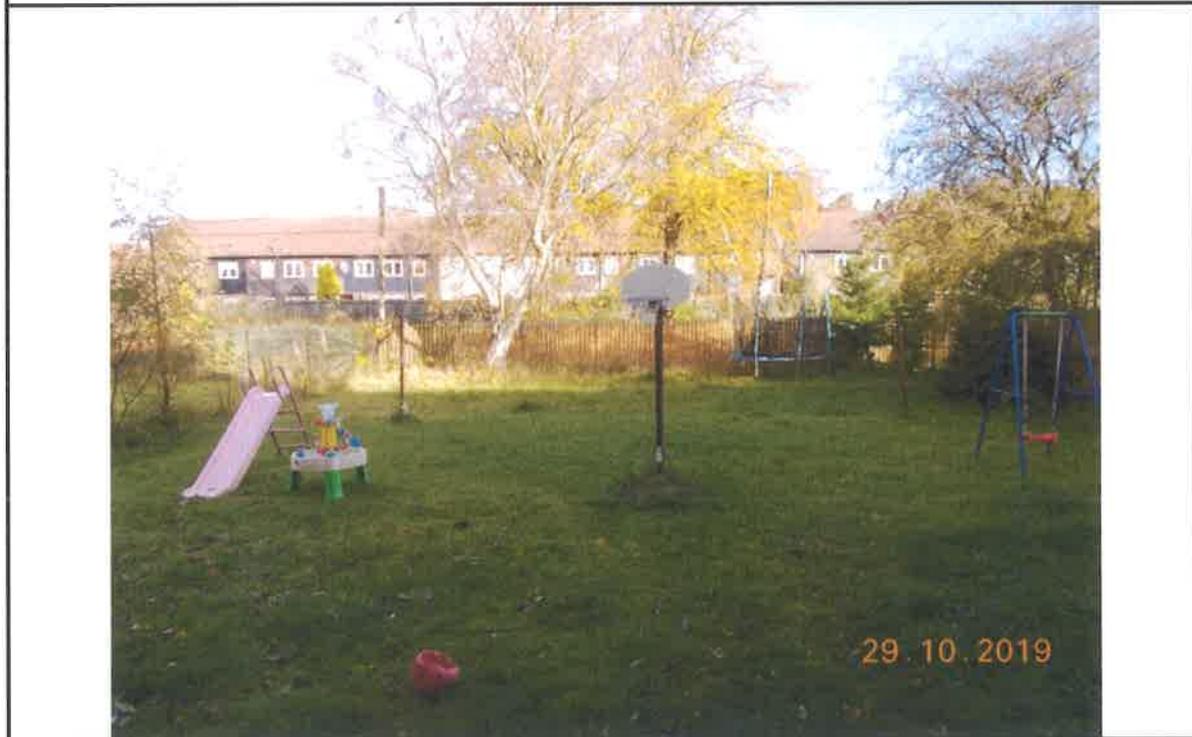
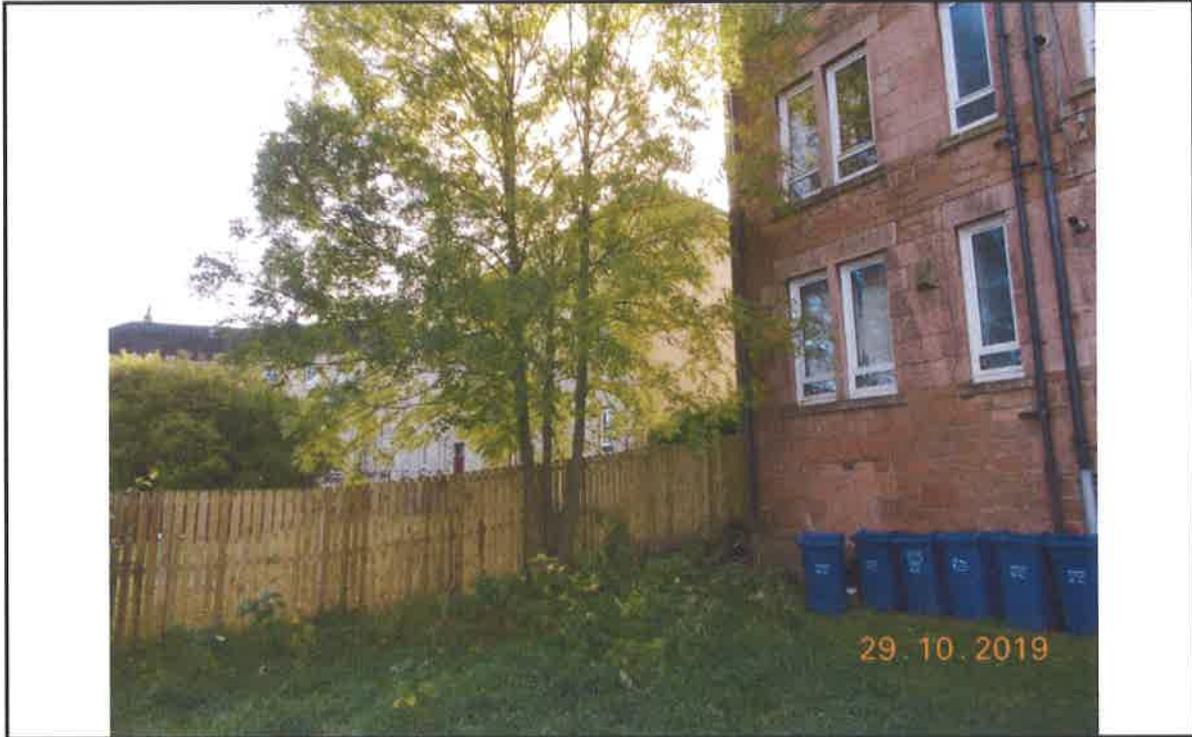
- xiv. The common close and rear communal garden appeared to be in reasonable condition. There was a tree to the rear of the building which had some branches close to the rear window, but this was not directly encroaching onto the window. No sap was visible (photographs 26 and 27)

34. The tribunal observed at its inspection that the common close and rear communal garden appeared to be in reasonable condition. There was a tree to the rear of the building which had some branches closer to the window, but these were not directly encroaching onto the window. The tribunal noted that this was not the time of year that sap might be expected.

26. Rear Garden

27. Tree to rear of property
