Certificate of Completion of Work under Section 60 (5) (b) of the Housing (Scotland) Act 2006

Re 34 Reids Avenue, Stevenston, Ayrshire, KA 20 4BH being the subjects registered in the Land Register of Scotland under title number AYR78871 ('the Property')

Housing and Property Chamber Reinspection Report

Property: 34 Reids Avenue, Stevenston, Ayrshire KA20
Ref No: PRHP/RP/16/0148

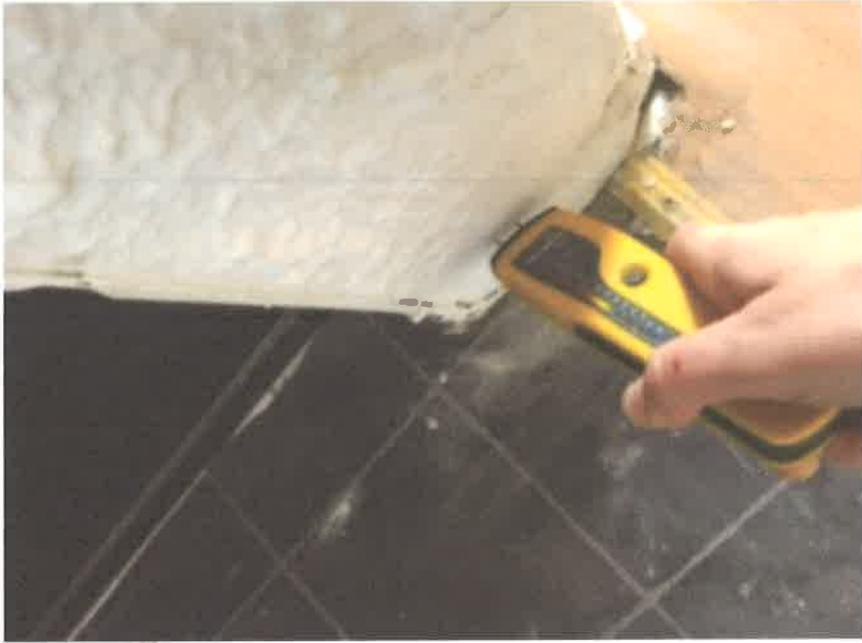
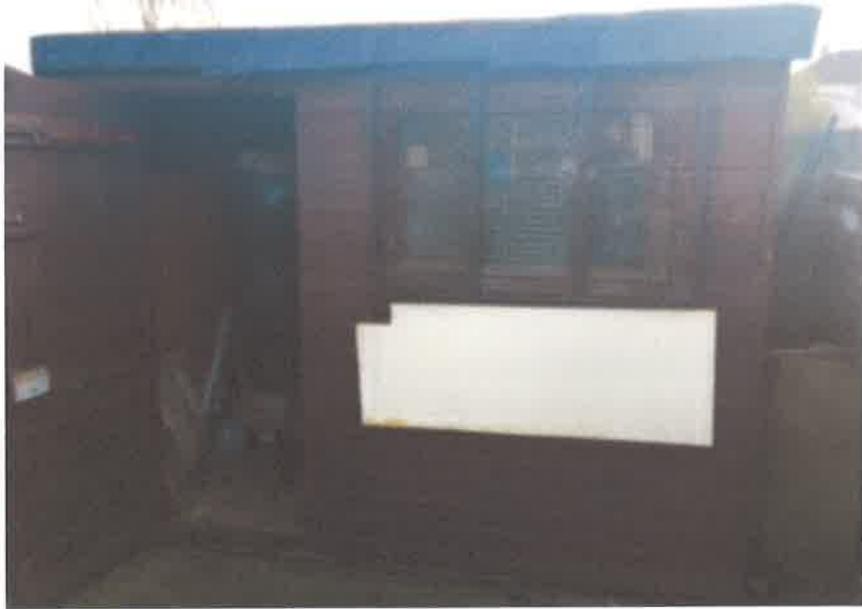
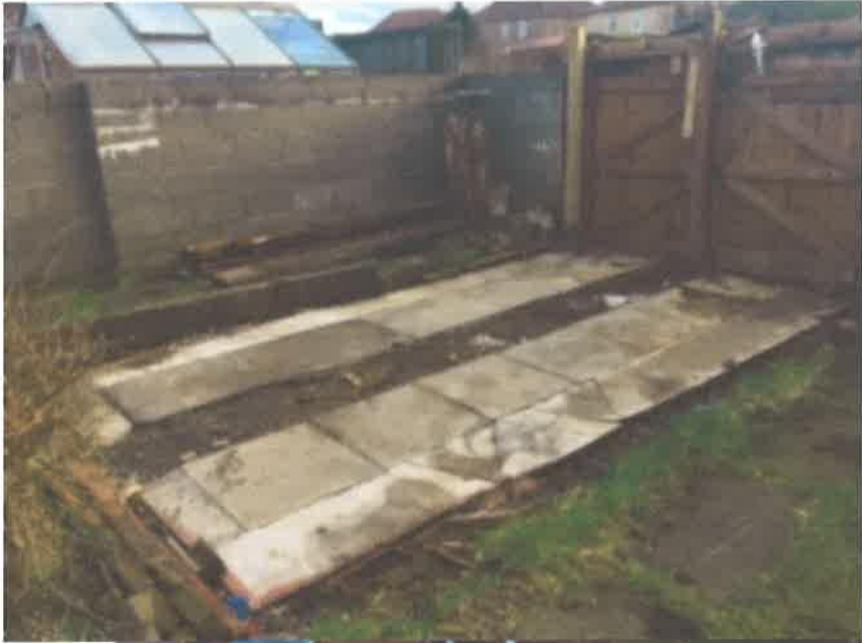
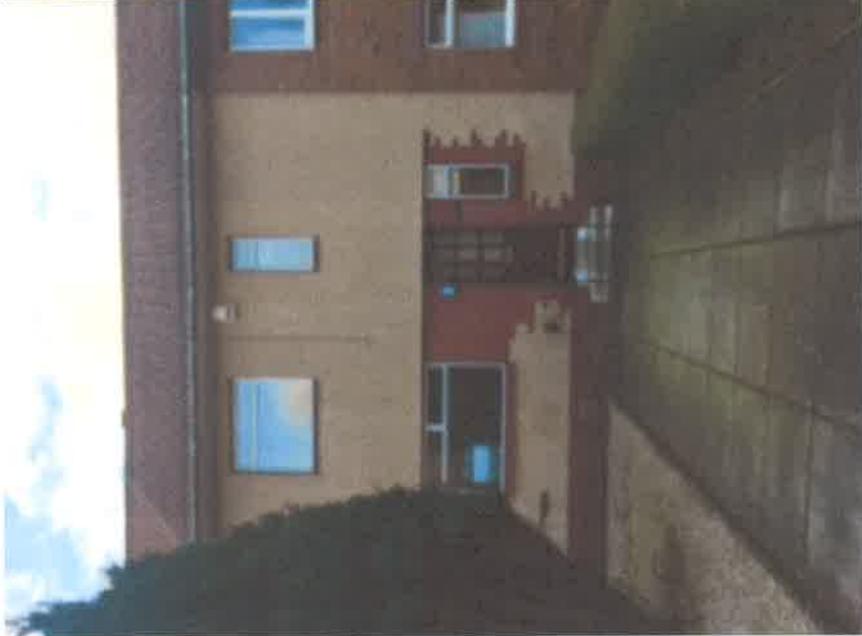
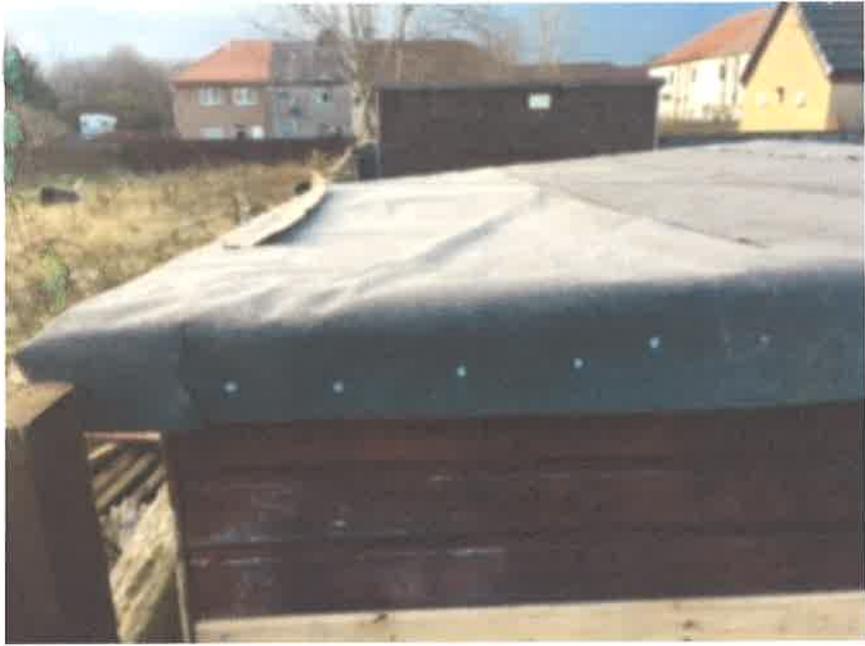
PHOTOGRAPHS TAKEN AT TIME OF RE-INSPECTION:

The gas fire in the livingroom was still inoperable.

The timber garage had been removed, albeit the base remained.

The timber shed had been roughly patched with timber materials and the roof roughly covered with felt. The roofing felt was not attached at the rear of the roof, timber sarking or roof boarding was insecure and decayed, as was flooring. The shed was not found to be wind and watertight or in reasonable state of repair.

Readings taken with an electronic moisture meter in the dining area were largely within acceptable limits and did not indicate significant structural dampness although at a corner there was a small area where readings were higher, A written report as required in terms of the order did not appear to have been received prior to re-inspection.
