**STATEMENT OF DECISION OF THE PRIVATE RENTED HOUSING COMMITTEE
UNDER SECTION
26(1) OF THE HOUSING (SCOTLAND) ACT 2006 ("the Act")**

**Property at 39 Wallbrae Road, South Carbrain, Cumbernauld G67 2PD
(hereinafter referred to as "the house")**

Reference PRHP/RP/14/0168

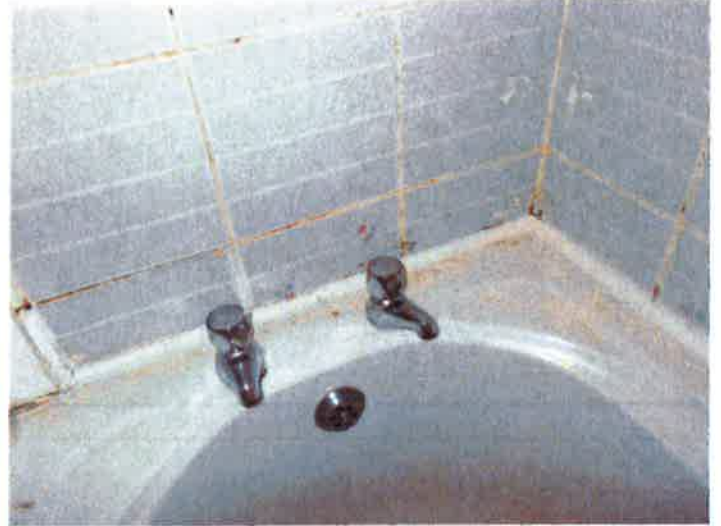
There are some slight marks to the new ceiling in the first floor bedroom left which is situated directly below the bathroom which could be a result of the paint drying out. The bath taps were turned on at the inspection for an extended period of time and no changes to these marks were observed (photos marked 1. (b)).

1. (b) Bath

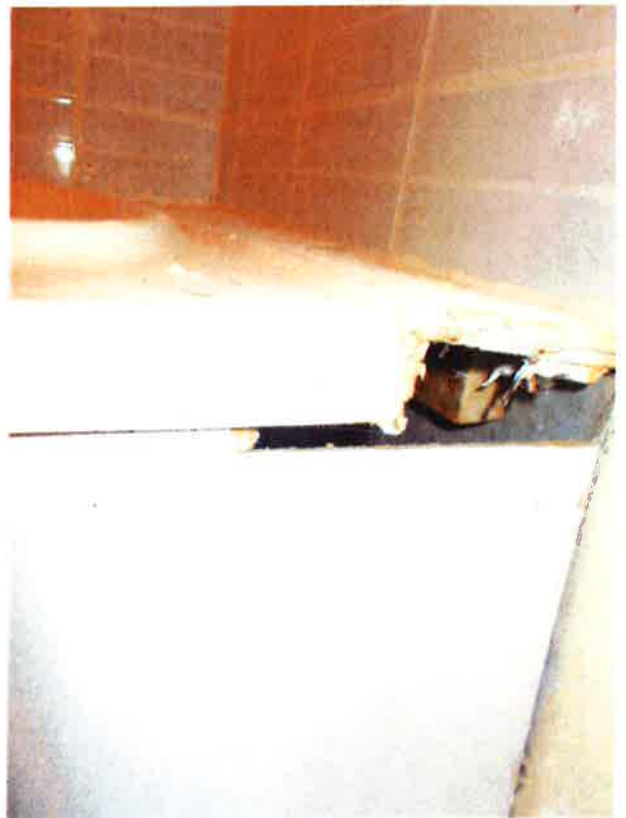
1. (b) Bath

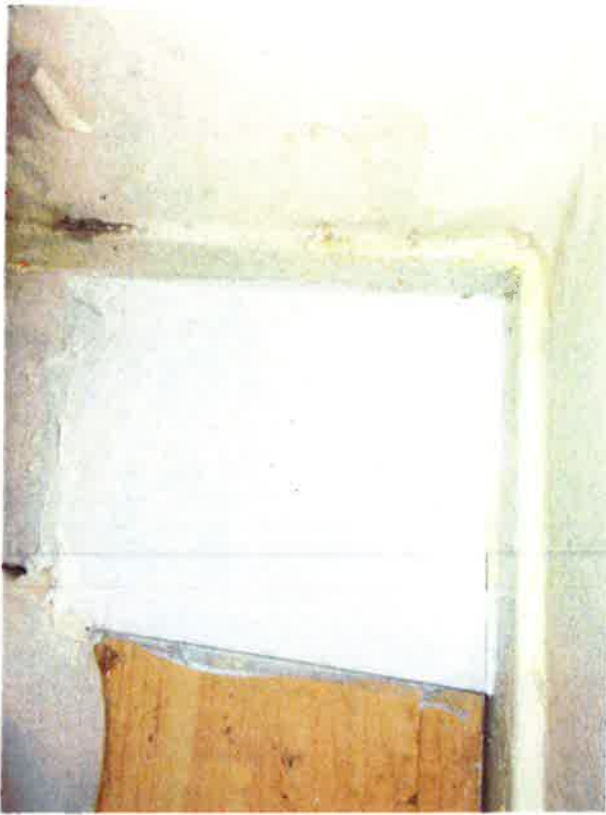
1. (b) 1st floor left room ceiling

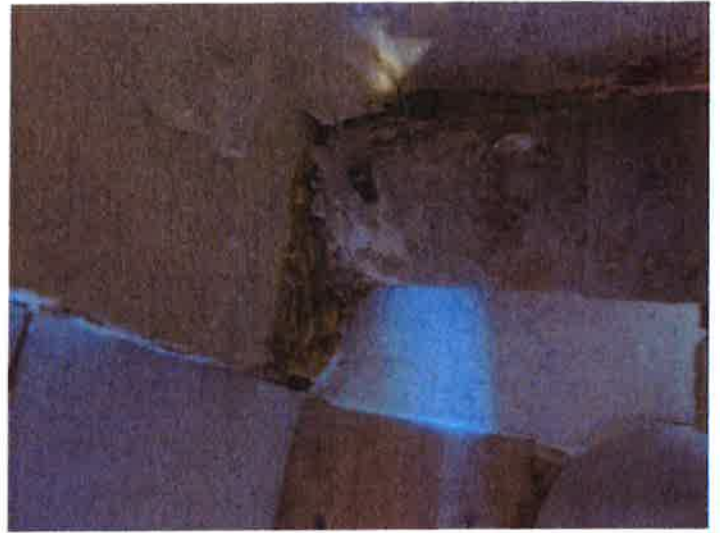
clean effectively. The boxing of the pipe work is now reasonably secure but some gaps remain (photos marked 1. (d)). The RSEO expressly stated that the laminate floor was to be repaired to ensure no gaps and that it could be readily cleaned. The repair carried out to the floor area was not a satisfactory repair and does not meet the requirements of the RSEO. The boxing of the pipe work is not of an acceptable standard because of the gaps evident around the fittings which could lead to difficulty cleaning the area and it has the potential for dirt to gather which is not accessible to clean and there is potential for an occupant's finger being caught in the gap. The Committee does not consider that this requirement of the RSEO has been fully complied with.

1. (d) Bathroom floor at toilet

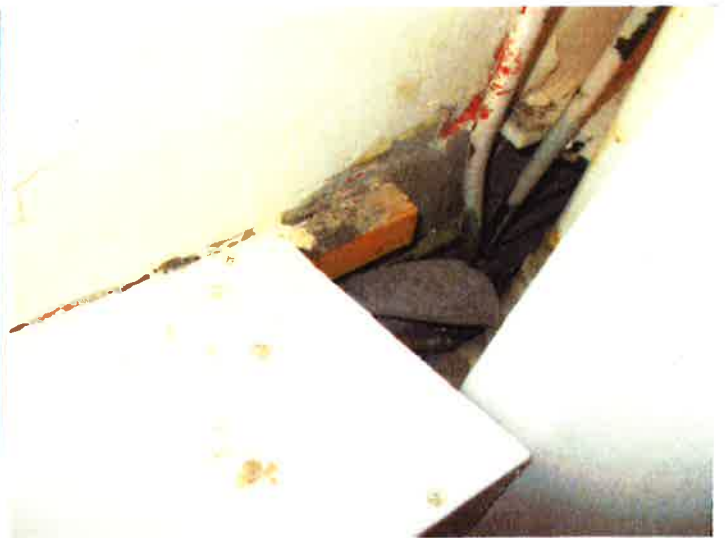
1. (d) Bathroom

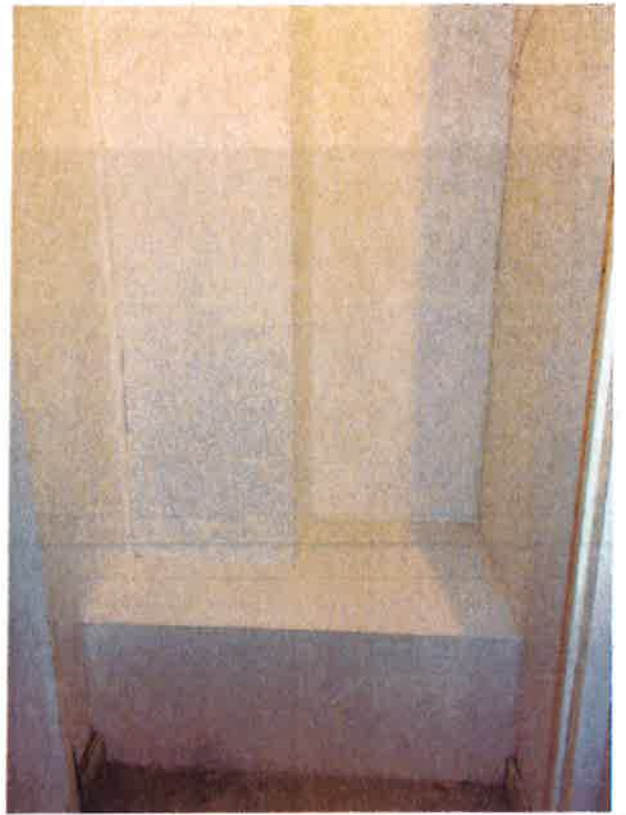
3.1. e) This requirement was part satisfied prior to the re-inspection on 6 August 2015 and detailed in the Decision dated 25 November 2015. The landlord has now painted the new plasterboard ceiling in the first floor bedroom left and installed a new plasterboard ceiling in the adjoining cupboard off the landing, he has also boxed in the pipe work in this cupboard and re-painted. The associated water damage to most areas including the ground floor has now been rectified although there is still some damage at the base of the wall in the first floor cupboard (photos marked 1. (e)).

1. (e) New ceiling in 1st floor room left

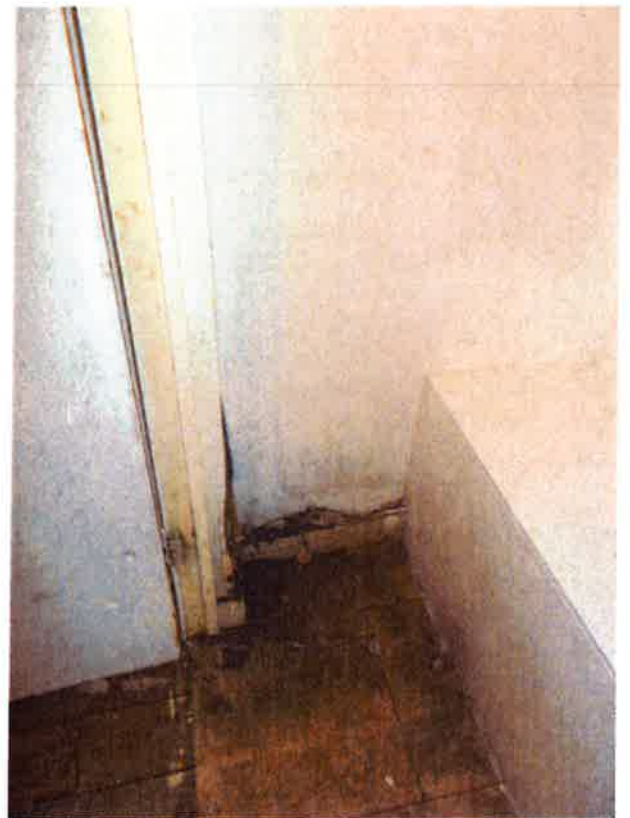
1. (e) Cupboard 1st floor landing - adjacent to room with boiler

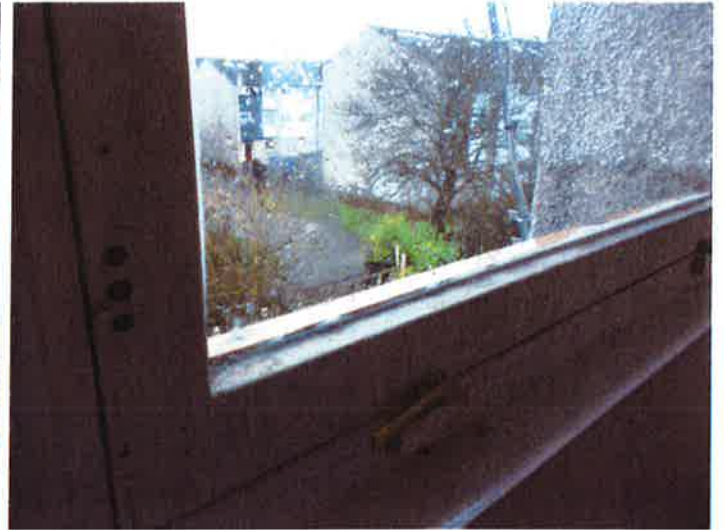
3. 1. f) The glazing to the broken window in the second floor bedroom right was replaced before the re-inspection on 6 August 2015 but the new section of external timber remains unpainted. A number of new handles have been fitted to several windows throughout the property and most of them open and close satisfactorily. However, the left hand side window in the first floor room to the right cannot be opened and it appears to have a defective restrictor. The handle to the ground floor toilet window which is not easily accessed due to its awkward position at height remains broken and there is no other means of ventilation in this room (photos marked 1. (f)).

1. (f) 2nd floor room right - window on right - external timber unpainted

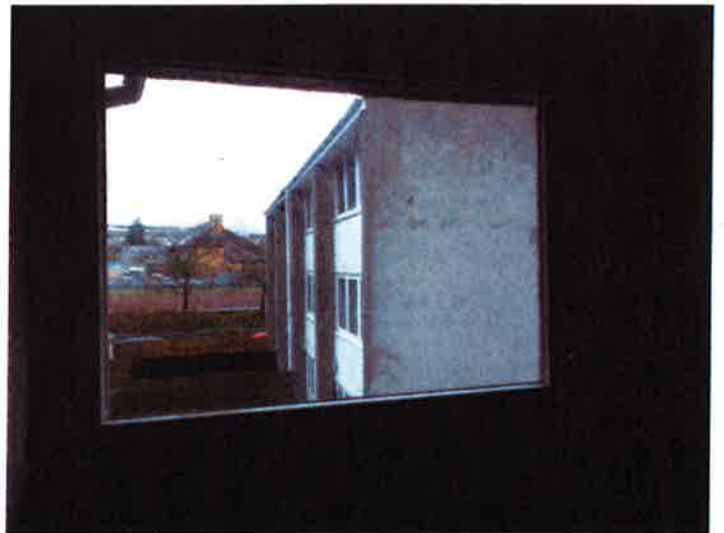
1. (f) 2nd floor room right - window on left new handle

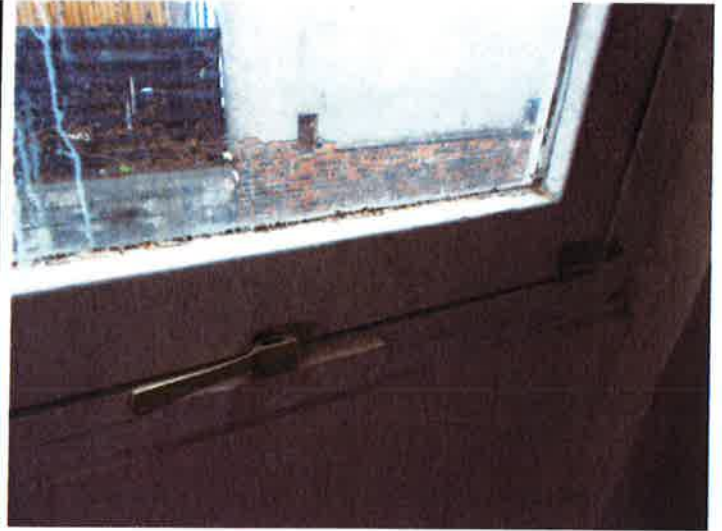
1. (f) 2nd floor bathroom window original handles satisfactory

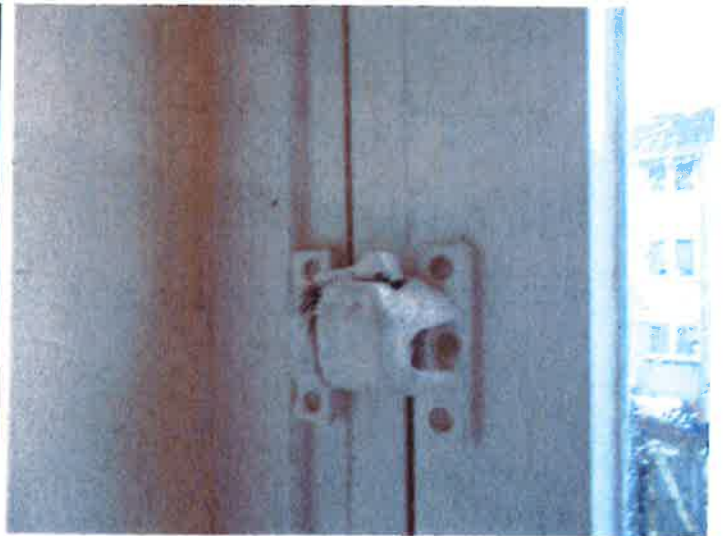
1. (f) 1st floor room on right - right window original handle satisfactory

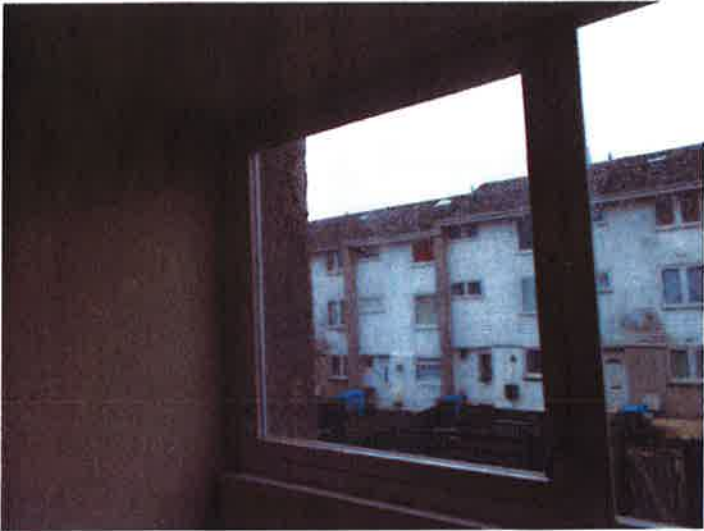
1. (f) 1st floor room on right - left side window does not open - restricter defective

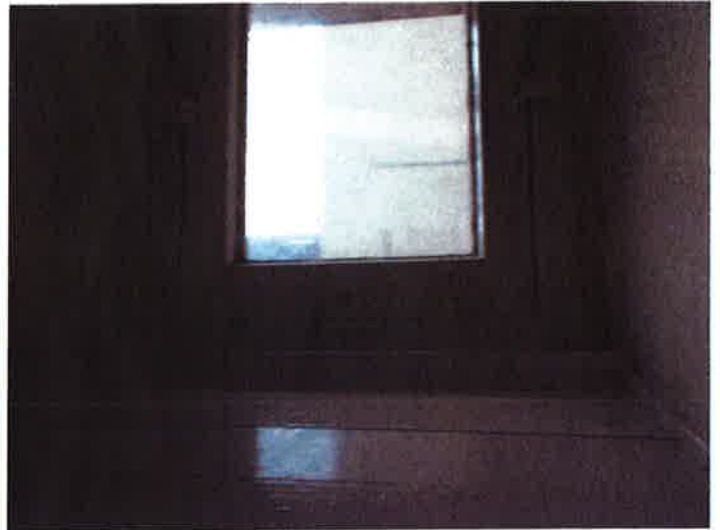
1. (f) 1st floor room on right - left side window does not open - original handles

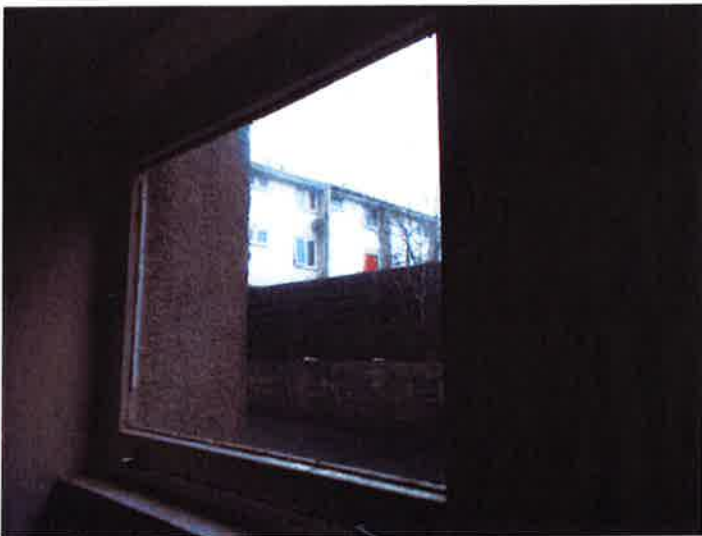
1. (f) GF Cloaks original window handle broken/not possible to reach window easily and no alternative form of ventilation

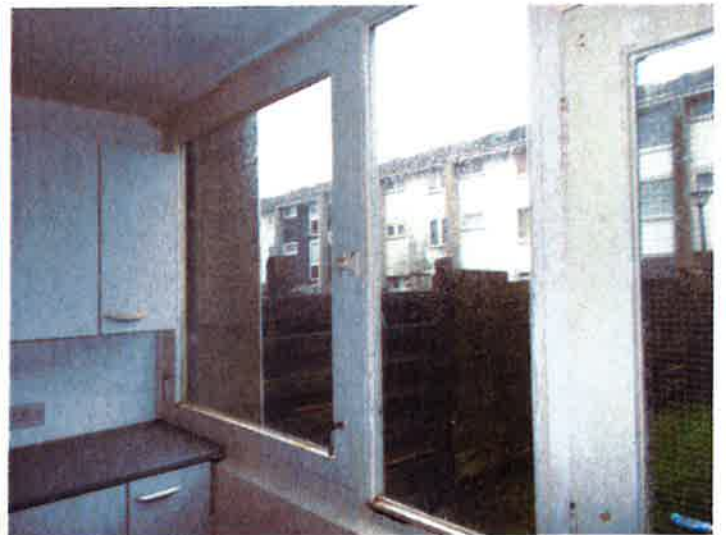
1. (f) GF room front - original handles satisfactory

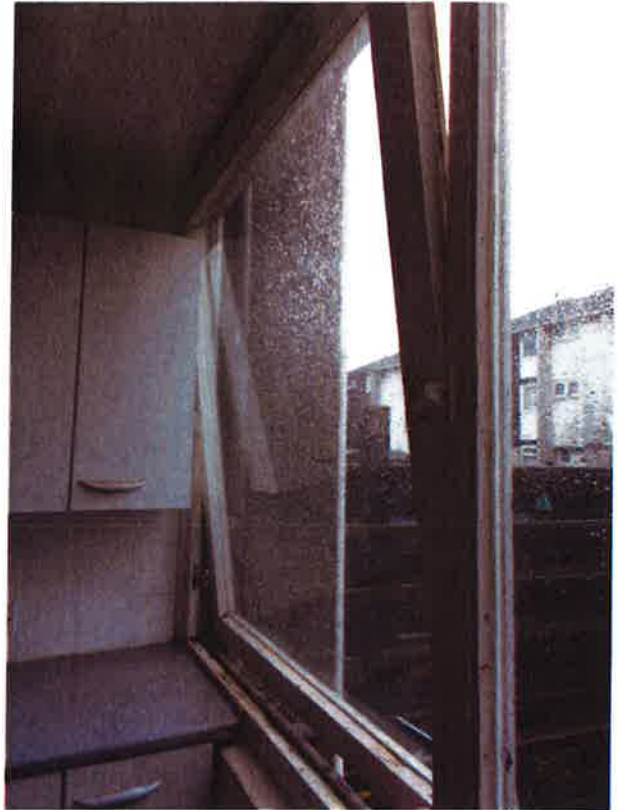
1. (f) Kitchen window on right original handles satisfactory

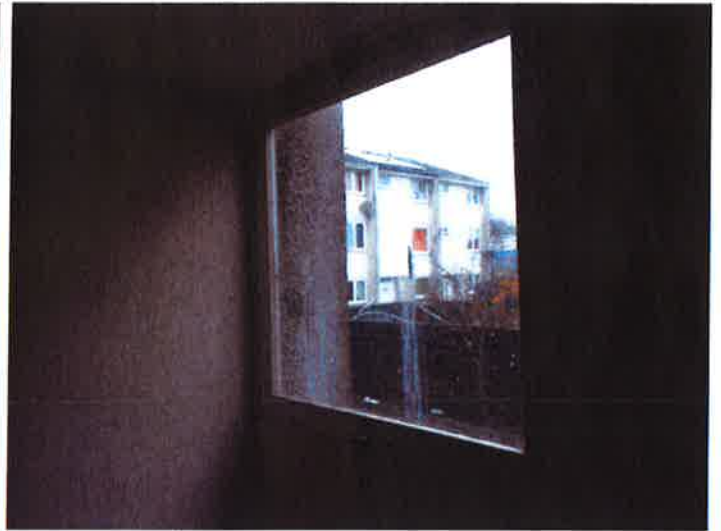
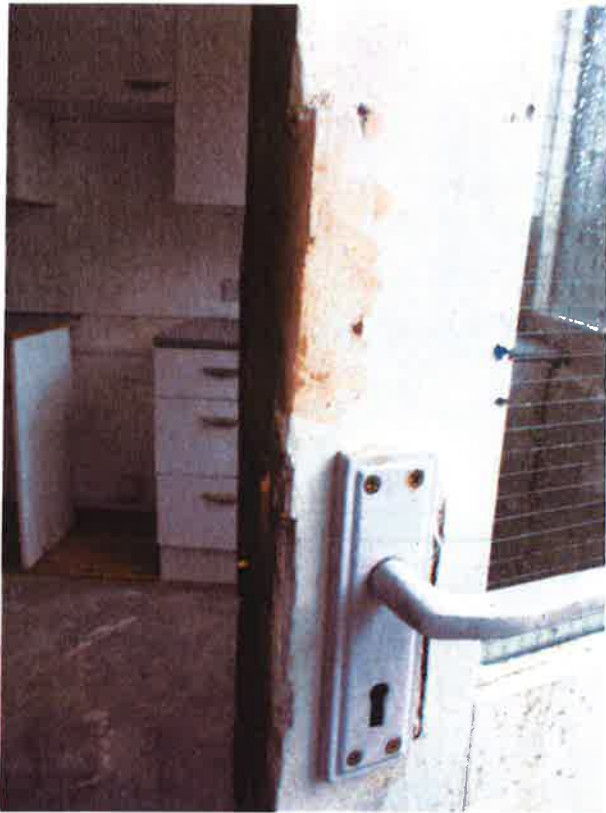
1. (g) 1st floor room left

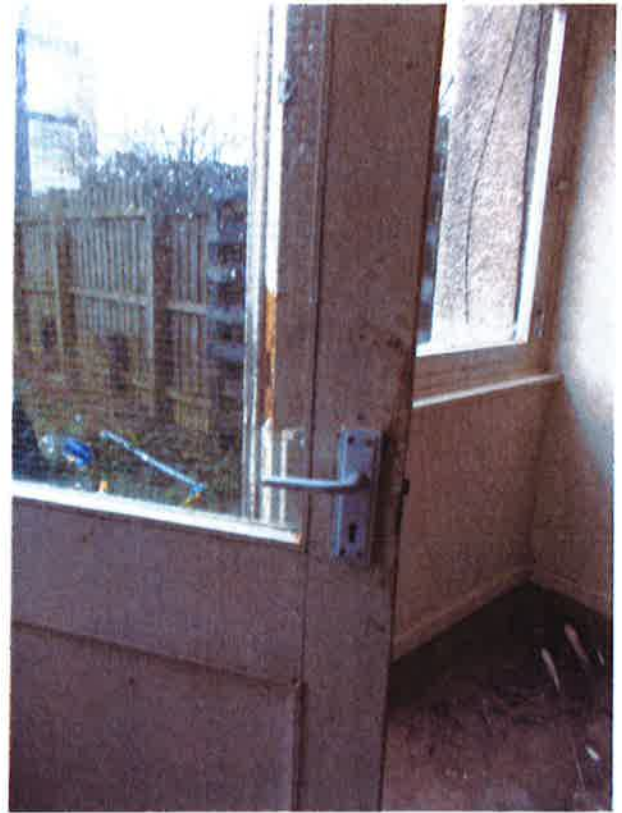
1. (j) New mortice lock to back door external

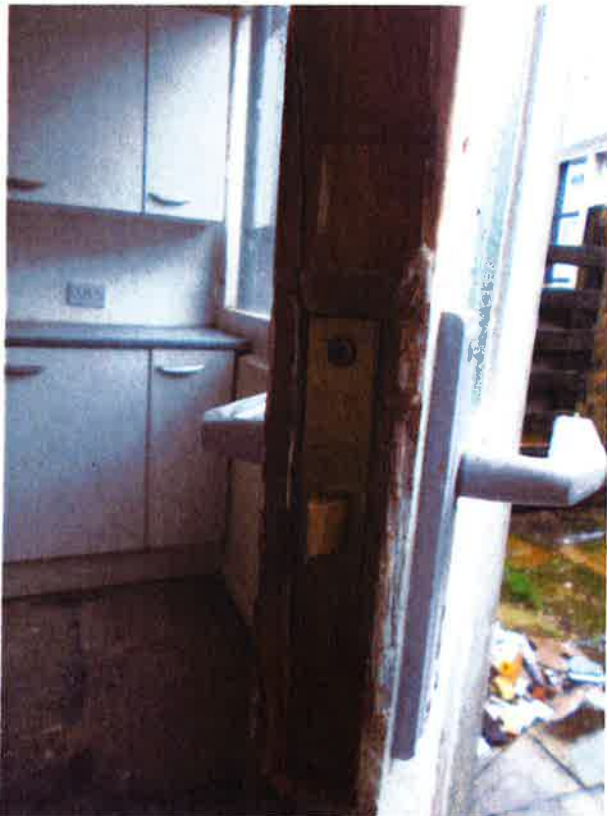
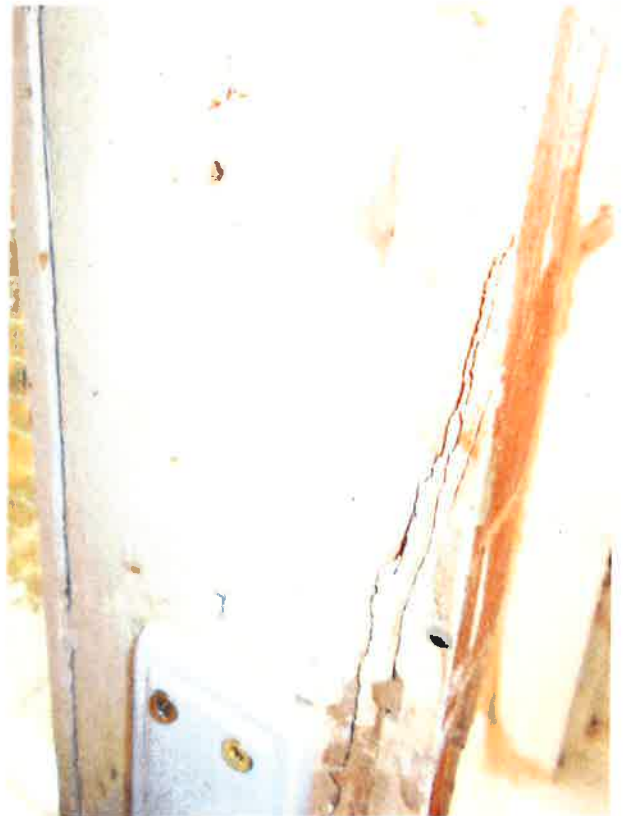
1. (j) Wood split to back door at new mortice lock

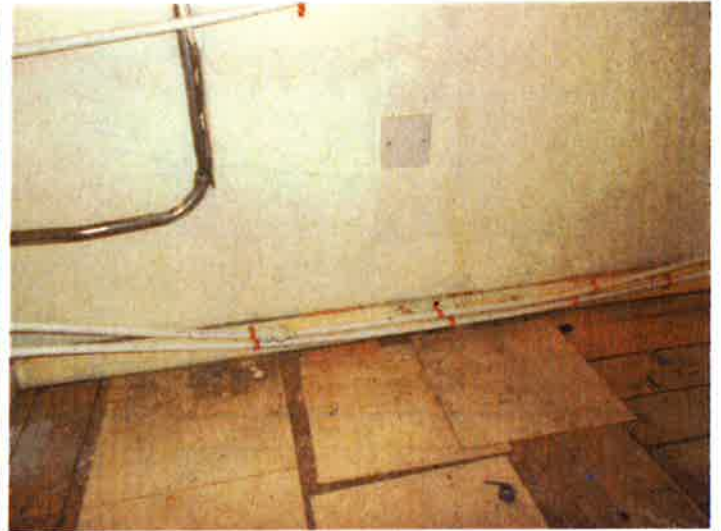
2. 2nd Floor cupboard

3. 2. The Landlord has now secured all the exposed plastic central heating pipes throughout the property using copper saddle clips. Some of the previous plastic clips remain in situ (photos marked 2.) The presence of the previous clips detracts from the appearance of the skirting but it is a minor issue and the Committee does not consider that a failure to comply decision should be made for this requirement of the RSEO.

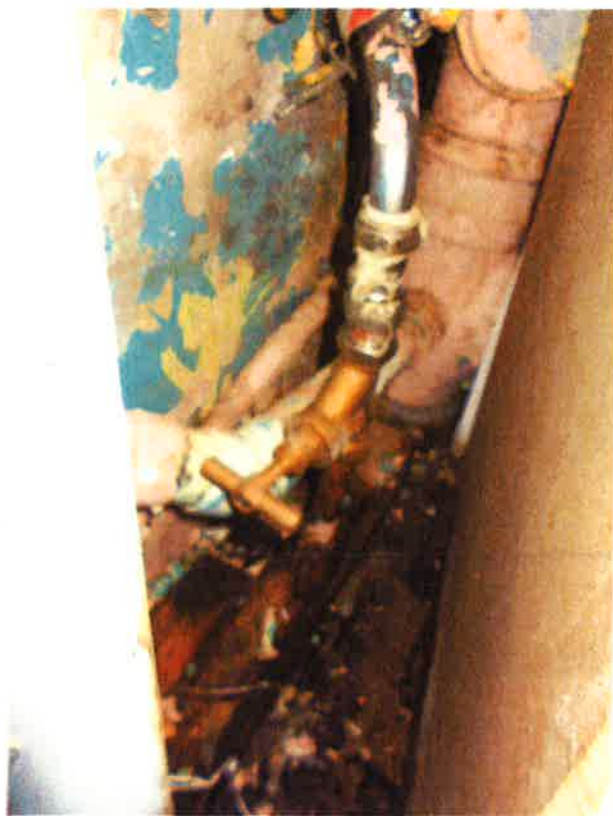
were wet. The boxed pipe work in the cloakroom has also been opened and not re-secured and there are loose screws protruding.

1. GF Cloaks - boxed pipes/exposed screws

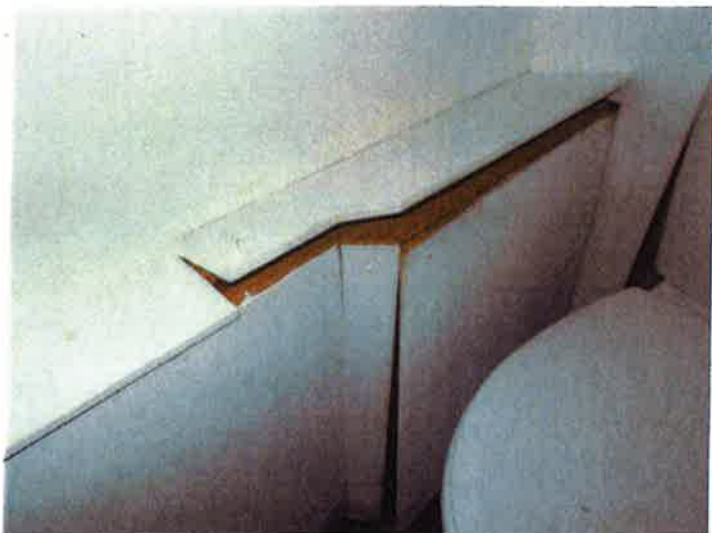
During previous re-inspections of this property by the committee the water was turned off. The committee asked specifically for all services to be fully connected for this re-inspection and it was noticed that there are currently significant leaks to pipe work in the ground floor cloakroom and in the meter cupboard off the ground floor hall and the floors in both areas

2. GF cloaks - pipe leaking behind boxing

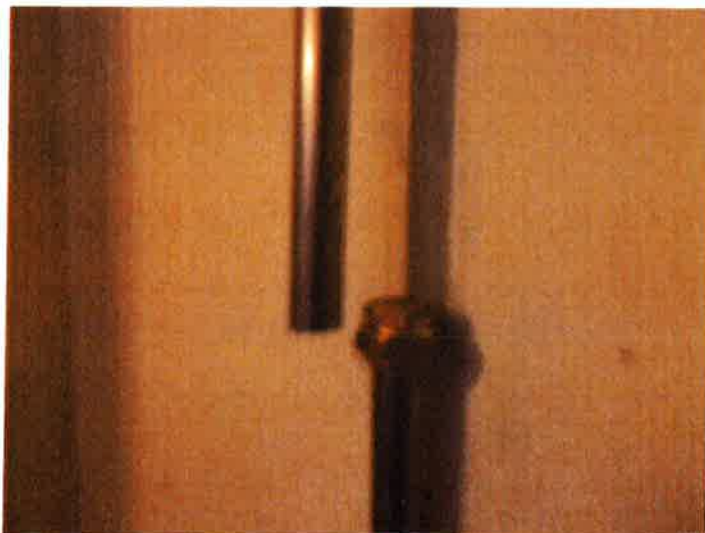
3. GF Cloaks - boxed pipes - unsecured/loose screws etc

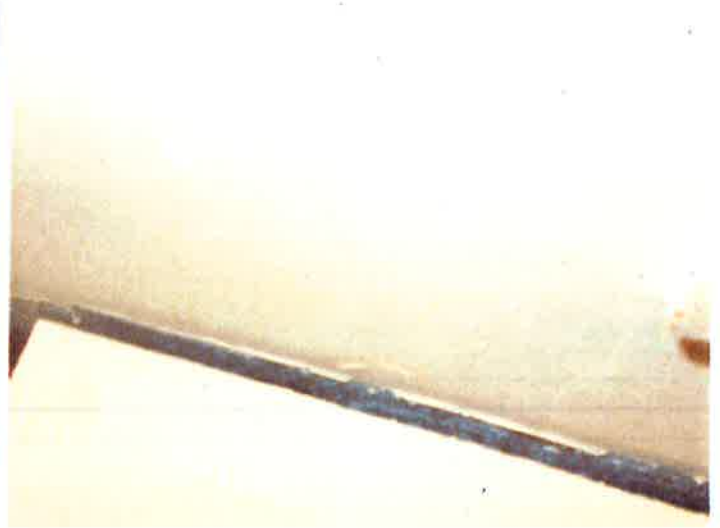
9. Gap at boxing/wall 1st floor room right

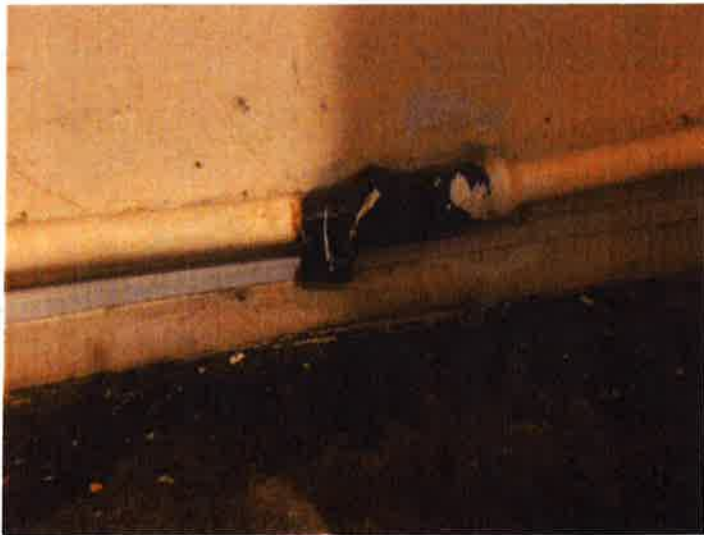
Several other sections of boxing to the central heating pipes have also been disturbed there are a number of areas where the boxing is currently unsecured/screws are loose and protruding and gaps evident.

10. 1st floor room right boxing not fixed to wall

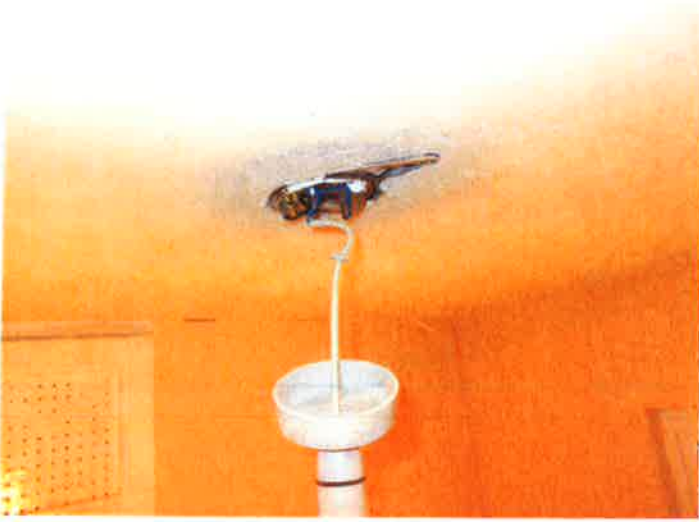
It was also noted that the ceiling mounted light fitting in the ground floor hall is loose and the ceiling is cracked. The hole in the tiling above the shower has been covered with a section of what appears to be painted MDF and has not been tiled to match the surrounding tiled wall and there remains a significant gap between the bath panel, tiling/sealant and wall in the bathroom. There are also gaps around some power points in the kitchen and a loose disconnected pipe in one of the second floor cupboards.

12. GF hall light fitting loose and hole to ceiling

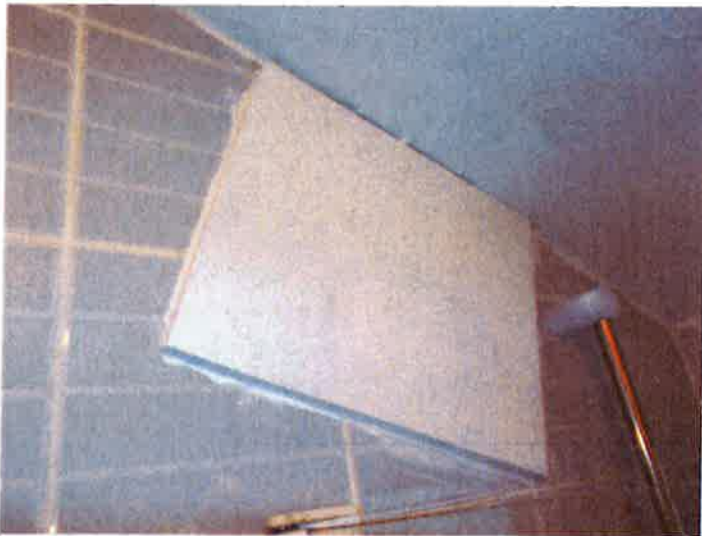
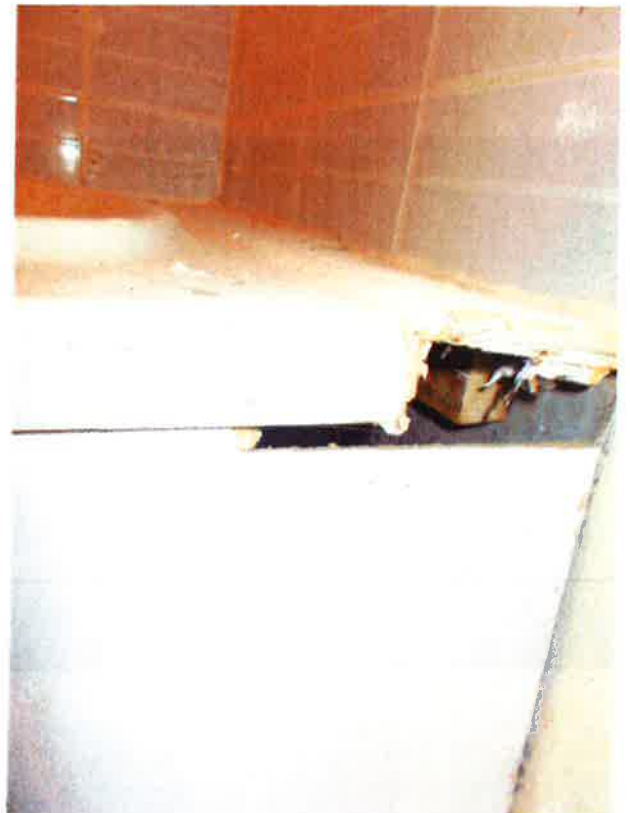
14. Bathroom - Repair to tiled wall above shower

15. Bathroom - repair to tiled wall above shower

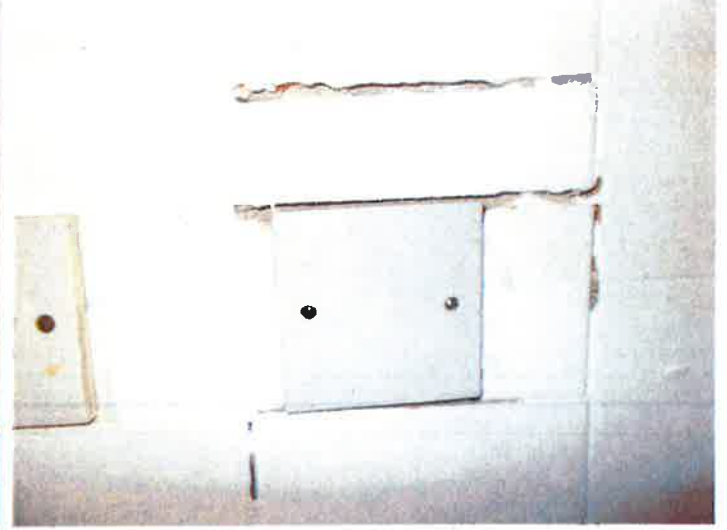
16. Bath - gap at panel/sealant/wall

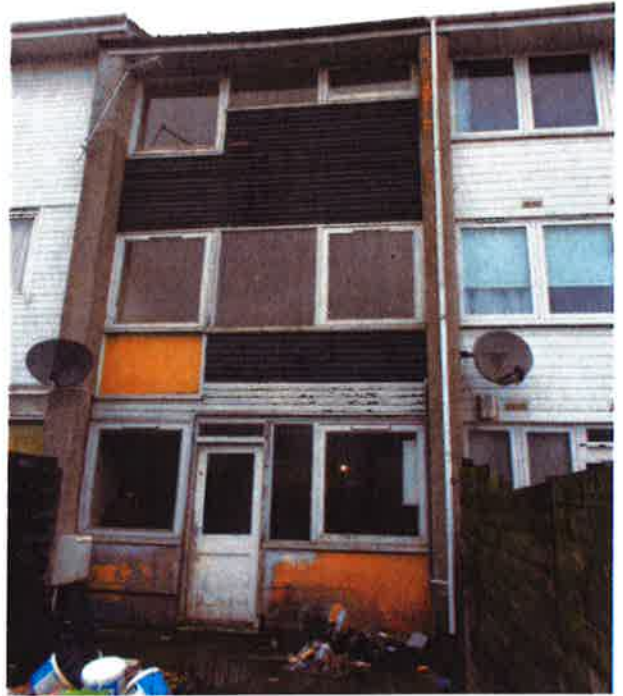
27. Rear elevation - timber cladding at base adjacent to gas meter

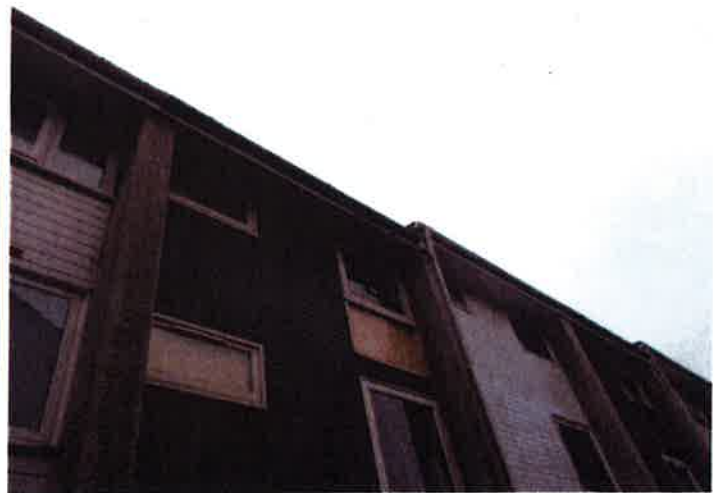
29. Rear gutter - choked with debris/vegetation
