**DETERMINATION BY PRIVATE RENTED HOUSING COMMITTEE re FAILURE  
TO COMPLY**

**STATEMENT OF DECISION OF THE PRIVATE RENTED HOUSING COMMITTEE  
UNDER SECTION 26(1) OF THE HOUSING (SCOTLAND) ACT 2006**

**Property at 15 Fir View, Calderbank, Airdrie ML6 9SW  
(hereinafter referred to as "the house")**

**Reference PRHP/RP/15/0261**

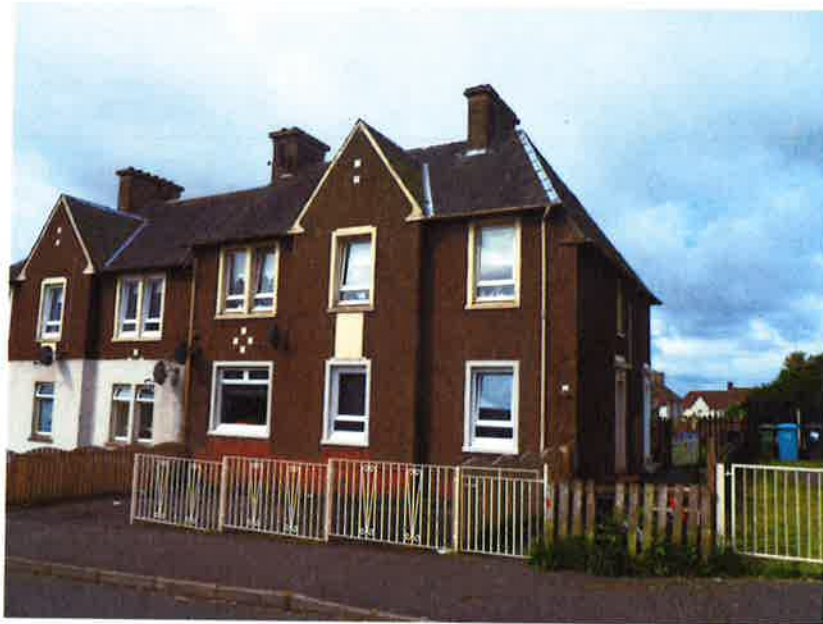
1. The property

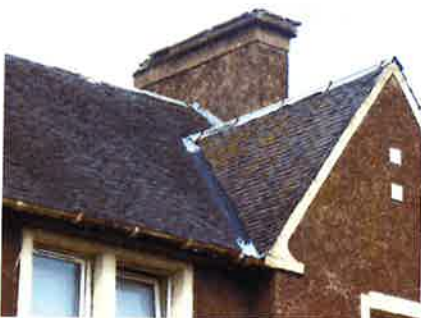
3. The Landlord produced a handwritten Roof Report dated 29 June 2016 prepared by George Peacock, Slater and Plasterer. This confirmed that the overall condition of the roof was satisfactory and that additionally the condition of the chimneystack was satisfactory.

2. Roof and chimney - front

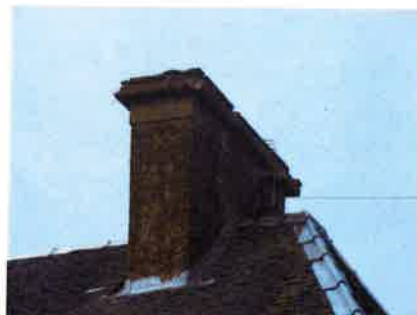
- i. The front door to the Property had been replaced in accordance with item 5 of the RSEO. Subsequent damage had been incurred as a consequence of which the door had required remedial repair and was not lockable.
- ii. The window at the top of the stairs still required to be replaced in terms of item 5 of the RSEO.
- iii. The middle bedroom at the front of the Property had been re-decorated following the earlier repair work, including plastering as a consequence of the former roof leak. There was no evidence of damp within the bedroom of the Property.
- iv. The electric hob/oven and the electric shower were in good working order.
- v. The roof seemed in a reasonable condition. There were no obvious signs of slipped slates. The ridge caps appeared to be in place. There was no evidence of leaking rhones. There was no evidence of loose or crumbling masonry around the chimneystack.

3. Chimney - front

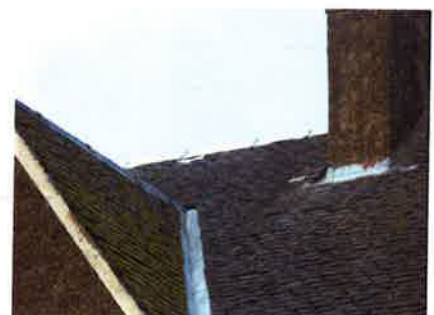
4. Valley gutter

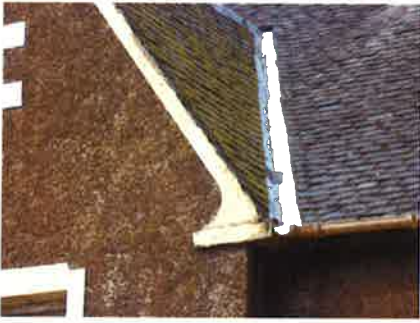
5. Repair to valley gutter

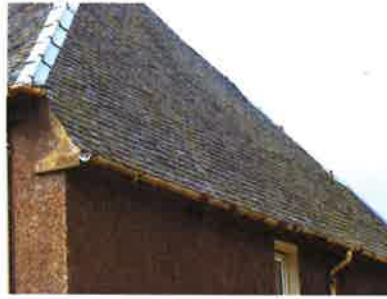
6. Roof gable

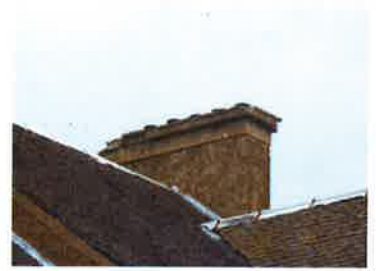
7. Roof and chimney - back

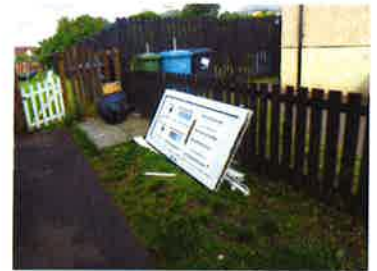
10. Previous front door

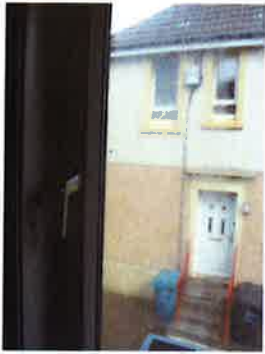
5. The Landlord advised that a new window has been ordered to replace the window at the top of the stairs within the Property. He advised that he expected the window to become available and be installed no later than the end of July 2016. He advised that the front door of the Property had been replaced on Wednesday 22 June 2016. On Friday 24 June 2016, the Police had attended at the Tenant's property with a Warrant and had forced entry, thus causing damage to the door. This background information had been confirmed by the Tenant at the time of the committee's earlier inspection. The Landlord was of the view that he had complied with the RSEO and that he did not require to further replace the door.

14. Hall window to be replaced

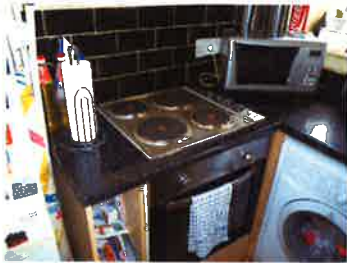
16. Replacement electric hob

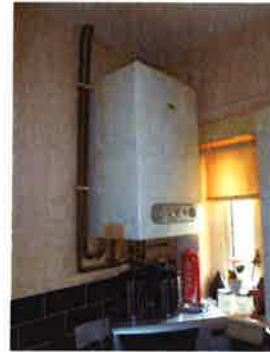
4. The Gas Safety Certificate previously issued raised no concerns with the condition of the boiler. No recent complaints have been received in respect of any problems with the boiler.

17. Gas boiler
