First-tier Tribunal for Scotland (Housing and Property Chamber)

Statement of Decision: Housing (Scotland) Act 2006 Section 24(1)

Chamber Reference Number: FTS/HPC/RP/19/3389

26 Firthview Terrace, Brucehill, Dumbarton, G82 4DT ("the property")

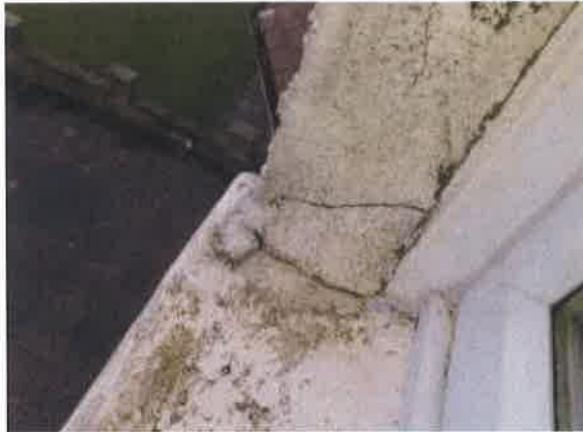
1 Cracking evidenced to rendered ingoes.

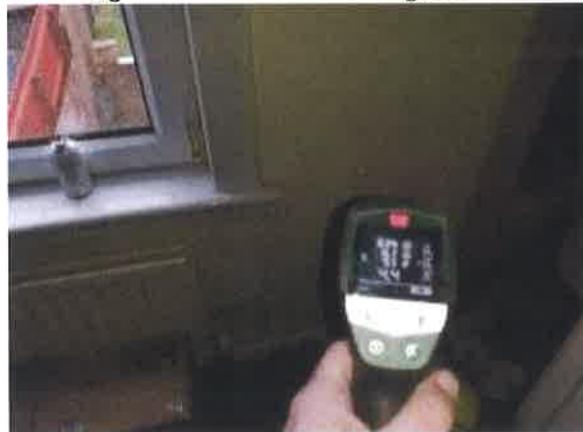
3 Surface wall temperature noted to be below dewpoint allowing condensation.

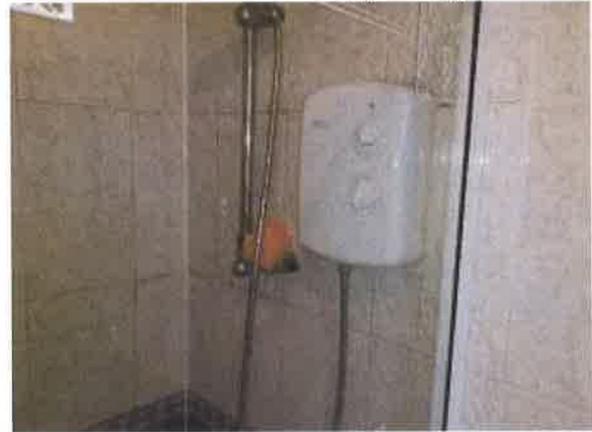
41. **Bathroom fittings.** The Tribunal is not persuaded by the Landlord's argument that the bath panel and shower hose are cosmetic defects. The panel is cracked and loose. The shower hose has several rust spots which have led to the Tenants not using same. The bath seal is also defective. The Tribunal is satisfied that all three require to be repaired for the property to meet the repairing standard

4 Shower hose corroded.

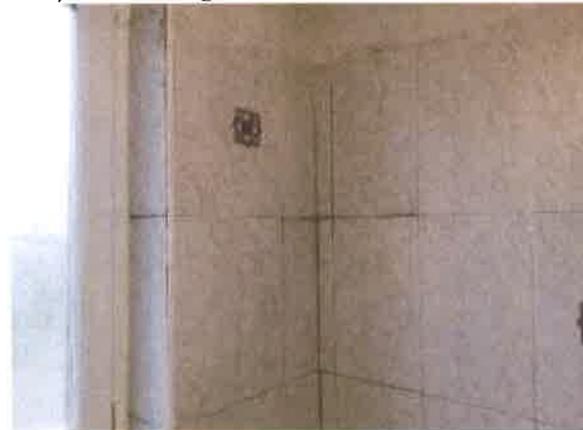
5 Mould growth within Bathroom.

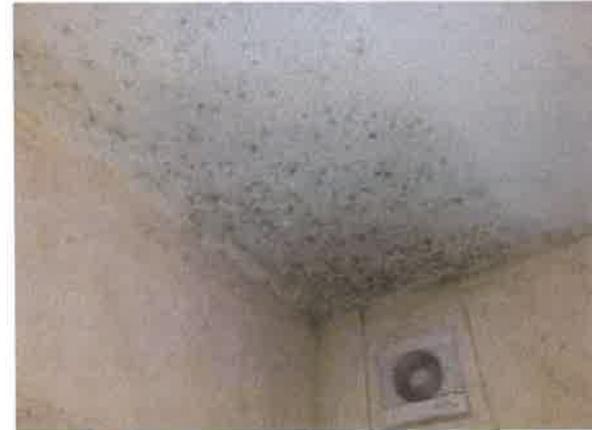
6 Mould growth to bathroom ceiling.

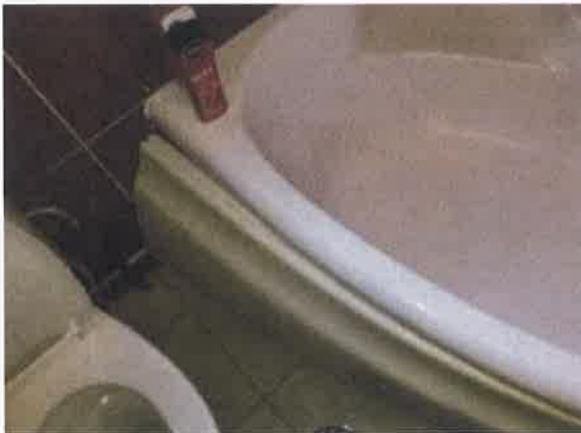
7 Split and loose bath panel.

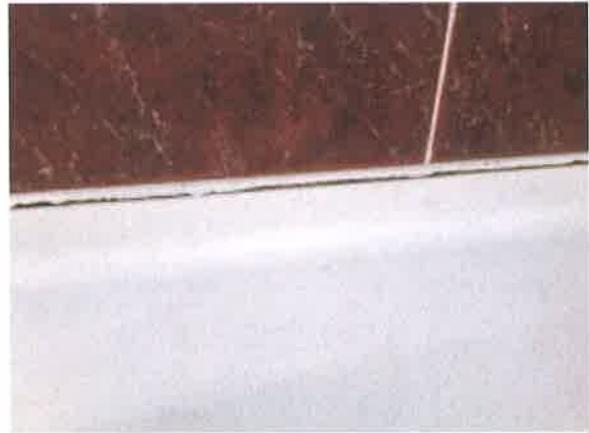
8 Defective bathroom seal.

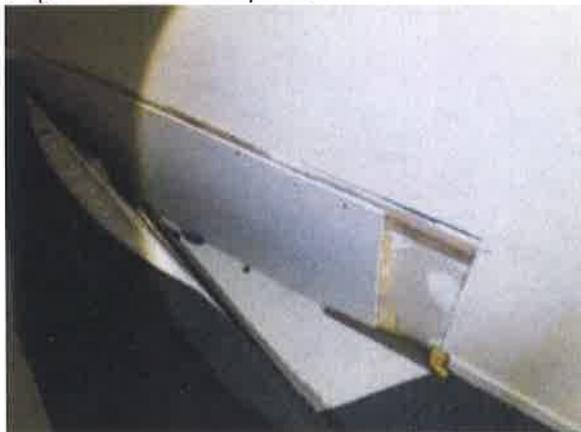
9 Patch repair plasterboard at attic floor.

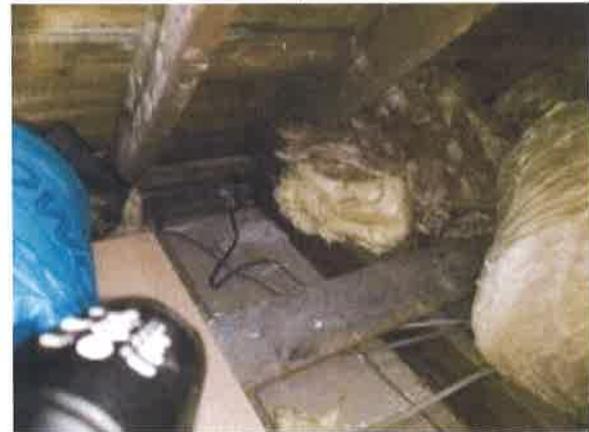
10 Areas of missing insulation in eaves void.

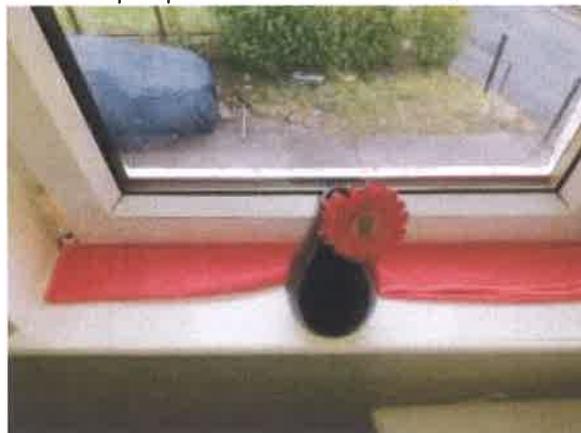
38. **The windows.** The Tribunal observed water and wet cloths on several window ledges during the inspection. The weather was not particularly wet or windy, and no water penetration or draughts were noted. However, it was noted that some windows are undersized with larger than recommended gaps between the sealed units and the frames. The Landlord has twice arranged for a window contractor to attend and carry out remedial work. This does not appear to have been successful and the Tribunal is satisfied that the windows are defective and as a result the property is not wind and watertight.

11 Typical example of cloths laid at windows.

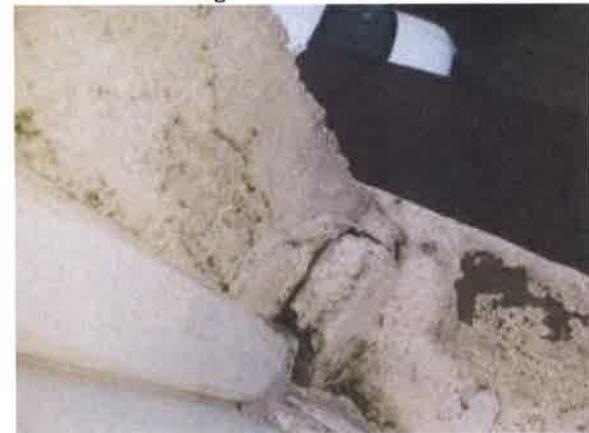
12 Cracking at rendered window ingoes.

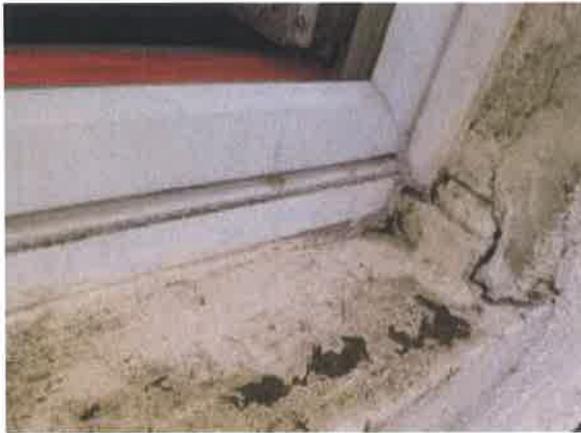
13 Further cracking at rendered window ingoes.

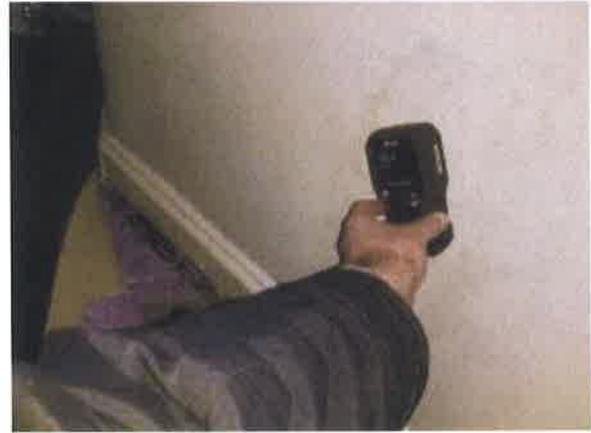
34. **Dampness.** The Tribunal undertook a "qualitative assessment" utilising a moisture profiling technique providing sub-surface/at depth moisture readings. This is a non-disruptive technique that does not provide the true moisture content, rather the relative measurement compared to other readings recorded. Anomalies were observed within the Living Room Bay window where very high readings were recorded, indicative of penetrating dampness.

14 Dampness recorded in Living Room at Bay window.

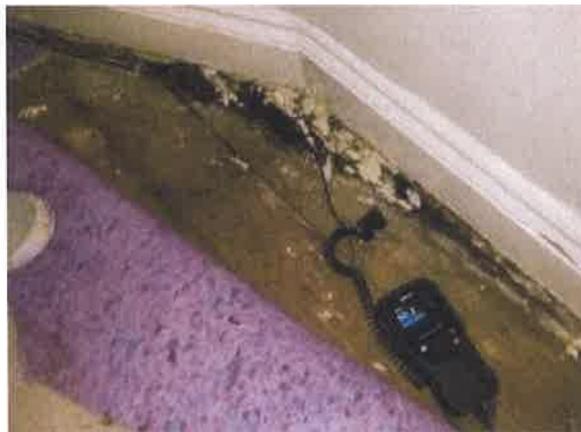
35. A "quantitative assessment" was also undertaken to the timber floor at the bay window utilising the pin-mode of the moisture meter. Such meters are calibrated to timber and provide the true moisture content of any timbers tested. Moisture content to the floor was considered to be at an unacceptable level with elevated readings and timber decay noted. Analysis of the environmental conditions was also undertaken which revealed that the surface temperature on a number of walls and most significantly the Bathroom and Entrance Vestibule was extremely low and despite relative humidity being recorded within a reasonable range, such surface temperatures were notably below dewpoint with heat loss apparent.

15 Timber decay at bay window floor.

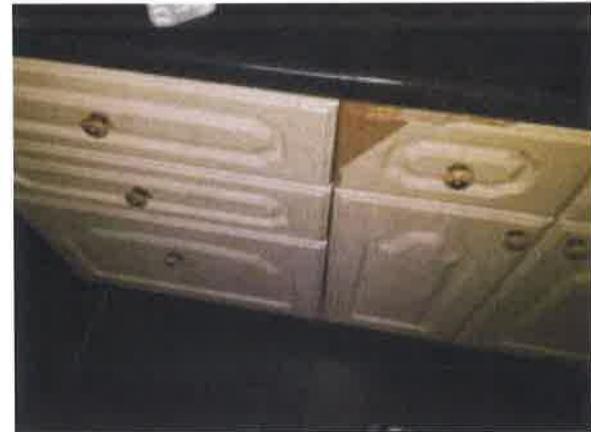
43. **Kitchen.** The Tribunal noted that there are missing and damaged kickboards in the kitchen and a damaged kitchen unit door, which require to be repaired.

16 Damaged doorfront to kitchen.

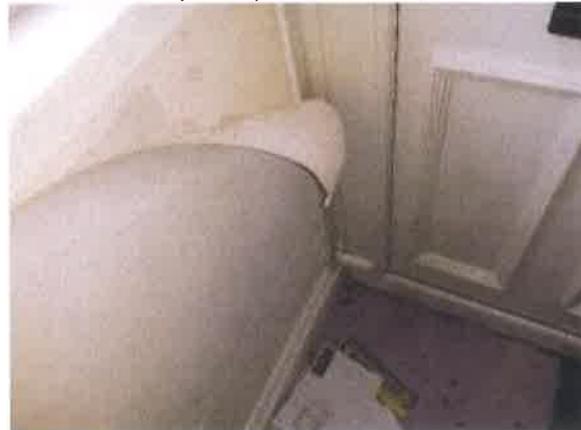
17 Peeling paper in entrance vestibule.

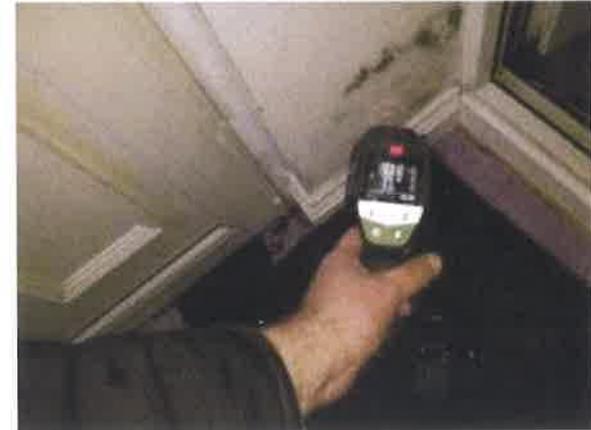
18 Surface wall temperature below dewpoint allowing condensation in entrance vestibule.

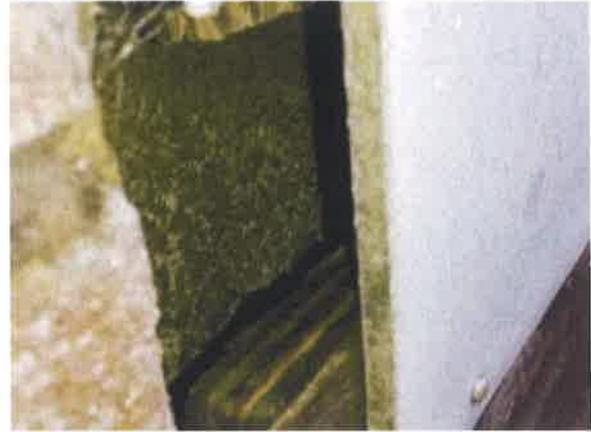
20 Entrance vestibule cladding missing trims.

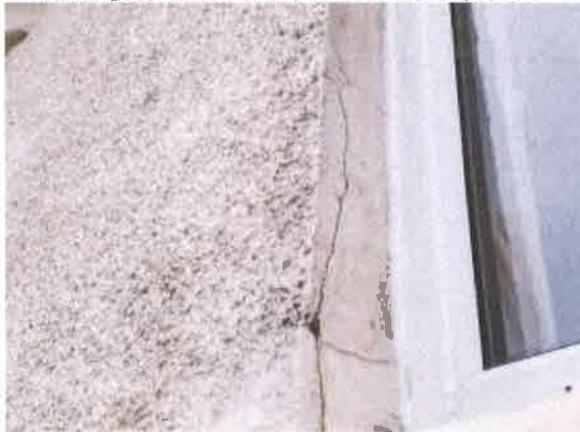
21 Defective rendered ingoie.

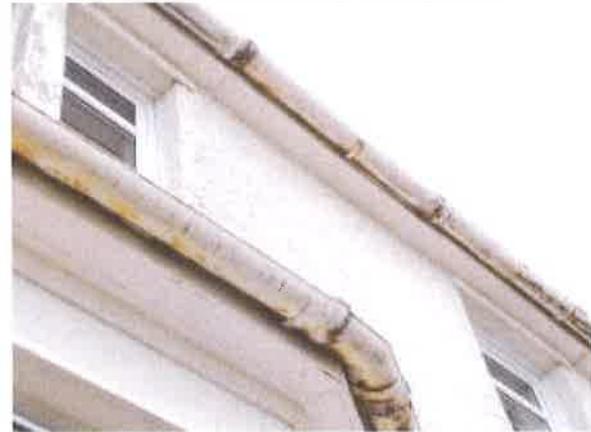
39. **External walls and gutters.** It was evidence from the inspection that the gutters are in disrepair and leaking. This was conceded by the Landlord at the hearing. It was also conceded that there are cracks in the render, although the Landlord thought that this had been addressed in September 2019. The Tribunal notes that the Landlord did not inspect the property following this repair or make other enquiries to establish if the work had fully addressed the issue. He simply accepted the word of the contractor. The Tribunal is satisfied that there are cracks which require to be repaired and that the current condition of the external walls does give rise to a breach of the repairing standard.

22 Leaking gutter joint over front elevation at first floor.

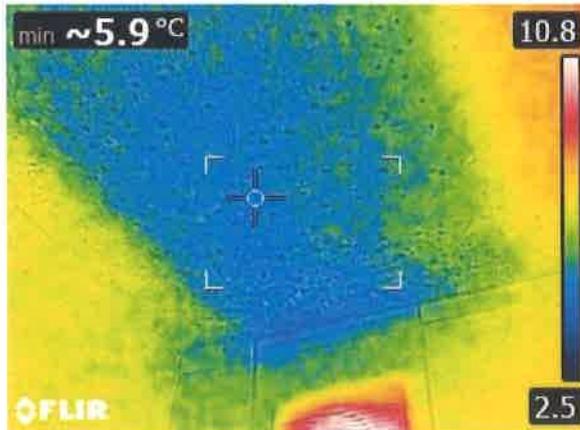
23 Cold areas within bathroom ceiling.

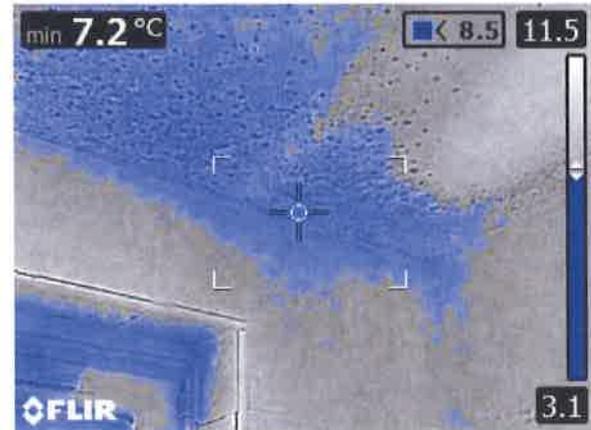
24 Condensation assessment, blue areas all below dewpoint.

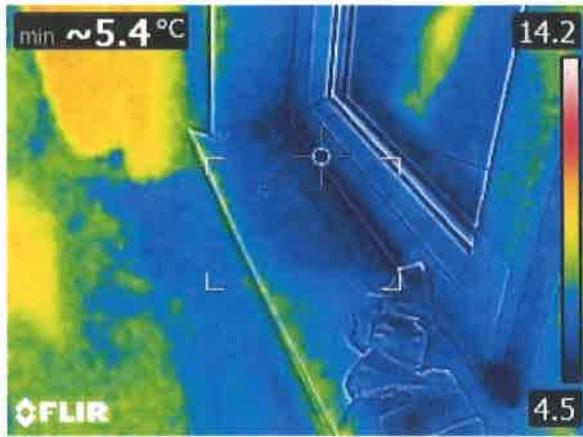
25 Water ingress at window.
