Statement of Decision of the First-tier Tribunal for Scotland (Housing and Property Chamber) under section 60(5) of the Housing (Scotland) Act 2006

Chamber Ref: FTS/HPC/RP/18/2946

29B Orchard Street, Renfrew, PA4 8RJ being the subjects registered in the Land Register of Scotland under Title Number REN89837 ('The Property')

3rd Re-inspection - Photograph Schedule
29B Orchard Street, Renfrew, PA4 8RJ

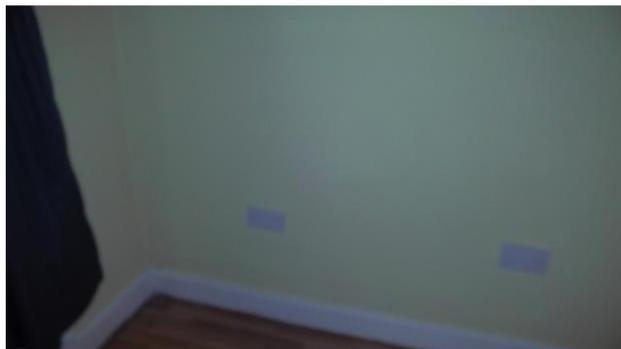
1.1 Living Room – The internal wall between the Living Room and the bedroom which was found to be saturated with dampness to a height of approximately 0.4 metres at the corner near to the bay window.

No dampness readings of any consequence were recorded at this location. Photo 2 below refers.

Photo 2 – Living room wall section

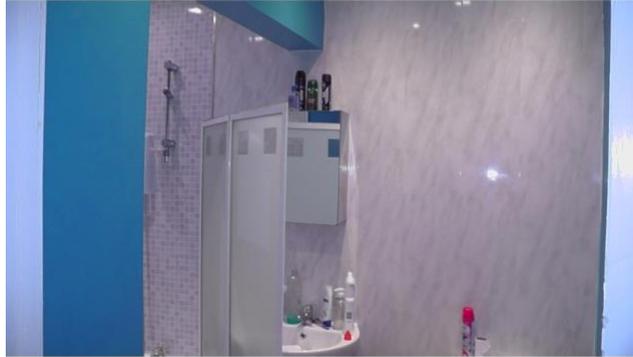
1.2 Bathroom – The party wall of the bathroom behind the whb + wc which was found to be saturated with dampness to a height of approximately 1.5 metres. The section of reinforced beam above and facing the bath which was also found to be saturated with dampness.

No dampness readings were obtained from the wall section behind the whb + wc.

At the previous inspection it was noted that this wall section had been fitted with a damp membrane and wet wall finish. Photo 3 below refers.

Photo 3 – Bathroom wet wall section

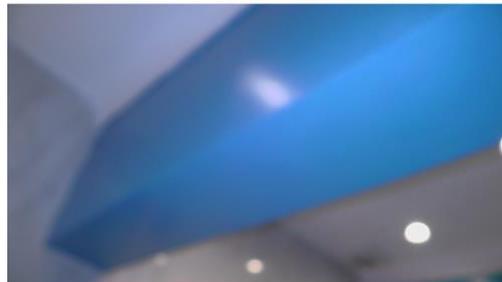
No dampness readings of any consequence were recorded on the ceiling beam section above and facing the bath unit.

Photo 4 - Inner beam section

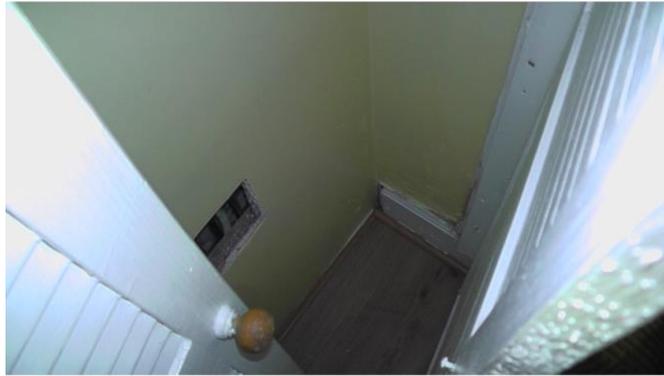
- a) The lower right hand side of the cupboard housing the boiler;

No dampness readings were obtained at this location. Photo 5 below refers.

Photo 5 – Boiler cupboard

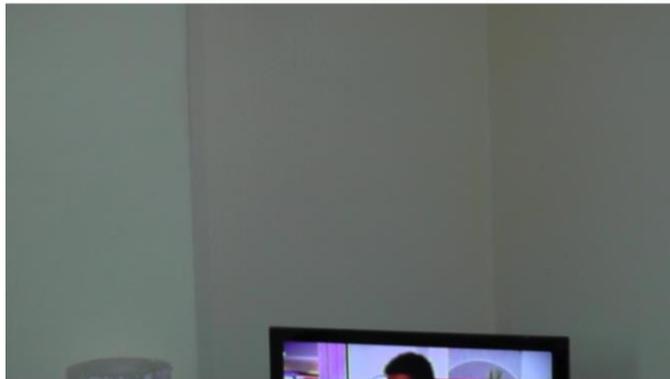
- b) The corner section of the party wall to the right of the old fireplace, and the section of the dividing wall between the dining/kitchen and bathroom above the new plasterwork at a height of approximately 1.5 metres;

No dampness readings of any consequence were obtained at this location. Photo 6 below refers.

Photo 6 – Corner section of party wall

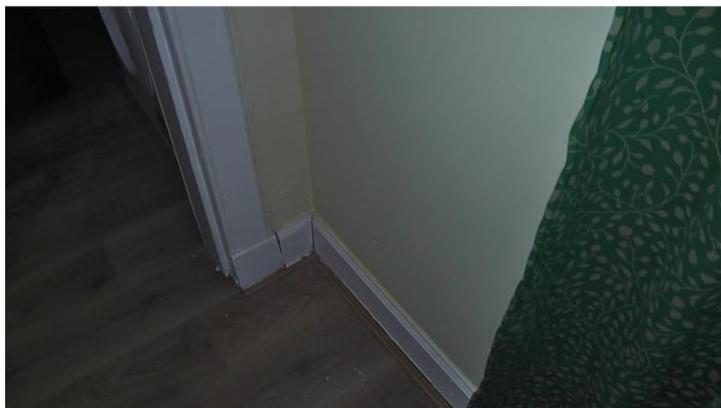
- c) The wall section immediately to the right of the doorway into the utility room.

No dampness readings were obtained at this location. Photo 7 below refers.

Photo 7 – Wall section at utility room doorway

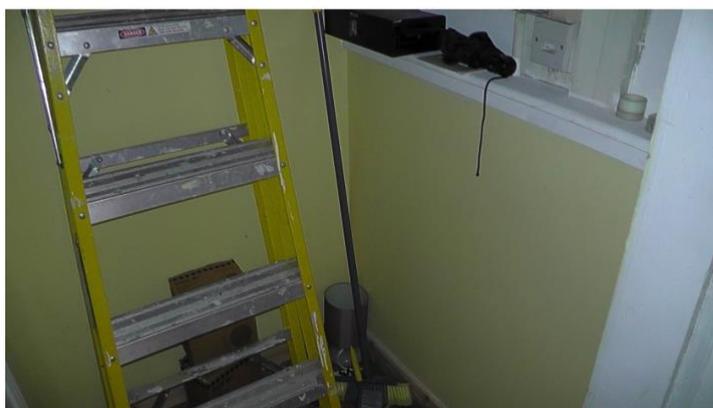
1.4 Hall Cupboard – The internal wall between the hallway cupboard and the close to a height of approximately 1.5 metres.

It was noted that the hallway cupboard had been box-framed. No dampness readings were obtained from within the cupboard. Photo 8 below refers.

Photo 8 – The box-framed hallway cupboard
