First-tier Tribunal for Scotland (Housing and Property Chamber)

STATEMENT OF DECISION: Housing (Scotland) Act 2006 Section 24 (1)

Chamber Ref: FTS/HPC/RP/20/1458

Pre-hearing inspection summary and schedule of photographs

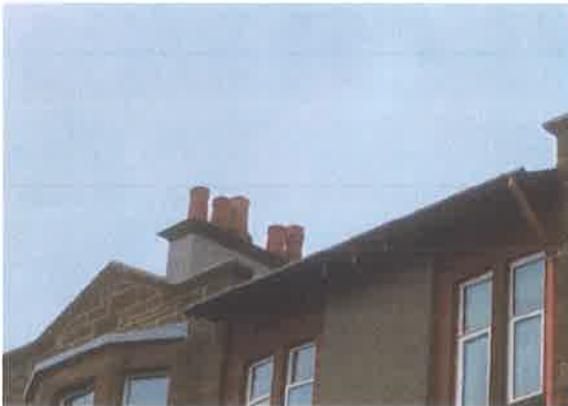
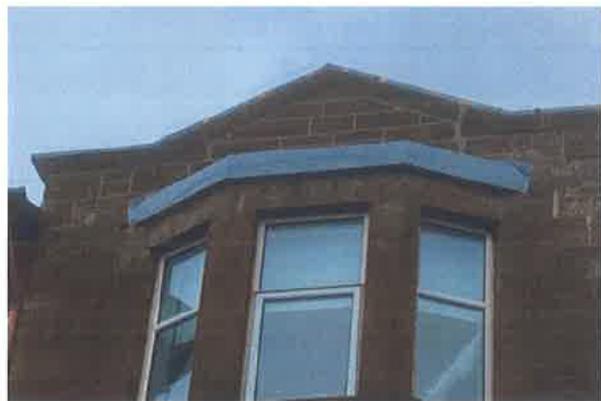
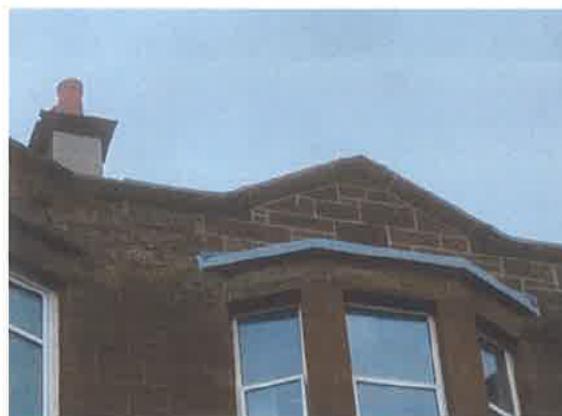
Photographs 1-3 illustrate recent repairs and renewal at the guttering, leadwork, bay window projections and chimneyhead.

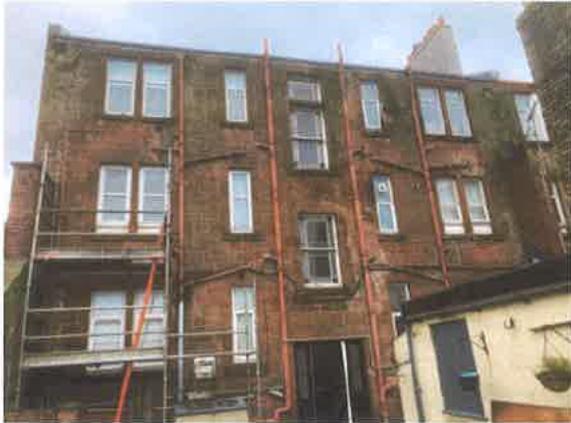
4

Photographs 4-6 illustrate the remains of the scaffolding, currently being removed, freshly rendered chimneyhead, replacement gutters and exposed stonework.

From the photographic evidence provided by the supervising surveyors, their accompanying report and my observations on site, it is clear that the substantial common repairs, including re-roofing, replacement gutters, renewal of leadwork and rendering at chimney have been completed. These major works were finished on or around 20th December. Scaffolding is currently being removed (photograph 4)

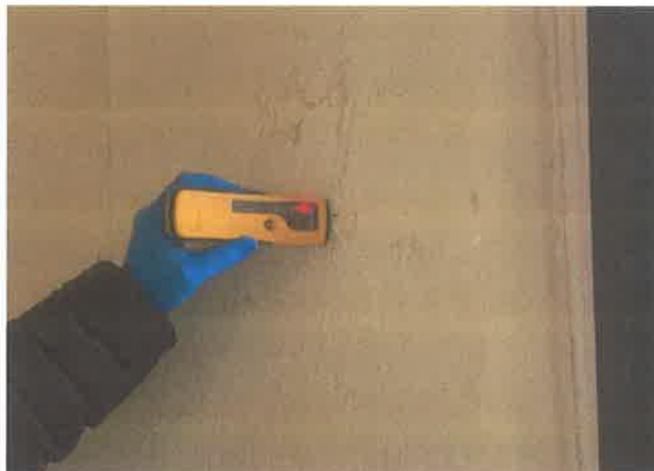
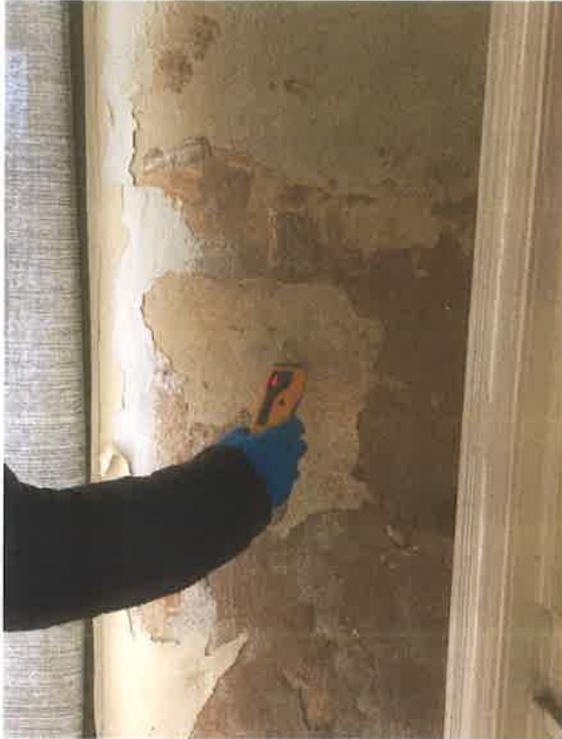
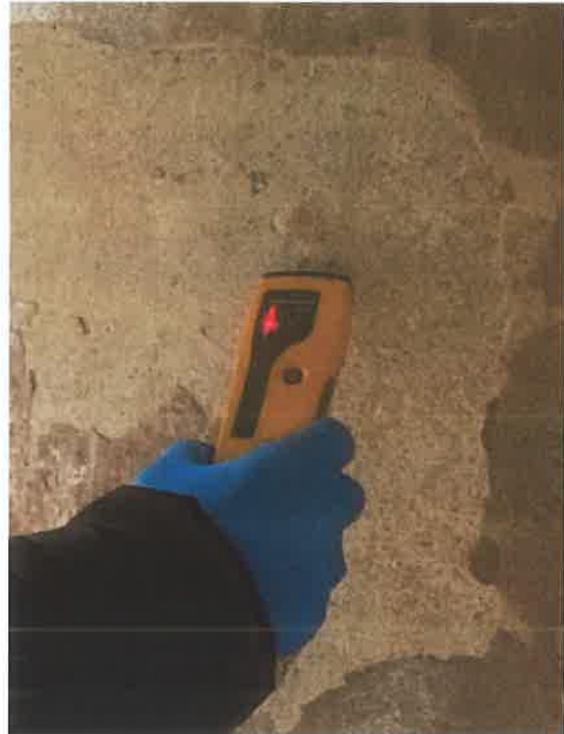
29. The Tribunal was satisfied that remedial works have been carried out to the roof, gutters chimney and bay windows at the property. Internally damp readings remain at the front wall although given the recent completion date of the external common repairs it is likely that these are the result of residual damp stemming from defects at the roof and associated leadwork which have since been addressed. The affected areas of plasterwork do appear to be drying out although the lack of any functional space heating within the property has hindered the drying process.

Photographs 7-9 illustrate damaged plasterwork at the internal face of the front elevation (bedroom and living room) and high, possibly residual, damp readings in the wall plaster.

Internally damp readings remain at the front wall although given the recent completion date of the external common repairs it is likely that these are the result of residual damp and surrounding areas of plasterwork do appear to be drying out.

34. Finally, during the reinspection to confirm that the issues in the RSEO have been addressed, the Tribunal will also reinspect those areas of damp noted in the "pre-hearing inspection and schedule of photographs" (**appendix 1**) in order to confirm the success or otherwise of the repairs to the external fabric of the building. Functional space heaters should significantly improve the timescale in relation to the drying out process.

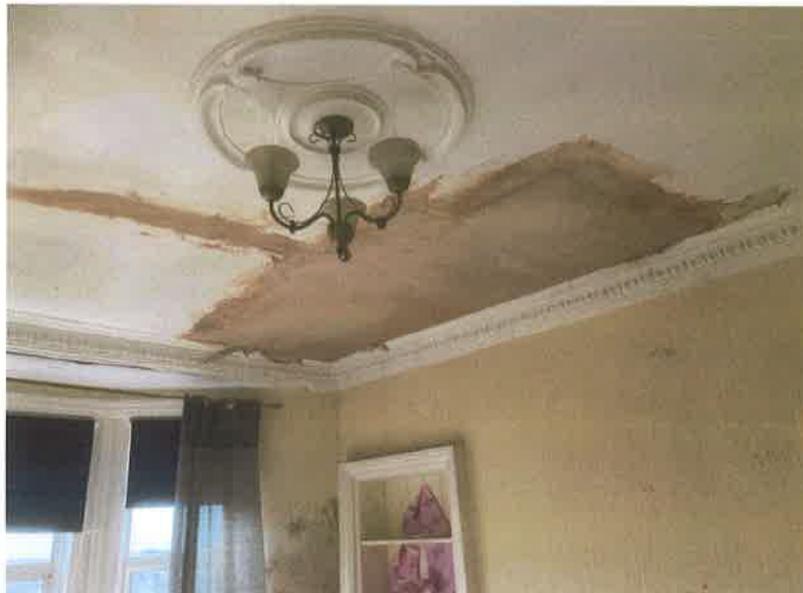
10

Patched repair at living room ceiling plaster.

The damaged ceiling identified in the application has been the subject of limited local repair (photograph 10) although this area, together with the remainder of the flat in general, has not been redecorated. Significant damp staining within the common close and stairwell remains although it is assumed that this will dry out following completion of the repairs to the common fabric.

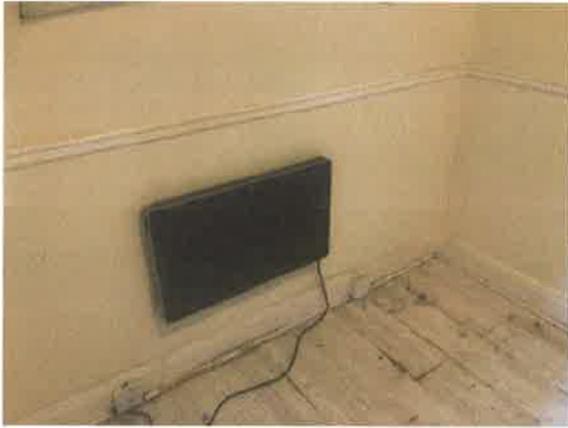
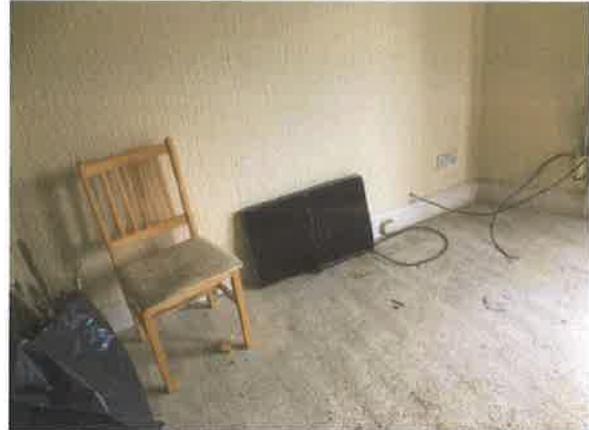
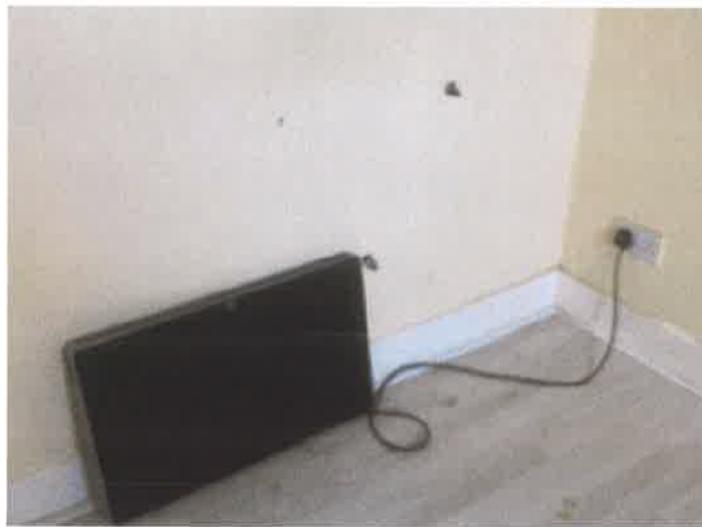
30. The former tenant complained that none of the panel heaters at the property were working and it has not been possible to confirm if they work or not. The bathroom heater is definitely not working.

Space heating (not in operation) is provided by wall mounted electrical heaters. Several remain unsupported and are resting on the floor – Photographs 11-13.

I was unable to confirm that the electrical heaters and hot water supply are functioning satisfactorily.

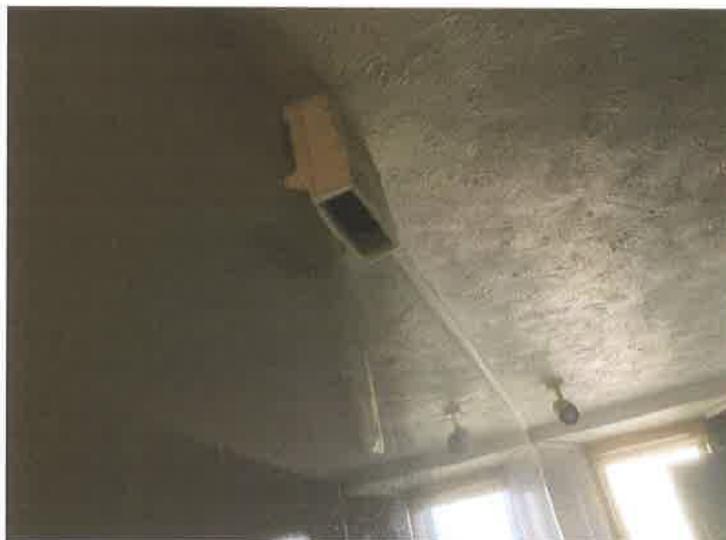
14:- Wall mounted, non-operational electric bathroom heater

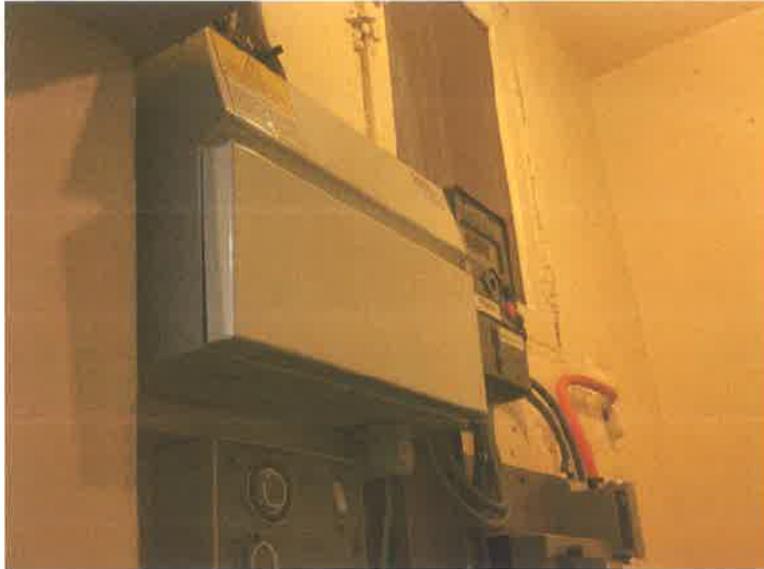
15

The electricity meter indicates a single standard tariff. The hot water cylinder was not accessible although the "hot water switch" at the meter appeared functional when in the on position.
