**STATEMENT OF DECISION: Housing (Scotland) Act 2006 Section 24 (1)**

**Chamber Ref: FTS/HPC/RP/22/4179**

**Flat 9, 67 Seagate, Dundee DD1 2EH (“The Property”)**

## Pre-hearing inspection summary and schedule of photographs

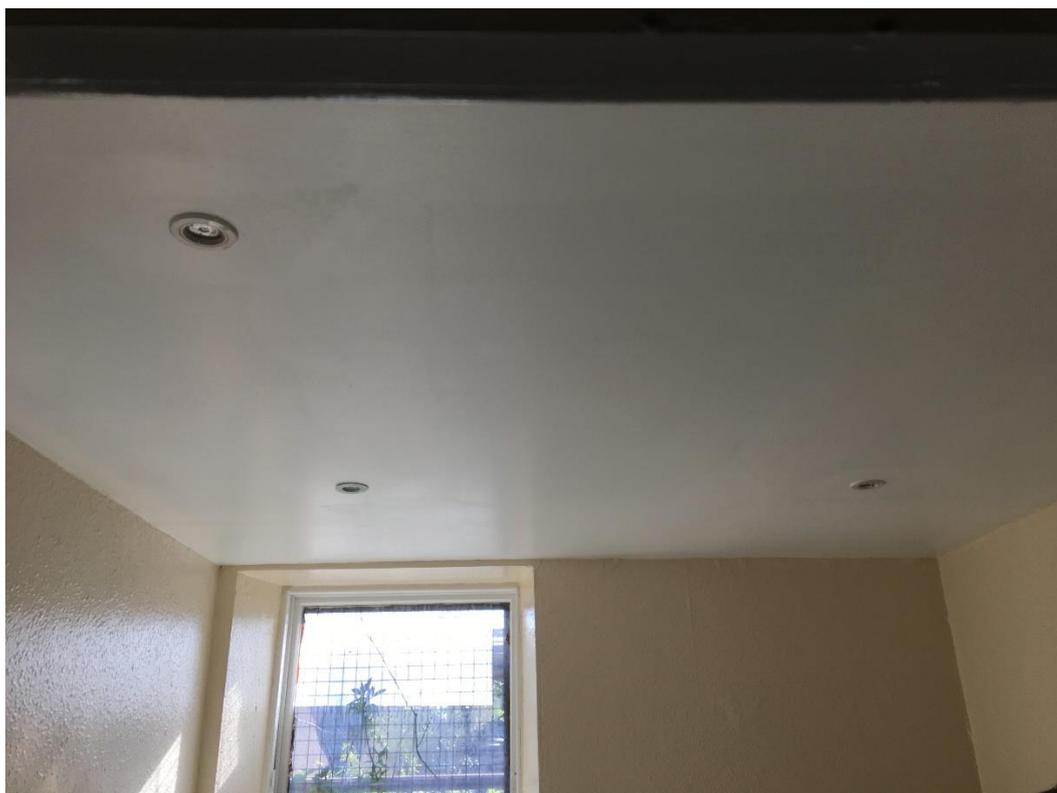
Renewed plasterwork in Kitchen.

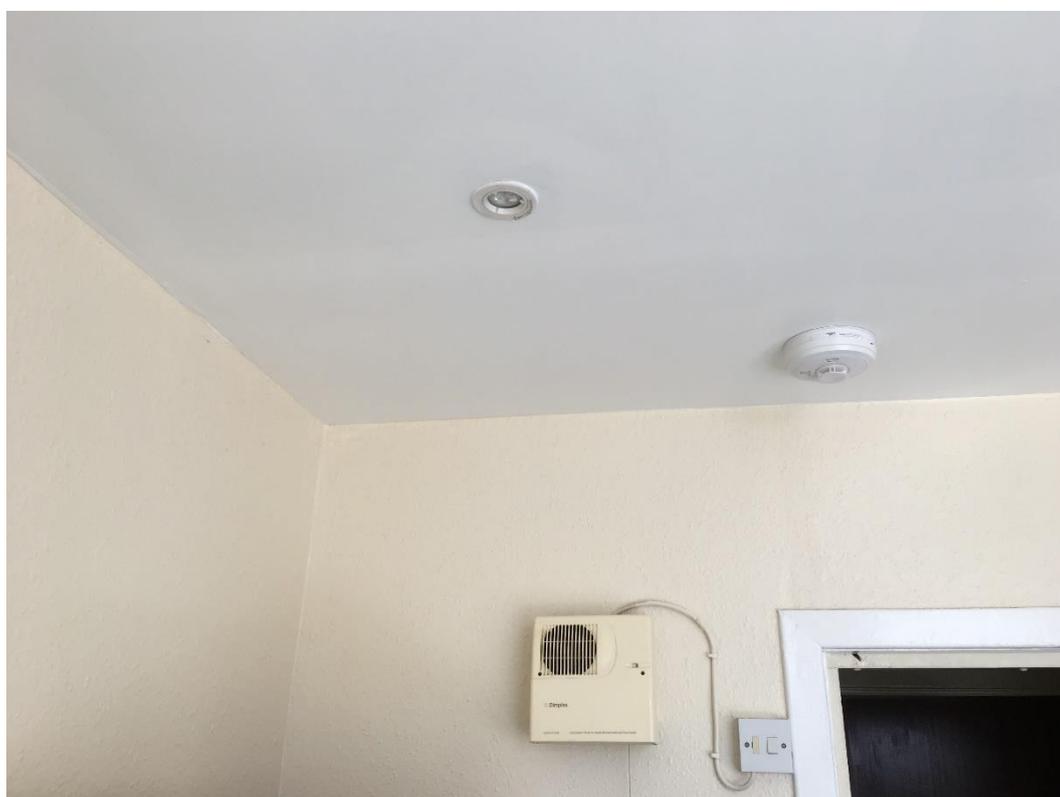
Renewed plasterwork in Kitchen (also showing Heat Detector).

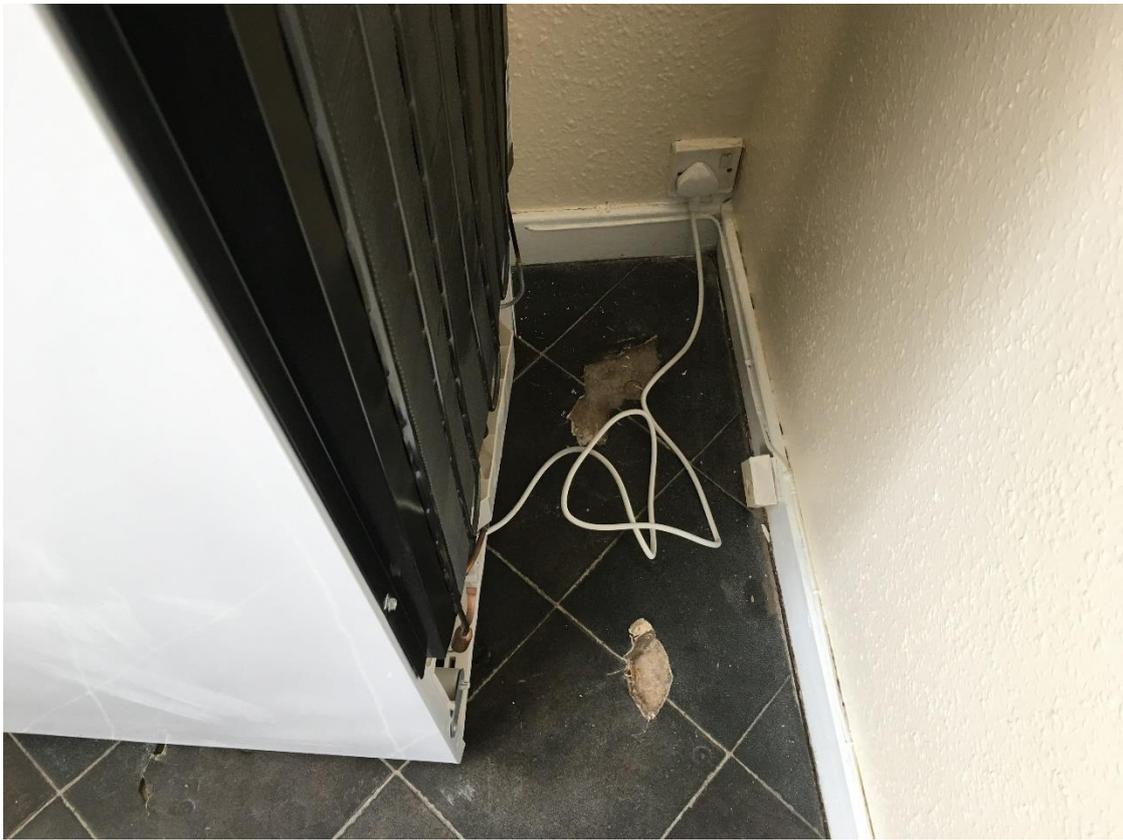
Damage to Kitchen floor covering.

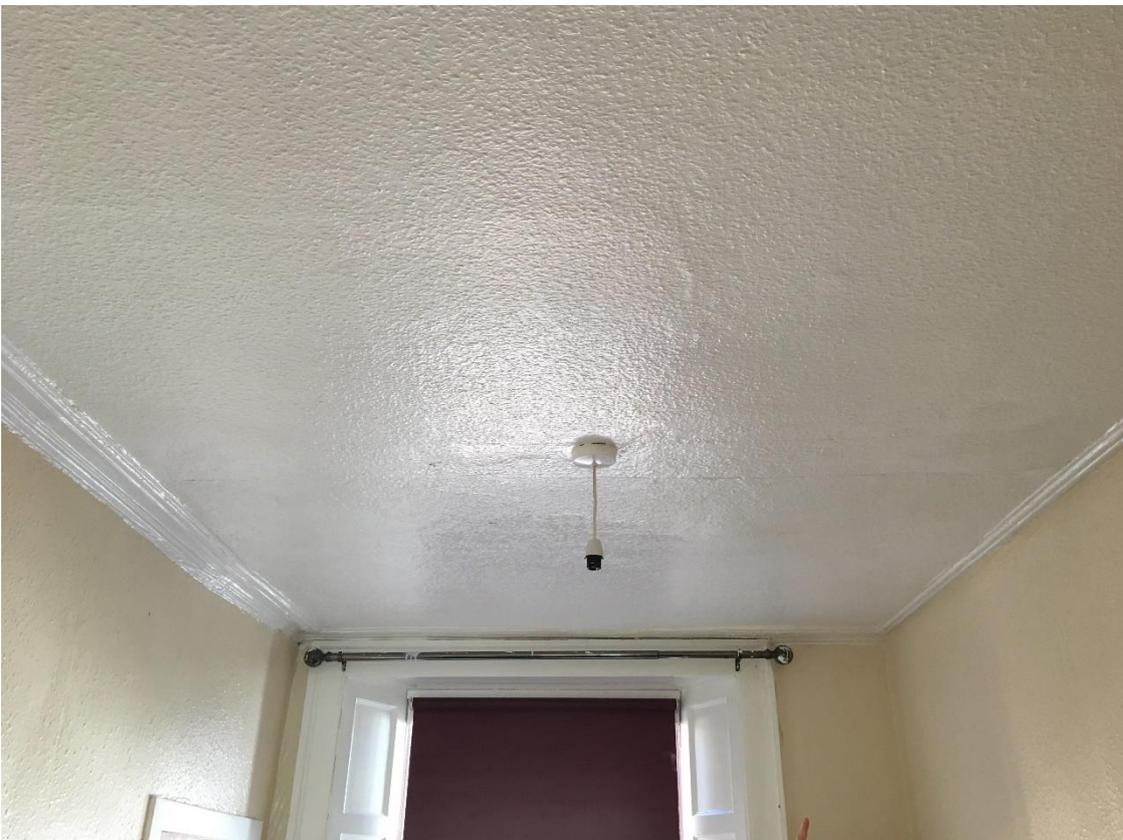
Renewed plasterwork in Lounge/NE Bedroom. High damp meter readings obtained at recess cupboard on East wall.

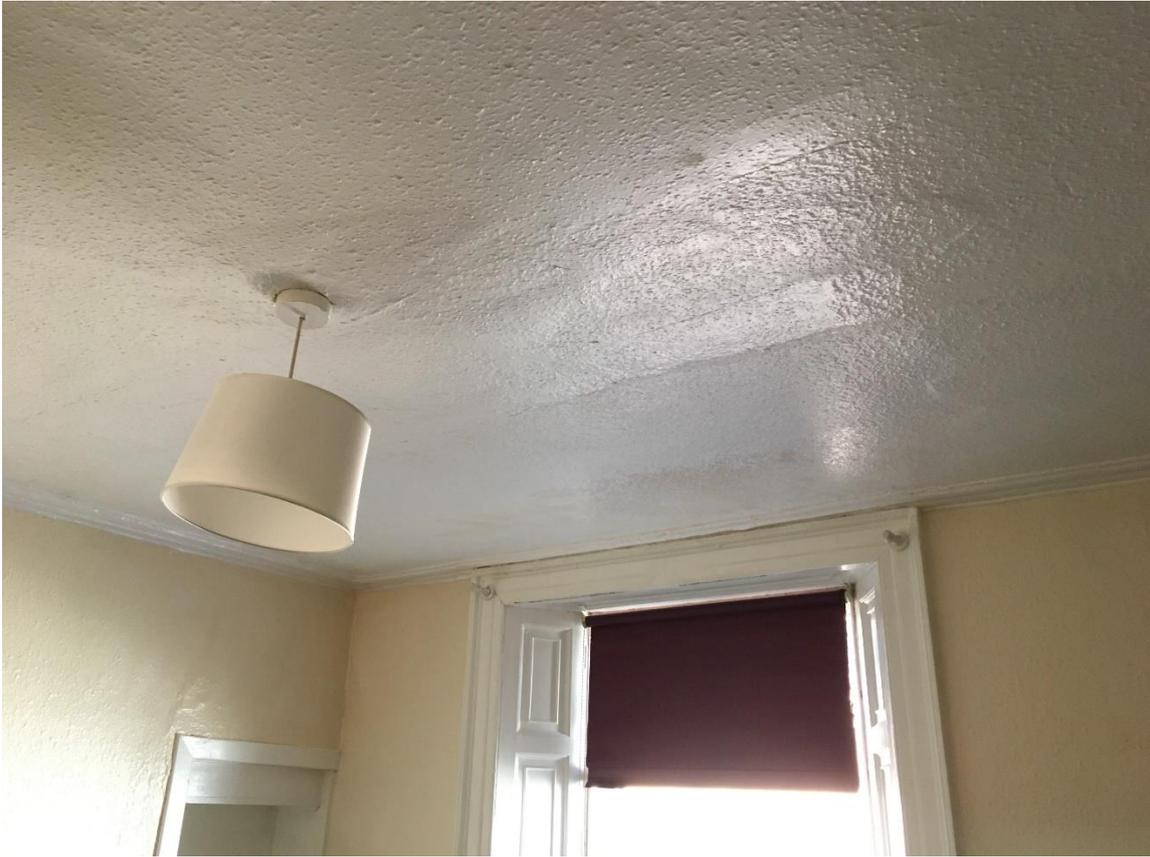
Repaired ceiling in Lounge/NW Bedroom.

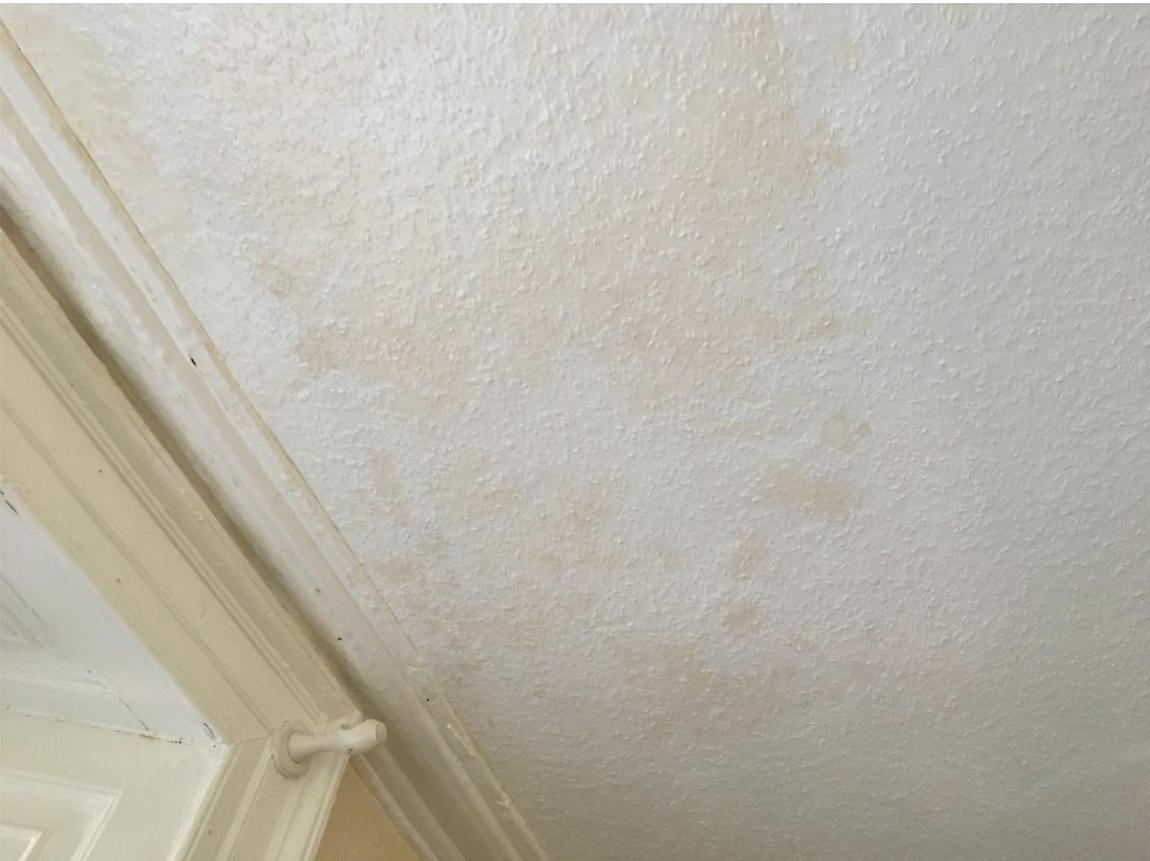
Damp staining evident at repaired ceiling in Lounge/NW Bedroom.

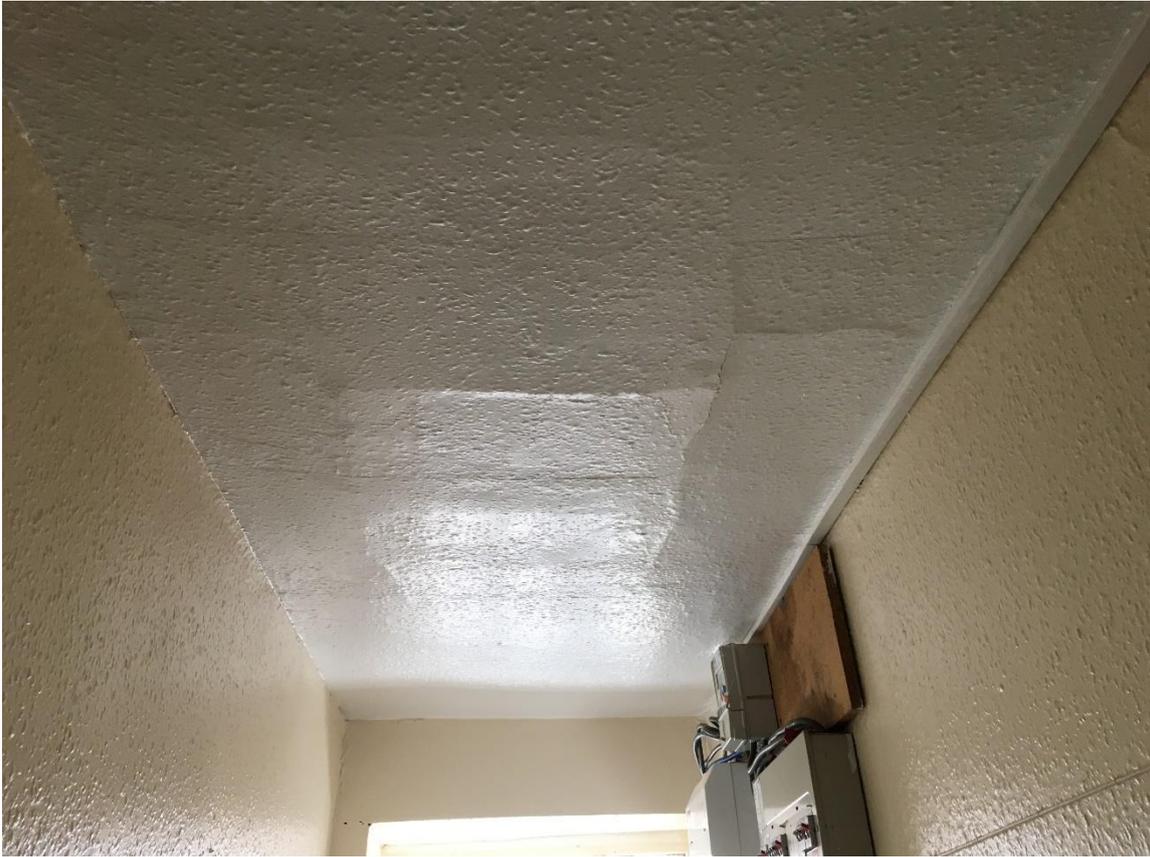
Drop/cracking to Hall ceiling.

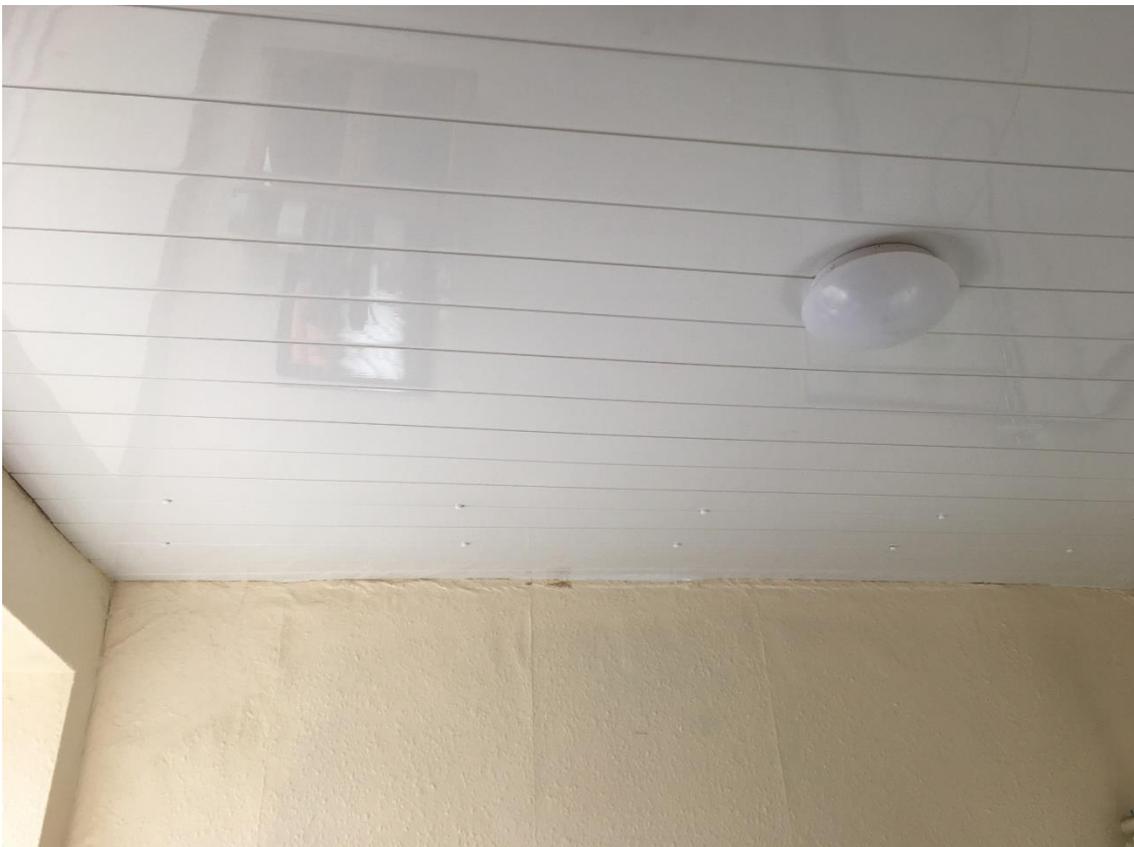
Recently re-clad Bathroom ceiling. Moderate damp meter readings obtained on west wall.

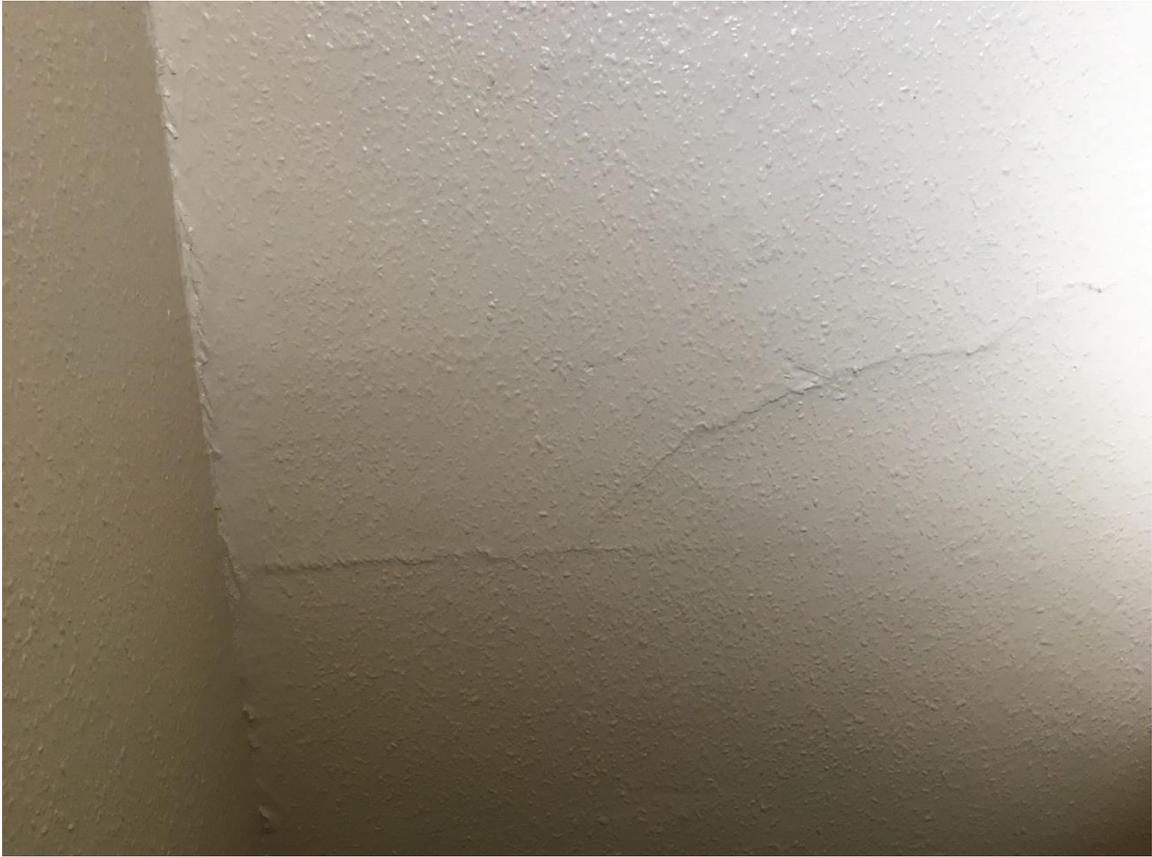
Horizontal cracking to plasterwork in stairwell.

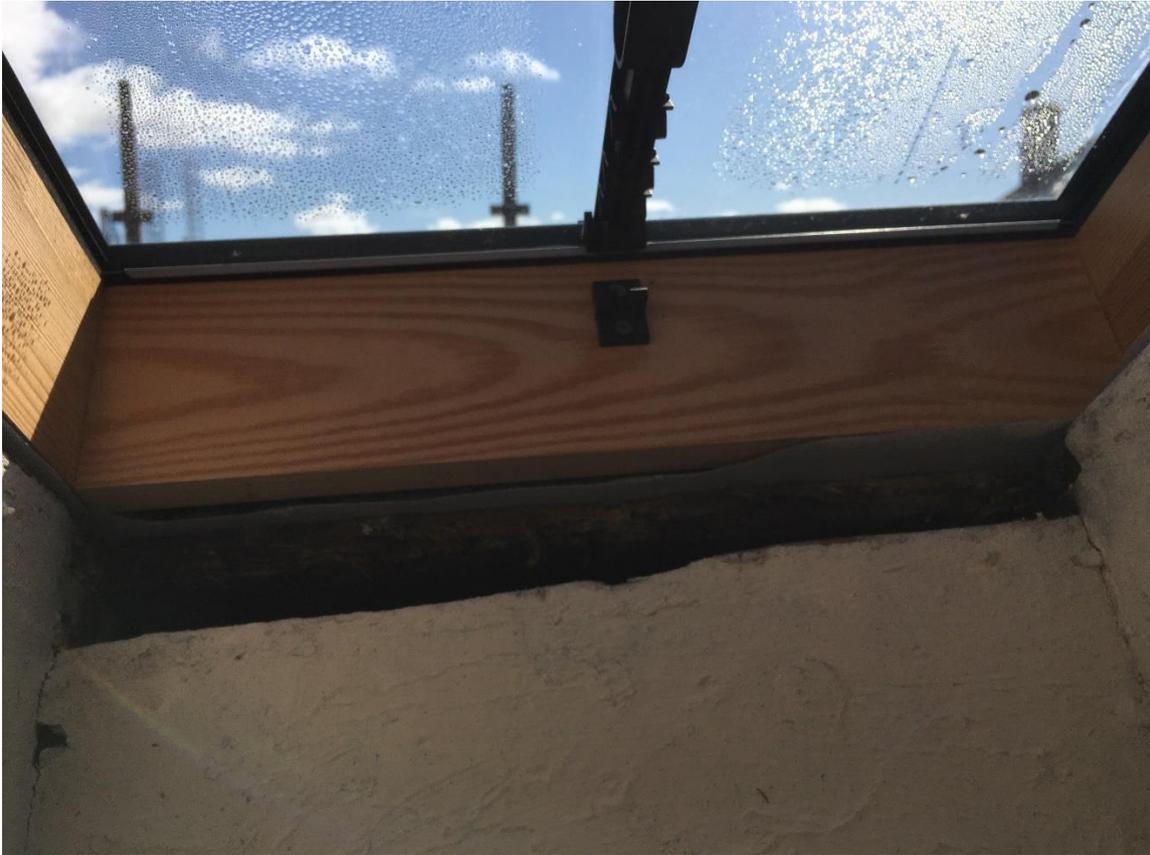
Gap in plasterwork at Attic Store skylight.

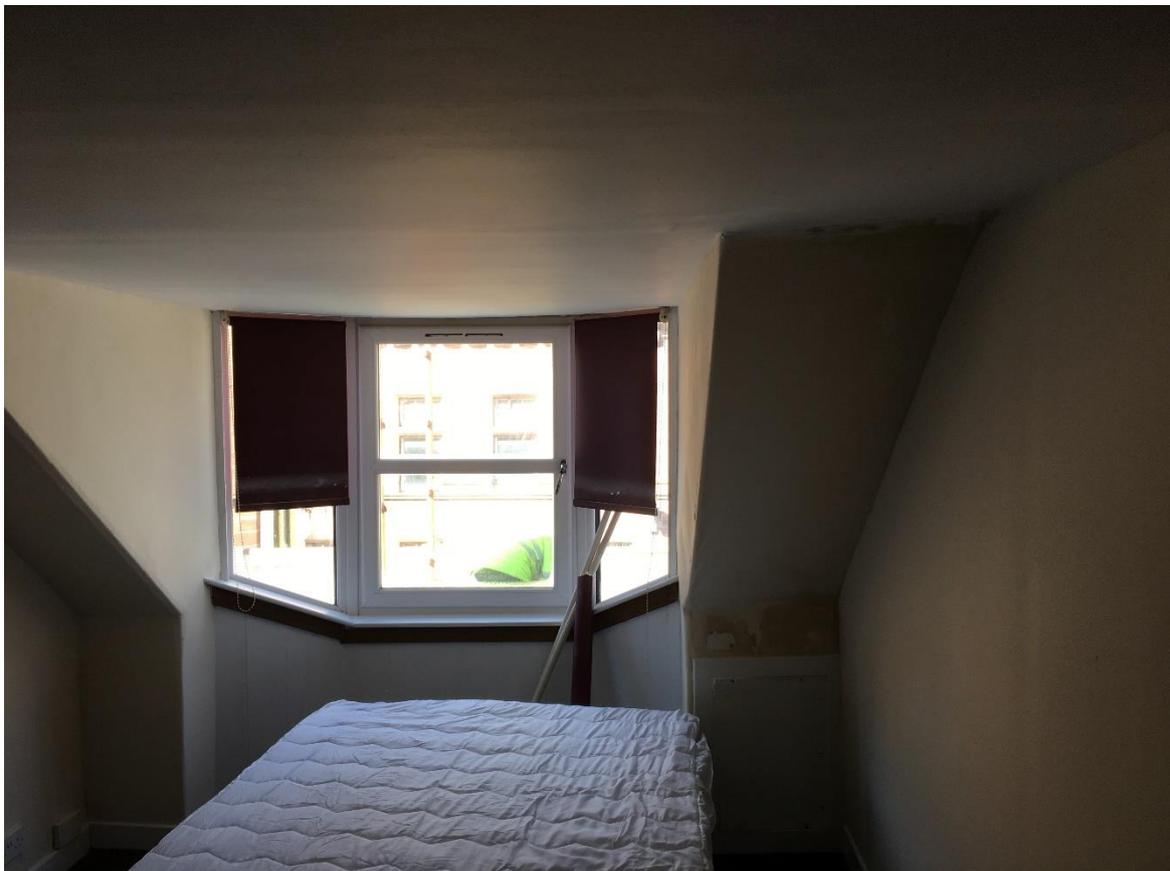
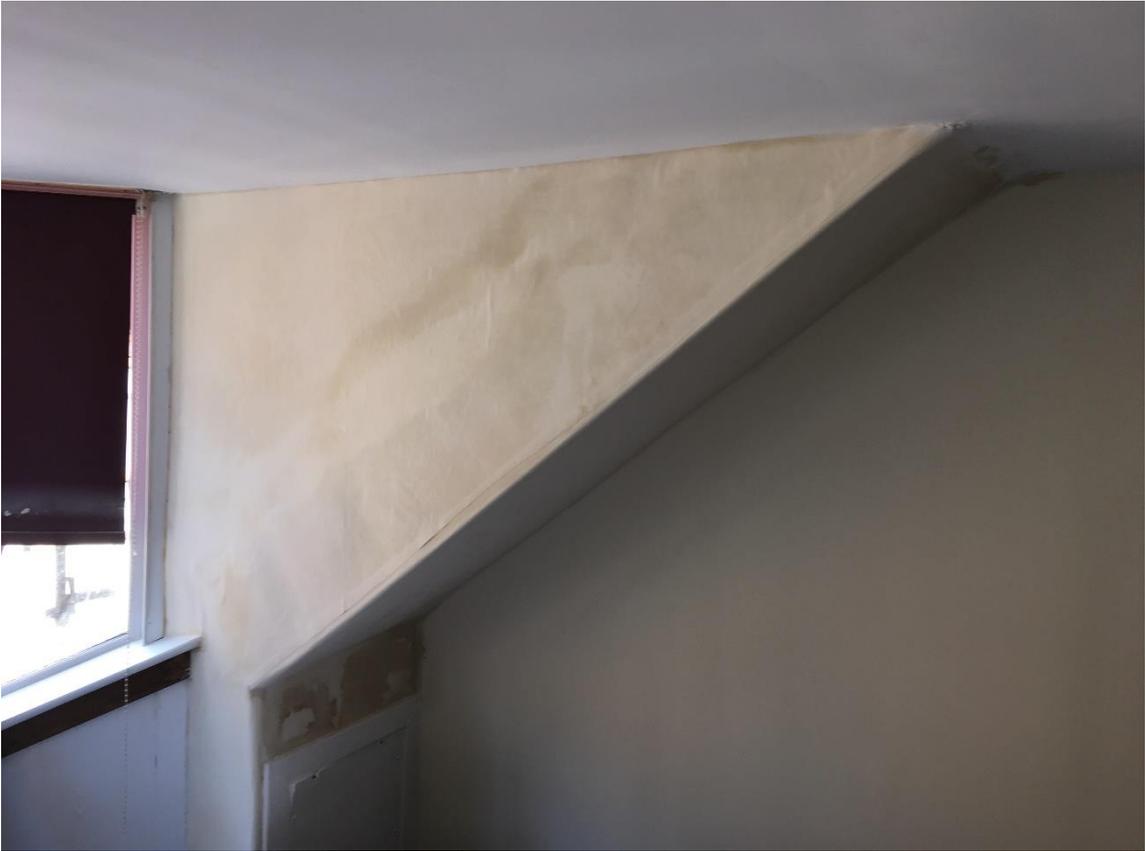
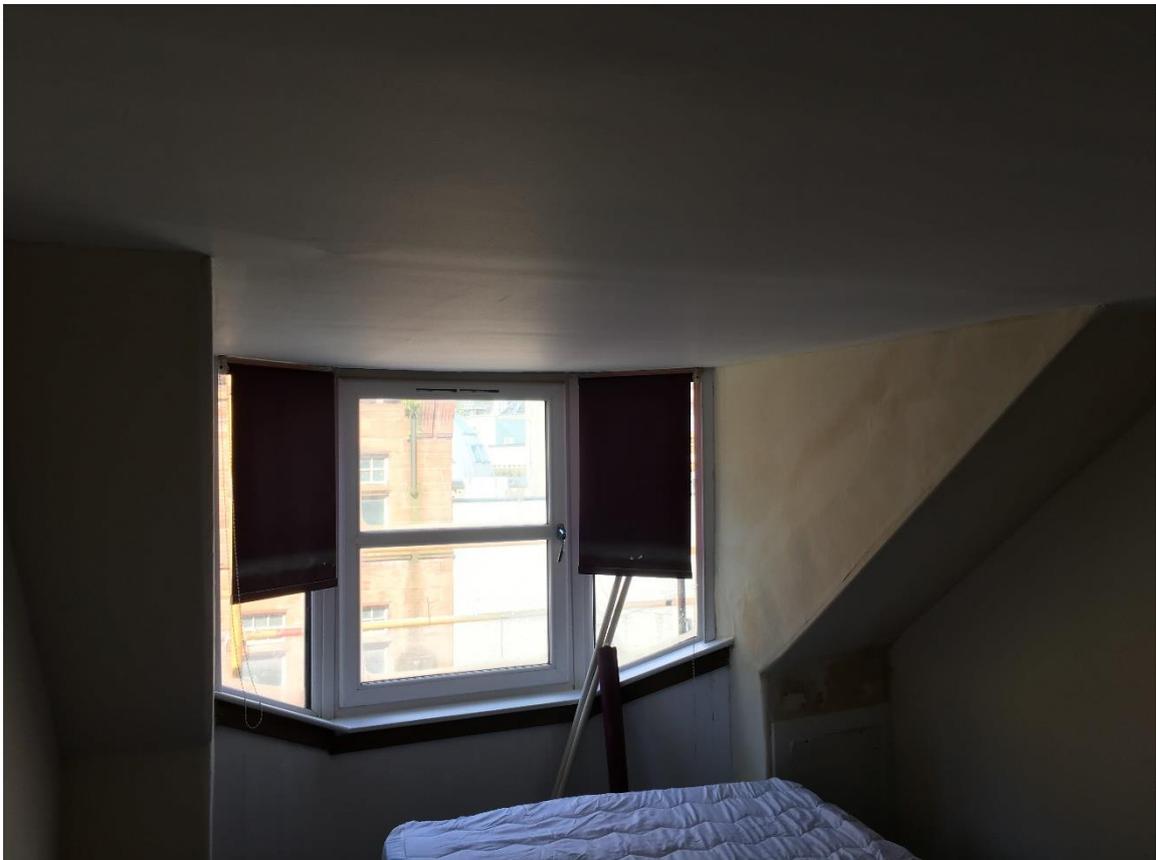
Renewed plasterwork in Attic Floor E Bedroom. Signs of recent water penetration evident.

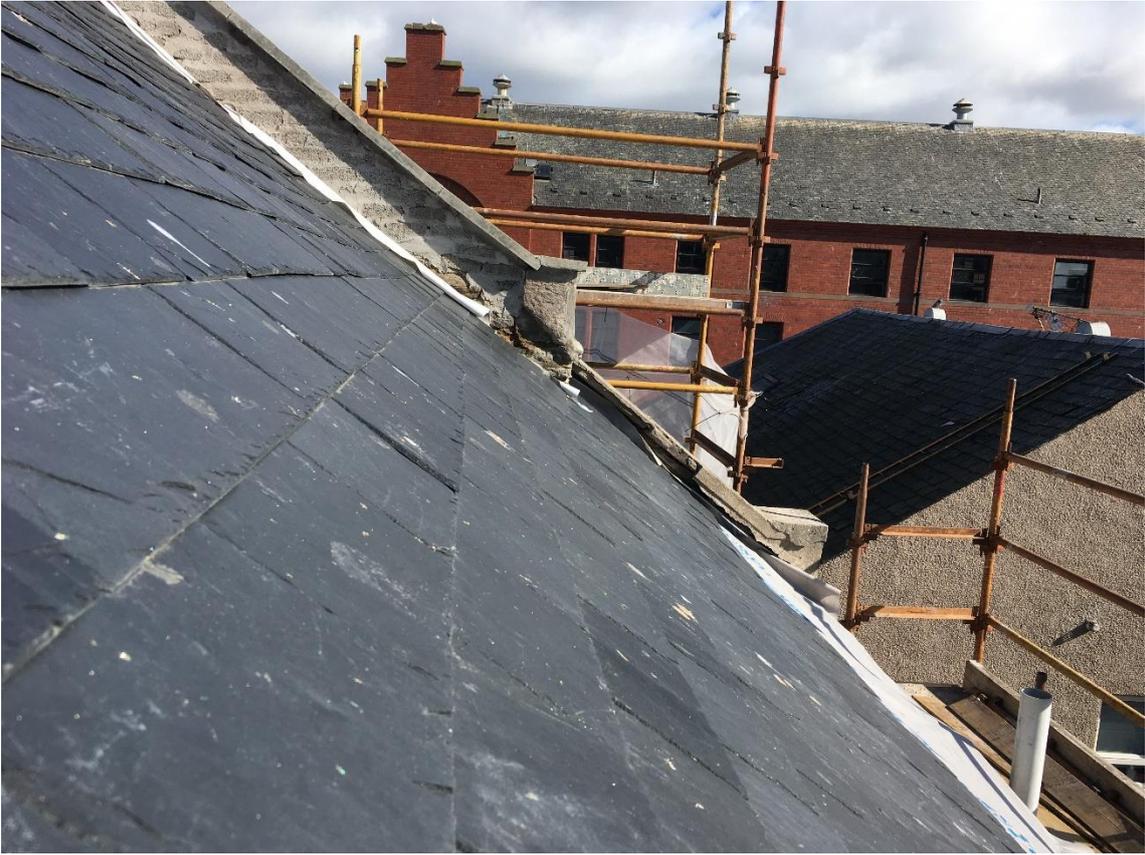
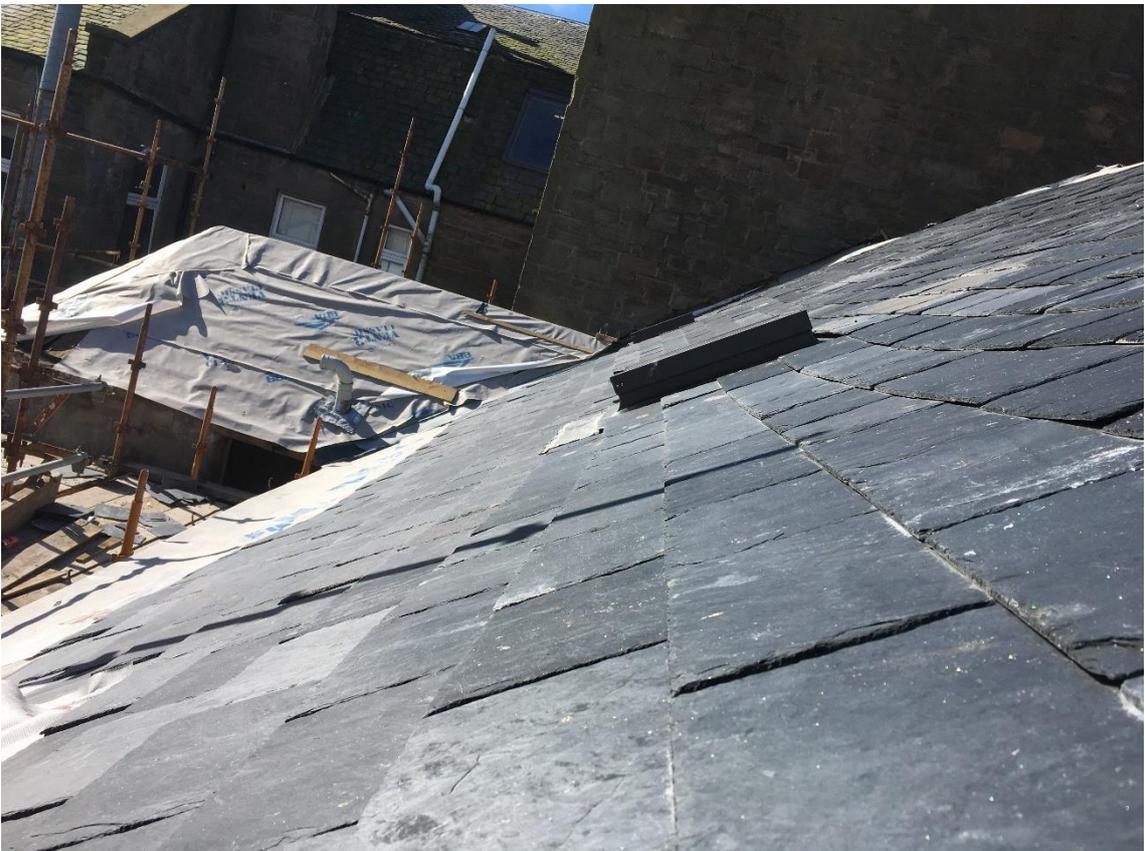
- e. Some parts of the roof do not have roof slates nor any adequate cover to prevent ongoing water ingress. Further water ingress is reasonably likely to continue to occur.

Rear elevation of roof under repair.

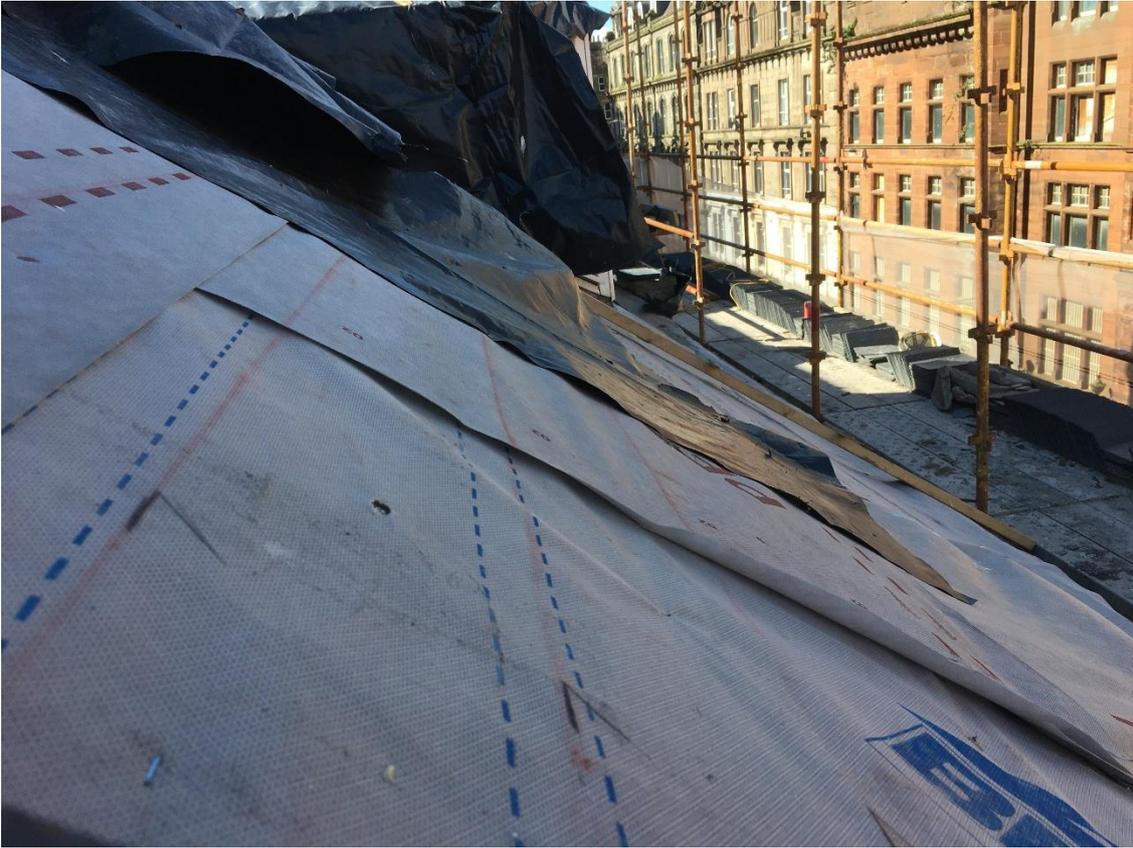
Front elevation of roof under repair.
