**Chamber Reference: FTS/HPC/RP/18/3305**

**STATEMENT OF DECISION: Housing (Scotland) Act 2006 section 24(1)**

**House address: Station House, Blair Atholl Railway Station, Blair Atholl, by Pitlochry ('the House')**

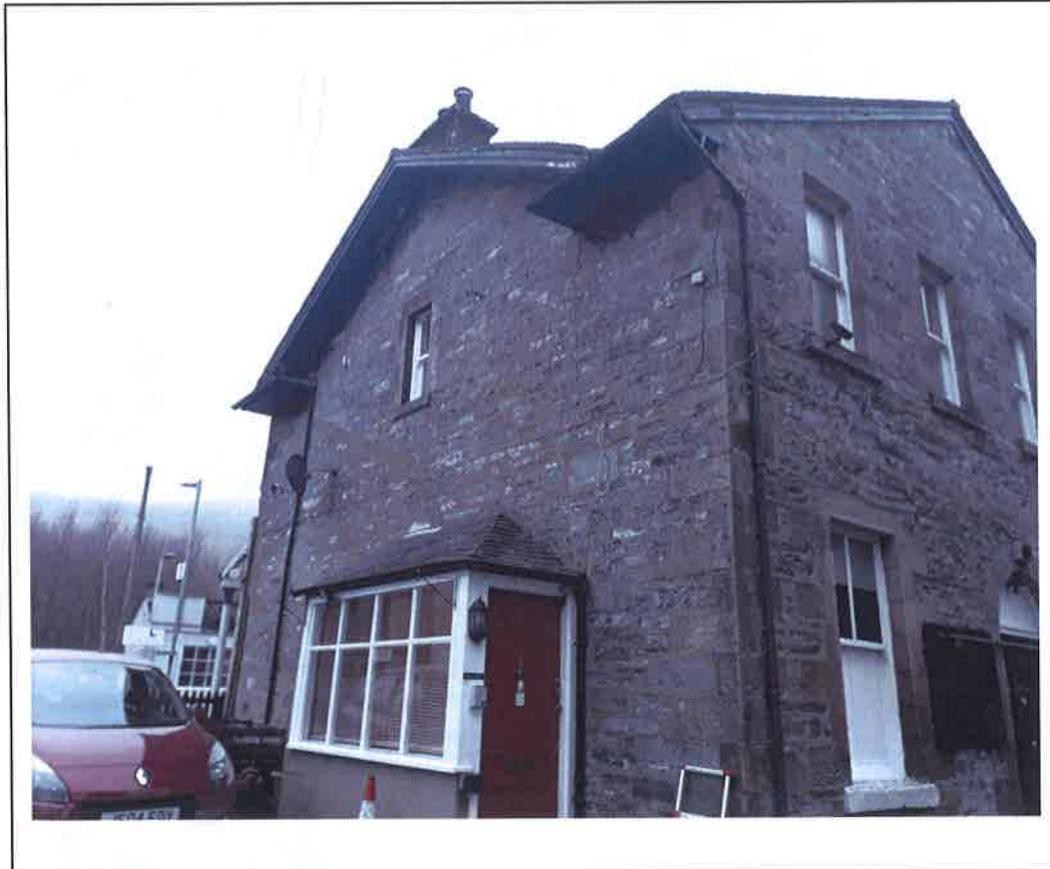
Entrance Porch

There was no evidence of current water ingress, however, there was staining evident on the walls, door and blinds that tended to indicate recent water ingress. A wall-mounted electric heater had been covered up and was no longer in use. The Ordinary Member tested the walls with a damp meter and found evidence of damp in the top corner of the stonework to the left of the external door.

1. Repair the porch to ensure that it is suitably wind and watertight;
2. Produce a satisfactory electrical safety certificate from a suitably qualified and registered SELECT or NICEIC electrical contractor on the installation within the House for the supply of electricity.
3. Repair or replace the soffits to ensure that they are in a reasonable state of repair and in proper working order;
4. Ensure that the moss is cleared from the roof and roof valley, thus ensuring that the gutters are put into proper working order.

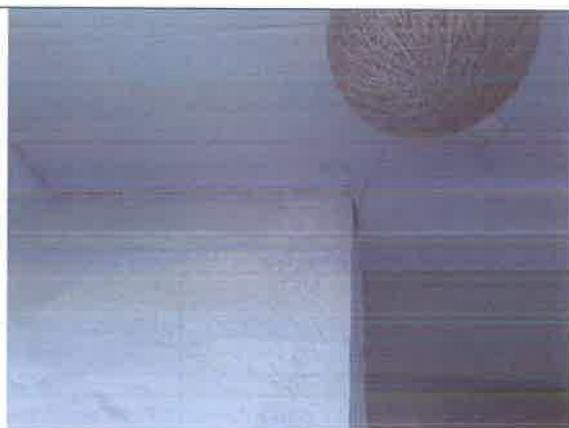
There is significant water ingress to the House in the porch area. This has affected the electrical supply to the porch area.

Damp staining in porch, high damp meter readings.

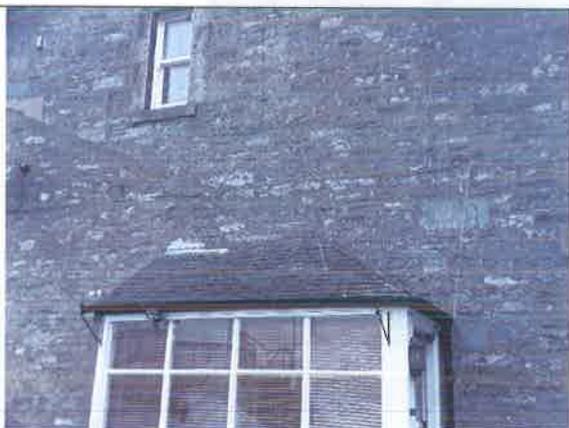
Porch Roof

Externally, there was evidence of an area of stonework filled in with cement by the Tenant in an attempt to stop the water ingress.

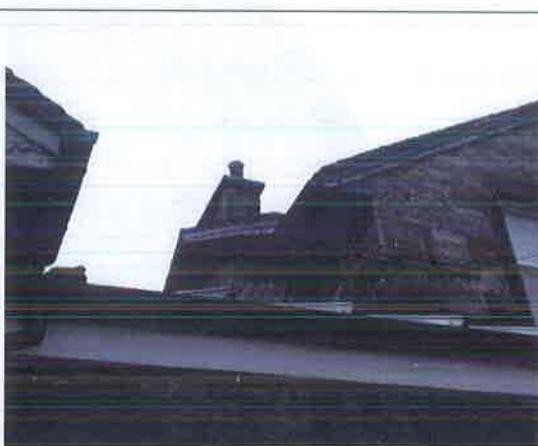
The soffits were wooden. The paintwork had deteriorated in places, and there were holes between the roof verge and the soffits. There was evidence of rotting of the soffits and the gutter was not securely attached to the soffits.

The soffits are not in a reasonable state of repair and in proper working order. The timber is rotten and there is potential for significant health and safety concerns to arise if the soffits were to detach from the cast iron guttering.

Weathered and rotten soffits. Damp staining below on stonework

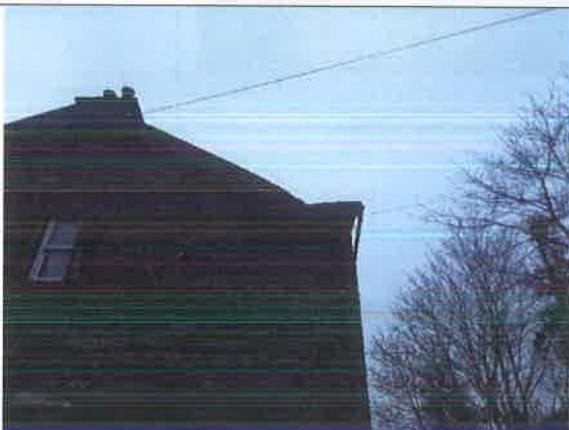
There was evidence of moss in the gutters, and a heavy growth of moss on the roof and in the roof valley. Although there was no current overflowing, as the weather was dry, there was evidence of damp staining on the wall directly below the guttering on the car park side of the House, which tended to indicate that overflowing had taken place.

The guttering is not in proper working order. There is evidence of staining to the stonework below the guttering on the car park side of the House. This is caused by build-up of moss on the roof, which is not accessible by the Tenant.

Damp staining below gutter and soffit

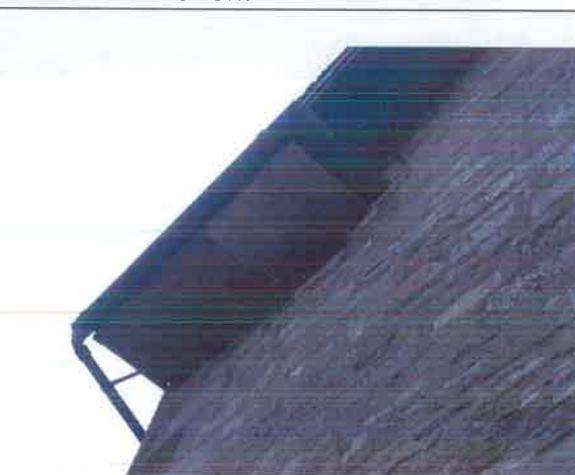
The problem with the soffits has been going on for years. The Tenant has carried out minor repairs to the soffit to try to patch it up. Four years ago, Network Rail came out to check the soffits and said they were rotten and required replacement. No work has since been carried out by Network Rail.

Patch repaired soffit

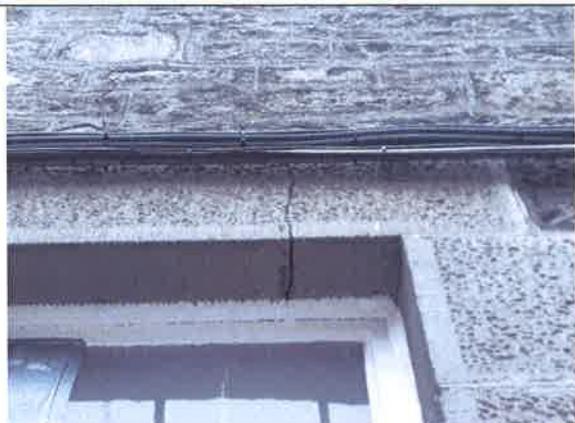
The Tenant pointed out additional concerns including cracks to the internal and external walls and lintels, uneven flooring, and bulging and cracks to internal ceilings. The Tenant rents the remainder of the ground floor, with the exception of the switch room, on a separate lease, and it is used for storage purposes. There was also evidence of cracks in the walls and ceilings in this area.

Crack in Lintel

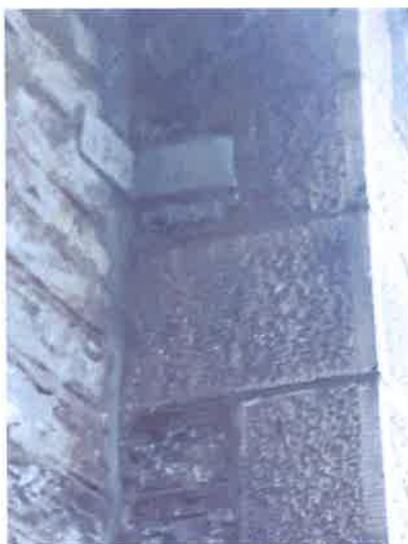
The Tribunal noted the survey carried out by Network Rail addressed the structural integrity of the House. The Tribunal observed that monitoring may be required by the Landlords to detect whether there is significant movement of the House

Structural repair and monitoring dated 13/1/81

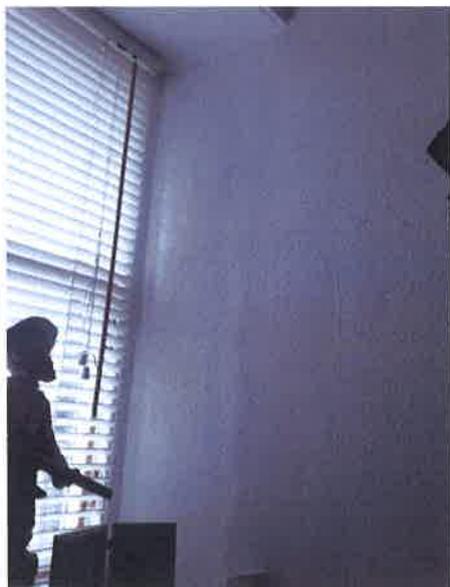
Plaster cracks adjacent to window.
