STATEMENT OF DECISION: Housing (Scotland) Act 2006 Section 24 (1)

Chamber Ref: FTS/HPC/RT/23/2130

Hillhead of Barrack, Auchnagatt, Ellon, Aberdeenshire AB41 8TR
("The Property")

Initial Inspection: Schedule of Photographs

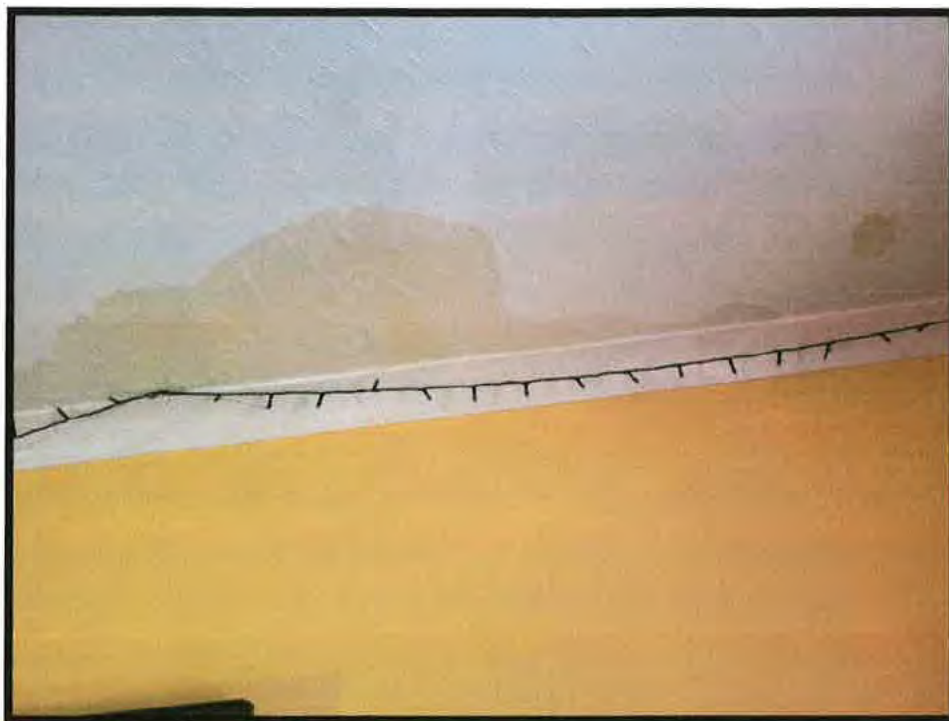
that although there was no significant mould present in the living room of the property there was staining above the fireplace and a high damp meter reading above the fireplace which he said was consistent with rubble building up behind the gable wall. He said that there was no significant damp in the hall or in the ground floor bedroom. There was significant mould in the bathroom although damp meter readings were generally normal except around the window in the. The upstairs right-hand bedroom had some mould present and high damp meter readings again consistent with rubble build up. The left-hand upstairs bedroom also had high damp readings on the gable wall. The ground floor box room had peeling and loose plaster and signs of historic and current dampness. There were signs of water ingress with a basin being used to collect water. The kitchen had extensive mould growth on the ceiling and window wall with high damp readings around the window in the and by the entrance door. Externally the property appeared to be in reasonable condition given its age and recent work had been carried out.

Photograph 2 Lounge – stain to ceiling above fireplace moisture reading 99%

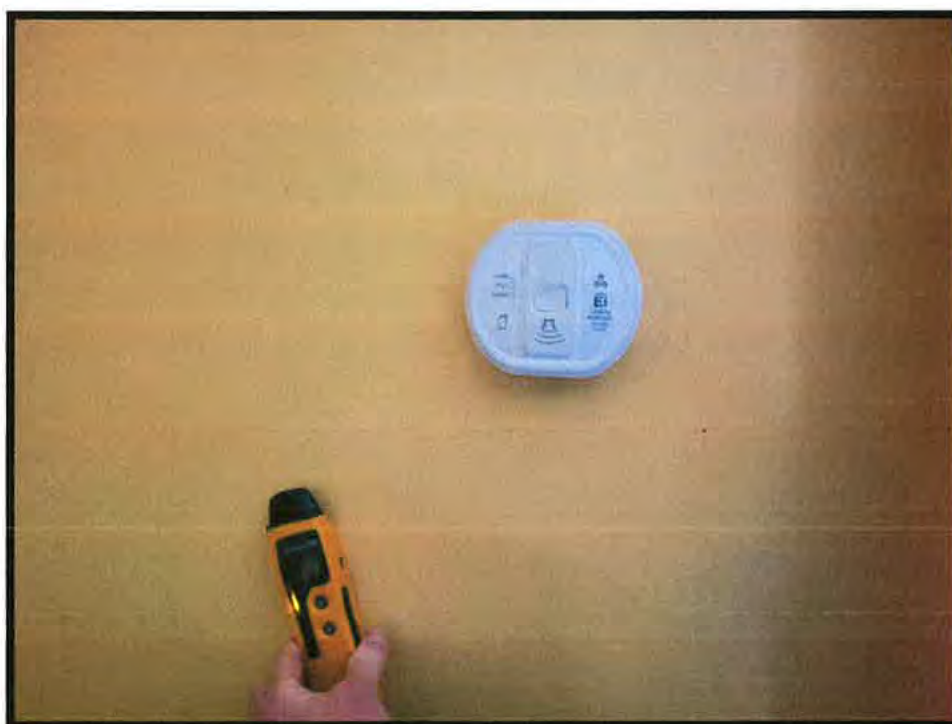
Photograph 3 Lounge – Typical moisture reading 17% to walls; CO alarm present.

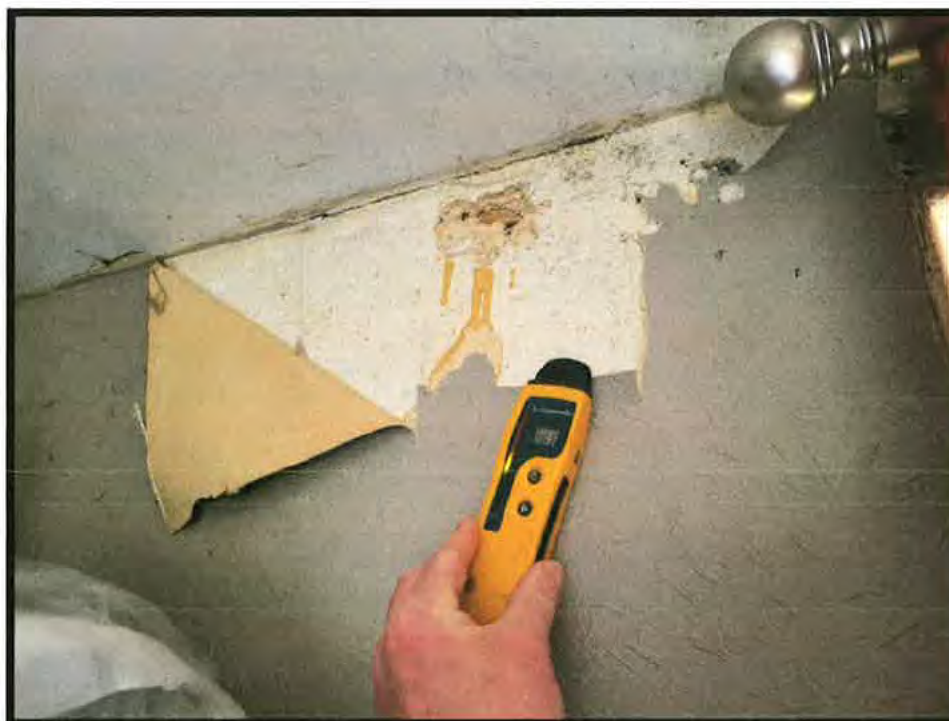
Photograph 5 Ground floor bedroom – wallpaper torn at curtain pole, moisture reading 17.3%.

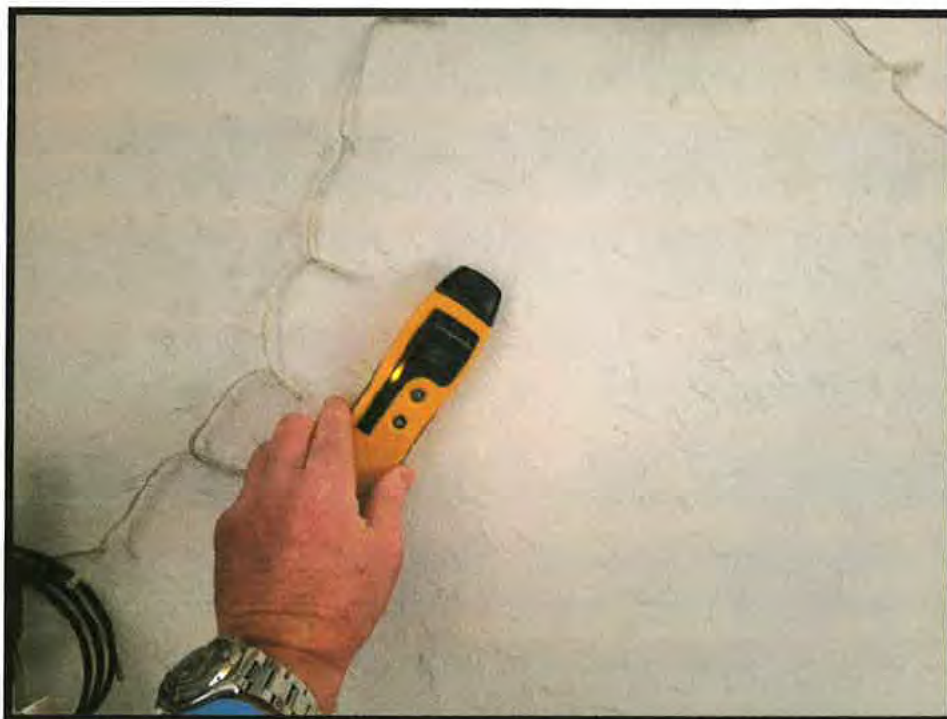
Photograph 6 Ground floor bedroom -- typical moisture reading 17%

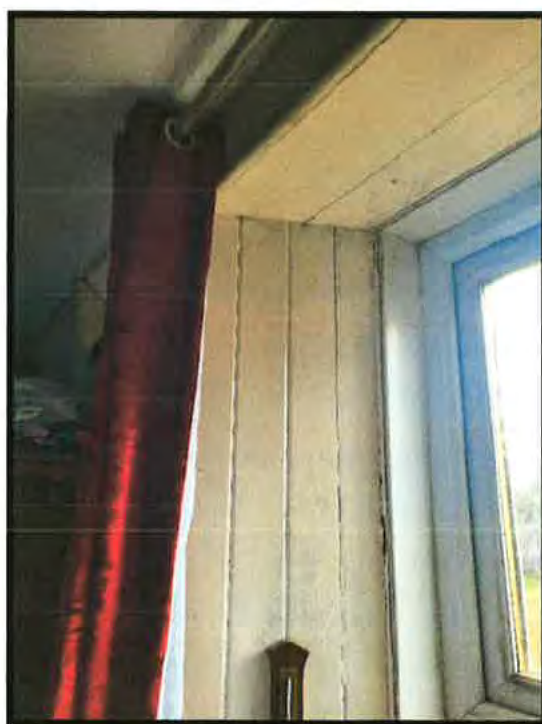
Photograph 7 Ground floor bedroom – slight mould at window ingo.

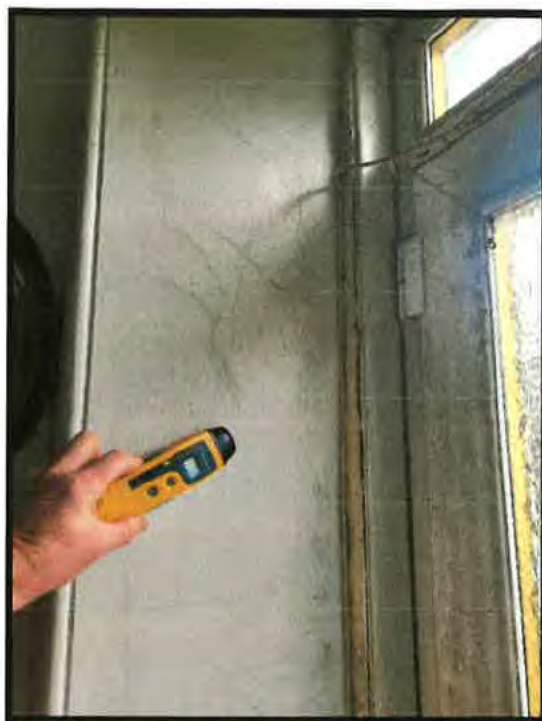
Photograph 8 Front Hall – Slight mould around door, moisture reading 17%. Traces of parcel tape around door edge.

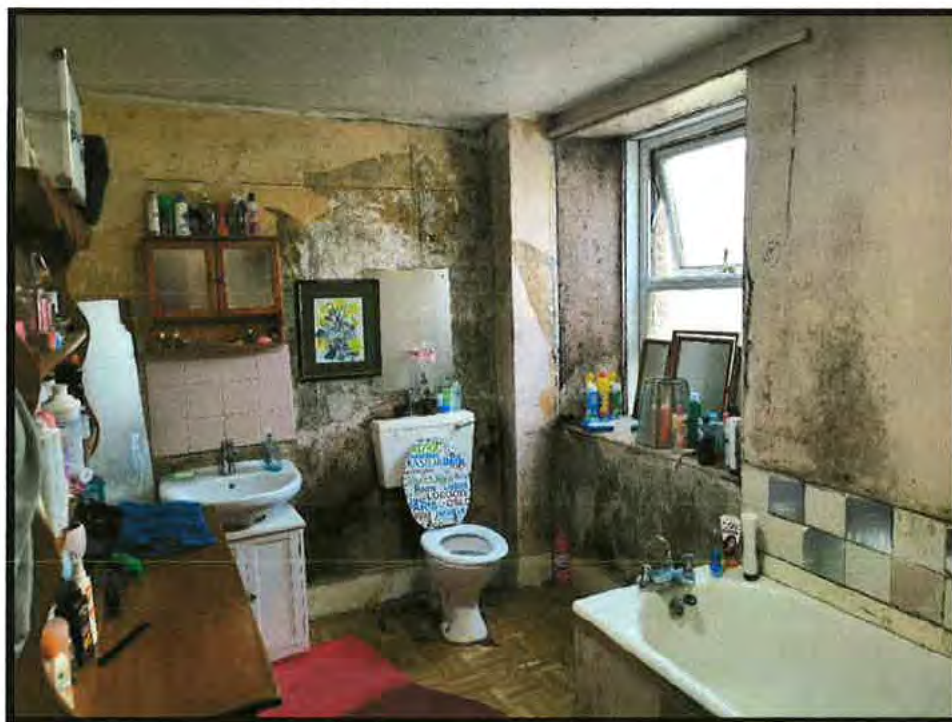
Photograph 9 Bathroom overview – heavy mould to outer walls, slight mould to ceiling. Traces of parcel tape around window.

22. The Tribunal also noted that the Landlord was prepared to install extractor fans in the kitchen and bathroom and carry out a deep clean of the property to remove the mould in the short term while the Tenant remained in the property. The Third Party Applicant's representative indicated that the Tenant would be open to agree to this proposal and the Tribunal would hope that this work would be carried out as soon as possible.

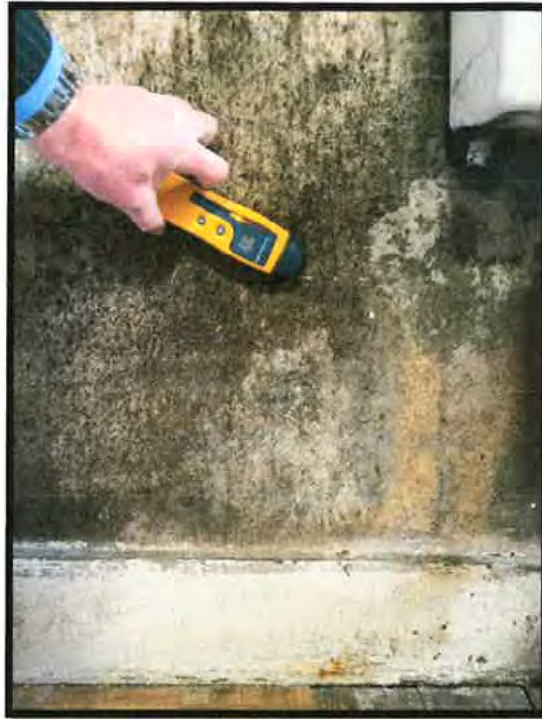
Photograph 10 Bathroom – Mould near WC, typical moisture reading 21%

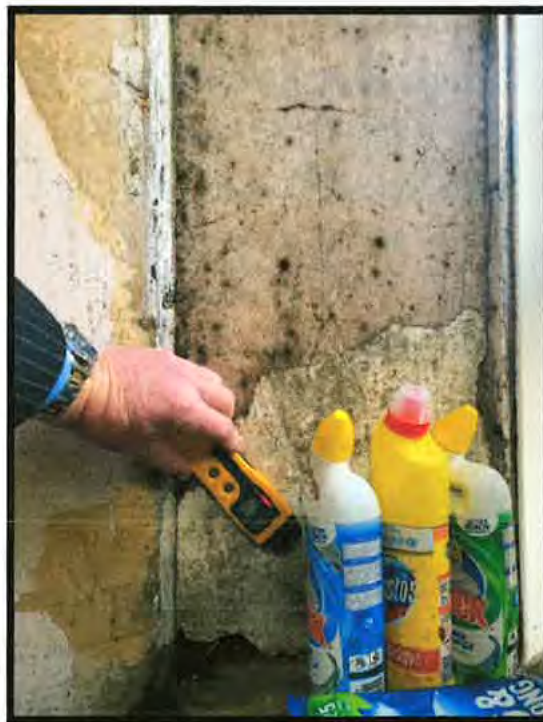
Photograph 11 Bathroom – Missing wallpaper at window ingo, moisture reading 73%

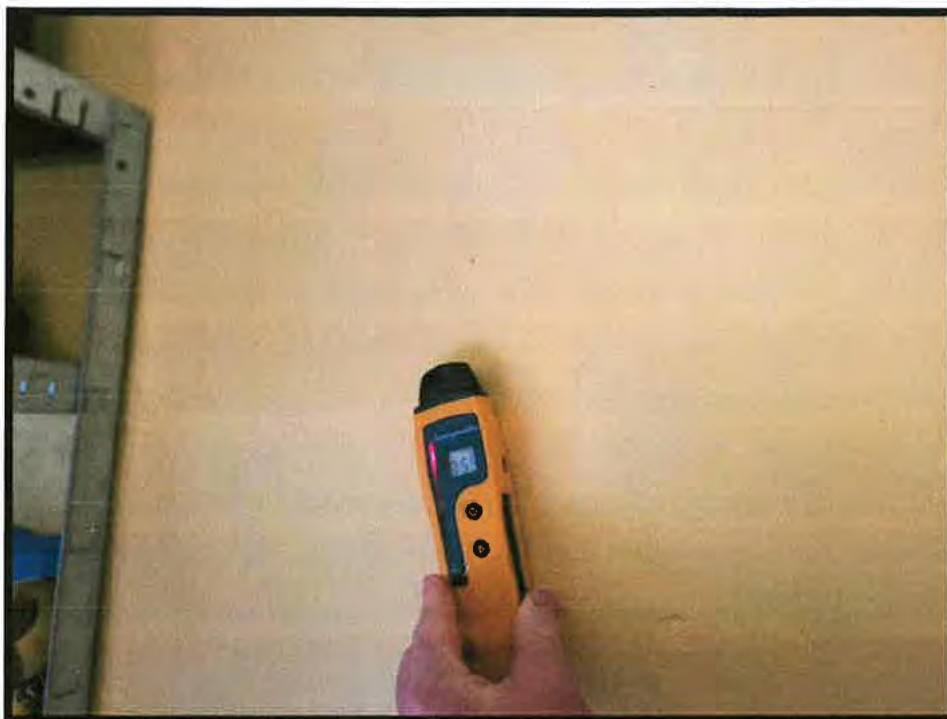
Photograph 12 Right hand bedroom 2 – Damp patch to gable wall, moisture reading 75%.

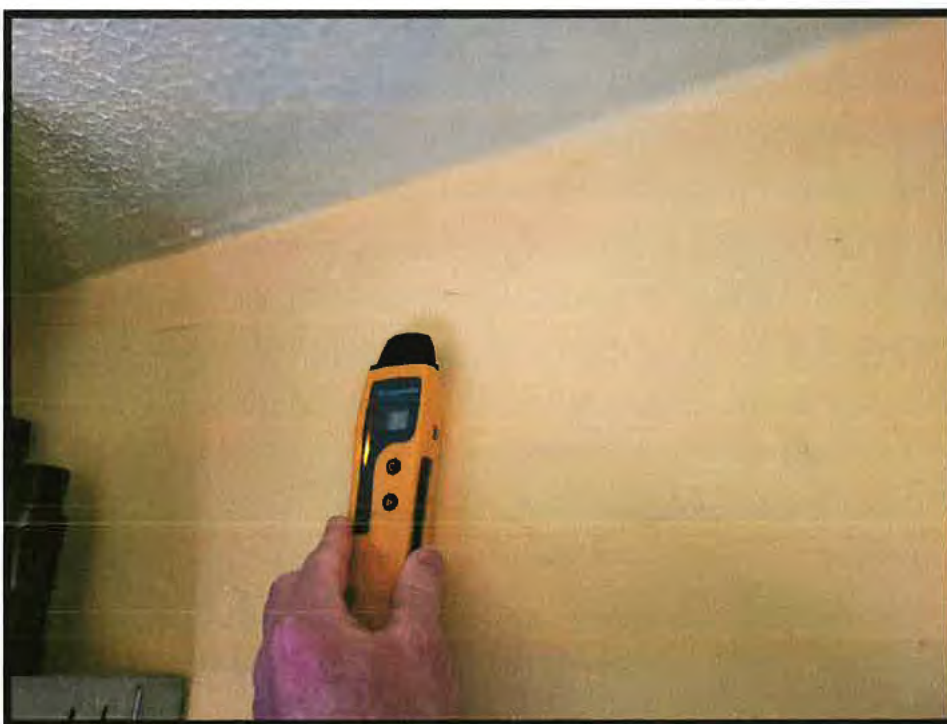
Photograph 13 Right hand bedroom – Typical moisture reading 21%

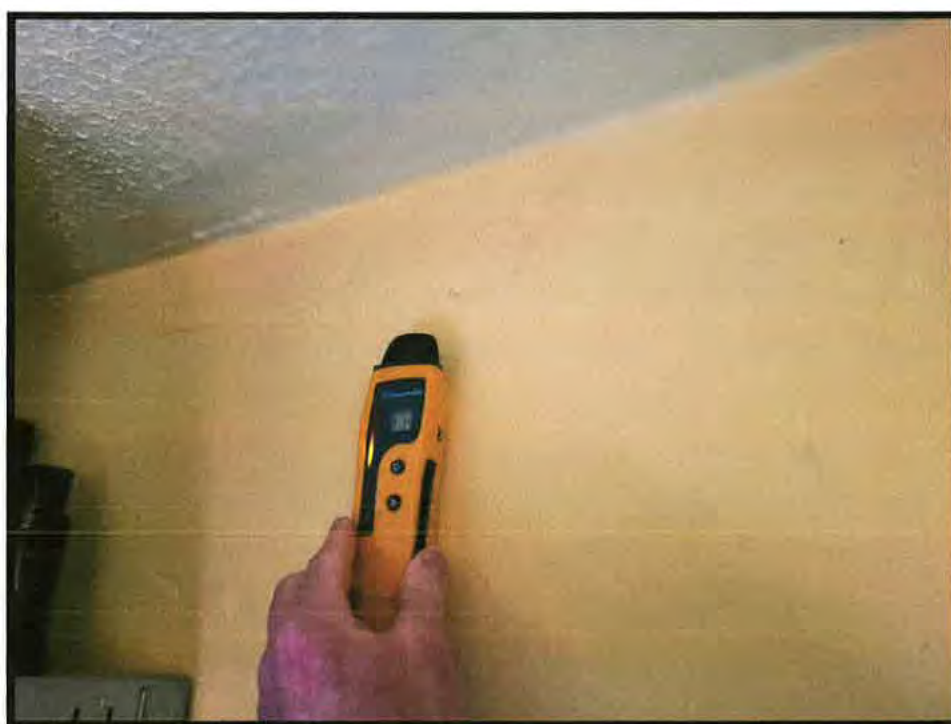
Photograph 15 Left hand bedroom -- Typical moisture reading 18%

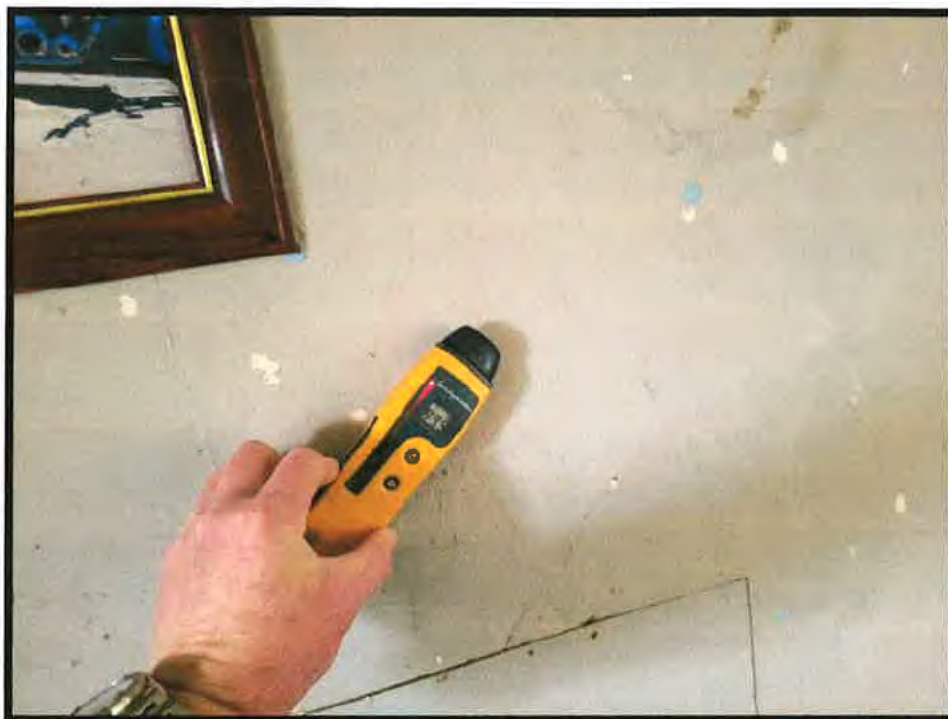
Photograph 16 Left hand bedroom – Damp patch, moisture reading 99%

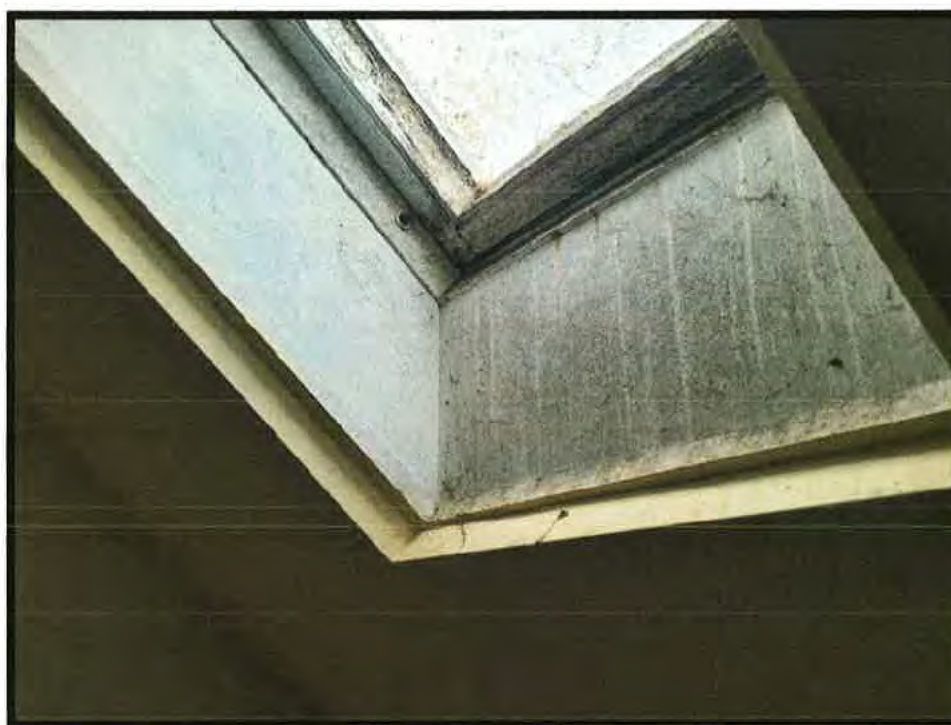
Photograph 17 Landing – Mould and dirt around velux window

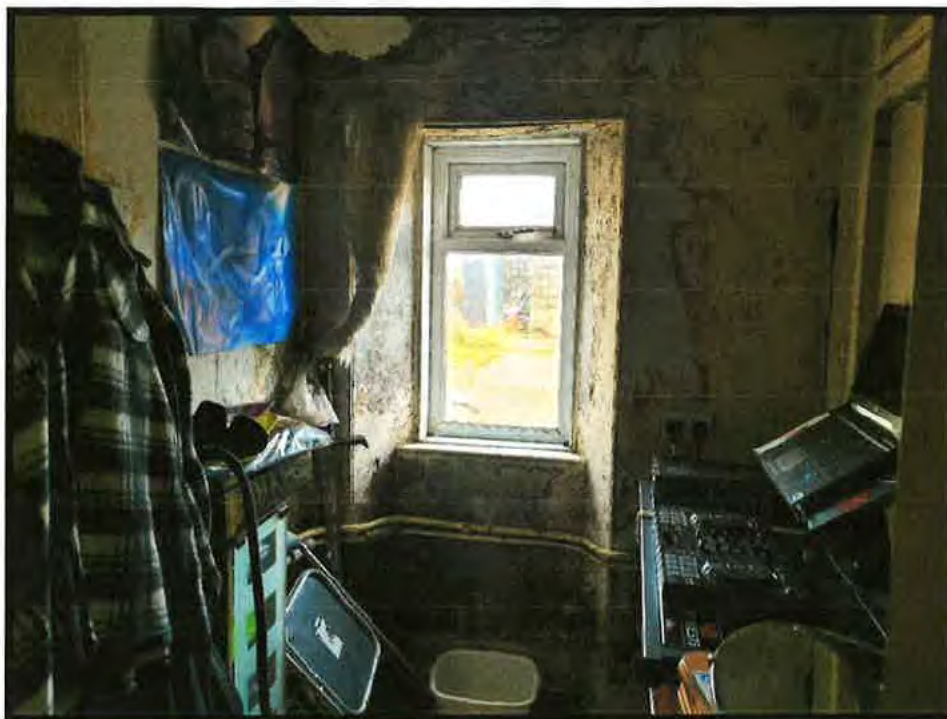
20. It was evident from the inspection that despite some repairs having been carried out at the property it still suffered from damp particularly around the fireplaces in the living room and upstairs bedrooms. There was also significant water ingress in the downstairs boxroom and high moisture readings were recorded near the door in the kitchen and around the window ingos in the bathroom and kitchen.

Photograph 18 Ground floor Boxroom – Overview. Loose plaster at window lintol, widespread bare, crumbling, cracked and damp plasterwork.

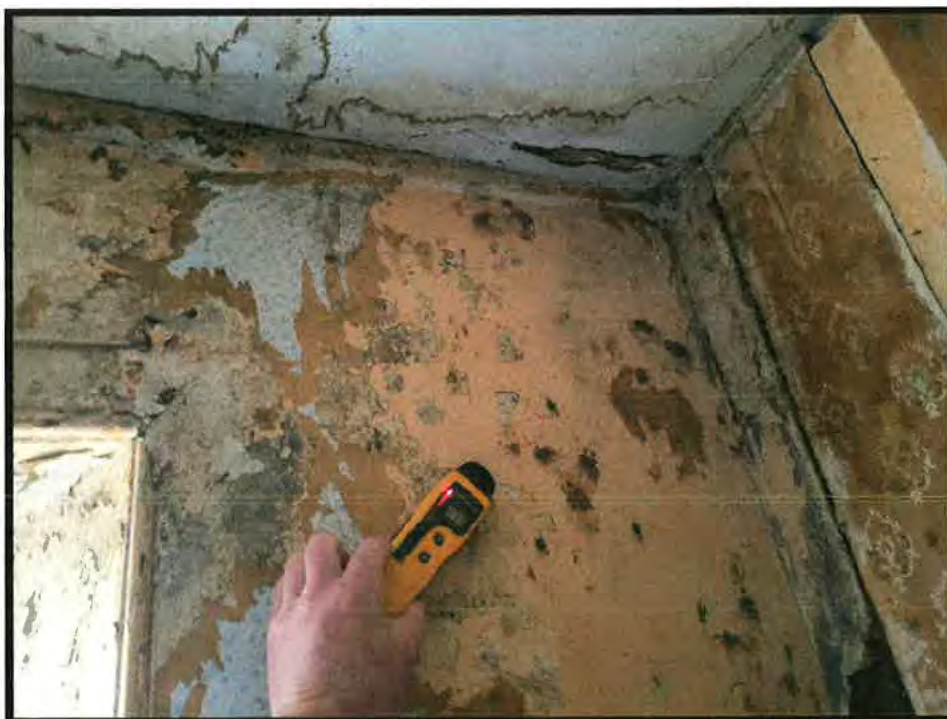
Photograph 19 Boxroom – Right hand side window, widespread high meter readings to outer wall, typical 99%.

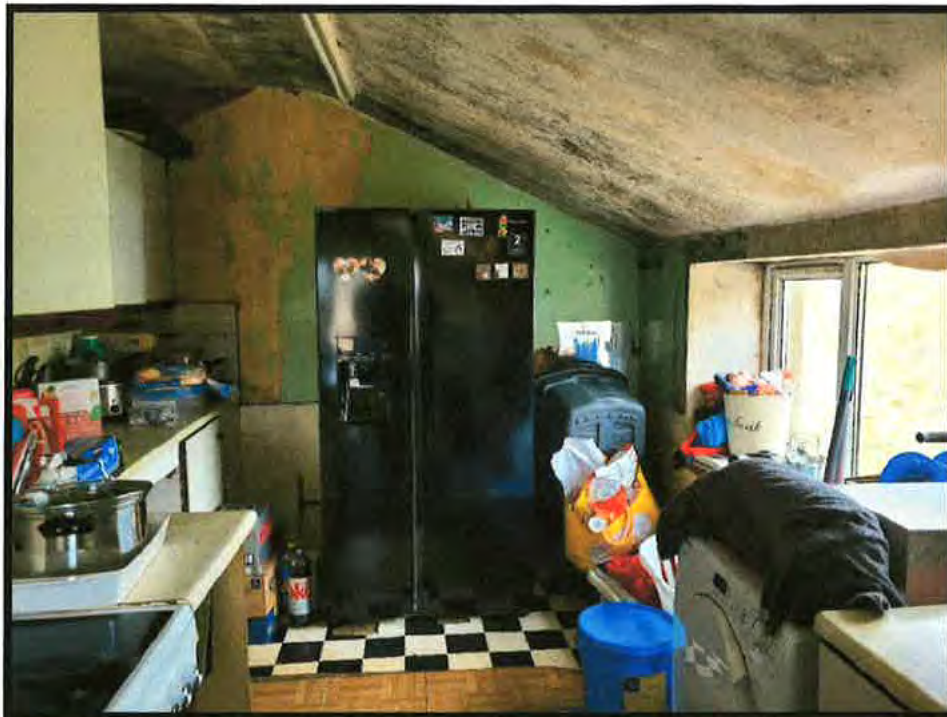
Photograph 20 Kitchen – Overview. Widespread mould to outer walls and ceiling.

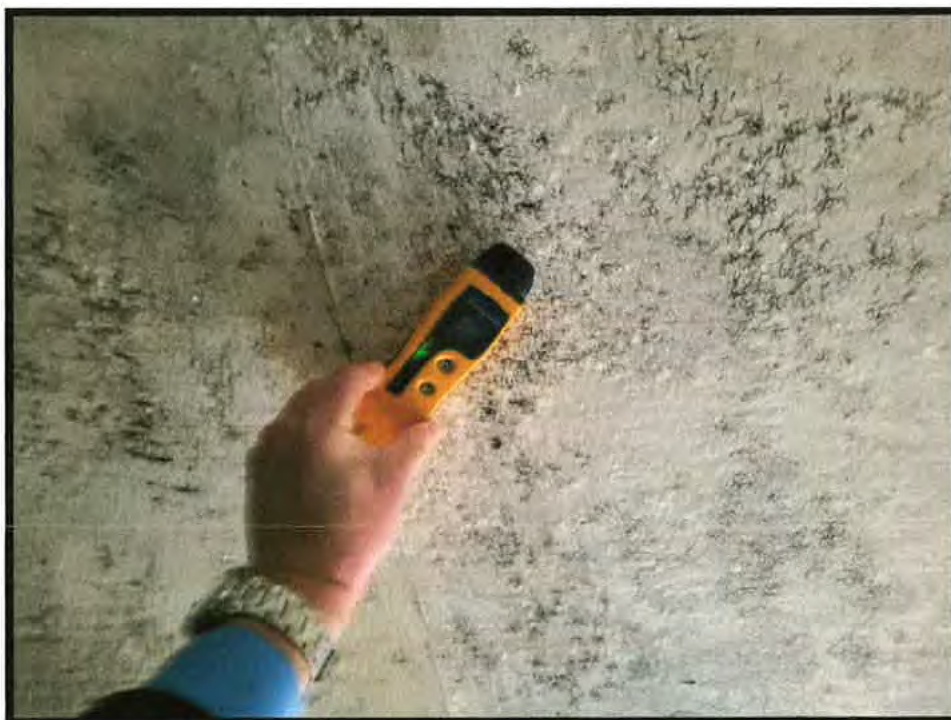
Photograph 21 Kitchen – Ceiling, typical moisture reading 13%.

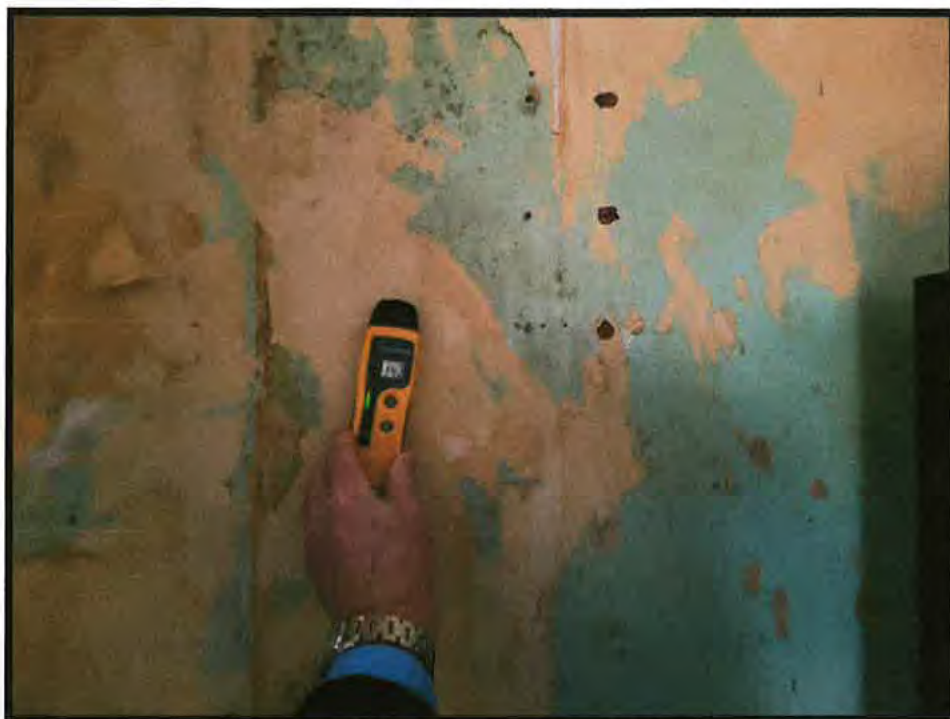
Photograph 22 Kitchen – outer wall, typical moisture reading 14%.

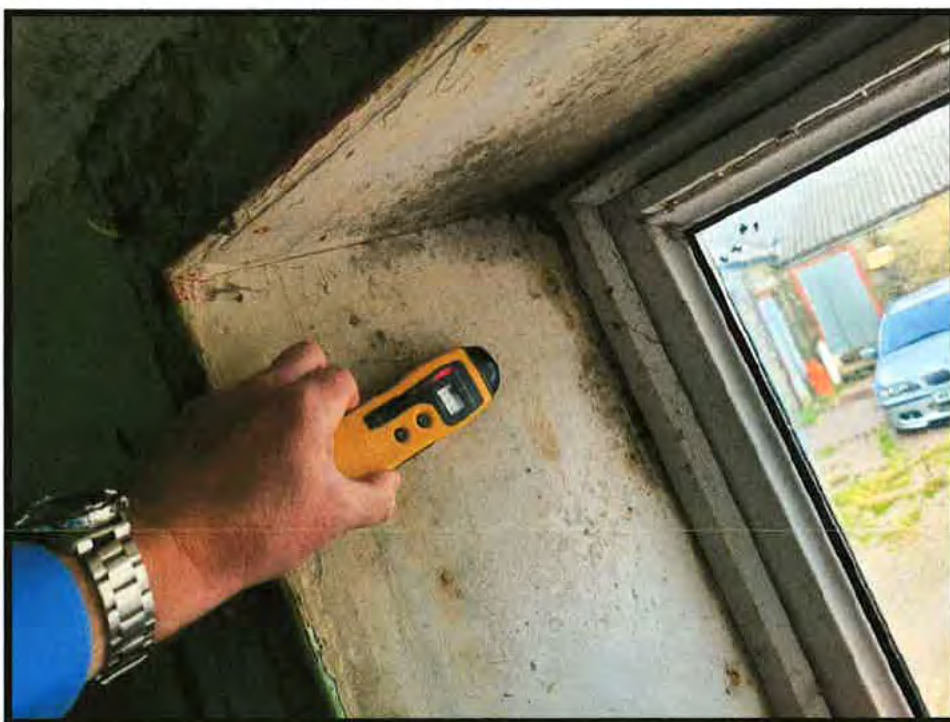
Photograph 23 Kitchen – damp patch at window ingo moisture reading 78%.

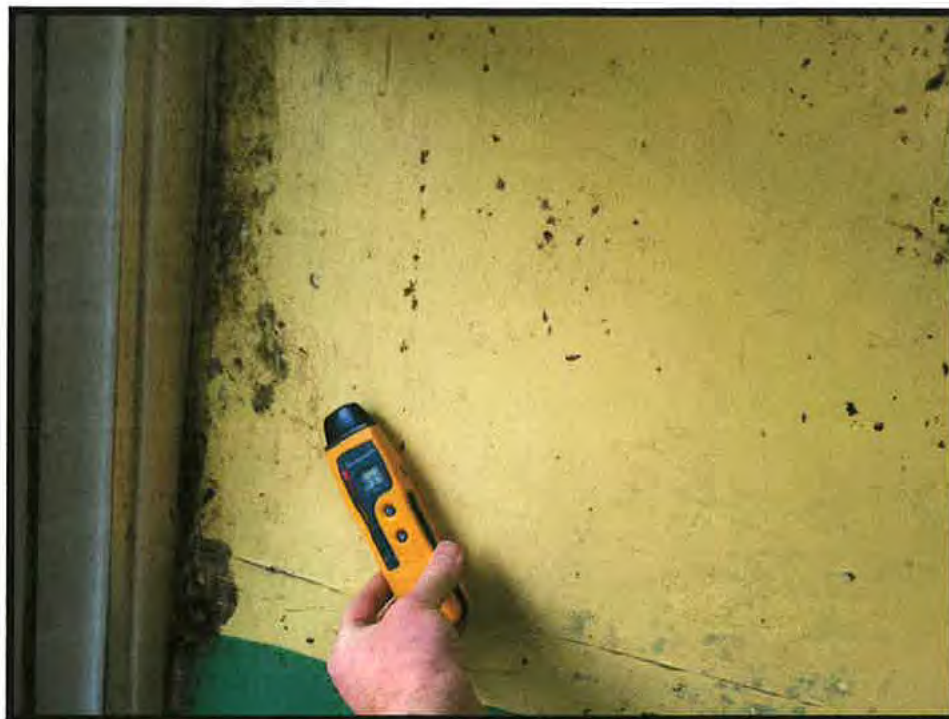
Photograph 24 Kitchen – hard plastered stone wall, right hand side of outer door, moisture reading 99%.
