Statement of Decision of the First-tier Tribunal for Scotland (Housing and Property Chamber) under Section 24(1) of the Housing (Scotland) Act 2006

Re: 38 Tiree Court, Irvine, North Ayrshire, KA11 (“the House”)

Chamber Ref: FTS/HPC/RP/23/3360

Schedule of Photographs
38 Tiree Court, Irvine, KA11 4JB
FTS/HPC/RP/23/3360

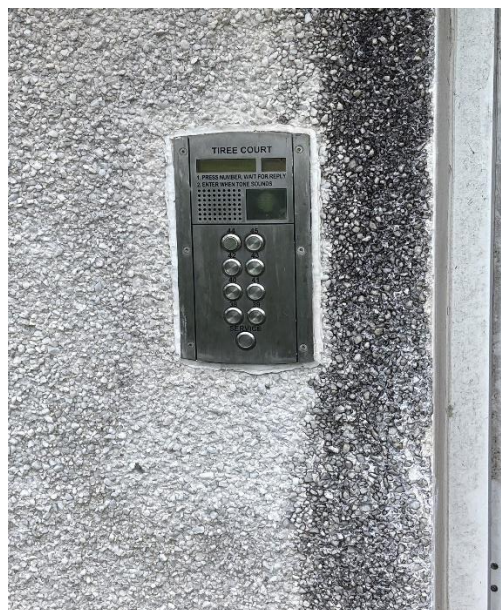
- i. Adjacent to the communal ground floor entrance to the building there is an electrically operated door entry system with individual "buzzers" serving each flat and a separate one for service access. There is

electrical power to the panel and also to the internal communication point within the flat although the “buzzer” is not working and there does not appear to be a remote means of opening the communal entry door from the flat.

agreed that there was power to the panel but that the feed does not work so the buzzer does not buzz. This causes difficulties for him if parcels are being delivered, etc. Other residents in the block were also having problems so the entry door was left open much of the time which is not ideal from a security point of view. Mr Grant confirmed that North Ayrshire Council did attend and carried out some external work to the entry system which they said had resolved the issue for other properties in the block but that Mr Grant's problem seems to be an internal one which is not their responsibility. Mr Scott explained that he has been in contact with North Ayrshire Council regarding the issue and had suggested an alternative to Mr Grant of a 'ring doorbell' type device. However, Mr Grant had refused this and the situation has reached a bit of a stalemate. Mr Grant explained that he did not want people to know that there was a video camera device at his property as he felt this could lead to him being targeted by other residents or visitors to the block. The Ordinary Member suggested some other type of doorbell device, without a camera, and it was agreed by Mr Scott that, if the existing system could not be fixed, such an alternative would be looked at.

2. Security entrance buzzer (bottom left) on communal system serving flats 38-45

4. The Tribunal was satisfied that the door entry system buzzer was not working and that, although the issue had previously been investigated as a possible common repair by North Ayrshire Council, it appeared to be, in fact, an internal issue and therefore, the responsibility of the Landlord. It appeared to the Tribunal from discussions at the Hearing that the Landlord and Tenant were both amenable to considering alternative resolutions to this issue, if the existing buzzer system could not be fixed. The Tribunal was satisfied that the current defect was a breach of the Repairing Standard in that any fixtures, fittings and appliances provided by the Landlord under the tenancy should be in a reasonable state of repair and in proper working order in terms of Section 13(1)(d) of the 2006 Act.

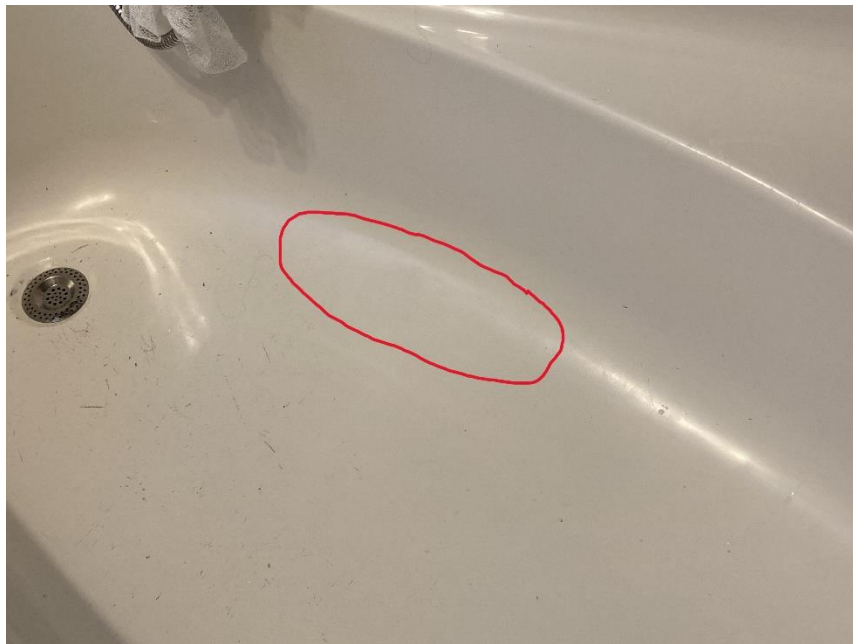
3.

- ii. Within the bath there is no evidence of any cracking affecting the fitting and the tenant confirmed that this had been satisfactorily addressed.
- iii. The bath side panel comprises fitted ceramic tiles. Evidence of separation cracking, notably at the grouting, was noted particularly at the junction of the bath and party wall with the hall and immediately around the rim of the bath.

3 – The area circled in red identifies the location of the alleged crack in the bath. This has since been repaired and there is no evidence of the crack

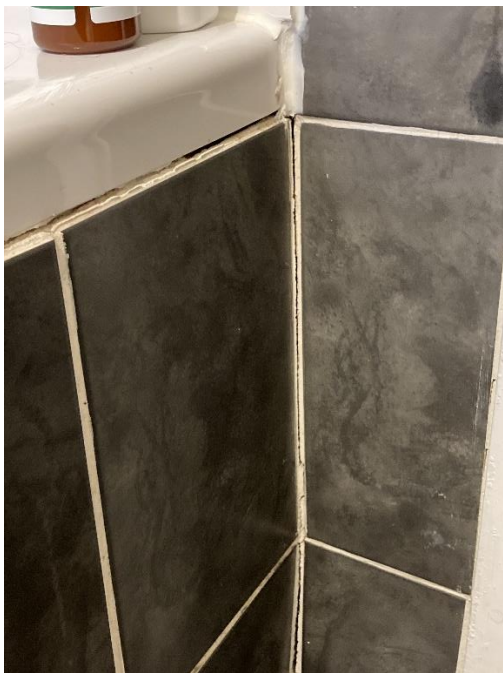
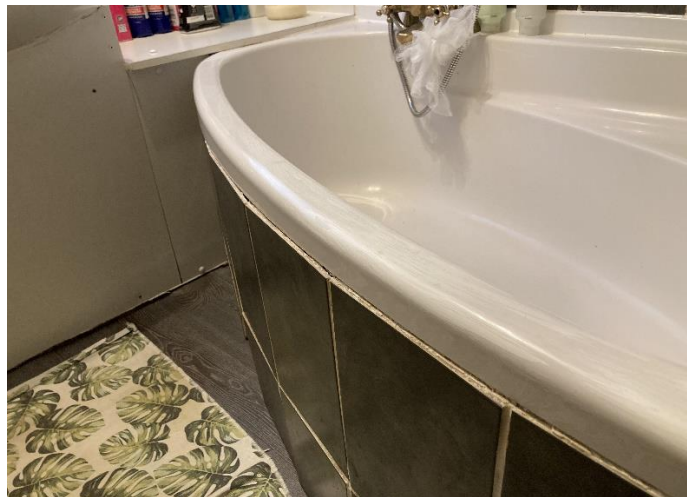
4 & 5 – The photographs illustrate cracked and missing grouting affecting the tiles on the side of the “bath panel”

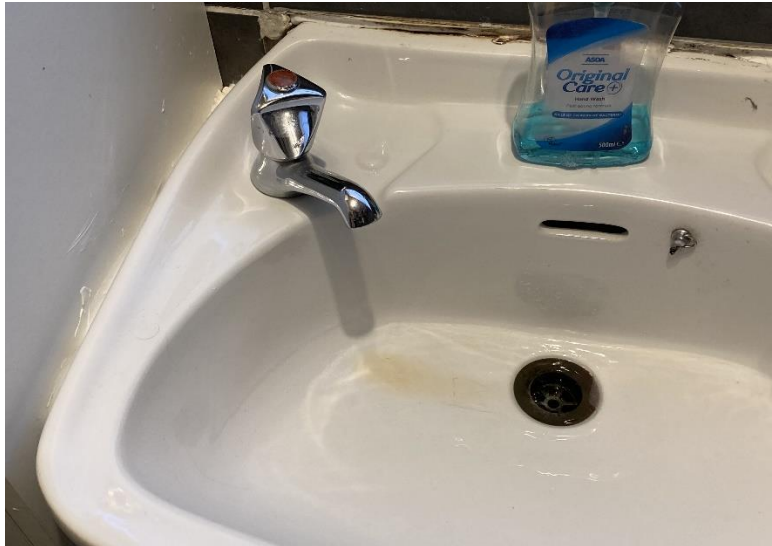
6

- iv. At the wash hand basin there is a constant drip of “warm” water from the hot water tap when in the closed position resulting in significant and semi-permanent staining to the basin.

The hot water tap has a constant drip when in the fully closed position which has resulted in staining to the wash hand basin.

6. In terms of the dripping tap in the bathroom, the Tribunal was satisfied that this was a long-standing defect, albeit a minor one, and that this should be rectified to ensure that the tap is in a reasonable state of repair and proper working order (Sections 13(1)(c)/(d) of the 2006 Act). The Tribunal was satisfied that other matters identified in the application concerning the bathroom had either been rectified already by the Landlord or did not constitute a breach of the Repairing Standard.

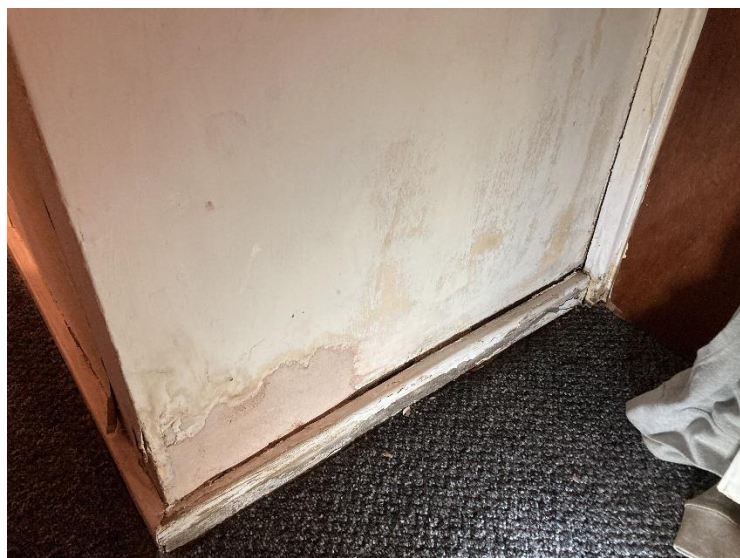
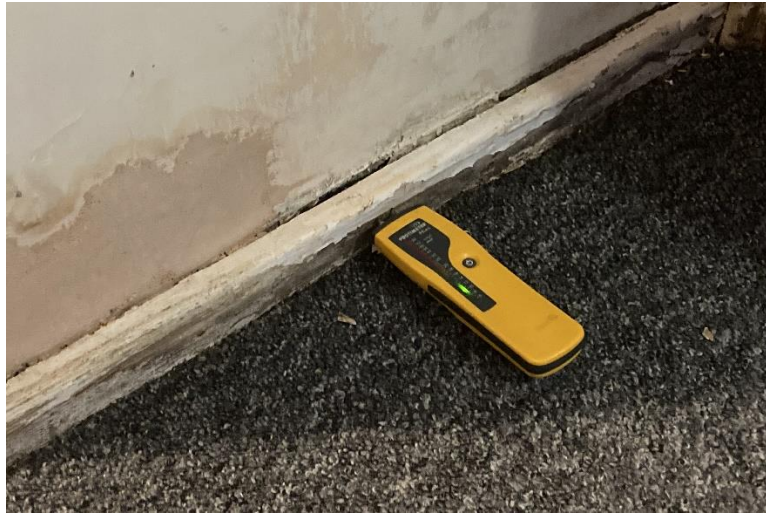
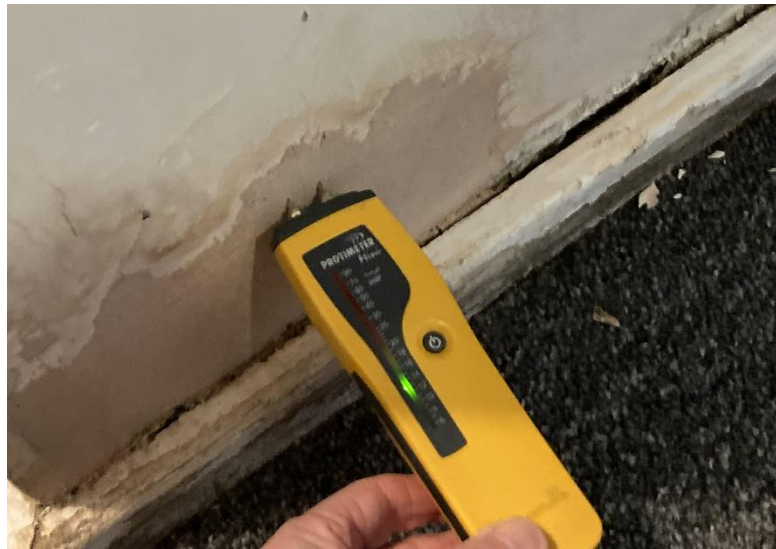
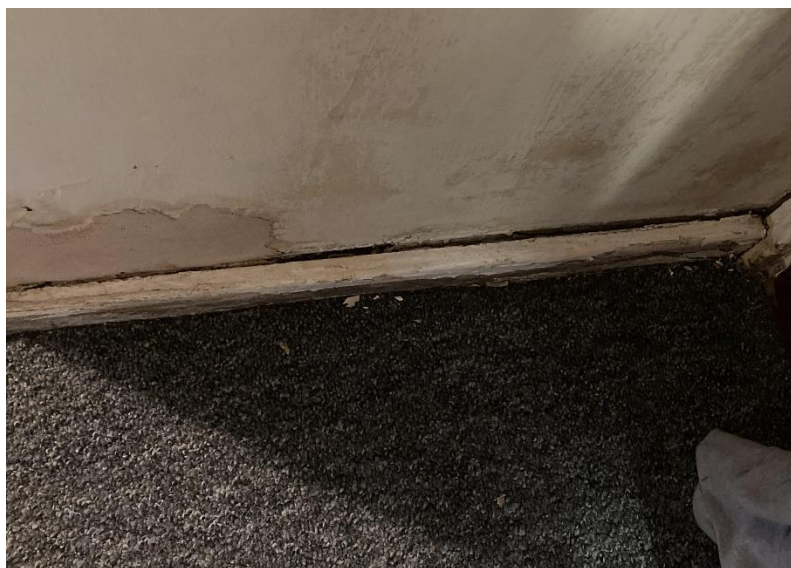
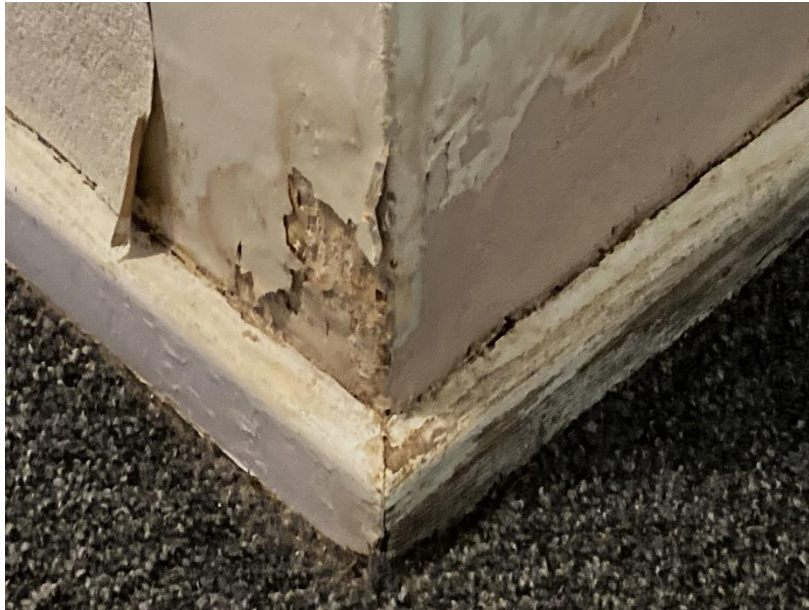
- viii. The lower level of the mutual wall between the bathroom and the internal hall displays evidence of residual damage likely as a

consequence of a previous water leak from the bath and shower attachment. This water leak has since been repaired although redecoration remains outstanding. There is no evidence of damp at this area although a degree of separation remains between the plasterboard wall and skirting board.

Photographs 7-11 all illustrate the lower level of the mutual wall between the bathroom and the internal hall. Moisture readings are low and at an acceptable level, although residual damage to the plaster wall remains as a consequence of a previous water leak at the area surrounding the bath and shower attachment. This water leak has since been repaired although redecoration remains outstanding.

7. The Tribunal was satisfied that the hall wall and skirting showed evidence of water damage, arising from a previous leak from the bathroom, the source of which had been rectified by the Landlord. Although the wall was completely dry, the damage caused to the skirting and the wall and the gap between the wall and skirting were unsightly. The Landlord's duty to repair and maintain includes the duty to make good any damage caused by repair issues which have been rectified and accordingly, the Tribunal considered that the Landlord should carry out some remedial decoration works in this area in order to comply with Section 13(1)(d) of the 2006 Act.

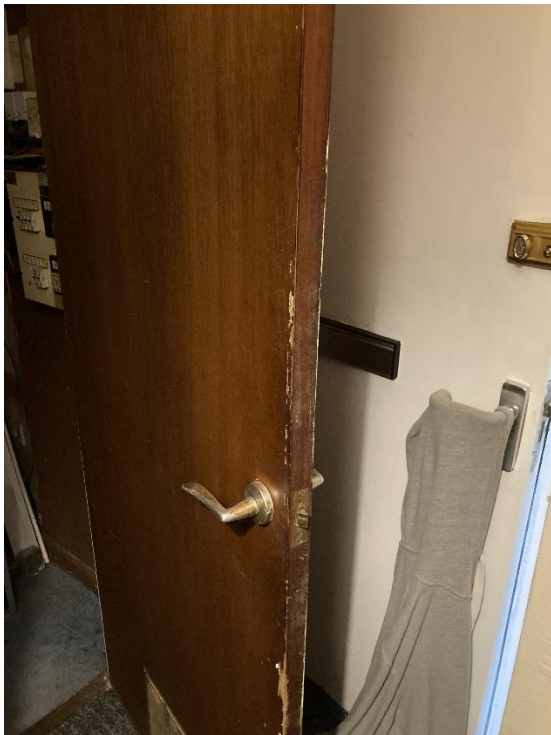
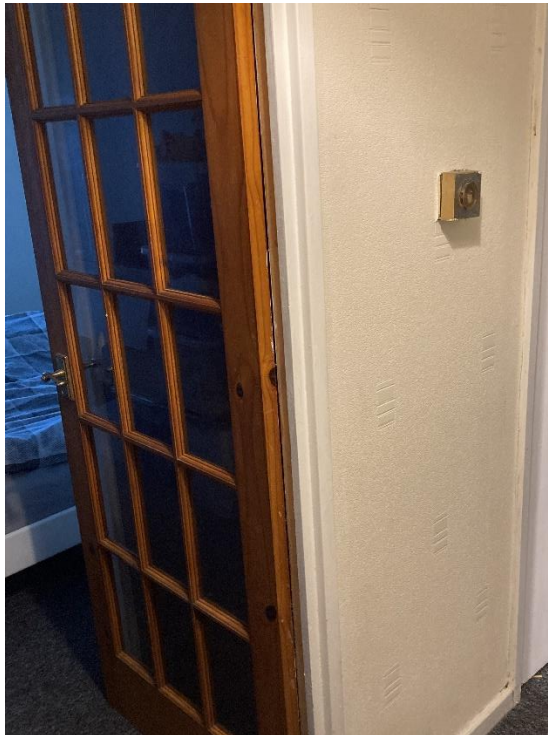
Photographs 12 and 13 illustrate internal doors, previously affected by condensation and mould staining of which there was no evidence at the time of inspection.

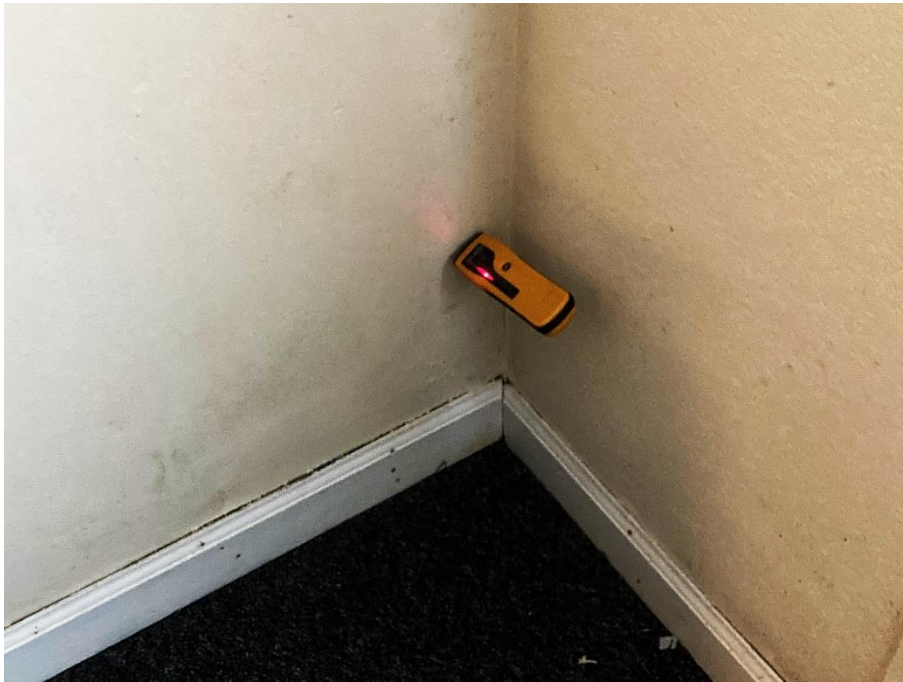
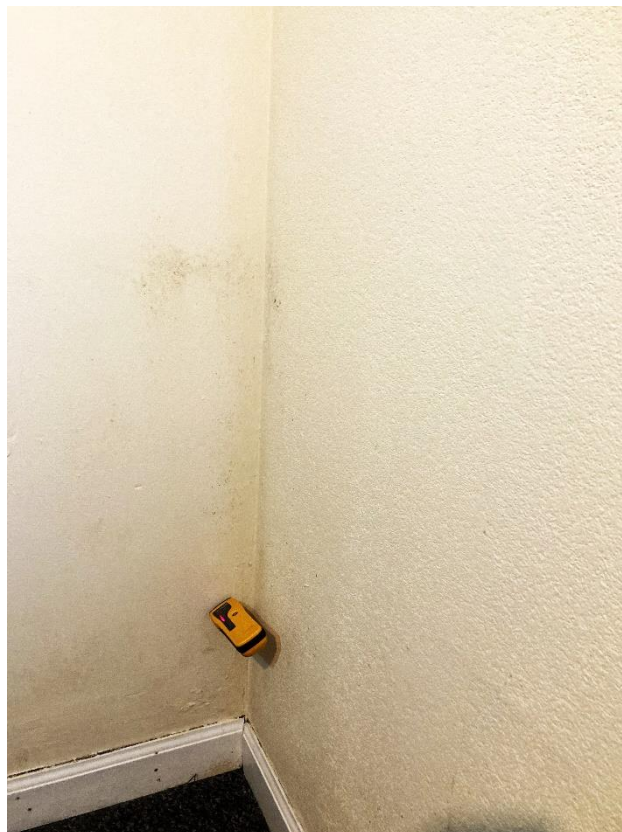
- ix. Moisture meter readings taken throughout the property were generally at an acceptable level. The exception is in the bedroom at the mutual wall with the ground floor common entrance where moisture readings are at a level likely to cause further deterioration to the internal fabric of the property should they remain.

Photographs 14 and 15 illustrate moisture readings at a level likely to cause further deterioration to the internal fabric of the property should they remain. The readings were taken in the mutual wall of the front bedroom and the common ground floor entrance hall towards the front of the building and entry door.

5. The Tribunal was satisfied, given their visual inspection and the damp readings in the corner wall area of the bedroom that further investigation is needed in order to identify the cause(s) and any remedial work deemed necessary to resolve the issue(s) thereafter carried out in order that the House is in a reasonable state of repair, wind and watertight and in all other respects reasonably fit for human habitation, in terms of Section 13(1)(a) of the 2006 Act. The Tribunal understood the Landlord's position in placing reliance on the investigations and findings of the specialist contractor in December 2020 and the fact that he understood the exterior of the property to have been re-rendered previously, as a common repair. The Landlord also considered, based on the opinion of the specialist contractor, as well as his own observations, that the Tenant was contributing to issues of humidity and dampness within the House. However, the Tribunal considered that the issue in the bedroom was more likely due to a structural type defect, which may well have arisen, or worsened, since the Landlord's contractor had investigated the matter

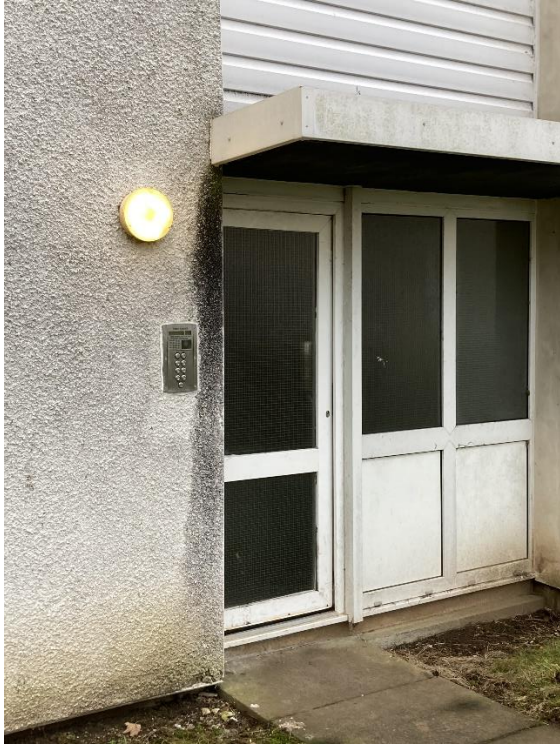
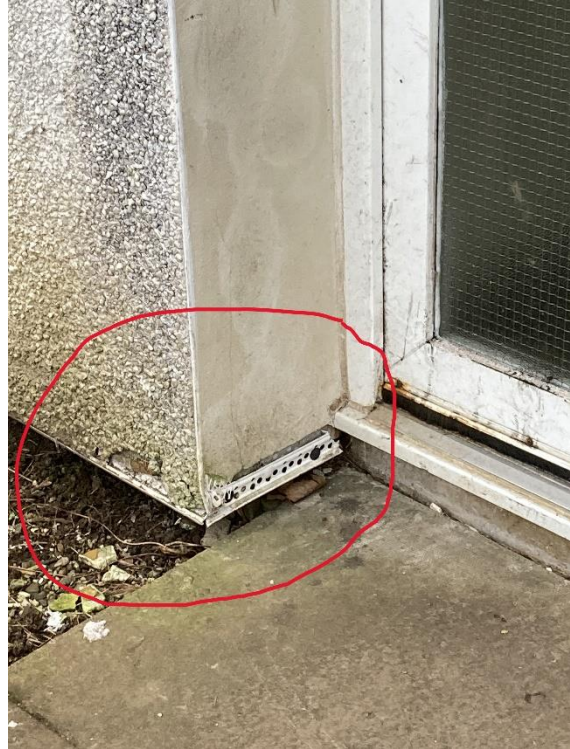
- x. Externally residual staining is evident on the rendering close to the front bedroom. This may have been the result of rainwater cascading from the adjacent roof projection during periods of severe weather. There is also a small area of bossed, cracked and missing render towards the base of the front wall.

Photographs 16 and 17 illustrate staining to the external rendering suggesting water cascading from the roof projection above the communal entrance and sections of bossed, cracked and missing rendering towards ground level. These areas coincide with the high moisture readings internally.
