STATEMENT OF DECISION: Housing (Scotland) Act 2006 Section 24 (1)

Reference number: FTS/HPC/RP/22/3634

Re: Property at Flat 3/1 55 Friarton Road, Glasgow, G43 2PP ("the Property")

Pre-hearing inspection summary and schedule of photographs

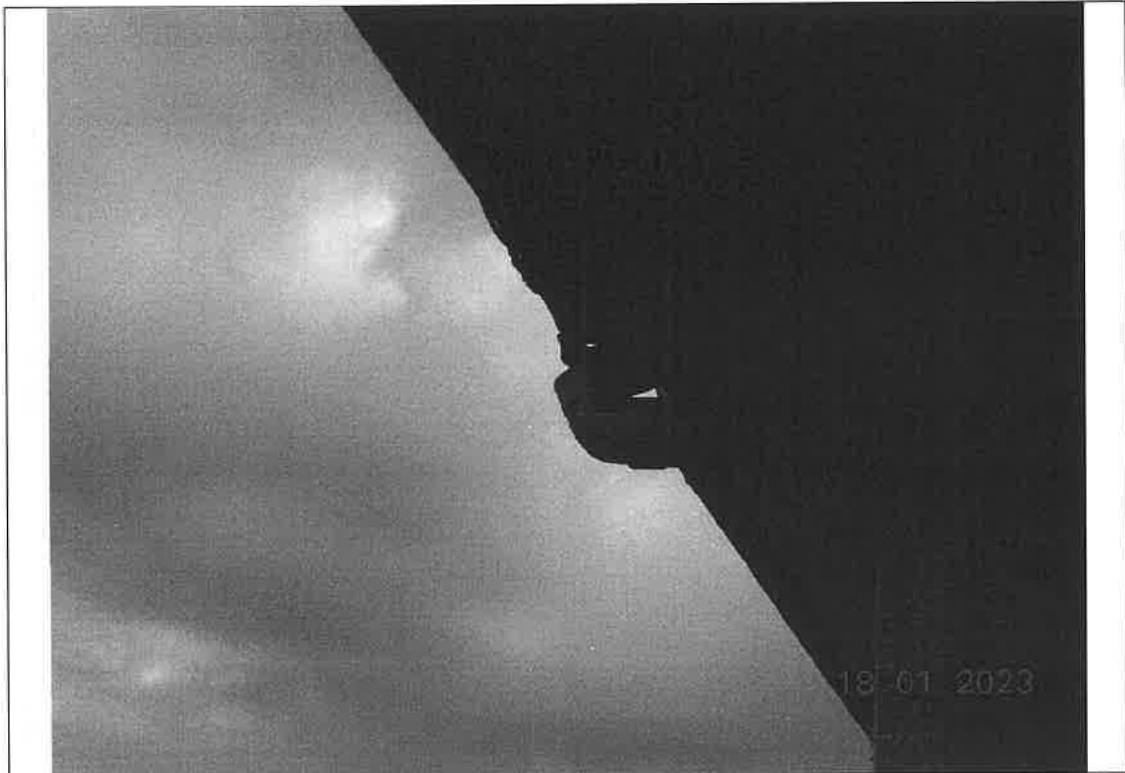
(e) To the front of the property, a downpipe has become disconnected. Debris has collected in the gutters serving the property. There are signs damp staining from overflowing gutters and downpipes on the outside walls of the property. The downpipes serving the property are rusted and show signs of unsuccessful temporary repairs.

11. Unconnected downpipe at balcony off Lounge.

- (a) Replace the roof finishes, including the flat roofed areas, and the rainwater goods.
- (b) Dry and repair Internal finishes damaged by exposure to water penetration.
- (c) Replace the loft insulation.
- (d) Install humidistat-controlled extract fans in the kitchen and bathroom.
- (d) Redecorate the inside of the property to remove the signs of water staining.

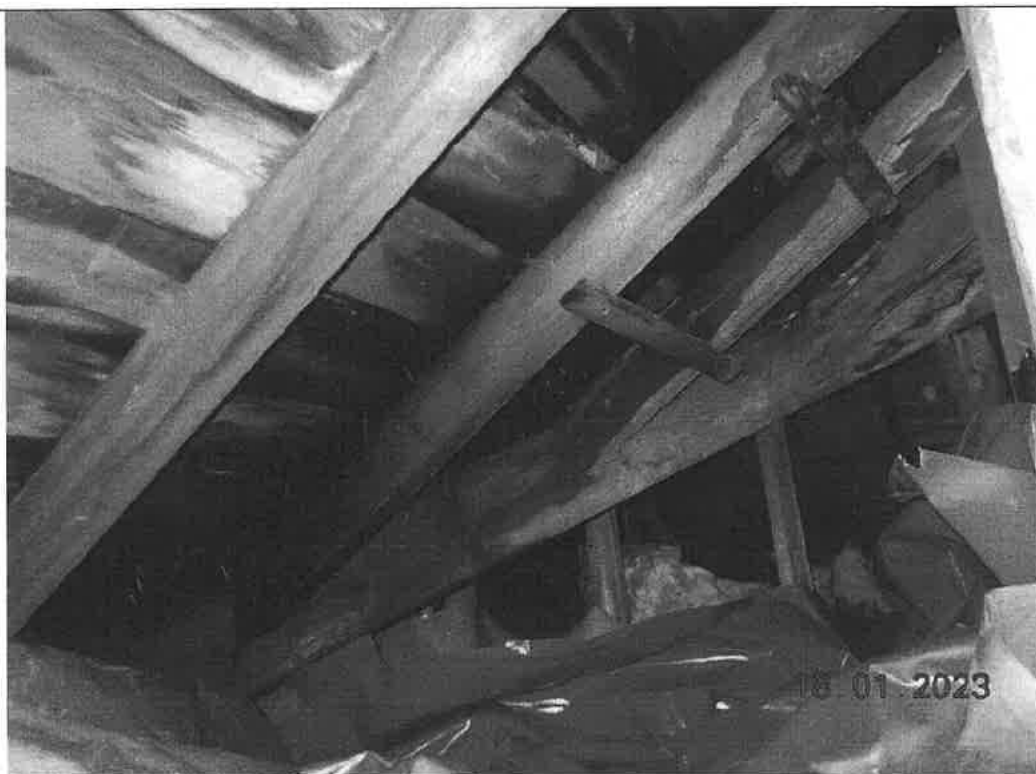
(d) Inspection of the roof void (through a hatch in the common stair) confirmed that polythene sheets had been laid in the attic space in an attempt to stem the flow of water coming through the roof.

23. Water staining and polythene sheeting in roof void over property.
