## **First-tier Tribunal for Scotland (Housing and Property Chamber)**

**STATEMENT OF DECISION:** in respect of an application Section 22(1) of the Housing (Scotland) Act 2006 (“the Act”)

**Chamber reference:** FTS/HPC/RP/17/0228

## Schedule of Photographs

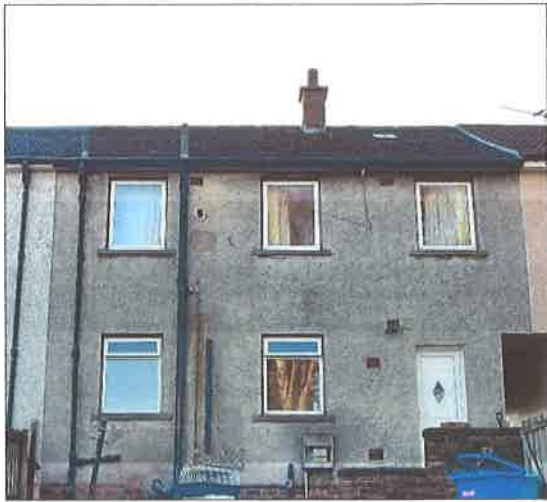
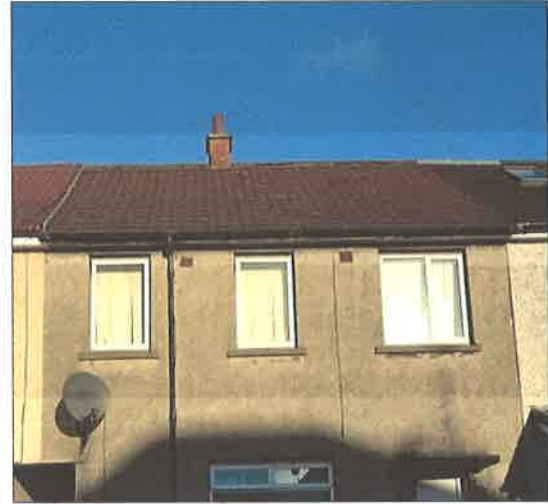
There do not appear to be any holes in the roof;

There does not appear to be a bird's nest at the back bedroom wall and  
No cracks could be seen in the external rendering.

Holes in roof - No evidence of missing or broken tiles – heavy covering of moss at the rear elevation. No evidence of bird's nest at rear bedroom window

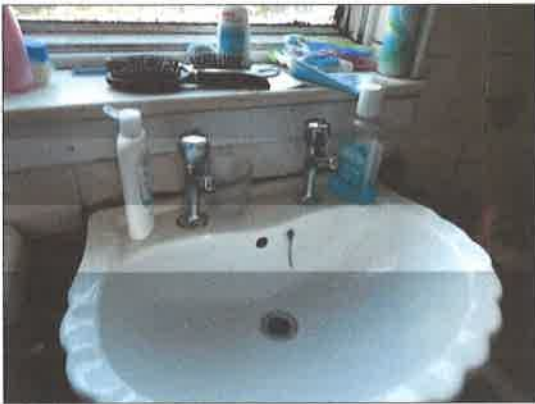
The bathroom wash hand basin hot tap appears to be in working order;

Loose leaking taps - New taps fitted

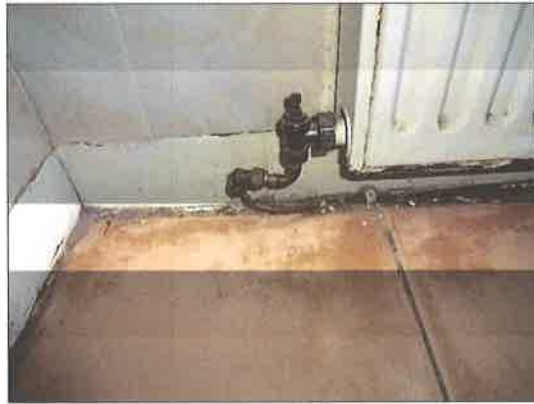
The bathroom radiator appears to be in working order and is not leaking;

Mould/rot and leaking Radiator – Repaired

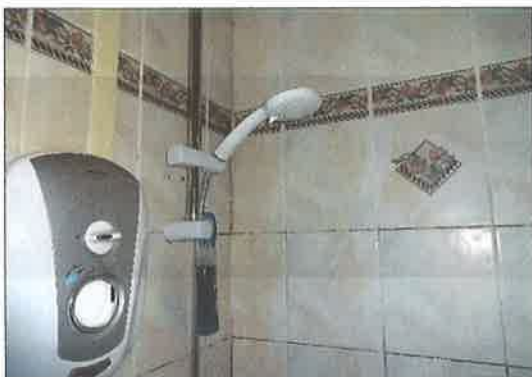
The shower head leaks and appears to require its seal to be replaced;

Loose shower head -  
Shower head replaced slight leak at seal

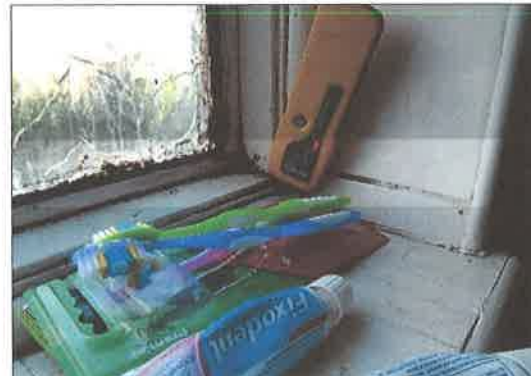
There is evidence of condensation mould at the sealant around the bath and at the frame of the bathroom window;

Mould within bathroom – Condensation

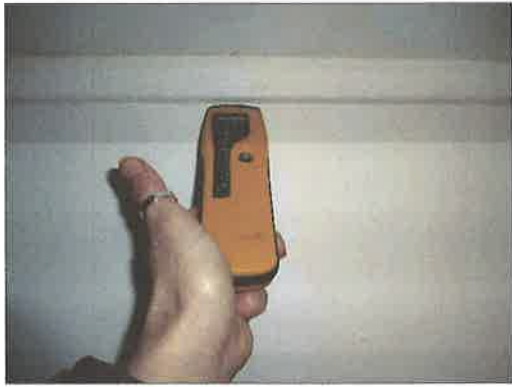
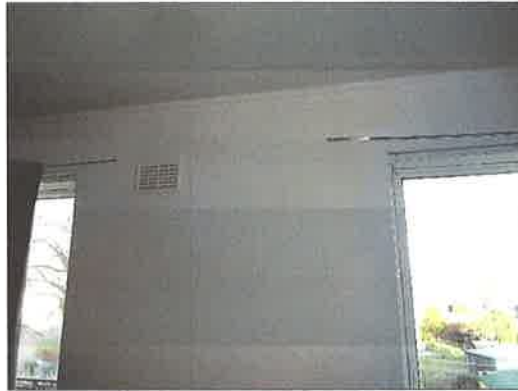
There are no wet patches or dampness in the walls and ceilings in either the hallway or the back bedroom, although recent treatment of the rear wall of the backroom was visible;

Dampness on walls and ceiling back bedroom – no evidence of water ingress  
Landlord cleared guttering and painted wall and ceiling.

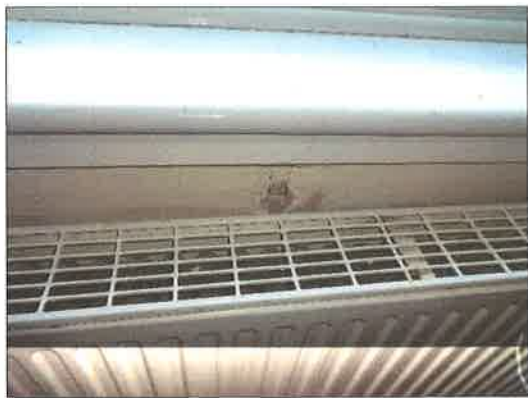
There is a crack in the plasterwork below the living room window at the point where the radiator is fixed, but no water ingress as a result;

Crack below living room window

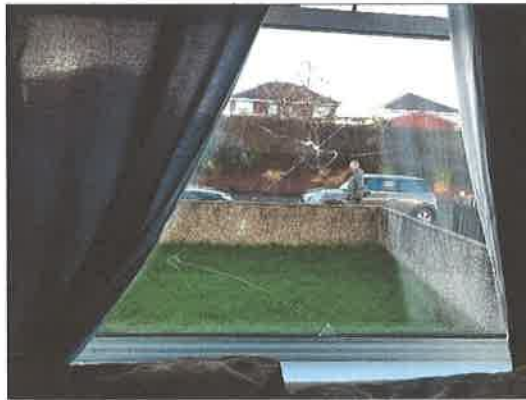
The external panel of the double-glazed living room window unit is cracked and broken;

17. In respect of Section 13(1)(b) of the Act, the tribunal found that at the date of  
the Inspection and Hearing the Landlord has failed to comply with the duty  
imposed by Section 14(1)(b) of the Act, the reason being that the external part  
of the double glazed unit of the living room window is broken and should be  
repaired and so the failed to ensure that the structure and exterior of the  
Property (including drains, gutters and external pipes) is not in a reasonable  
state of repair and in proper working order.

Broken living room window

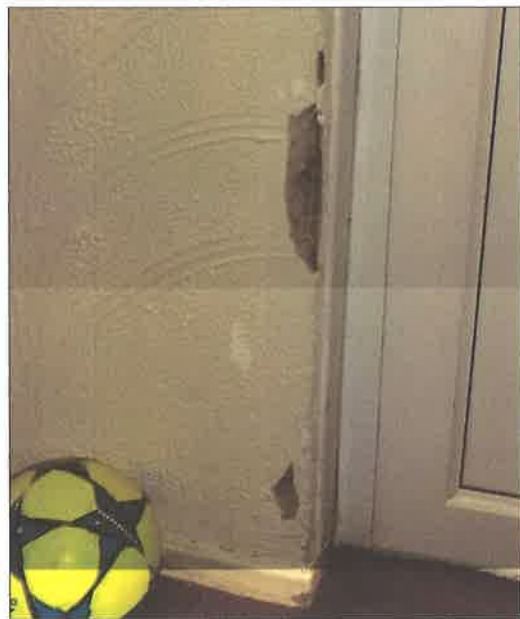
There is damage to the plasterwork in the hallway at the edge of the wall at the front door, but no water ingress as a result;

Holes in wall - hall

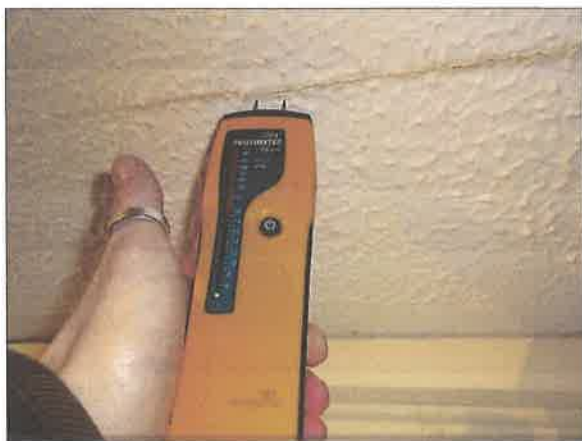
There is slight cracking in the downstairs hall ceiling which appears to be of an age and not recent;

Wet patched hall ceiling – historic water marks no evidence of recent water ingress
