## Determination by Private Rented Housing Committee

### Statement of decision of the Private Rented Housing Committee under Section 24 (1) of the Housing (Scotland) Act 2006

Ref PRHP/RP/16/0199

Property at Northfield Farm House, Auldgirth, Dumfries, DG2 0TR being part of the subjects described in Disposition in favour of Thomas William Kennedy recorded GRS (Dumfries) 19<sup>th</sup> May 1926 (Search Sheet 3608) ('the Property')

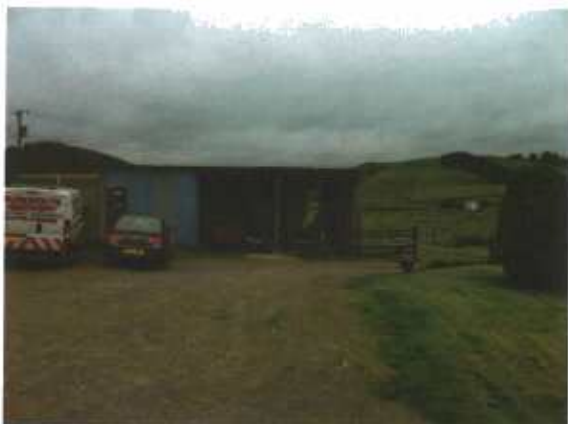
The Committee saw that sheeting was missing from the side of the shed the Tenant uses for storing wood located in the south east corner of the Property.

The Committee acknowledged that the tin shed/barn is part of the Property leased to the Tenant as it is included in the subjects defined in the lease. They determined that the missing sheeting of the tin shed/barn results in it NOT being in a reasonable state of repair and proper working order.

05 - Shed (wood store) with missing sheeting

1. Repair or replace the front and back doors (including the locks) to render them in proper working order.
2. Repair or replace the side sheeting of the barn used as a wood store located on the south east corner of the Property to render it in proper working order.
3. Eradicate the dampness in the rear porch.
4. Install:
  - 4.1 One functioning smoke alarm in the room which is frequently used by the occupants for general daytime living purposes.
  - 4.2 One functioning smoke alarm in every circulation space, such as hallways and landings.
  - 4.3 One heat alarm in every kitchen.
  - 4.4 All alarms should be hardwired and interlinked and
  - 4.5 One CO detector in every space containing a fixed combustion appliance.

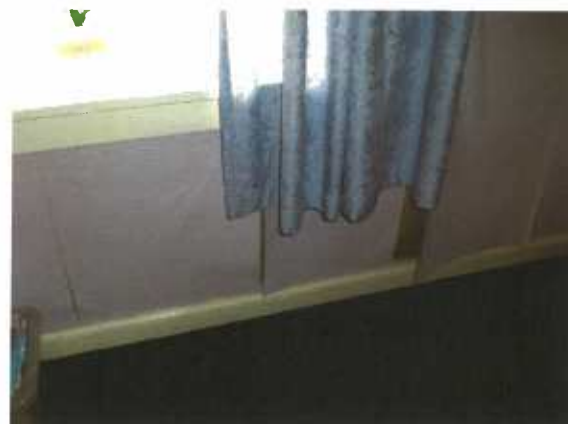
- Ground floor Bedroom  
The Tenant showed the Committee the area to the right of the window where the wall paper is loose. The surveyor member of the Committee tested this area with a damp meter but no dampness was detected.
- Main Bedroom (Upper floor)  
The Tenant showed the Committee the dormer haffits and explained that they are damp. The surveyor member of the Committee tested this area with a damp meter and confirmed that this area is damp and the readings are particularly high.
- Second Bedroom (Upper floor)  
The Tenant showed the Committee an area of dampness to the ceiling of the second bedroom on the north west gable. The surveyor member of the Committee tested this area with a damp meter and confirmed that this area is damp and the readings were also particularly high.

06 - GF bedroom - loose wallpaper

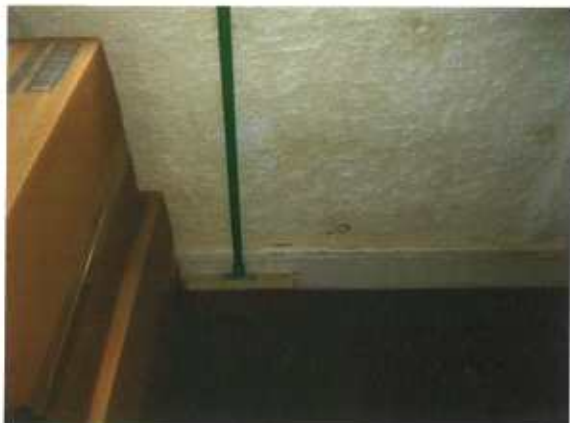
- Kitchen  
He explained that there is dampness in the area of the wood panels which were located below the floor mounted kitchen units. The surveyor member of the Committee tested this area with a damp meter but no dampness was detected.
- Rear Porch  
The Tenant showed the Committee the area of damp in the rear porch where there is a hole in the lined wall. The surveyor member of the Committee tested this area with a damp meter and confirmed that this area was damp.

The Tenant also pointed out that the Electricity Consumer Unit is located in the rear porch and the Committee noted that it was hanging off the wall and was loose and dangling by the electrical wire.

The area of dampness in the rear porch results in the Property not being wind and water tight and in all other respects reasonably fit for human habitation. The Committee accepted that the necessary repairs to the roof had been completed in respect of the dampness found in the two upper bedrooms and considered that the above normal levels of dampness found in these rooms was due to the fact that the drying out of these areas was ongoing.

07 - Rear porch - dampness and defect

14. The Committee strongly recommends to the Landlords that the electrical consumer unit is inspected and repaired by a suitable qualified electrician.

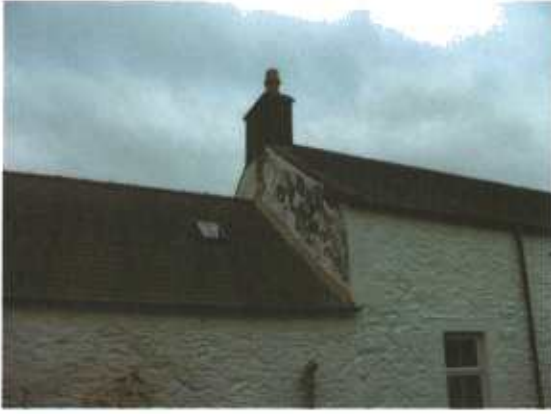
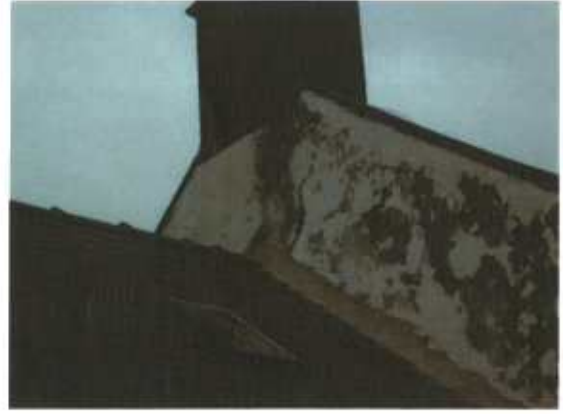
09 - NW gable of house

The Tenant advised that a roofer had spent two weeks repairing the slates on the roof recently. The Committee noted that new mortar had been fitted between the junction of the roof of the outbuilding which adjoins the farmhouse and the north west gable.

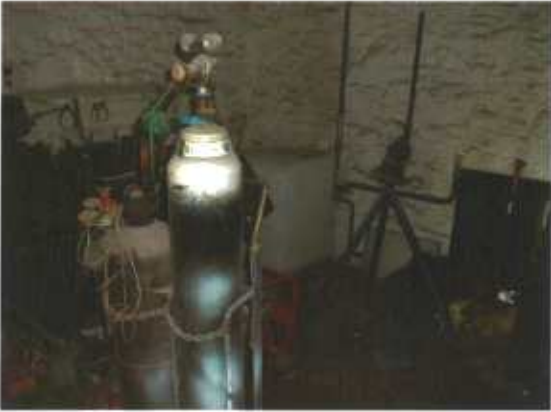
The Tenant explained that the oil fired central heating boiler had been serviced approximately five weeks previously and it was now working satisfactorily.

The Committee accepted the evidence of the Tenant to the effect that the central heating boiler had been serviced recently and it is now working properly and accordingly it is in a reasonable state of repair and proper working order.

11 - Oil-fired boiler in workshop

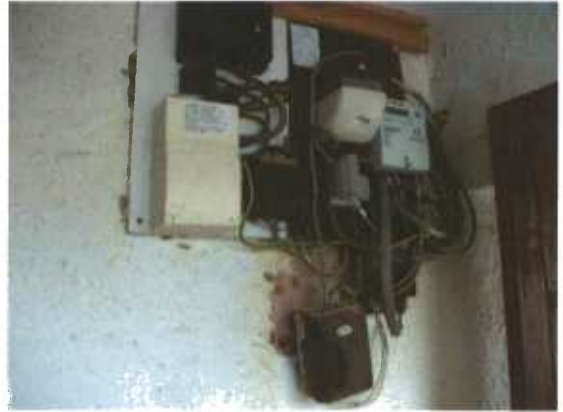
12 - Main electrics board at inspection

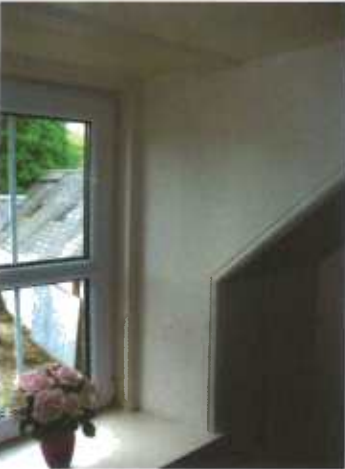
- Kitchen  
The Tenant accepted that the damp meter did not record any dampness but explained that there is probably dampness behind the wooden panels which had been installed approximately 33 years ago.
- Rear Porch  
The parties acknowledged that there was dampness in the rear porch.
- Ground floor Bedroom  
The Tenant accepted that the damp meter did not record any dampness in the areas where the wall paper was coming away from the wall.
- Main Bedroom (Upper floor) and Second Bedroom (Upper floor)  
Nick Wright explained that the dampness may be residual dampness following the repairs carried out to the roof that had not yet dried out.

13 - Dampness at dormer haffit

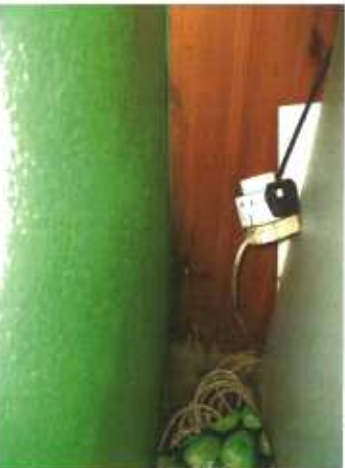
15 - Kitchen

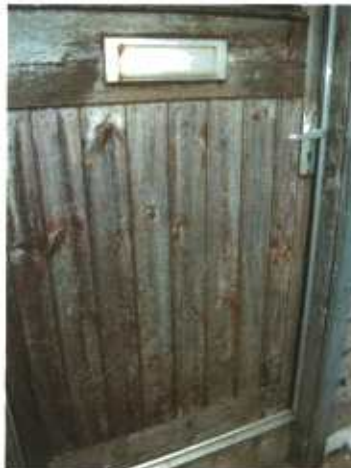
The Committee inspected the wooden front door and back door of the Property. They found that the front door was stiff to open and close and did not operate easily. The back door had two broken wooden panels at the bottom of the door and the lock did not work properly.

Also the said condition of the front and back doors of the Property results in them NOT being in a reasonable state of repair and proper working order.

16 - Front door

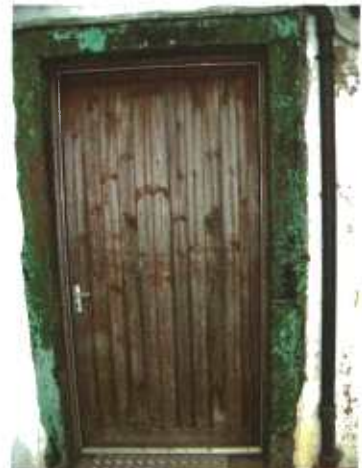
17 - Rear door
