**Repairing Standard Enforcement Order (RSEO): Housing (Scotland) Act 2006
Section 24**

Chamber Ref: FTS/HPC/RP/18/2233

5 Cocklaw Farm Cottages, Ayton, Eyemouth, TD14 5RJ (“The Property”)

STATEMENT OF DECISION: Housing (Scotland) Act 2006 Section 24 (1)

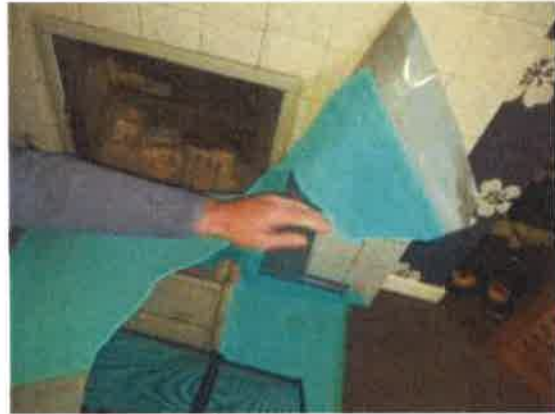
The Tribunal inspected the fireplace in the lounge. The Tenant submitted that smoke had started to come out of the brickwork and floor surrounding this one day. The Fire Brigade had been called and they had had to take certain steps which resulted in there being holes in the wall and floor around the fireplace. The fireplace had been rendered unusable and the back boiler that provided heating had been removed. The Tribunal accepted that that back boiler had been removed/was no longer working and that the fireplace itself was defective. There were holes in the flooring and walls around the fireplace. The Landlord alleged that he had some concerns about exactly how this issue had arisen and how and why the

2 Temporary protection at fireplace.

- (a) To carry out redecoration works to the water damaged areas in the upstairs bedroom and bathroom
- (b) To repair or replace the fireplace and back boiler system in the Property or otherwise to install an appropriate central heating system compliant with the repairing standard.

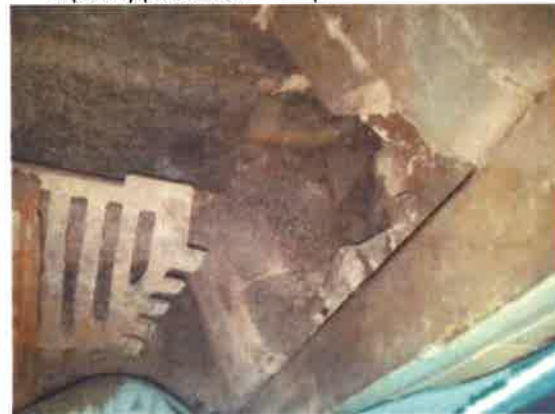
Fire Brigade had been called out. However, the Tribunal could only base its decision on the evidence before it on the day. It was apparent that the fireplace had been damaged and the back boiler removed. It was apparent that there were holes around the wall and floor of the fireplace. The Landlord indicated that he wished to install a new oil fired central heating, as he had in the neighbouring cottages that he owned. The Tribunal was satisfied that it was appropriate for the Landlord either to install a new oil fired central heating, which would render the need for the fireplace and back boiler redundant. The Tenant indicated he would be happy with this being done. Alternatively, the Landlord could repair/replace the fireplace and back boiler. Which option was taken was a matter for the Landlord.

4 Damage within fireplace.

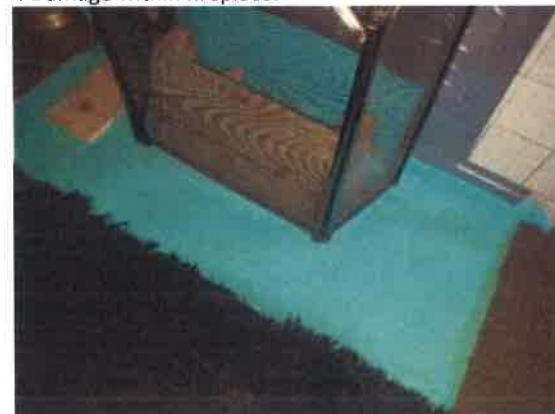
6 Temporary protection at hearth.

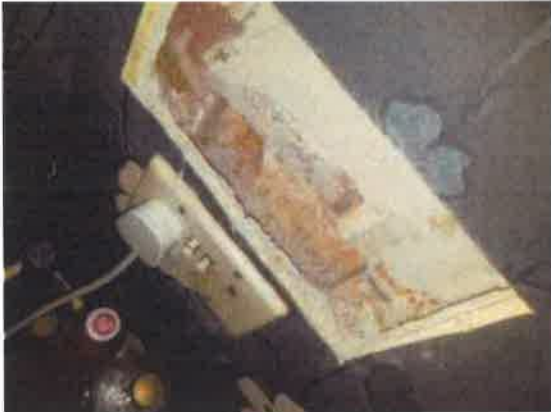
- (15) The holes in the wall and floor around the fireplace were a breach of the repairing standard.
- (16) The steps at the side door of the Property did require repair work and did not meet the repairing standard.

7 Damage adjacent to fireplace.

- (h) To repair the holes in the wall and floor surrounding the existing fireplace.
- (i) To repoint the steps at the side door of the Property and to render it secure.

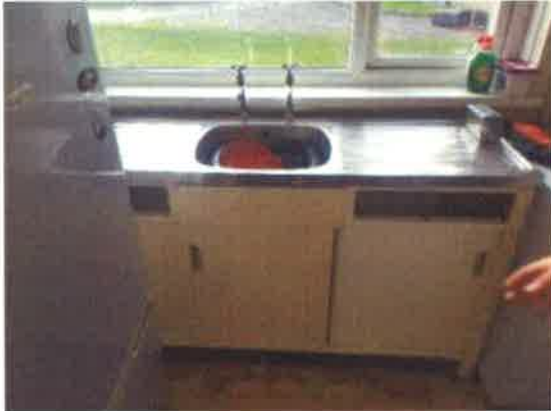
The Tribunal inspected the kitchen sink at the Property. It was apparent from a test on the day that this was not draining correctly. The Tribunal also noted that the inside of the sink unit was in very poor condition and that there were a number of missing doors. Overall the Tribunal was of the view that the sink unit needed to be replaced and a new sink and unit installed.

9 Kitchen sink.

- (d) To replace the kitchen sink and surrounding unit to a standard compliant with the repairing standard.
- (e) To clear the external drain to ensure it is in proper working order and compliant with the repairing standard.

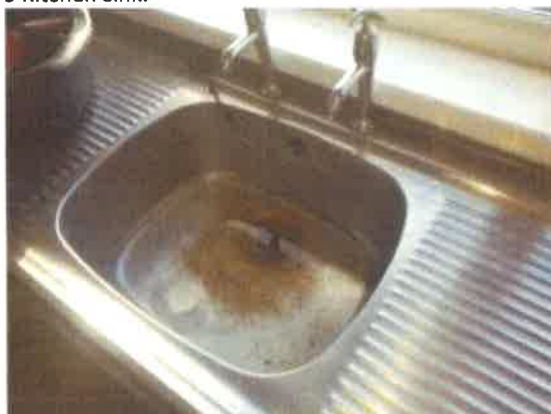
11 Blocked drainage at sink.

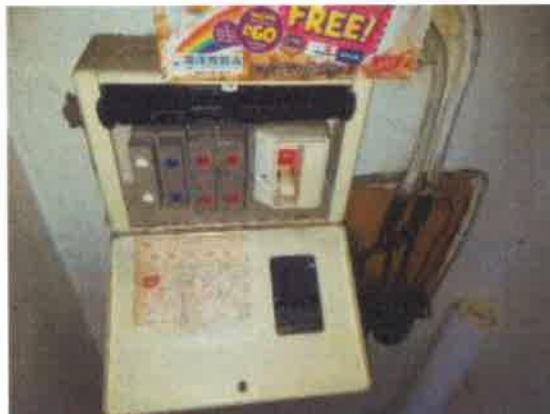
- (5) Whilst the consumer unit was dated it met the repairing standard.
- (6) Whilst the earth bonding from the consumer unit to the water pipes was preferable nonetheless this was not a requirement of the repairing standard.

14 Consumer unit with rewirable fuses.

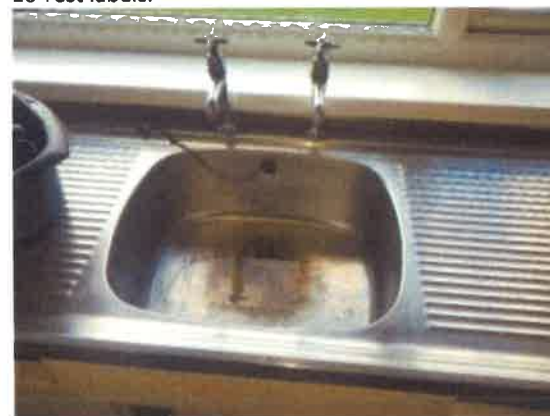
18 Drainage blockage.

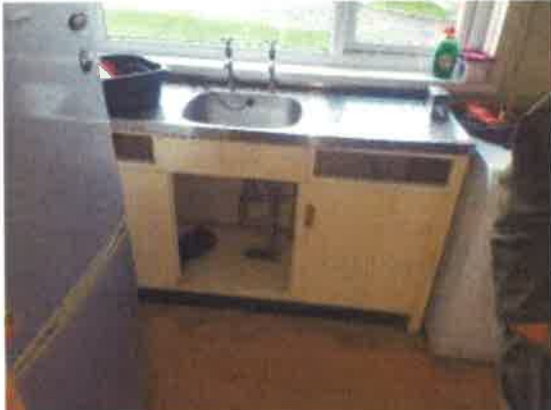
19 Missing components of kitchen base unit.

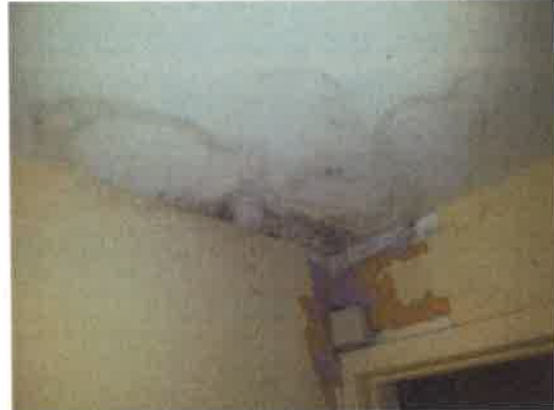
The Tribunal noted that there was water damage to the ceilings to an upstairs bedroom and the bathroom. However damp meter tests of these areas proved to show that there was no current moisture. The Tribunal was satisfied that this was historic water damage. These areas would require to be made good and redecorated by the Landlord but no other works were required. From an exterior visual inspection, the roof appeared to be in reasonable condition. The Landlord advised that works had been carried out in the past to address a leak.

20 Water damage within bathroom.

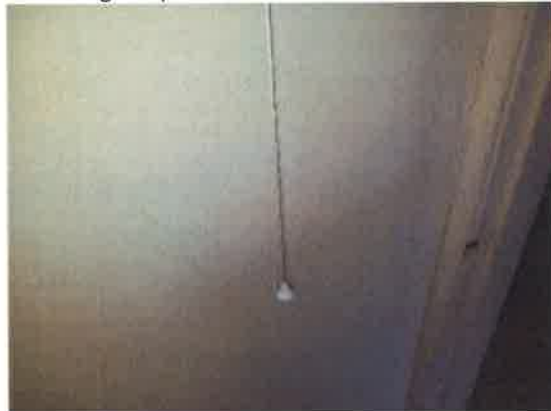
21 Water run off marks within Bathroom.

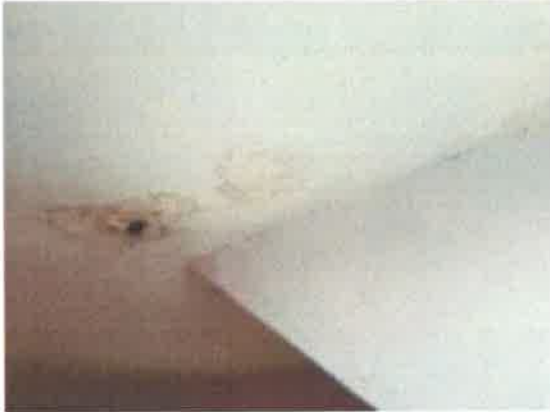
25 Water damage within Bedroom.

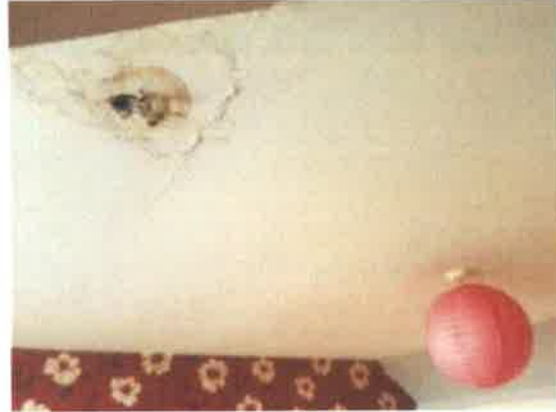
26 Water damage within Bedroom.

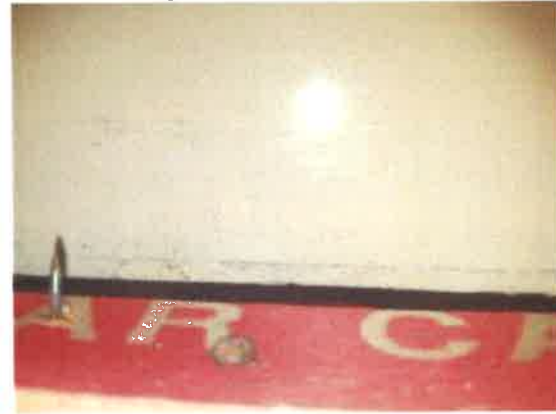
28 Gap at underside of skirting – unsealed.

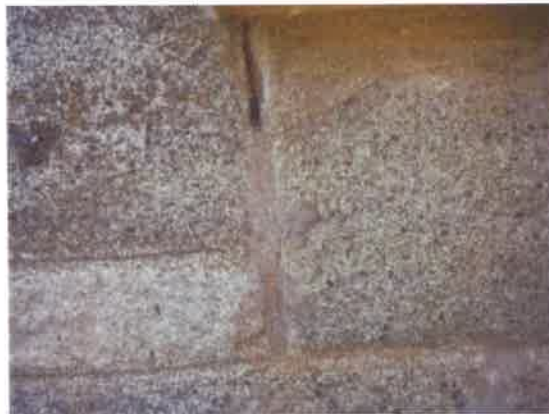
The Tribunal noted the Tenant's assertion that water had penetrated into the cavity insulation in the wall. However there was no evidence to this effect. There evidence of some defective pointing repairs that had been carried out previously to the exterior of the Property and a couple of other minor cracks on the end elevation of the Property. These were relatively minor in nature but would benefit from being attended to and any defective areas re-done.

29 Defective pointing.

- (c) To carry out appropriate pointing works to the exterior and chimney of the Property sufficient to render it compliant with the repairing standard.

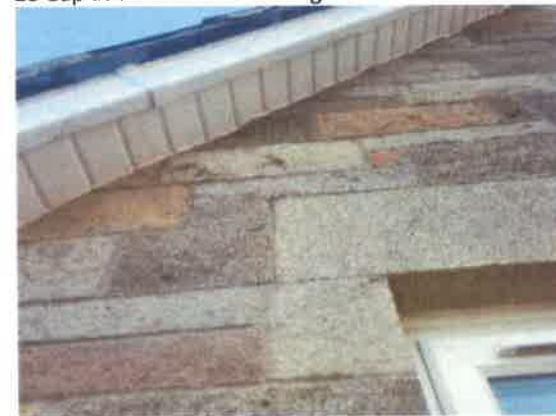
The Tribunal did note that there was some areas of asbestos sheeting at the edge of the roof. This was relatively common in Scotland. The asbestos was in the open air and therefore did not represent a risk to human health. The Tribunal was satisfied that there was no breach to the repairing standard in this regard.

30 Possible asbestos cement at verge.

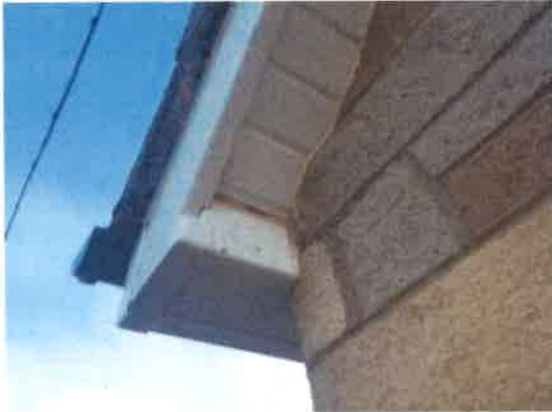
31 Possible asbestos cement at verge.

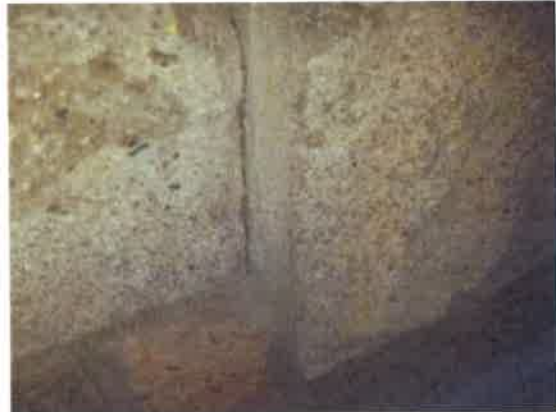
32 Cracking to pointing.

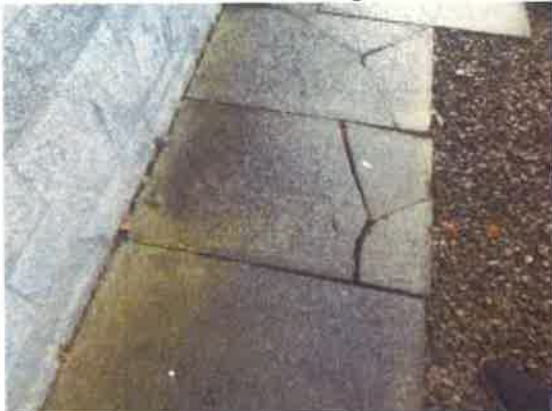
The Tribunal inspected the path at the side door of the Property. Whilst it was a little uneven generally it was still within acceptable parameters. However there were two or three cracked slabs that were a trip hazard. The Tribunal was of the view that the Landlord would require to replace these in order to meet the repairing standard.

33 Defective concrete paving slabs.

- (f) To replace the cracked paving slabs to the side of the Property.
- (g) To carry out repairs to the potholes at the end of the driveway leading to the Property sufficient to render it compliant with the repairing standard.

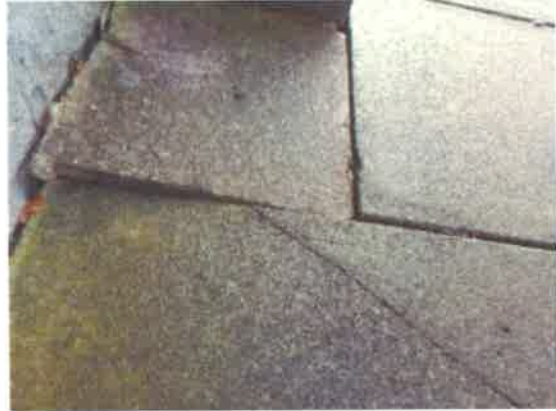
34 Defective concrete paving slabs.

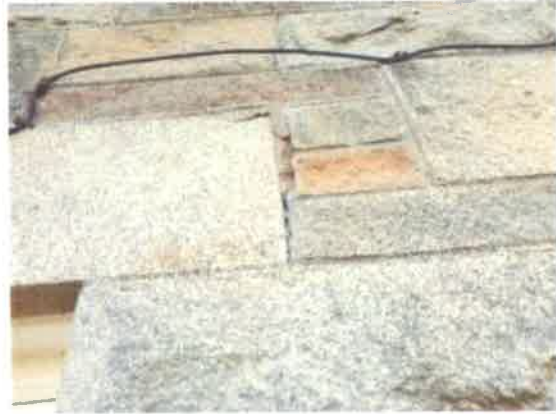
36 Cracking to pointing.

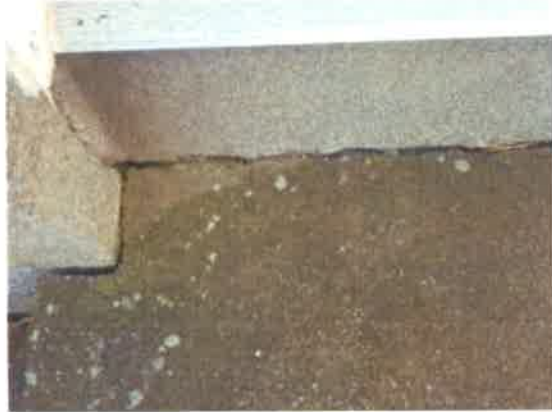
The Tenant alleged that the steps at the side door were insecure. The Tribunal did note that there were several areas of cement pointing that had come out. This left some larger gaps that water could penetrate into and cause damage to the Property. The Tribunal was satisfied that it would be appropriate for the Landlord to carry out repairs to the pointing to ensure that water could not penetrate and that the steps were stable.

38 Open junctions with gable steps.

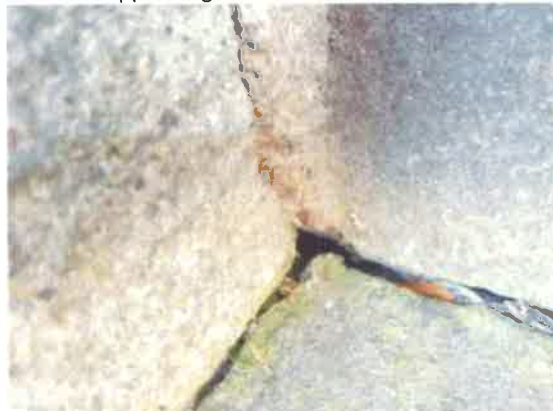
39 Open junctions with gable steps.

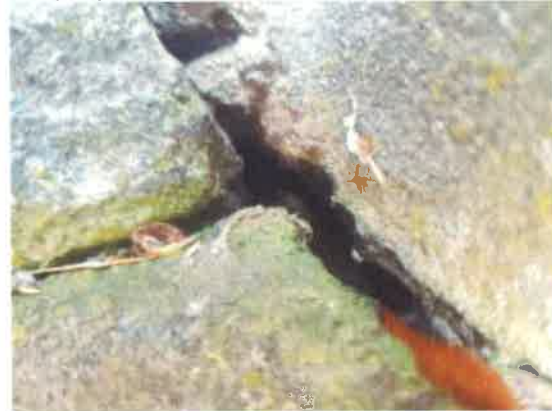
40 Close view of gap at gable steps.

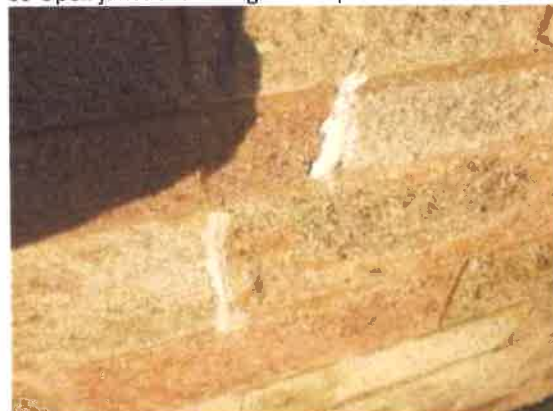
41 Patch pointing works.

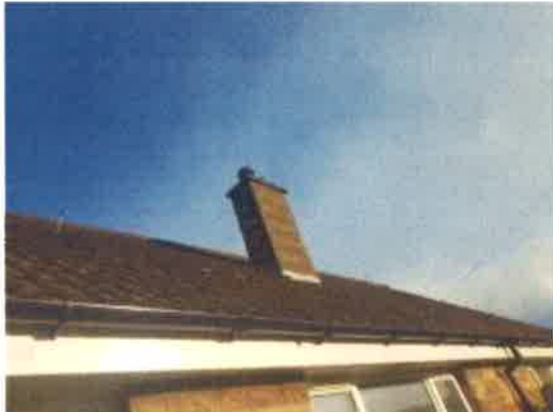
The Tribunal inspected visually the chimney. There was some minor pointing repairs required that the Landlord should carry out but otherwise the chimney looked to be to an acceptable standard.

43 Chimneystack.

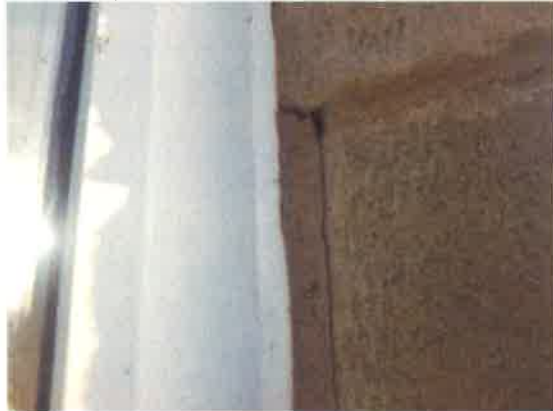
45 Cracking to pointing.

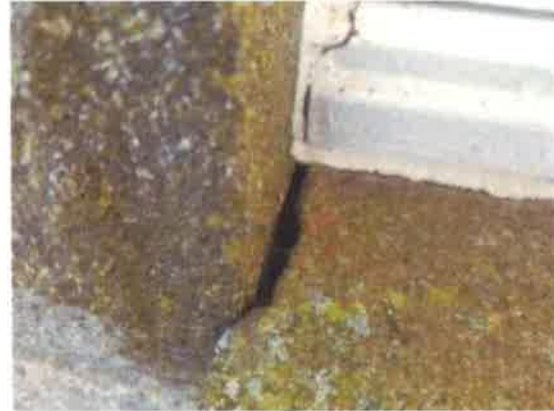
46 Open gaps at sills.

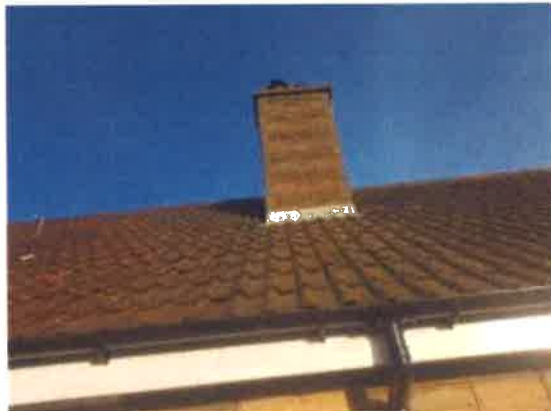
51 Chimneystack.

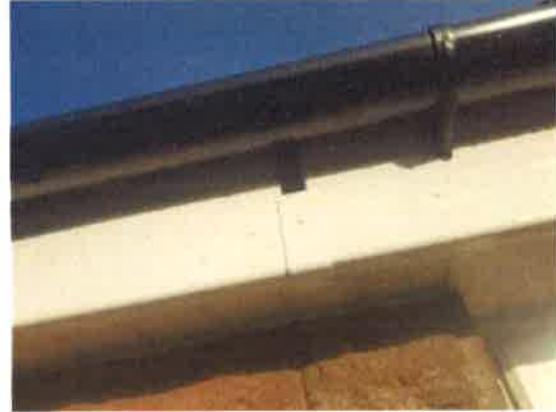
The Tribunal noted that the cold water tank overflow was partially blocked due to gutter facings that had been installed. It was noted that if a new oil fired heating system was installed the cold water tank would be redundant. If this was the option that was taken then the Landlord would not require to carry out any further works in this regard. If, however, it was the case that the fireplace and back boiler were reinstated then the facings would need to be adjusted to ensure that the cold water tank overflow was properly exposed.

56 Overflow at fascia.

- (j) In the event of a new fire/back boiler being installed at the Property to ensure that the cold water tank overflow pipe is not blocked.

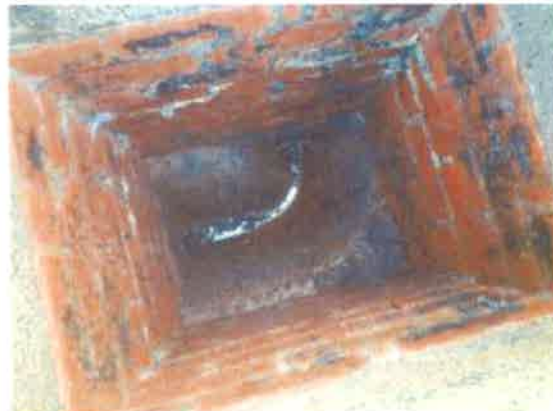
The Tribunal carried out an inspection of the external drain. From lifting the drain cover and inspecting this visually it was apparent that this was at least partially blocked. The Landlord would require to clear this.

59 Impairment of drainage flow.

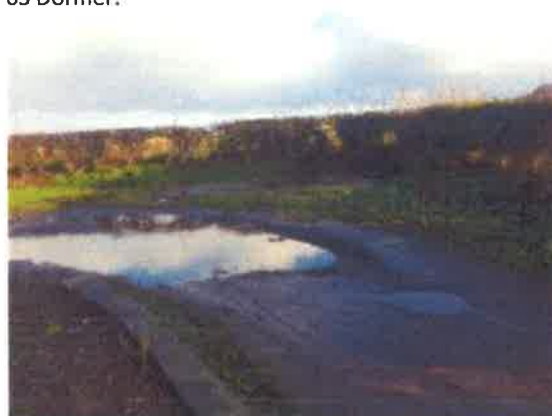
had been flooded at some point in the recent past. There was some debate as to the date the video had been taken. In any event the Tribunal was of the view that it would not be uncommon for there to be flooding on occasion in a rural location of an undrained road. It was unrealistic to expect the Landlord to carry out any material drainage works taking into account the age, character and location of the Property. There was however an area at the end of the drive that had a number of larger ruts and potholes. These were beyond what might be reasonably expected to be tolerated and the Landlord would require to carry out some repairs to improve this area.

65 Potholing and water ponding.

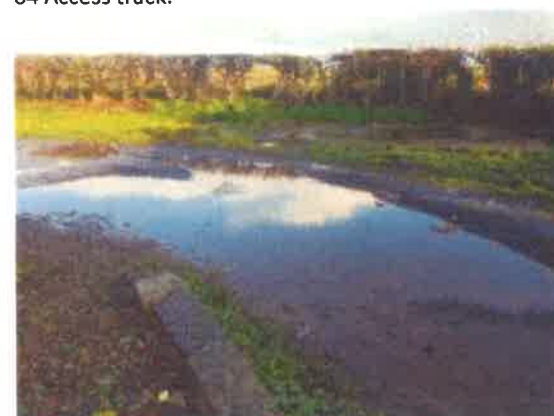
66 Potholing and water ponding

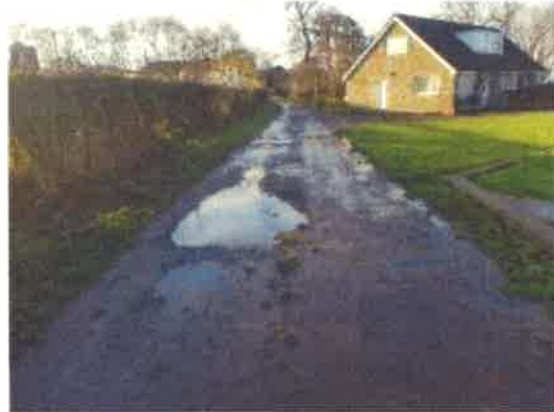
68 Potholing.
