**Repairing Standard Enforcement Order (RSEO): Housing (Scotland) Act 2006
Section 24**

**Property at B/1 10 Garland Place, Dundee, DD3 6HE
("the Property")**

STATEMENT OF DECISION: Housing (Scotland) Act 2006 Section 24 (1)

Photographs taken during the inspection of
B/1, 10 Garland Place, Dundee, DD1 3BA

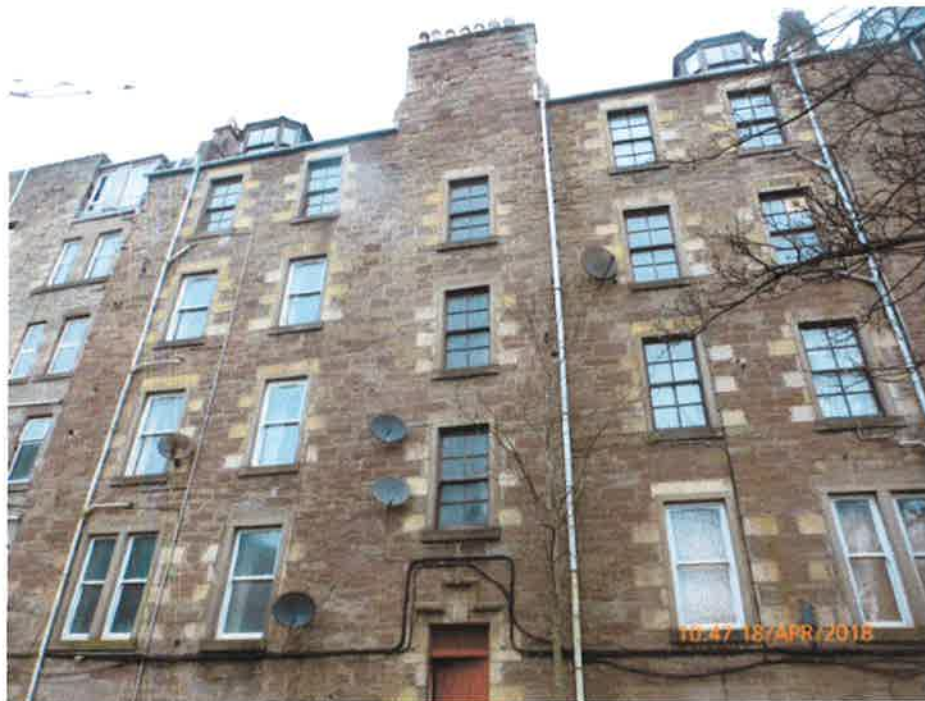
Rear of the block

The Third Party Applicant also complained that the stonework was stained and scaling in places and a number of open joints were observed. The Tribunal had noted some open joints and flaking masonry during the inspection. The Landlord had repaired some open joints at the front and undertaken to repair some at the rear wall of the building.

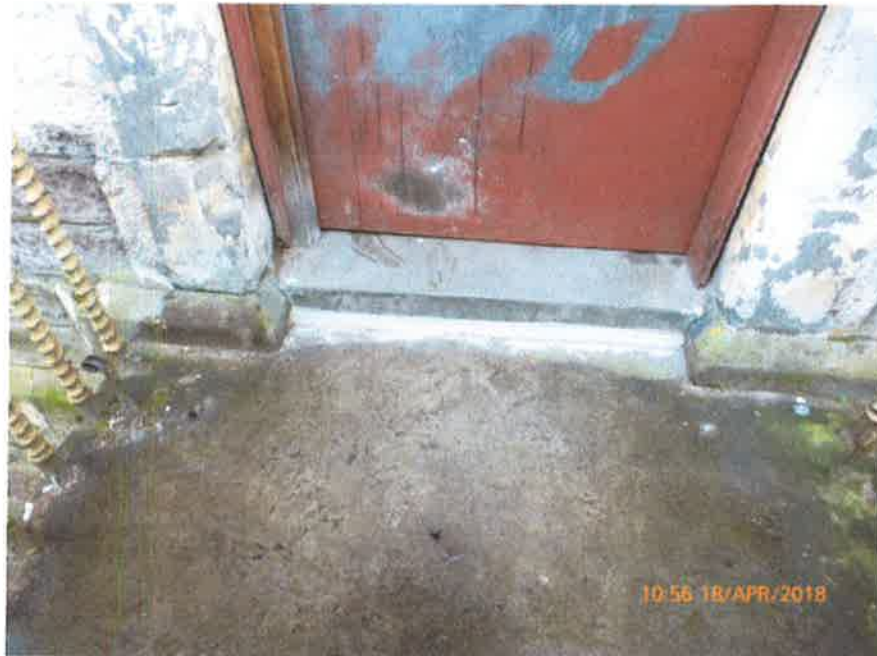
Recently repaired front door step

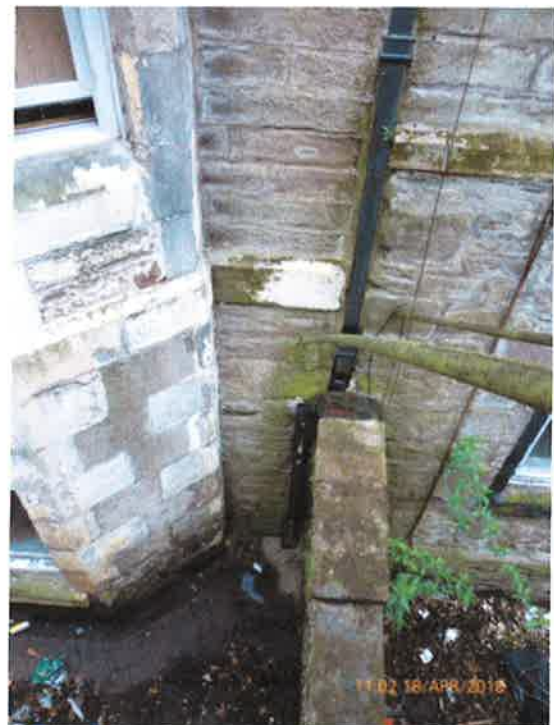
Front drain

Mr Evans explained that the front downpipe had been blocked. When he cleared away debris at the front, he found a drain which had also been blocked and the drain was cleared too.

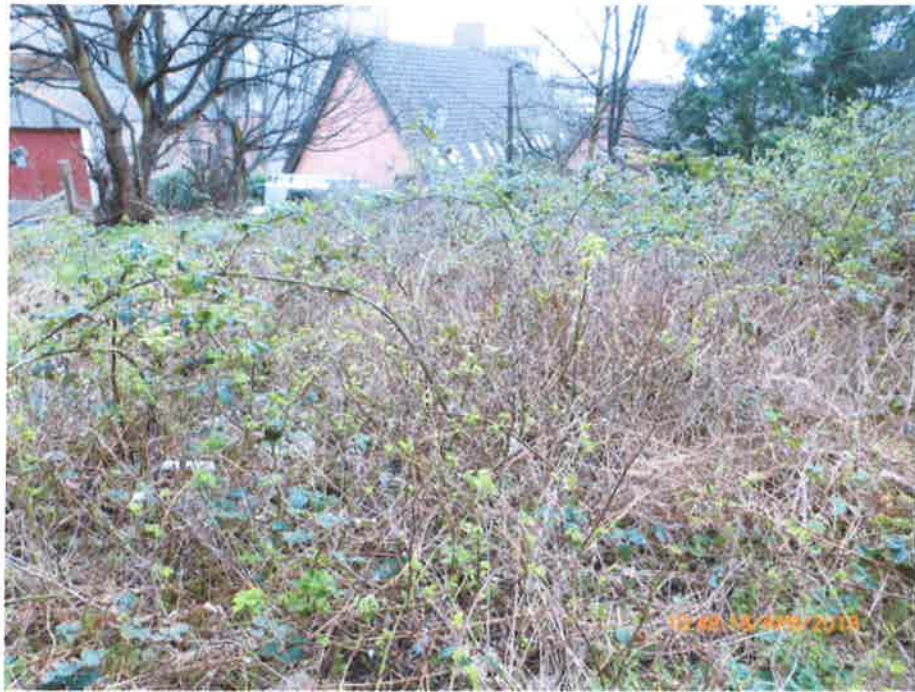
Rear Garden

- 12) The rear drying green is very badly overgrown and unusable. This requires to be cleared.*
4. By Minute dated 23rd February 2018, a Convener of the Tribunal with delegated powers under section 23A of the Act, intimated a decision to refer the application under Section 23(1) of the Act to a Tribunal for a determination.

The Third Party Applicant had also complained that the rear drying green was very badly overgrown and unusable. The Tribunal noted the state of the rear drying green at the inspection.

The Tribunal accepted that this was a common area but were of the view that in addition to safety issues, there were also concerns regarding the tenant's enjoyment of the property being restricted by the state of the rear drying green. The Tribunal considered that it was the Landlord's duty under section 14(1) and also within the Landlord's power and discretion to have the rear drying green cleared in order to be used by the tenant. The Tribunal noted that work in this common area was already being undertaken on the Landlord's behalf.

- (f) instruct a suitably qualified contractor to clear the rear drying green to ensure it is in a reasonable state of repair.

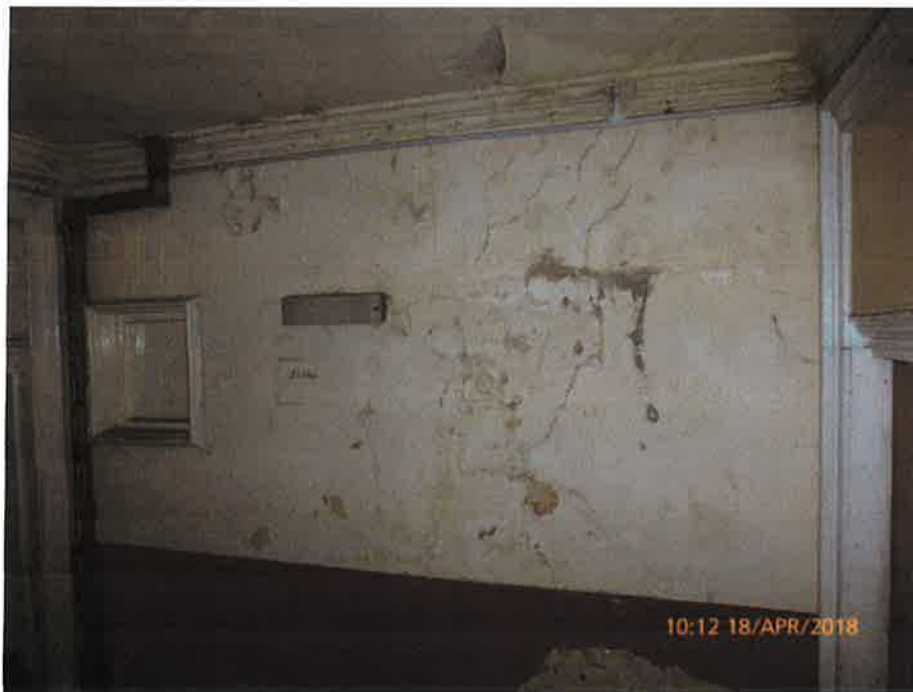
Stairwell

- 6) The lower sash window in the south bedroom is ill fitting and should be rehung or replaced.*
 - 7) Signs of dampness are evident in the entrance close and basement stairwell which may be as a result of leakage from one of the upper floor flats. This should be investigated and cause repaired. Close and stair redecoration is required in places.*

The Tribunal considered that there may have been dampness issues in the common parts for some time and that there were areas within the close and stairwell where redecoration may be required. The Tribunal observed that a maintenance management scheme for the building would be desirable to address ongoing issues in relation to these common areas but having regard to the overall condition of the building, the Tribunal did not determine there was a breach of the repairing standard by the Landlord in this regard.

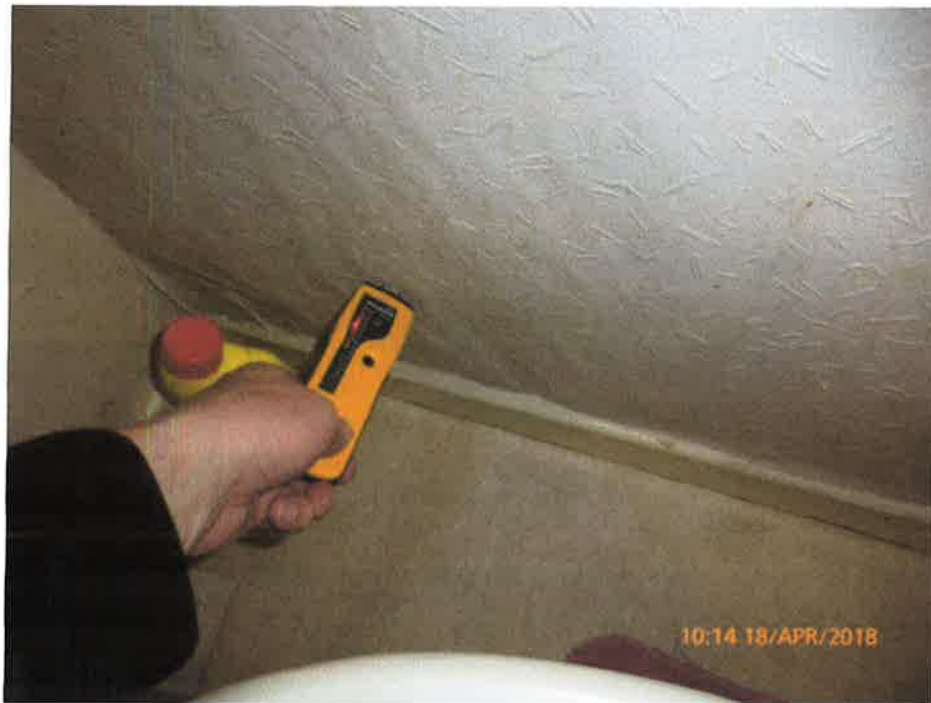
Whilst the Tribunal accepted the Landlord's explanation regarding dampness caused by previous leaks in relation to the area beside the bathroom, the Tribunal did not accept that all of the areas of dampness identified and the high damp meter readings obtained during the inspection related to residual damp problems. The Tribunal were of the view that that specialist investigation would be required to establish the cause of damp in the property and any necessary repairs required.

Damp in rear wall

- (a) instruct a suitably qualified Damp Proofing Specialist to investigate the cause of dampness in the property and to provide a report to the Tribunal, carry out any works recommended in the report, and provide evidence that the works have been completed satisfactorily in order to ensure that the house is wind and watertight and in all other respects reasonably fit for human habitation;

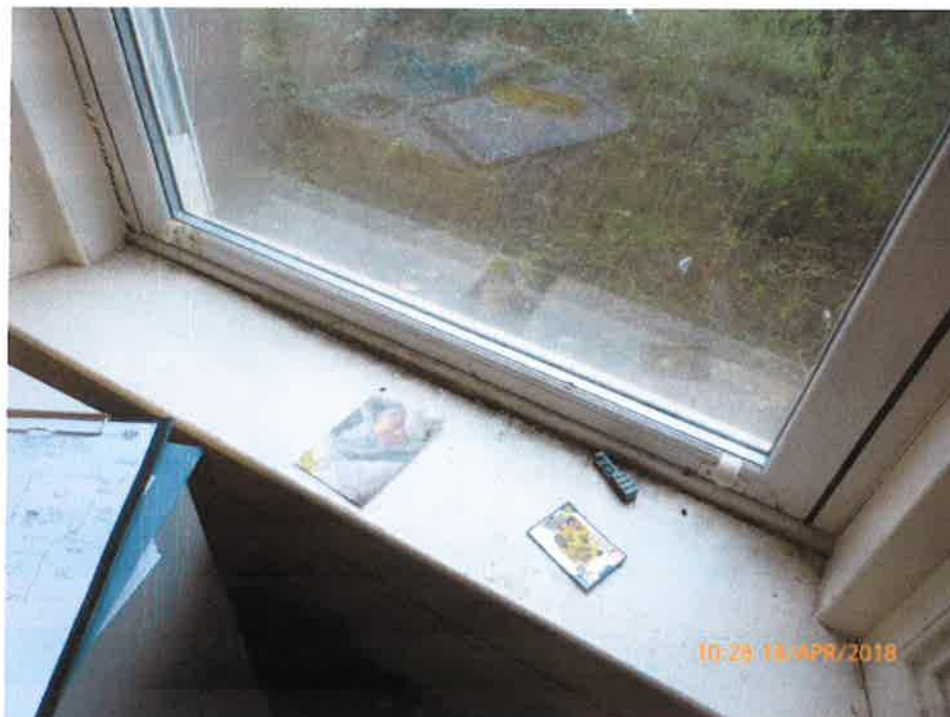
Rear bedroom window

window was found to have a noticeable gap in the window frame. The Tenant advised that the heater in the bedroom had been refitted but was not working properly as it only worked intermittently when full on.

The Third Party Applicant had also complained that the lower sash window in the south bedroom was ill fitting. The Tribunal noted an apparent gap in the window frame which the Landlord had undertaken to have a window specialist look at. The window could open and shut.

The Tribunal considered the window to be in reasonable working order and determined that there was no failure to comply with the repairing standard in this regard.
