Repairing Standard Enforcement Order

Ref prhp/rp/15/0282

Re: 41 Roslea Drive Glasgow G31 2QR ("the Property") registered in the Land Register of Scotland under title number GLA10017

Determination by Private Rented Housing Committee
Statement of Decision of the Private Rented Housing Committee issued under
Section 24(1) of the Housing (Scotland) Act 2006

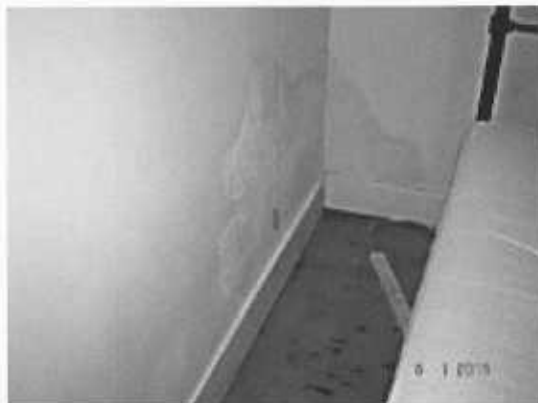
- i) There appears to be rising dampness in a corner of bedroom 1 (photographs "Staining in Bedroom " and "meters readings- Bed 1" of the Schedule refer) ;

Staining in Bed 1.

1. Ensure that damp proofing works are carried out by a suitably qualified damp proofing contractor to ensure that the rising damp within the Property is eradicated;
2. (a) Instruct an inspection by a licensed asbestos contractor of the artex ceiling in Bedroom 2 of the Property and (b) carry out such works as are found necessary as a result of the inspection;
3. (a) Instruct an inspection by a suitably qualified building or plumbing contractor of both the common downpipe external to bedroom 2 and the penetrating dampness on an internal wall of bedroom 1 of the Property and (b) carry out such works as are found necessary as a result of the inspection and
4. Make good any internal plasterwork and décor damaged or disturbed as result of these works.

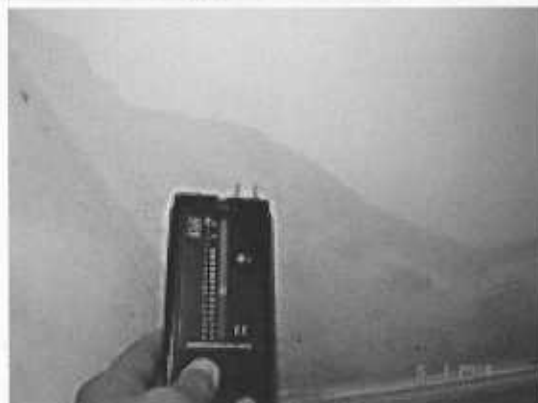
High

meter readings –Bed 1

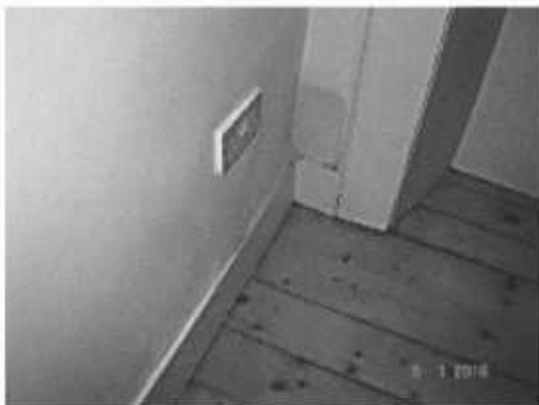
Staining in Bed 1

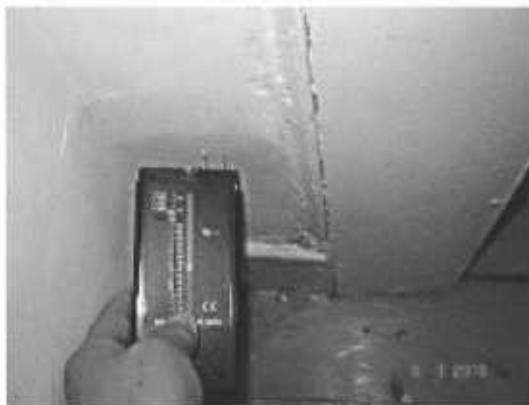
High meter readings – Bed 1

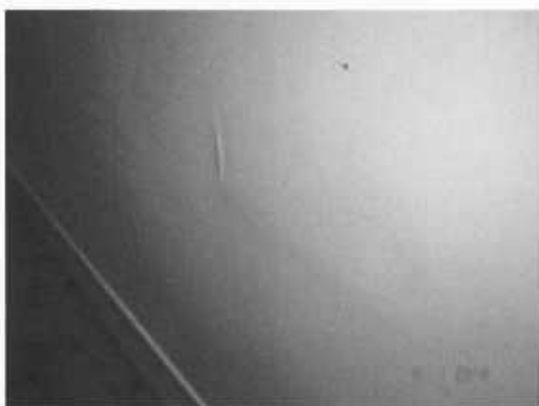
9. With regard to a damp patch at approximately three feet above floor level on the bedroom wall adjacent to the bathroom, Mr. Kelleher explained to the Committee that he was not aware of this and agreed with the Surveyor Member of the Committee that the likely cause of this was a leak from the shower fixed to the adjacent bathroom wall. Mr. Kelleher advised the Committee that the Landlord would instruct this to be investigated.

- ii) There appears to be penetrating dampness on an internal wall of bedroom 1 (photographs "Stain patch in Bed 1 " and "meters readings/high meter readings- Bed 1" of the Schedule refer);

Stain patch Bed 1

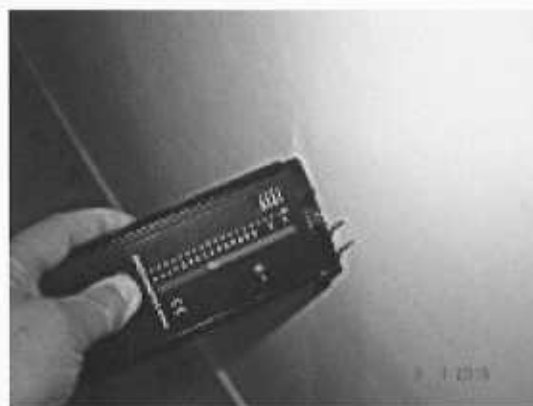
High readings at patch-Bed 1

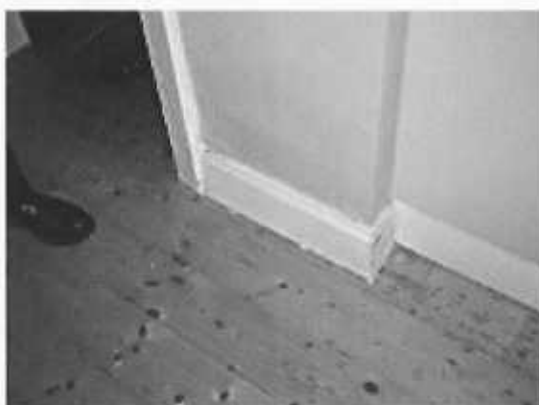
- iii) There appears to be rising dampness in the hall (photograph "high dampness readings in hall" of the Schedule refers);
- iv) There appears to be rising dampness in bedroom 2 (photographs "Stain in Bed 2 " and "high meter readings at stain Bed 2" of the Schedule refer);

Stain in Bed 2

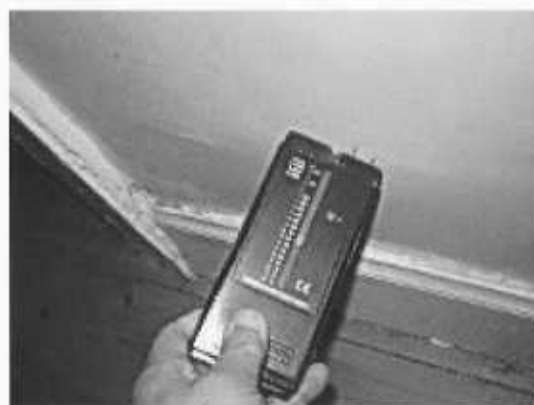
High readings at stain in Bed 2

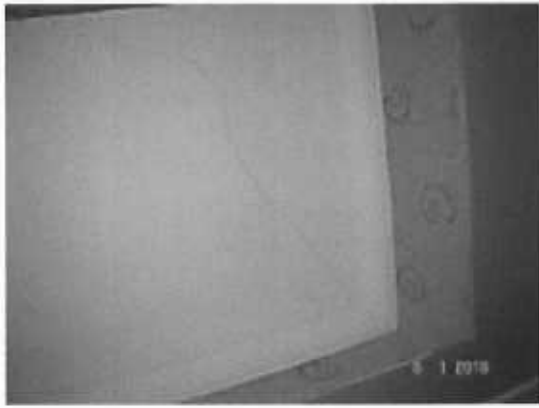
11. With regard to the crack in bedroom ceiling, Mr. Kelleher and Mr. Jamieson explained to the Committee that this appeared to be a surface crack to the artex finish. Neither Mr. Kelleher nor Mr. Jamieson knew the age of the artex but estimated it to be before 1983.

- v) There is a crack in the ceiling artex of bedroom 2 and as the artex is of likely age of more than 30 years there is a likelihood that asbestos materials are exposed. (photograph "cracking in artex ceiling in Bed 2" of the Schedule refers);

Cracking in artex ceil
In Bed 2

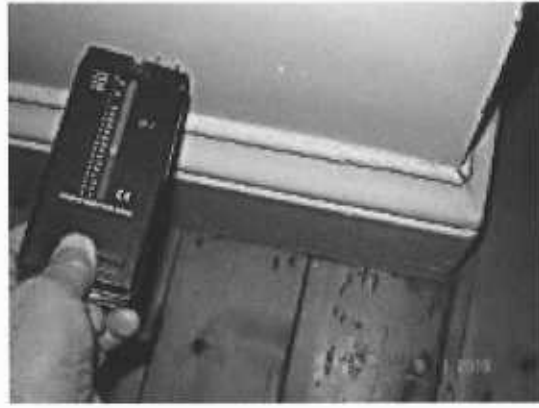
10. With regard to the dampness in the hall, Mr. Kelleher explained to the Committee that he was not aware of this and advised the Committee that the Landlord would instruct the Contractors dealing with the rising dampness to investigate this.

High damp readings in
Hall

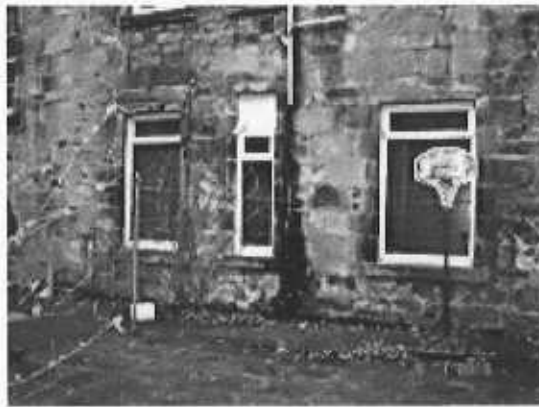
12. In response to the Surveyor Member of the Committee's questions regarding the extent of the works instructed, Mr. Kelleher produced a copy of the specialist report from August 2014 and confirmed that the works instructed were those recommended in the report and included an underfloor inspection. Mr. Kelleher confirmed that internal plasterwork and decoration would be carried out on completion of the works. Mr. Kelleher accepted that the external common downpipe required to be inspected with a view to repair.

- vi) The common downpipe external to bedroom 2 appears to be blocked and leaking (photograph "choked downpipe at rear elevation" of the Schedule refers);

Choked downpipe at rear elevation.
