**First-tier Tribunal for Scotland (Housing and Property Chamber)**

**STATEMENT OF DECISION of the First-tier Tribunal for Scotland (Housing and Property Chamber) under section 24 (1) of the Housing (Scotland) Act 2006**

**Reference number: FTS/HPC/RP/22/2846**

**Re: Property at 8M King Street, Musselburgh, East Lothian EH21 7EP (“the Property”)**

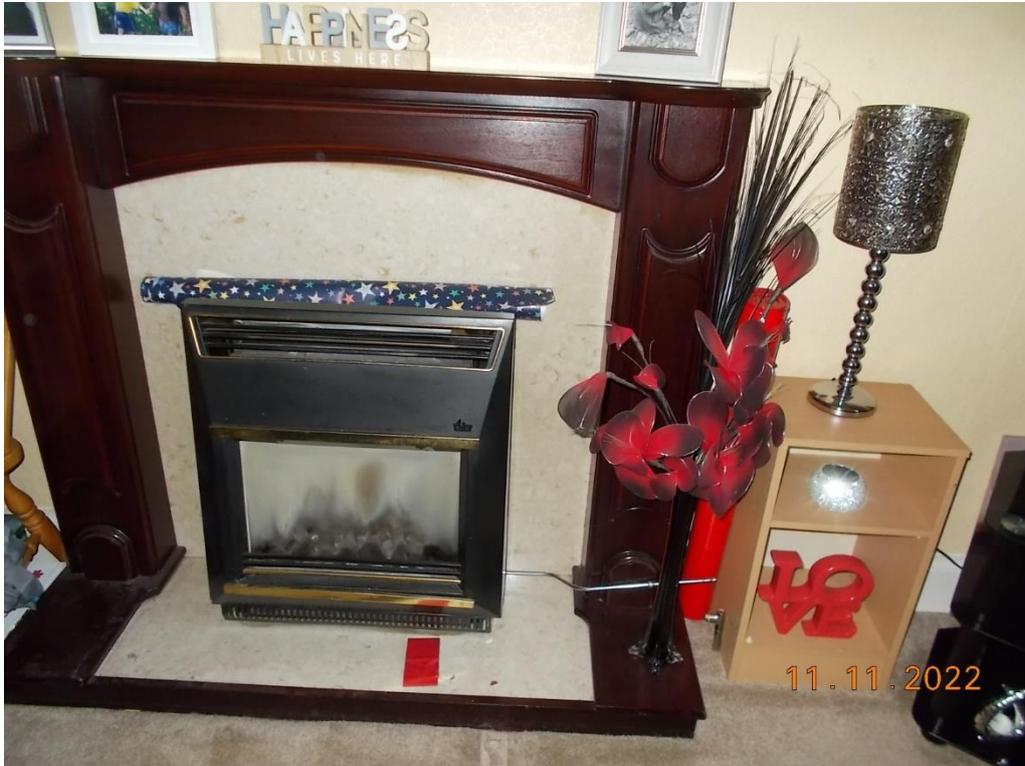
- c) There was no fixed heating system
- d) A Gas Fire had been installed in the Living Room. The gas supply pipe serving this was found to be disconnected. [**Photos 1 and 2**]

1. Gas Fire in Lounge

32. The order will also require that the landlord instructs a Gas Safe registered engineer to undertake a full inspection of all gas fittings and appliances and to repair and renew any parts which are identified within that report as requiring repair or replacement. The landlord will require to provide a gas safety certificate to the tribunal which meets the current standards.

34. The order will also require that the landlords to make satisfactory provision for heating in all apartments regularly used by occupants.
35. The order will also require that the landlords to either remove the existing gas fire, if an alternative satisfactory provision is made, and make good any damage caused or if it is to be retained restore to proper working order.

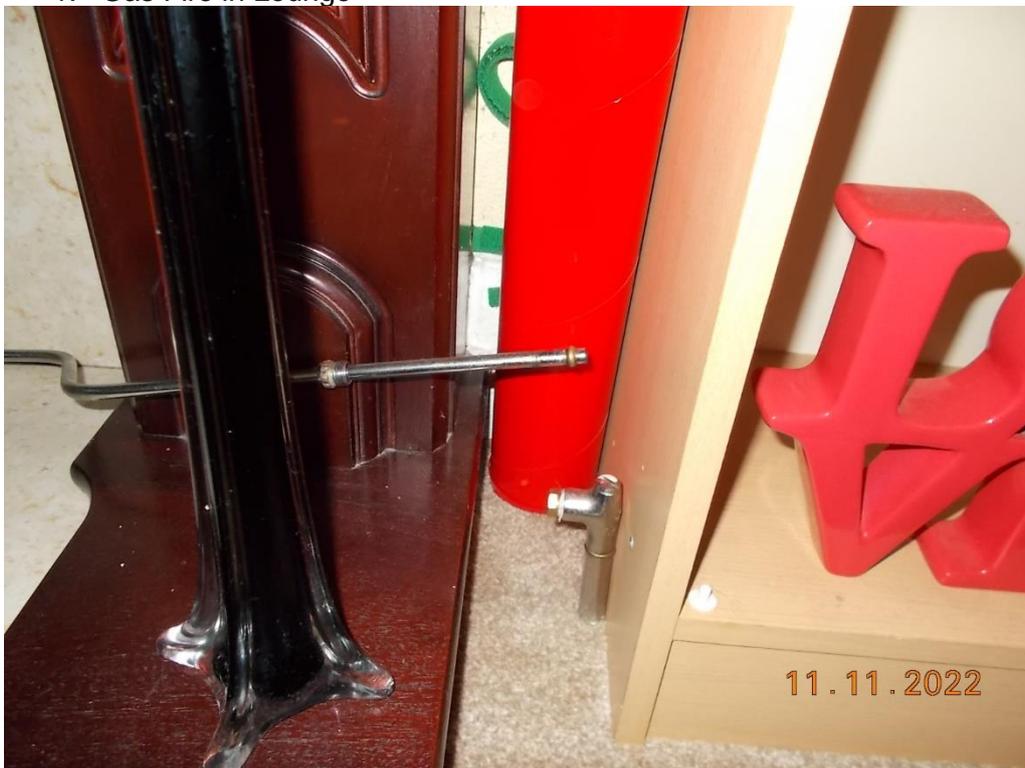
2. Disconnected gas supply pipe to Gas Fire in Lounge

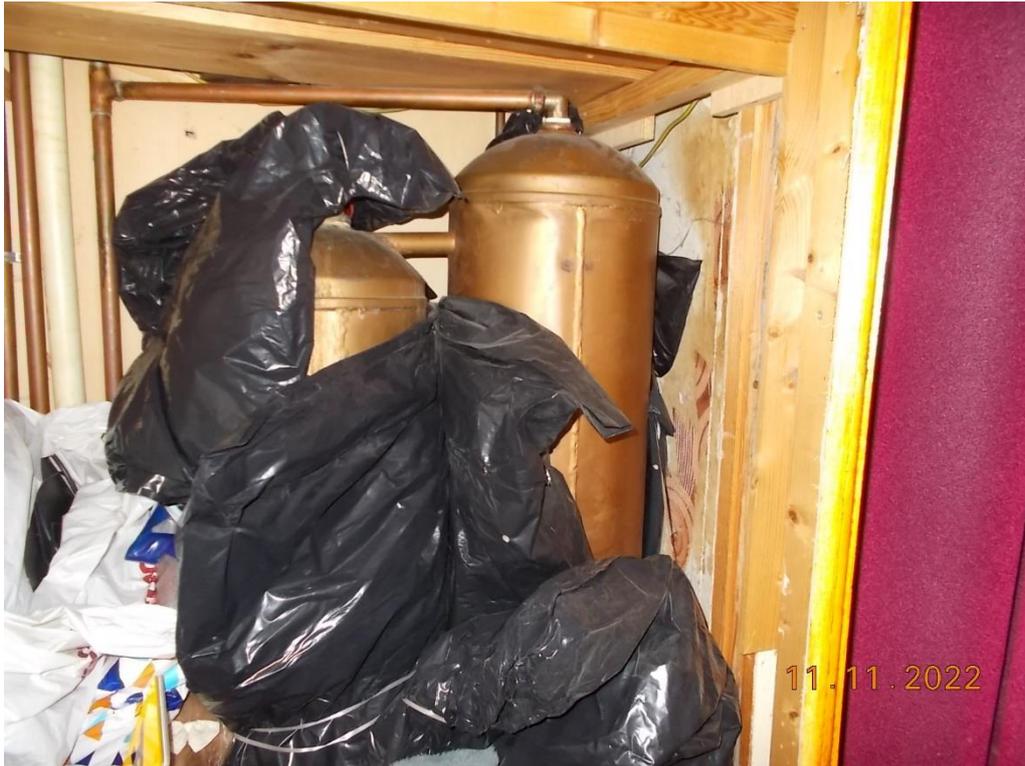
- e) In a cupboard off the Bedroom there was a copper hot water cylinder, of an older style, wrapped in an insulating jacket of limited thickness which was partially displaced. An electrical heater immersed in the cylinder heated water and was controlled by an on/off switch with neon indicator. The cover to the electrical wiring and terminal on the immersion heater was displaced and insecure. [**Photos 3, 4, 5 and 6**]

3. Hot water cylinder.

36. The order will also require that the landlords to either remove the installation for heating water, if an alternative satisfactory provision is made, and make good any damage caused or if it is to be retained restore to proper working order in a manner which provides a satisfactory supply of hot water.

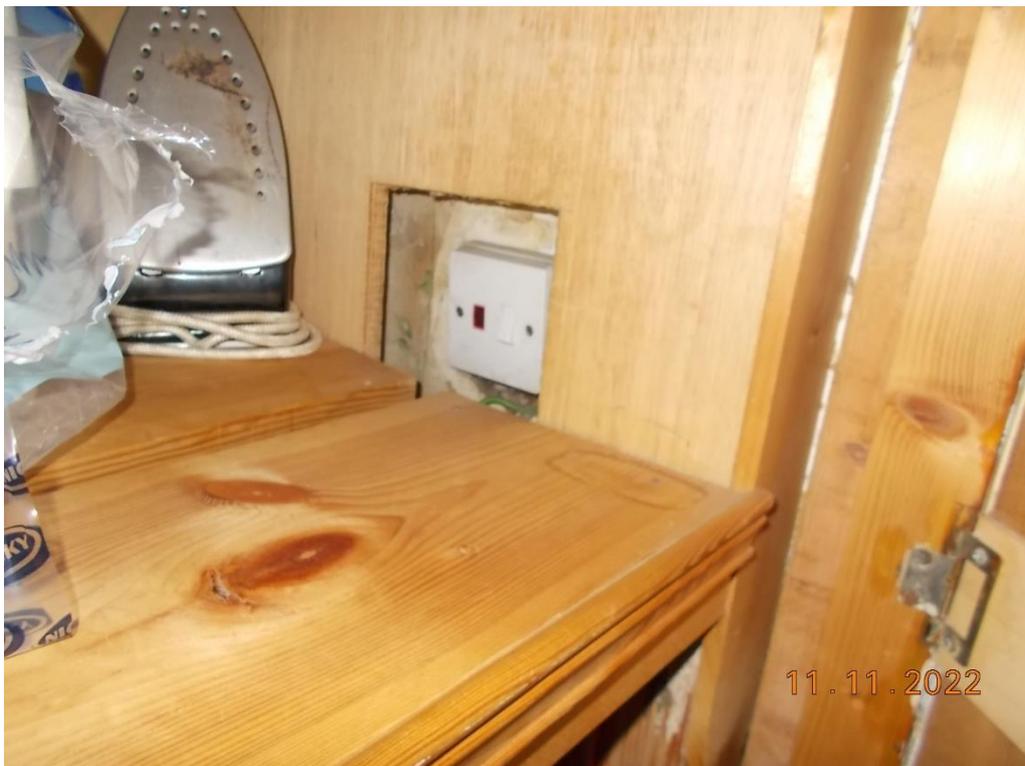
4. Switch controlling immersion heater in hot water cylinder.

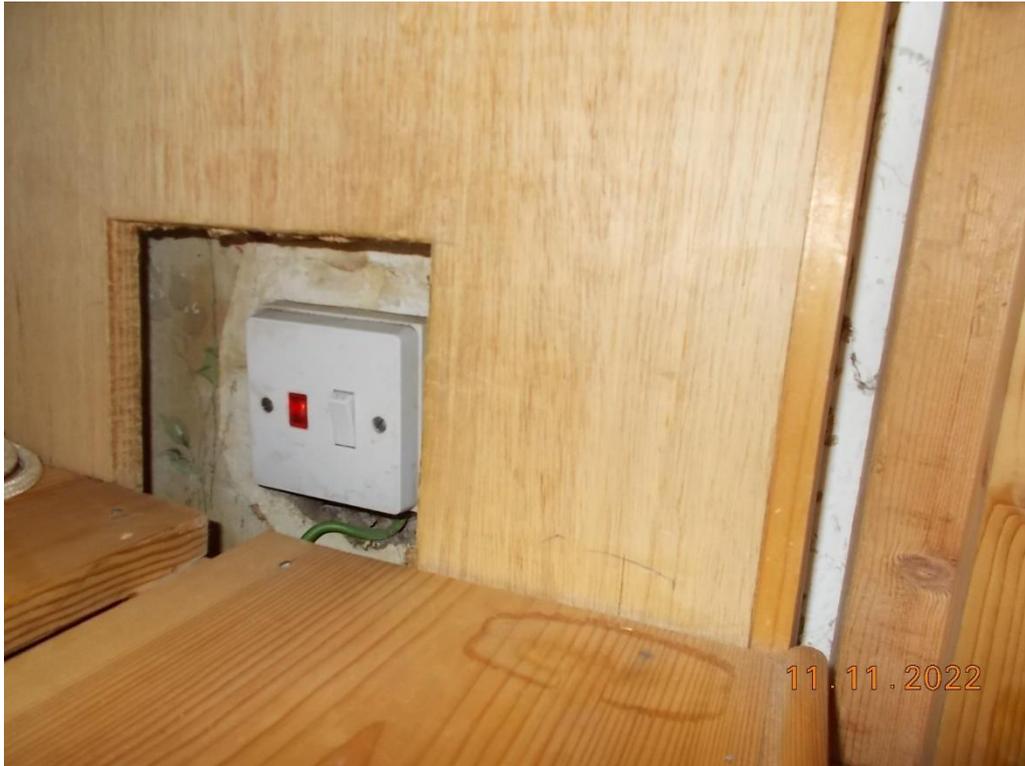
5. Switch activated and neon indicator lit.

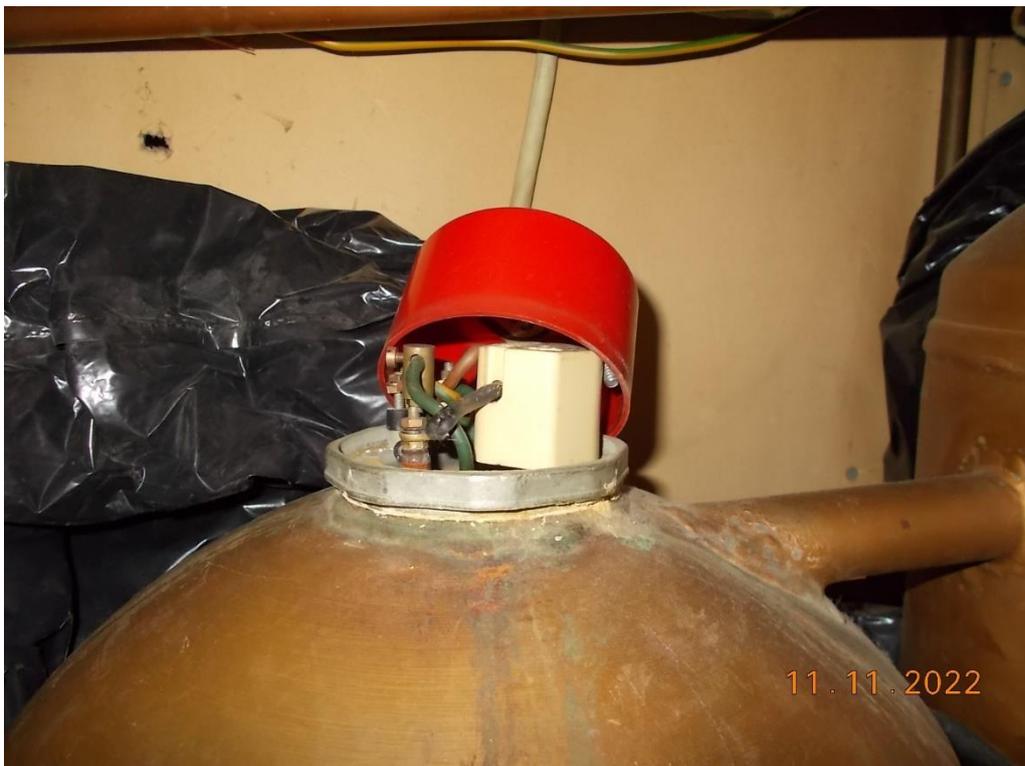
6. Electric immersion heater with cover displaced and cables and terminals exposed.

30. The tribunal accordingly proposes to make a repairing standard enforcement order requiring the landlord to undertake a number of works.
31. These works will include the requirement to instruct an appropriately qualified electrician to carry out a full inspection of the electrical installations and apparatus throughout the property and to produce an appropriate electrical installation condition report to the tribunal.

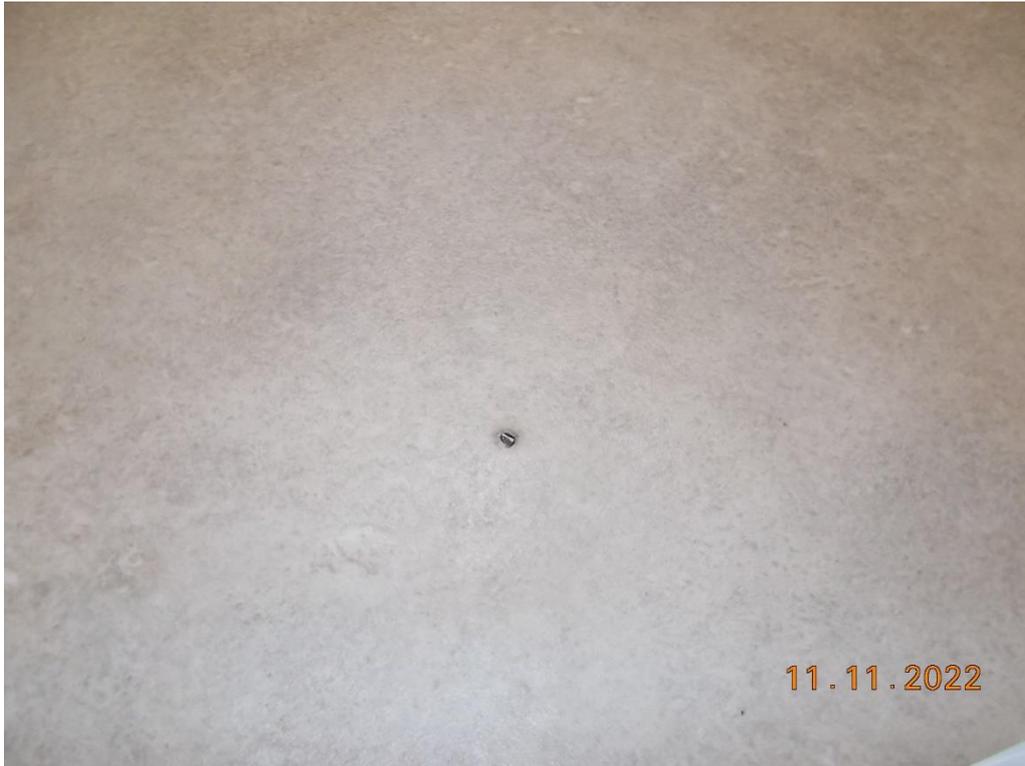
- f) The Kitchen floor covering was examined. One nail head projected through the covering near the door from the hallway. A further two minor "lumps" in the surface of the covering were observed giving the appearance of nail heads which had become raised but had not yet penetrated the covering. [**Photos 7 and 8**]

7. Nail penetrating vinyl floor covering in Kitchen at door from Hallway.

37. The order will also require that the landlords to remove or otherwise adjust nails in Kitchen floor to prevent them penetrating the floor covering and repair or replace the damaged covering to render the flooring in all respects fit for human habitation.

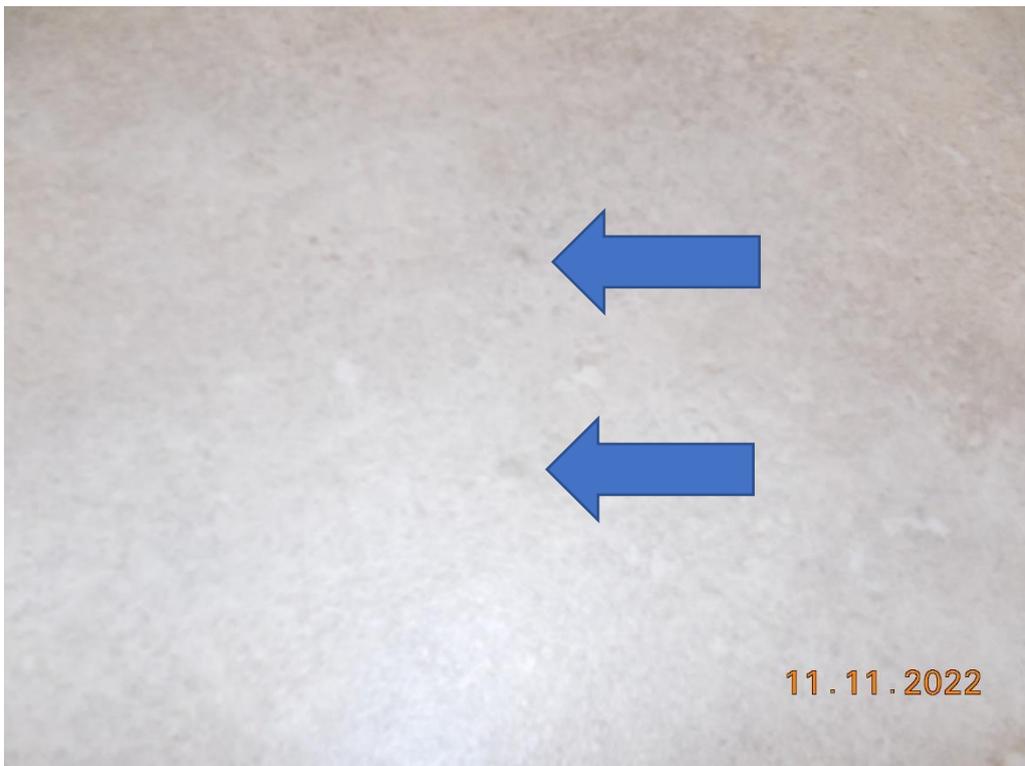
8. Two raised areas (arrowed) of vinyl floor covering which appear to be nails in underlying floor structure.

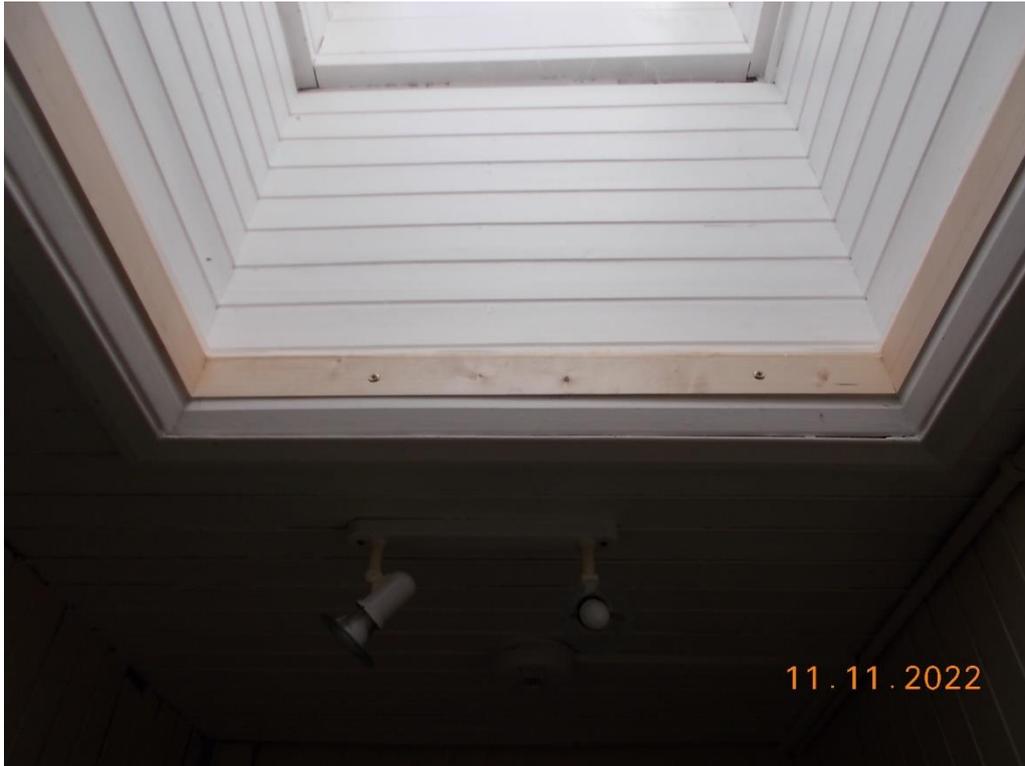
- g) There is a translucent plastic panel in a metal frame at roof level in the Kitchen. This provided daylight to this apartment. As a lowered ceiling has been provided in this apartment a shaft has been created between ceiling and roof levels. In the period immediately before the inspection, it was reported that, contractors acting for the Landlord had attended and placed some Perspex sheeting on a timber frame over the base of the shaft in an attempt to restrict air flow. There

were high winds at the time of inspection, and this caused the Perspex sheet to move, as the silicone used to seal it to the timber framing did not appear to be effective. [**Photos 9 and 10**]

9. Perspex and timber framing added to skylight window in Kitchen.

38. The order will also require that the landlords to carry out works necessary to eliminate or control draughts, whilst ensuring required levels of ventilation are maintained, to leave the House wind and watertight and in all other respects fit for human habitation.

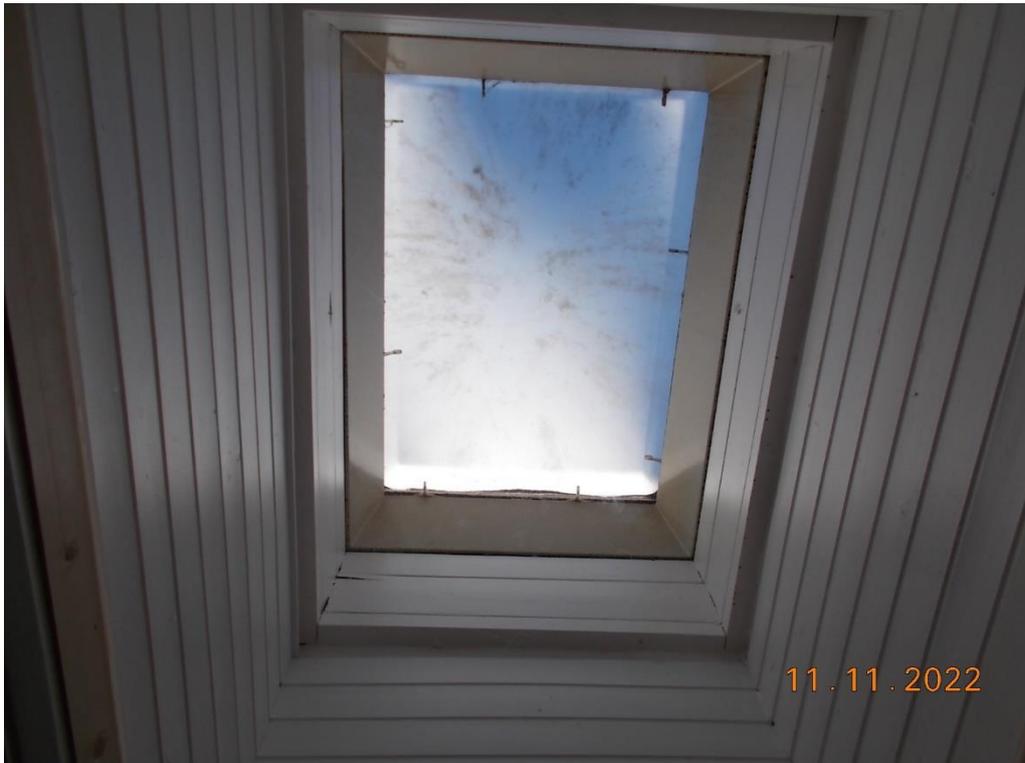
10. Skylight window in Kitchen.

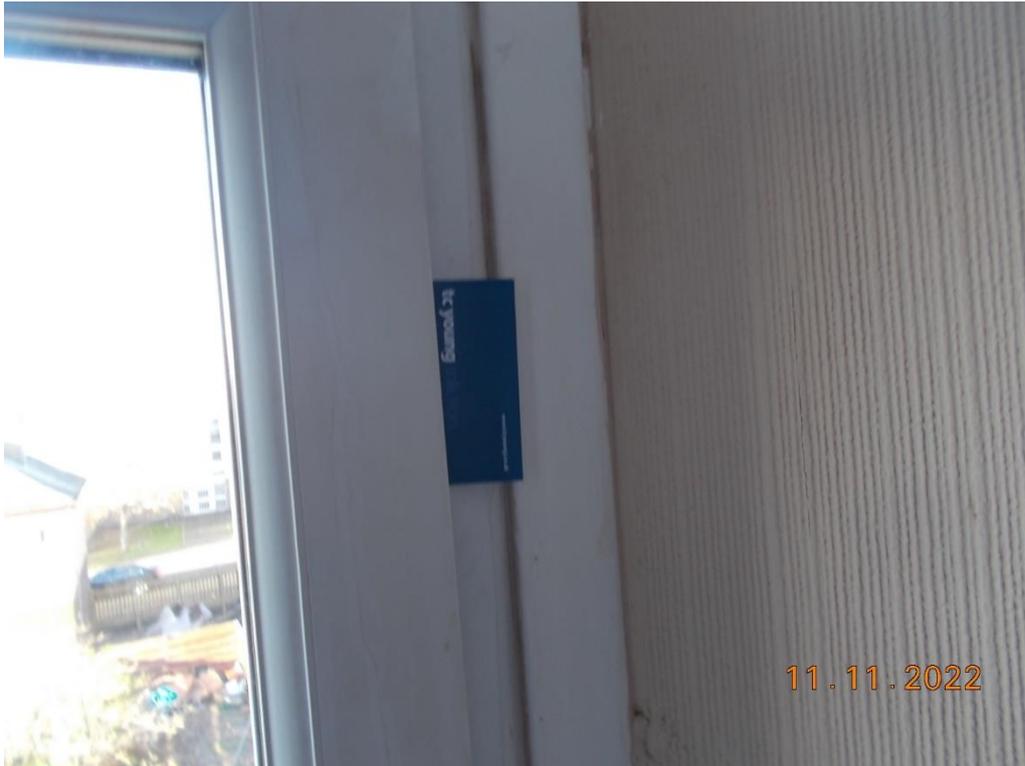
- h) There are uPVC framed tilt and turn style windows in the Bedroom and Living Room. Following the application and before the inspection, it was reported that, contractors acting for the Landlord had attended and adjusted the windows. The window seals in the Living Room were found to be compressed properly whilst those in the bedroom were not. A business card could be introduced between the seal on the sash and the frame. [**Photo 11**]

11. Bedroom window. Card inserted easily between sash frame seal and frame.

39. The order will also require that the landlords to carry out works necessary to the Bedroom window to eliminate or control draughts, whilst ensuring required levels of ventilation are maintained, to leave the House wind and watertight and in all other respects fit for human habitation.

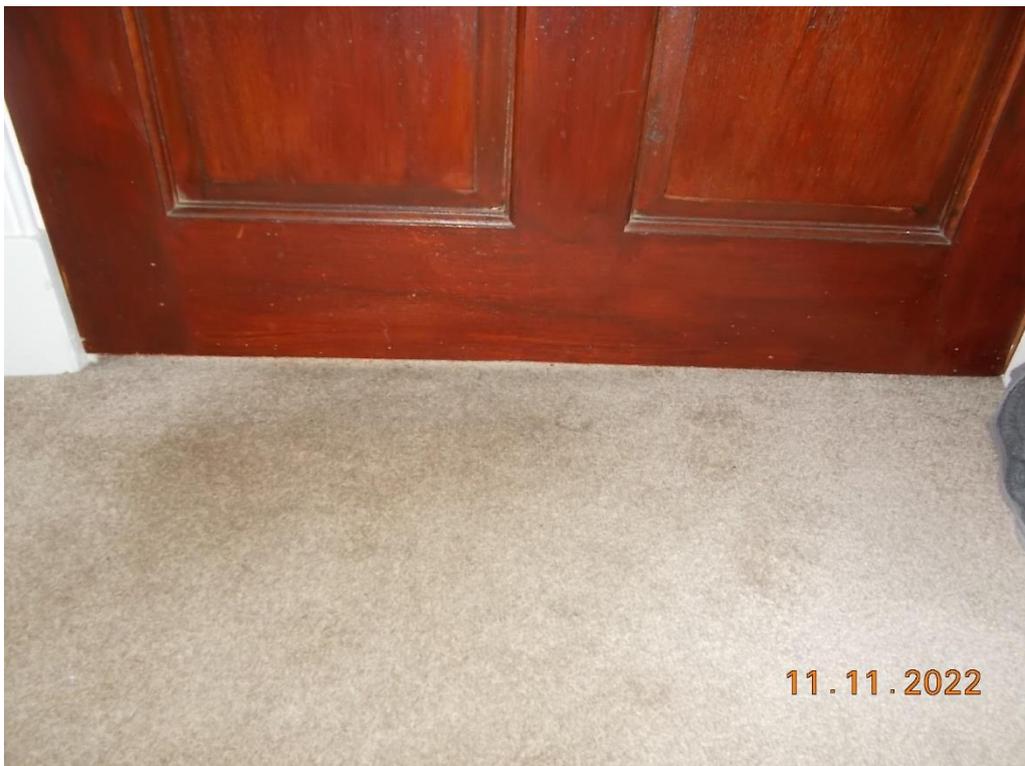
- i) The timber front door was inspected. A gap exists between the bottom of the door leaf and the floor. [**Photo 12**].
- j) It was reported that the Wasps Nest was not visible and thought to be on the roof of the property.

12. Main door from flat to stair. Gap visible under door.

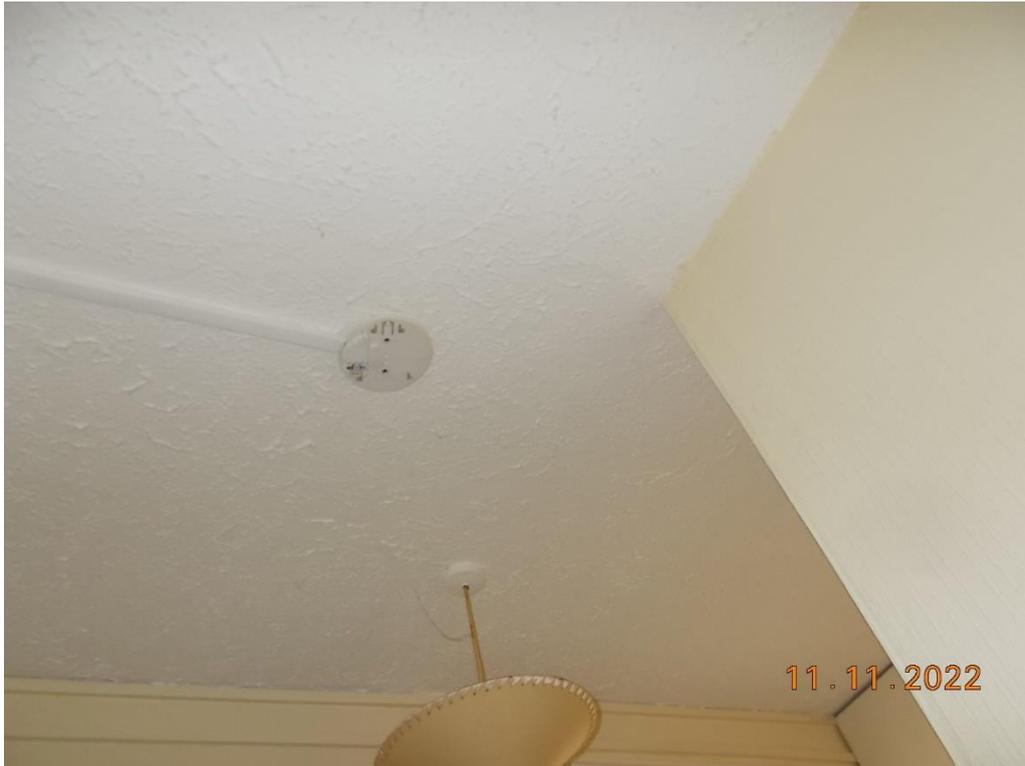
- k) Miss Lynch confirmed that she had received a Carbon monoxide alarm through the post, but this had not been “installed”.
- l) It was noted that the smoke detector and alarm in the hallway was missing. A heat detector and alarm was noted in the Kitchen and a smoke detector and alarm was present in the Living Room. These operated when tested. [**Photo 13**].

13. Missing smoke detector and alarm in Hallway.

33. The order will also require that the landlord to provide evidence showing the installation of smoke detectors, heat detectors and carbon monoxide detectors within the property in compliance with the requirements set out in the guidance issued by the Scottish Government in terms of the Housing (Scotland) Act 2006.
