STATEMENT OF DECISION: Housing (Scotland) Act 2006 Section 24 (1)

Chamber Ref: FTS/HPC/RT/18/1378

**13 Glenburchy Place, Fraserburgh AB43 9QT
("The Property")**

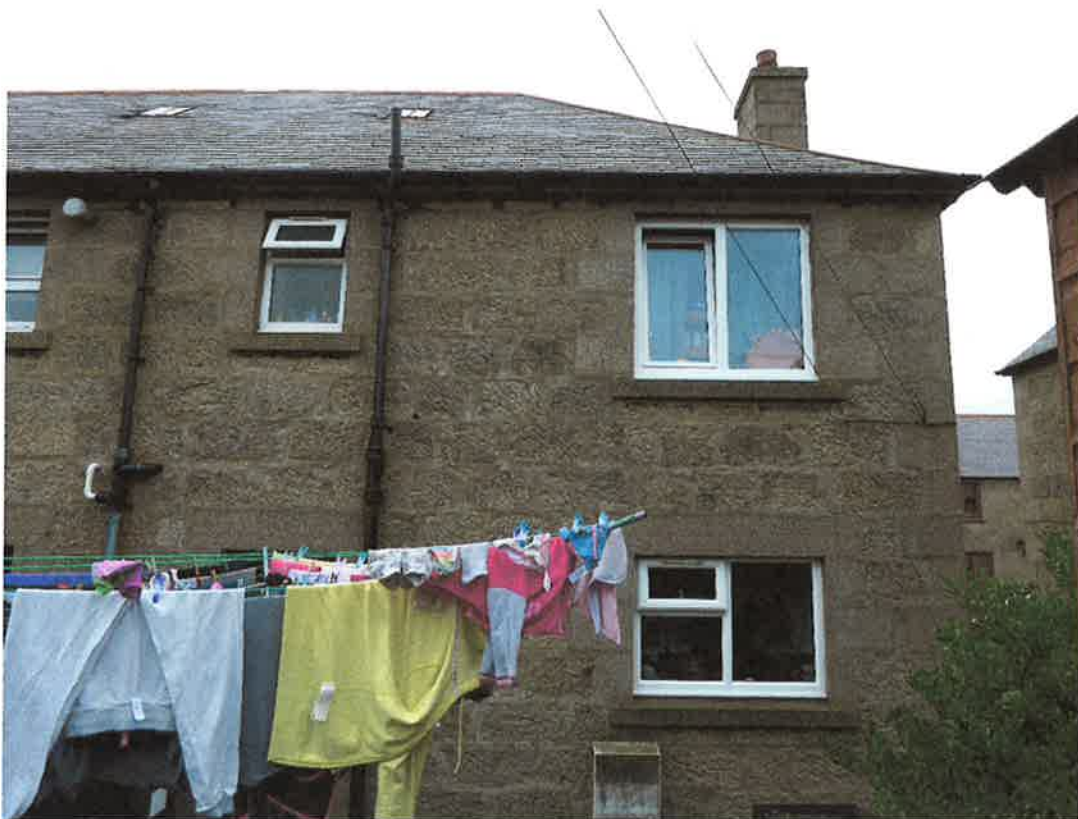
15. The Tenant confirmed that the rear bedroom window had been replaced in the week before the inspection.
16. Mrs Kuzmickis said that when she had been pregnant she had been unable to open the windows and even now she still found them difficult to open as they were very stiff. She felt that her complaints to Forbes Property had not been taken seriously and that she had been laughed at. She was concerned that her children's health had been affected by the mould and damp.

Rear elevation – new 1st floor bedroom window tilted inwards.

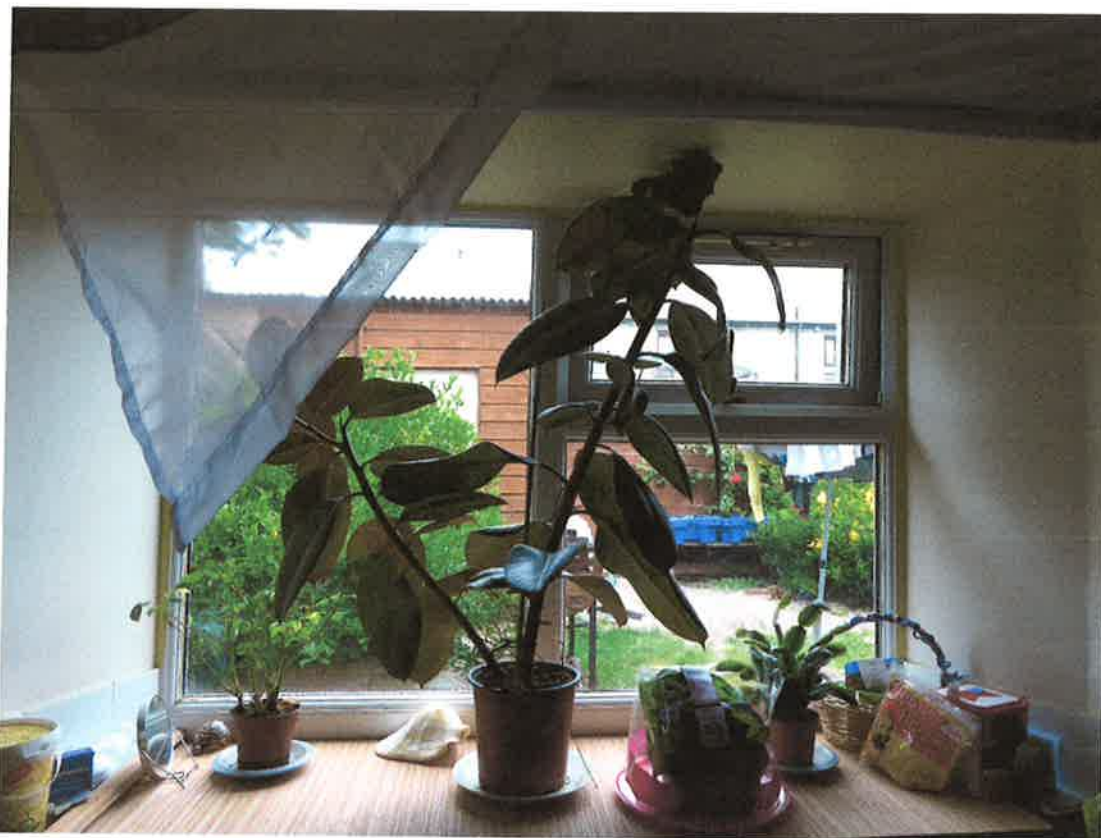
- Although the window in the kitchen provides adequate ventilation it is difficult to access to open.

Kitchen window above worktop.

26. Although there is adequate ventilation in the kitchen from the window it is not in the most accessible position and whilst the Tribunal felt it would not be appropriate to insist on an extractor fan being installed in the kitchen it would strongly recommend that the Landlord consider putting one in as this would no doubt improve the ventilation and reduce the risk of mould growth.
