STATEMENT OF DECISION: Housing (Scotland) Act 2006 Section 24 (1)

Chamber Ref: FTS/HPC/RT/22/1795

Flat 3/2, 1 Canning Street, Dundee, DD3 7RZ ("The Property")

Schedule of photographs taken during the inspection of 3/2, 1 Canning Street, Dundee
DD3 7RZ by the First-tier Tribunal for Scotland (Housing and Property Chamber)
on Wednesday 28 September 2022

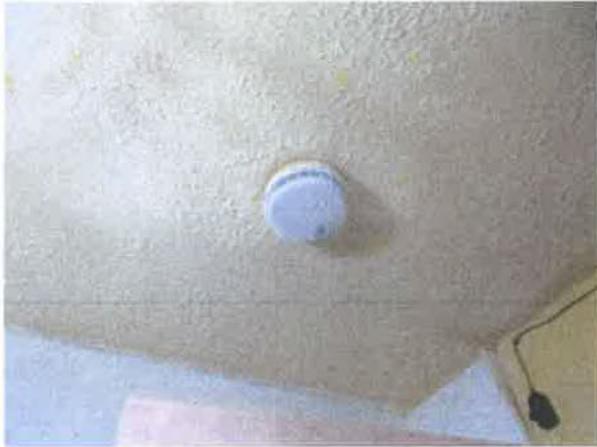
The Tribunal did note, however, that a valid smoke/heat detection system had been installed and appeared to be interlinked as required and was working on the day. Although outwith the ambit of the complaint, the Tribunal did note that a new boiler had been recently installed and that the relevant carbon monoxide detector was present, although it would benefit from being relocated in a higher position, above all doors and windows, where possible, to ensure compliance with current statutory guidance.

Hall - ceiling mounted smoke detector
(interlinked)

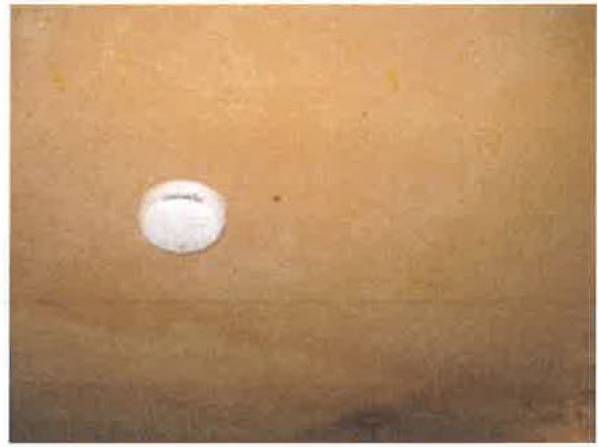
Living Room - ceiling mounted smoke detector
(interlinked)

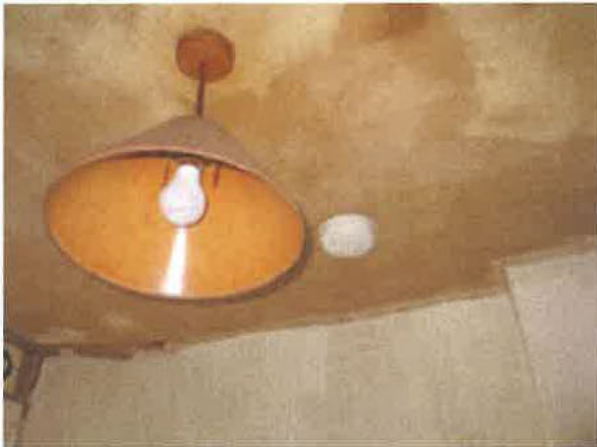
Kitchen - ceiling mounted heat detector
(interlinked)

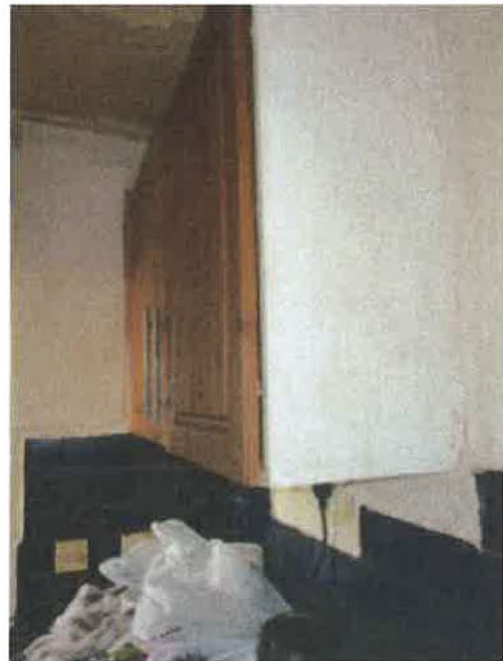
- The kitchen units did not meet the repairing standard and were beyond economic repair and needed to be replaced
- The kitchen sink did not appear to be functioning correctly;

The Tribunal inspected the kitchen units. They were clearly a good number of years old and had suffered significant wear and tear. A number of doors were ill fitting and misaligned, some had defective hinges/missing door handles and there was evidence of damage to the internal framework and panels in some units. It was apparent that previous repairs had been made although this appeared to be unfinished with debris left by tradesmen in one base unit. The Tribunal would normally specify that it was for a landlord to carry out repairs or replacement as they saw fit. However, in this particular case, the Tribunal was of the view that the units were of an age and condition that they could not reasonably be repaired as any repairs would only last briefly. The units were beyond their economic life and accordingly required to be replaced. The Tribunal also inspected the kitchen sink. This did appear to be draining correctly on the day. However, there was a bottle jammed between the edge of the unit and the drain underneath the sink to facilitate this. On the basis the Tribunal had determined that the units needed to be replaced, then the plumbing/drainage would need attention as part of the kitchen replacement anyway.

Kitchen - wall mounted cabinets - right side -
misaligned doors/gaps etc

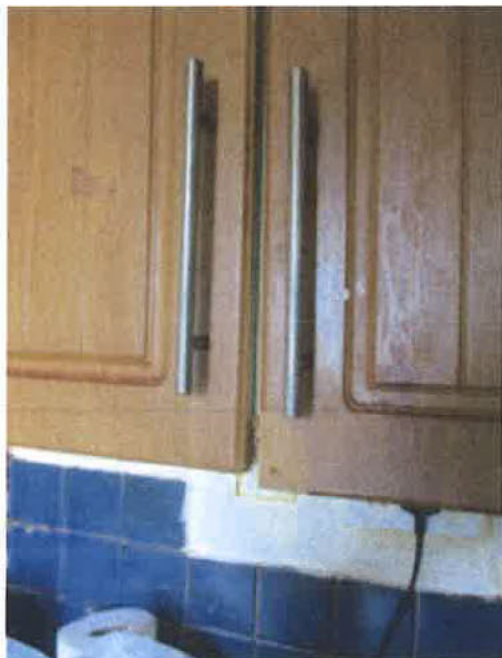
Kitchen to right side- wall mounted double unit - misaligned doors/defective hinges

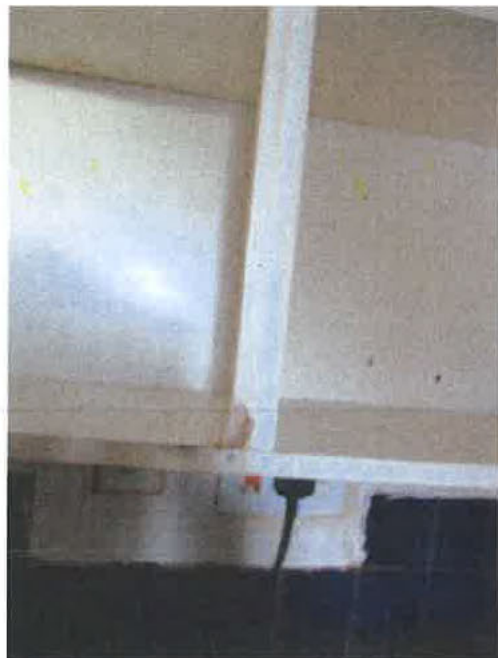
Kitchen to left side- double base unit - damaged internal framework

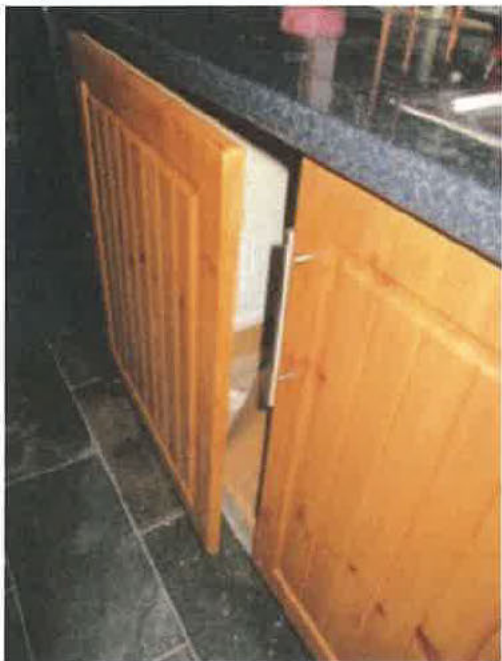
Kitchen to left side - double base unit - one door not closing properly/missing handle

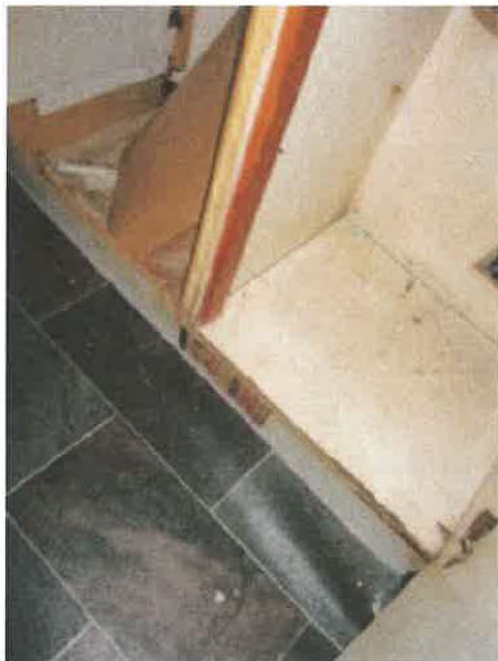
Kitchen to left side- double base unit - interior base panels damaged/debris left by joiner

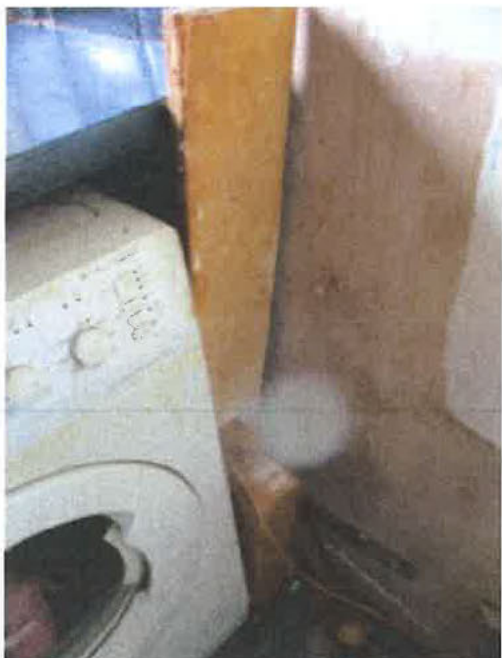
Kitchen - large gap to side of washing machine

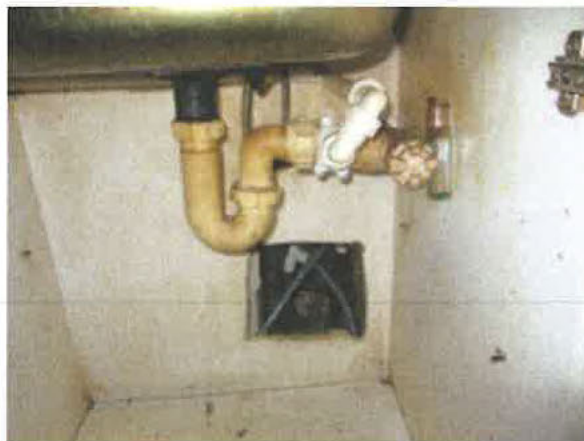
Kitchen - pipework below sink/small plastic bottle jammed between pipe and side of cabinet

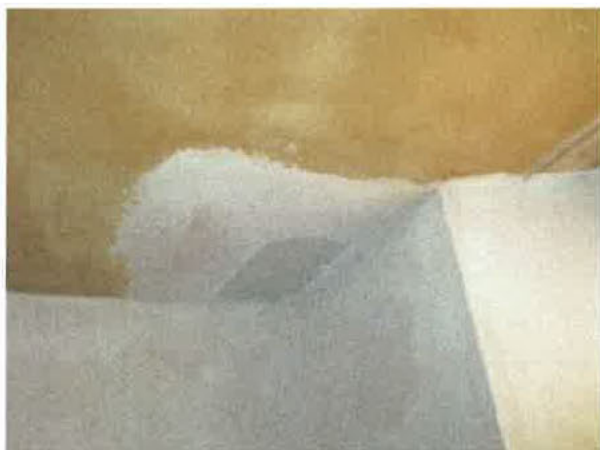
The Tenant had advised that there had been a leak in the corner of the lounge around two years ago and a small area of the ceiling had come down. It was apparent that this had now been attended to and the ceiling hole had been patched to an acceptable standard. The Tenant advised that this had been done the day before the inspection. Redecoration works had not yet been completed and this would require to be done by the Landlord. The Landlord was vague as to the cause of the leak and whether works had been done to address the root cause of this before fixing the ceiling. In any event the Tribunal took damp meter readings on the wall below where the hole had been. There were moderate to high meter readings in evidence that would suggest that water penetration was still occurring. Accordingly, the Landlord would require to carry out investigations to identify the source of the water ingress and to carry out all appropriate works to rectify this and thereafter carry out any redecoration required.

Living Room - north east corner of ceiling replastered

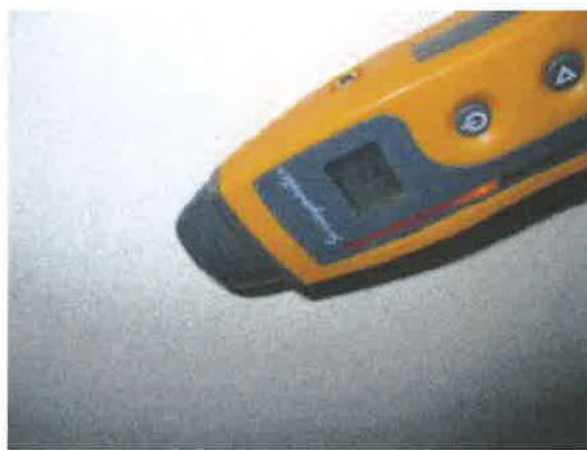
- The hole in the living room ceiling had been repaired but not yet redecorated. There was evidence of ongoing damp penetration;
- The lounge and bedroom windows/sills did not meet the repairing standard and required to be repaired or replaced;

Living Room - internal face of rear wall (north facing) moderate damp meter readings to left of window across large area

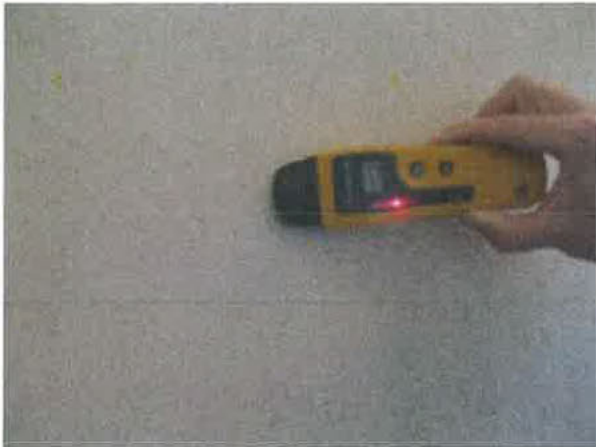
Living Room - internal face of rear wall (north facing) localised high damp meter readings to left of window

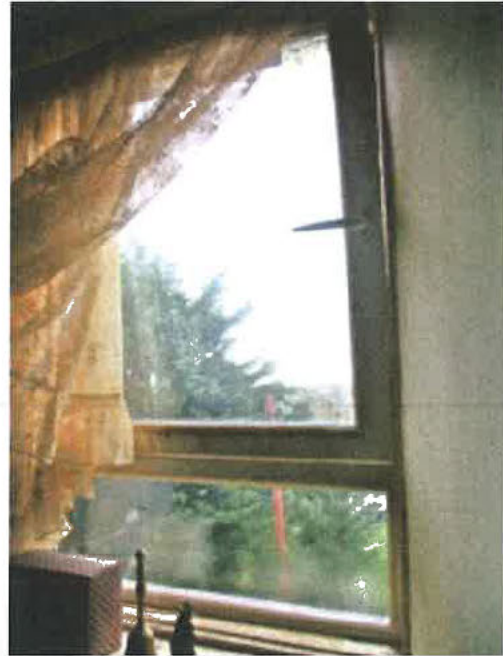
Living Room window

The Tribunal then inspected the windows in the kitchen, lounge and bedroom. The kitchen window did appear to be working correctly. However, the lounge window was badly fitted with the sill and there were gaps between the window and the sill that did not meet the repairing standard. The Tribunal did manage to open and close the lounge window but with the greatest of difficulty and it was clearly not in proper working order. Likewise, on inspecting the bedroom window, it was apparent that this did not open and close correctly and at least one of the hinges was broken. The Landlord would therefore require to carry out repairs to the lounge and bedroom windows/sills to ensure they were capable of opening and closing properly, were draught free and otherwise met the repairing standard.

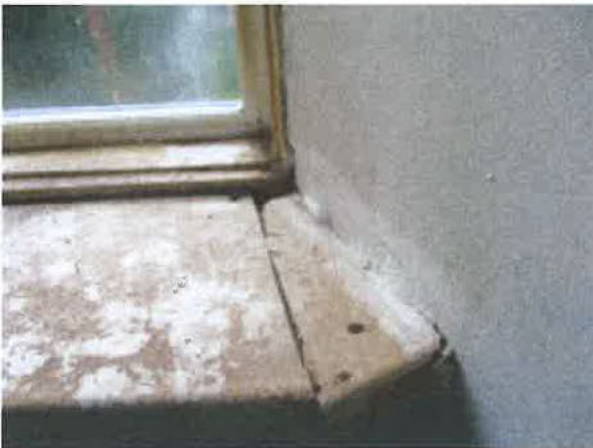
Living Room window sill split/gaps

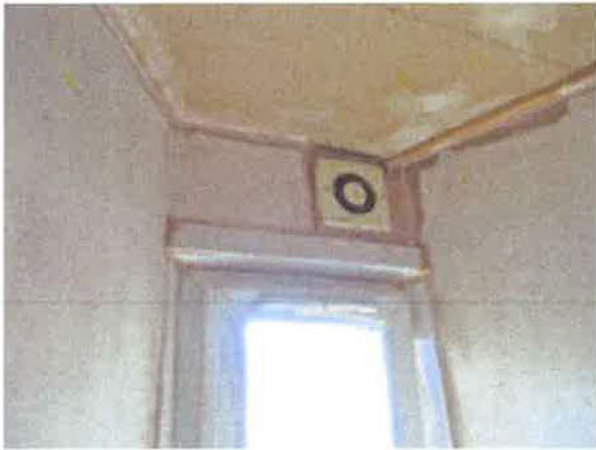
registered with any of the regulatory bodies. The Tribunal also noted that it was apparent that the fans/vents in both the bathroom and kitchen were clearly inoperative yet the EICR had not picked this up. Overall the Tribunal was not satisfied that the electrician was suitably qualified and registered and had done a proper job. Accordingly a fresh EICR would be required, produced by a suitably qualified and registered electrician. The Landlord would require to carry out any works required by the EICR to ensure it was issued without any works labelled as C1 or C2 in the EICR.

Kitchen - extractor fan above window - not in proper working order

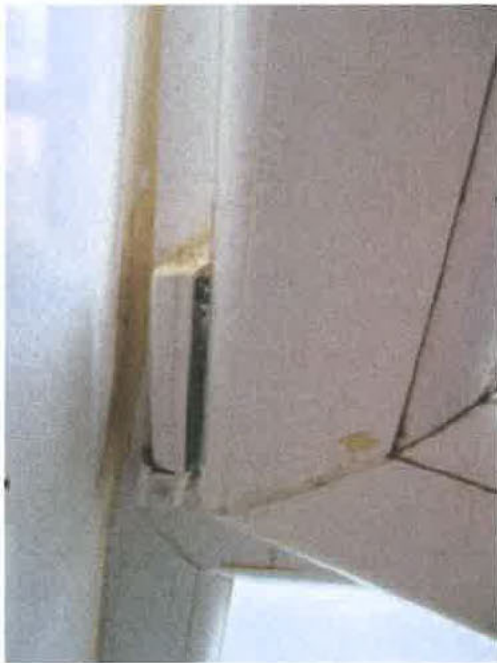
Main Bedroom - left side middle window - damaged mechanisms/hinge

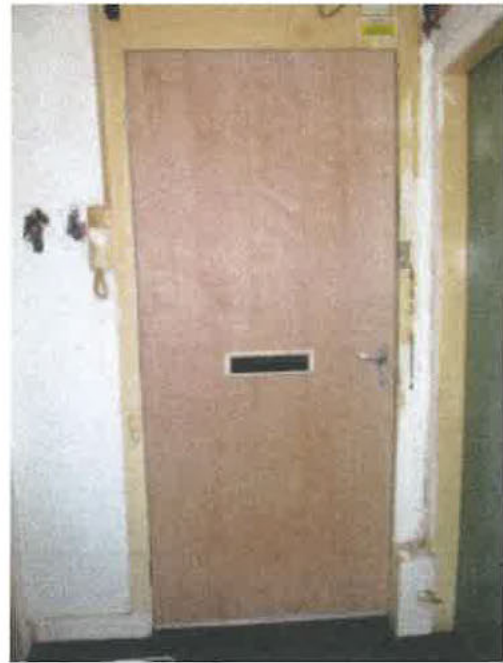
The Tribunal then inspected the main door of the Property that led to the communal stairway. A new door had been installed the day before the inspection. There appeared to be some lengthy history between the parties as to how a previous door had become damaged that involved lost keys and the fire brigade. The convoluted explanation was of little relevance to the Tribunal and, in any event, the Landlord had appeared to take on responsibility for replacing the door. Whilst there was now a working door the Tribunal noted that the Landlord appeared to have installed a basic internal door. As this was the main external door an internal door was insufficient. In terms of the Building Standard Domestic Technical Handbook (2018 Edition) flat entrance doorsets that allow access directly in to a dwelling from a shared or communal area are required to provide fire and smoke protection. Whilst the Tribunal appreciated that the Landlord had attempted to achieve compliance here, what had been installed did not meet the required technical standards and the Landlord would require to install a new main entrance door compliant with the relevant regulations.

Hall - new front door (hollow core interior type)

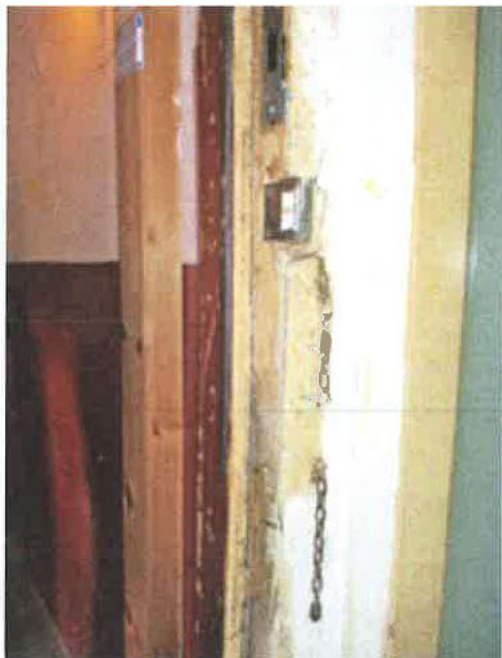
Hall - old front door frame in situ/rubber seal defective

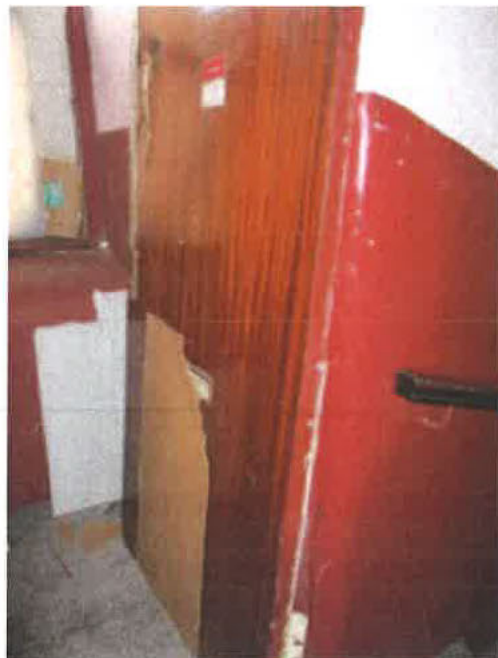
Close Landing - old front door damaged/removed by fire brigade

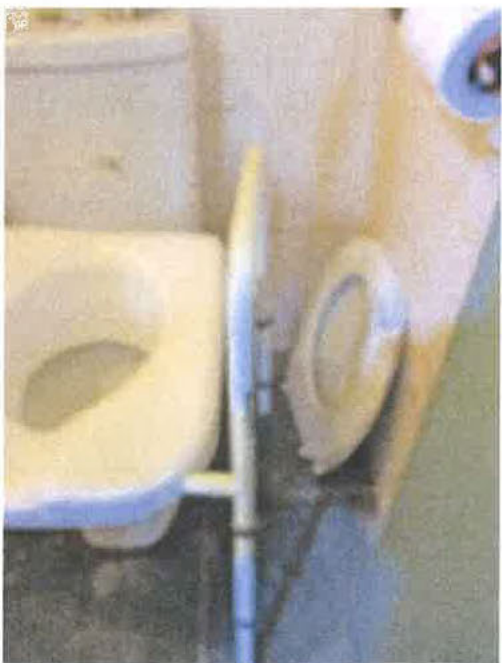
The Tribunal then inspected the shower room. The Landlord advised that he had provided a new toilet seat recently. However, the one present appeared to the Tribunal to be older and the connections on it were broken. A new toilet seat would require to be provided and installed by the Landlord.

Shower Room - toilet seat not fixed to bowl

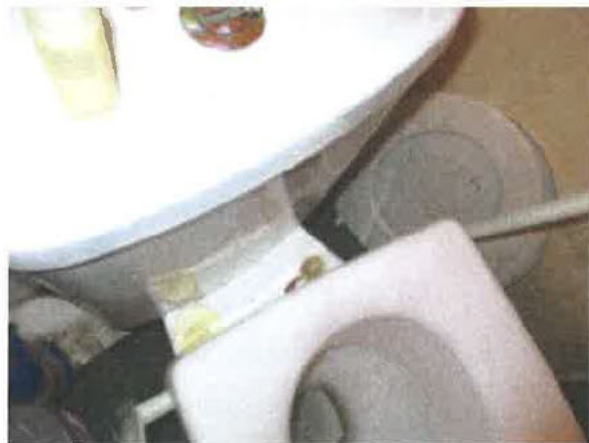
Shower Room - damaged seat fitting on rim of toilet bowl

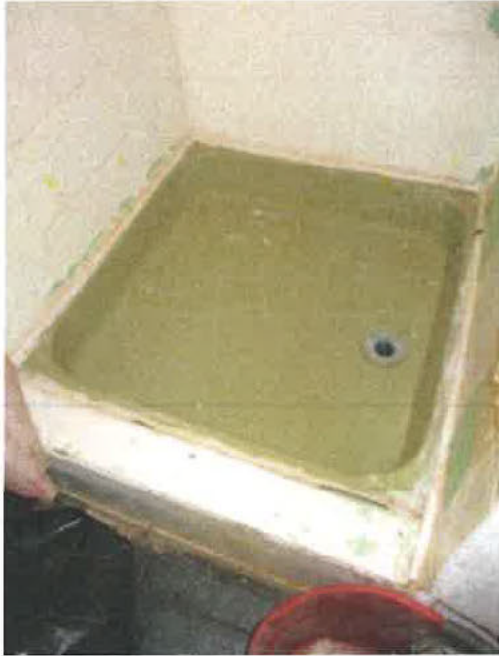
The Tribunal also inspected the sealant around the shower. This was in poor condition and would benefit from being replaced by the Landlord.

Shower Room - defective seal to shower tray

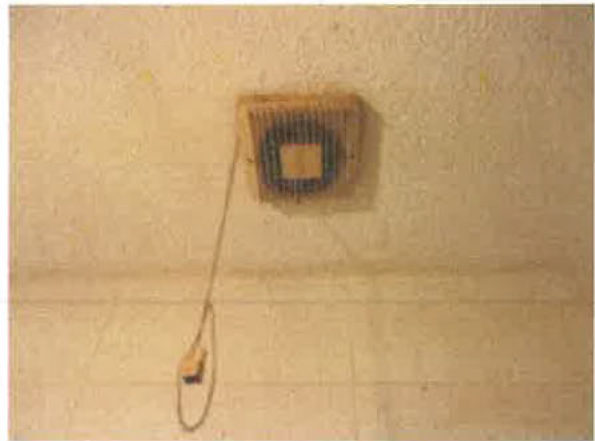
Shower Room - extractor fan - possibly defective/
electrical fault
