**Statement of decision of the Private Rented Housing
Committee under Section 60 of the Housing
(Scotland) Act 2006**

PRHP Ref: RP/16/0113

Re: Property at 16 Rice Way, Motherwell ML1 2JL (“the Property”)

Photos from inspection
PRHP/RP/16/0113
1st November 2016
Surveyor Ian H Murning TD

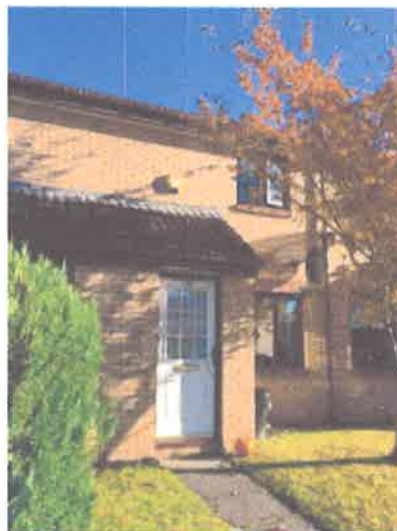
1

Front Elevation

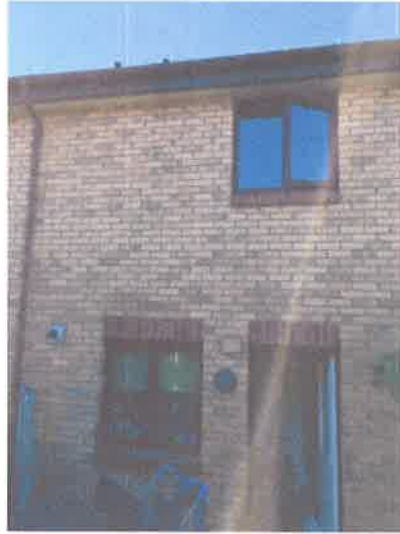
2

Rear Elevation

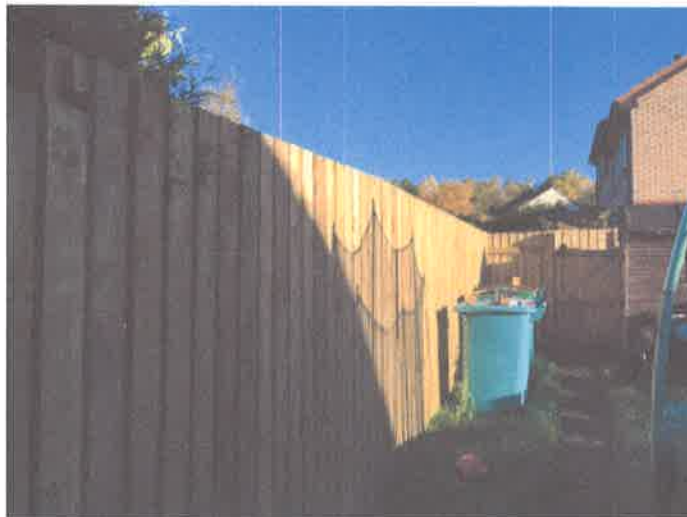
3

10. At the time of the re-inspection the weather was dry and cold. The Committee inspected the fence in the garden. A new 6ft fence has been erected along the boundary with the neighbouring property and along the bottom of the garden. A gate has also been installed at the bottom of the garden. The Committee inspected the back and front doors at the property. The tenant identified draught excluders which have been fitted to the sides of the doors. No adjustment has been made to the bottom of the doors. There is a small gap between the bottom of the kitchen door and the frame. The Tenant confirmed that since the adjustment she has not noticed any draughts from the door. The front door was adjusted in a similar way. It already had a draught excluder and no gap. The tenant advises that she has attached a draught excluder to the internal door between hall and living room and has not been aware of any draughts from the front door. The Committee inspected the windows. Silicone has been applied to the space between the glass and the frame internally and externally. The kitchen window and the hall window only have the silicone on the outside. The Tenant confirmed however that since the window repairs she has not noticed condensation. No condensation or mould was noted by the Committee. The Tenant pointed out that no silicone has been applied to the gap between window frame and the sill in a couple of the windows. The Committee noted the replacement extractor fan in the bathroom which the tenant confirmed to be effective. The Committee noted that there is no heat or CO detector in the kitchen which is of concern. The smoke detector in the living room has been disconnected by the Tenant because of its proximity to the kitchen causing it to activate whenever she cooks. The Committee noted that this should be re-located or perhaps replaced with a heat detector.

New Boundary Fence & Rear Gate 1

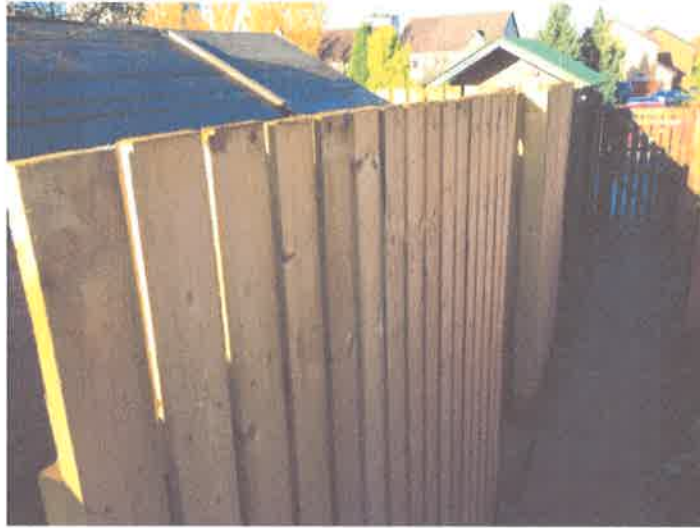
4

Rear Access Path - New Fence & Rear Gate 2

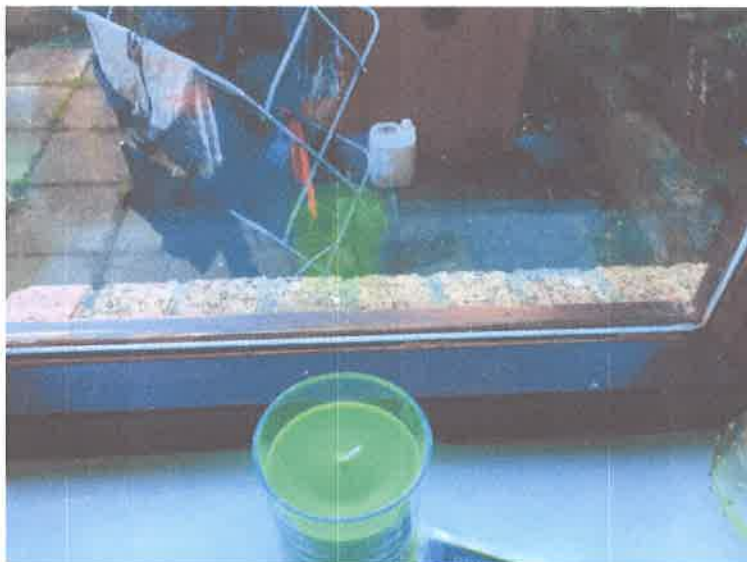
5

7. The Surveyor member issued a re-inspection report which indicated that items 2 and 3 of the RSEO had been completed. Item 1 had largely been completed namely that the windows had been repaired and some re-painted. Silicone had been applied to the space between the glass and timber frame in all but one kitchen window. Item 4 of the RSEO had not been completed and the fence and gate were in the same condition as at the first inspection.

Kitchen Window Frame

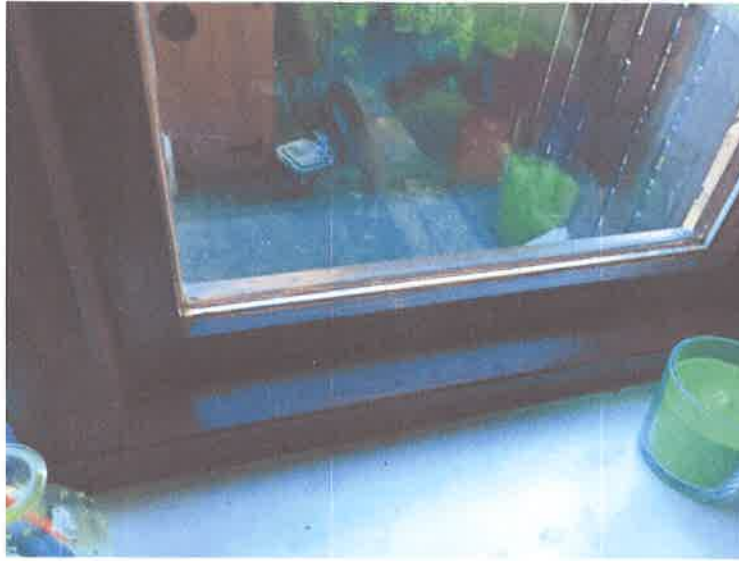
6

Kitchen Window Frame

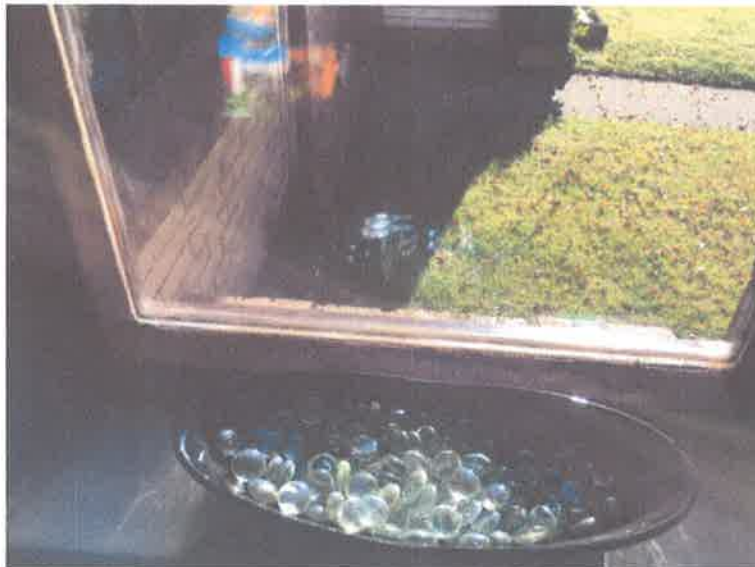
7

Porch Window Frame

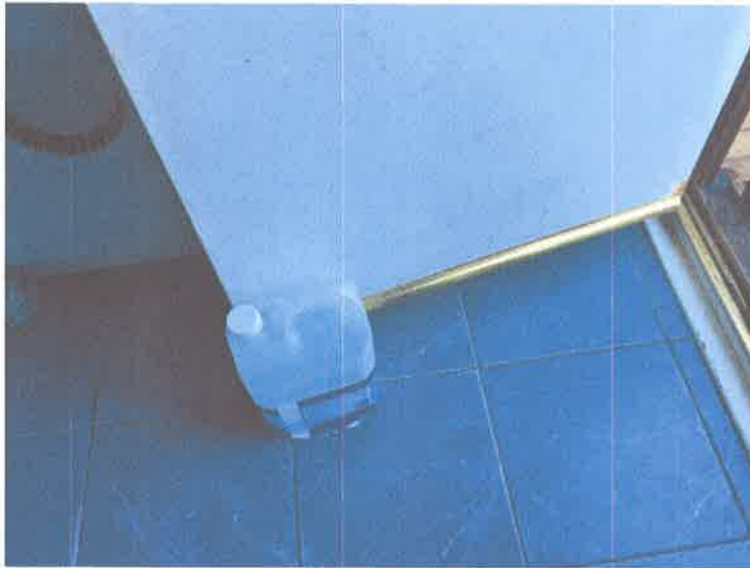
8

Rear Kitchen Door Threshold

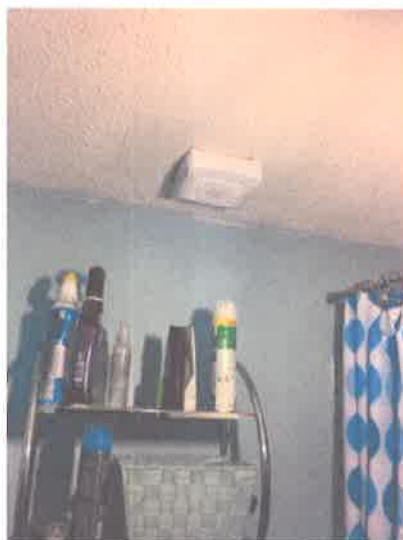
9

Bathroom Ceiling Mounted Extractor Fan

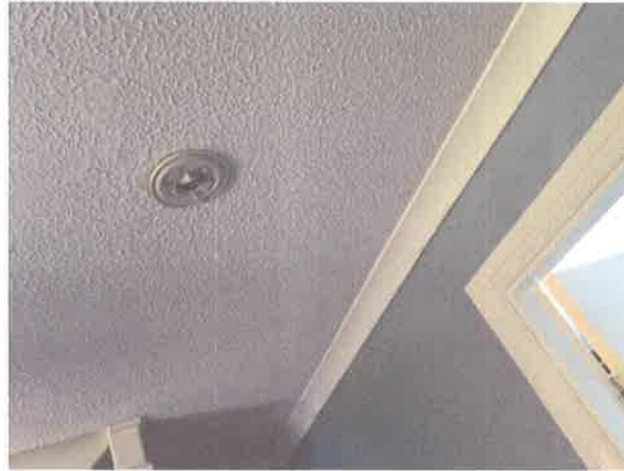
10

Smoke Alarm Base Unit on Living Room Ceiling – Detector Head Unit Removed

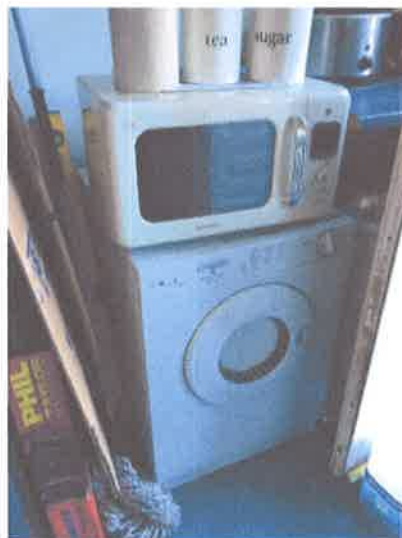
11

Clothes Dryer in Kitchen
