Repairing Standard Enforcement Order

Case reference number : PRHP/RP/16/0119

Re:- Property at Flat 101, 38 Boyd Street, Largs, KA30 8LE ("**the property**")

**Photographs taken at 38 Boyd Street, Largs KA30 8LE on 29 July 2016
(PRHP/RP/16/0119)**

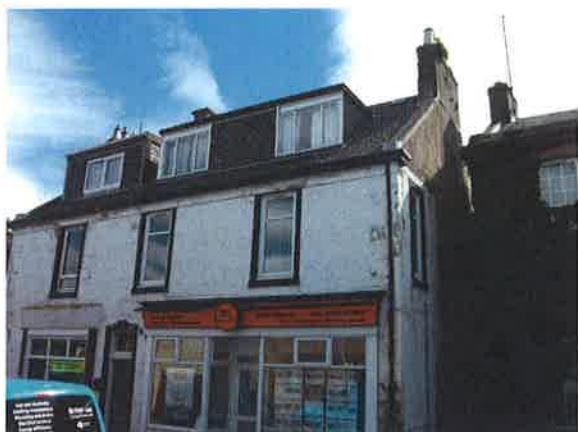
01 - Front Elevation
(First floor flat, above 24-7 property shop)

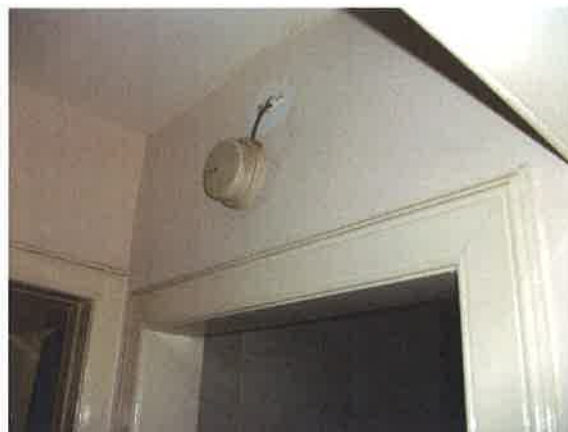
- (e) The hard wired smoke alarm in the hall was not working.
- (f) A schedule of photographs showing these items taken by the surveyor member are attached to this decision.
- (g) The external guttering appeared to be blocked and there appeared to be evidence of vegetation growing from the guttering.
- (h) The committee noted there appeared to be no carbon monoxide detector within the property.
- (i) The committee determined that the bath was draining correctly and there were no problems in that regard.
- (j) The committee could not determine whether the bed frame was broken

02 - Hall - smoke detector
(not working at inspection)

- Provide hard wired smoke, heat and carbon monoxide alarms within the property to fully comply with current standards.
- Repair or replace flushing mechanism in cistern
- Replace or refit toilet seat
- Replace kitchen flooring
- Produce and provide a valid gas safety certificate as required in terms of the Gas Safety (Installation and Use Regulations) 1998
- Obtain appropriate reports from a recognised specialist company to establish the extent of the works required to eradicate dampness in the property and in particular within the living room and bedrooms of the property and to carry out these works including internal redecoration
- Provide an energy performance certificate in respect of the property in terms of the appropriate regulations.
- Provide a valid and up to date Electrical Installation Condition Report.
- Remove vegetation and clear gutters so that they function properly.

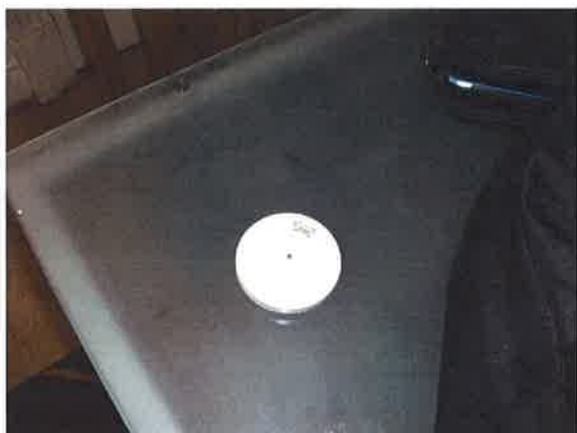
5. The first complaint which had been raised by the tenant was the lack of a smoke detector. The Committee noted that a battery operated smoke detector was lying on a shelf within a unit in the living room and that there was a hard wired smoke detector in the ceiling in the hall but it was not properly fixed to the wall.

03 - Lounge - battery-operated smoke alarm
(loose unit but working at inspection)

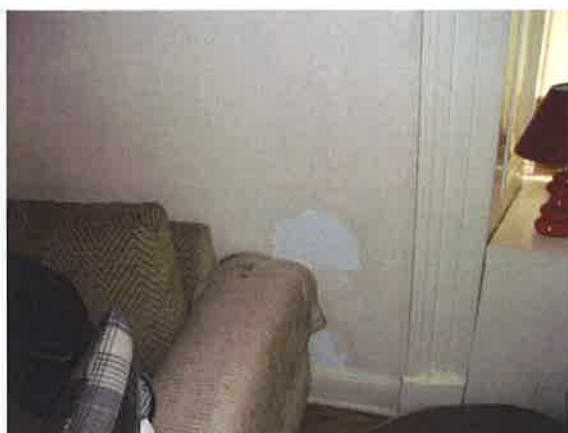
- (b) The surveyor member of the Committee took meter readings in various places during the inspection which confirmed the existence of severe dampness levels within the lounge, at the south gable window and at the south west corner. The committee also noted the presence of damp patches in the ceiling at the south gable wall in the lounge and in both the front and rear bedrooms. It was impossible to take meter readings owing to inability to access these areas.

04 - Lounge - dampness at south gable window
(severe dampness levels recorded at inspection)

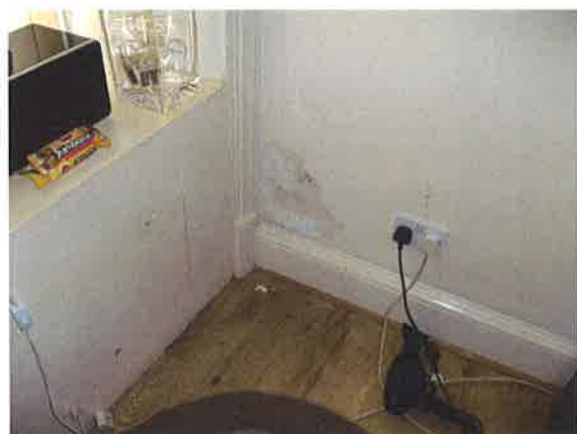
05 - Lounge - dampness at SW corner
(severe dampness levels recorded at inspection)

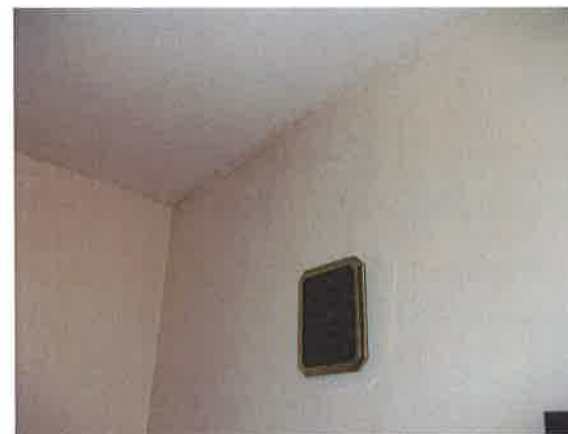
06 - Lounge - dampness at ceiling south gable wall
(visible damp stains but not tested or measured at inspection as furniture prevented access)

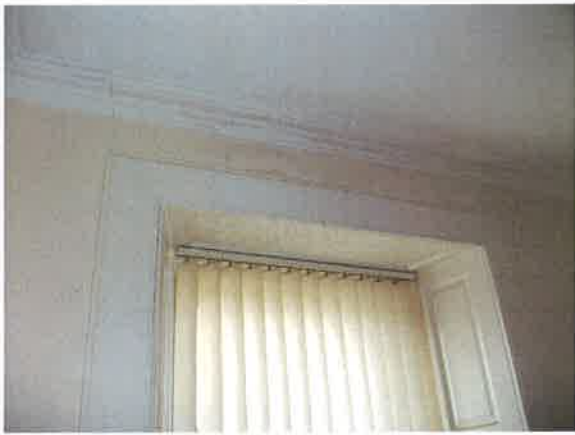
07 - Front bedroom - dampness above window
(Front gutter is directly above the window)

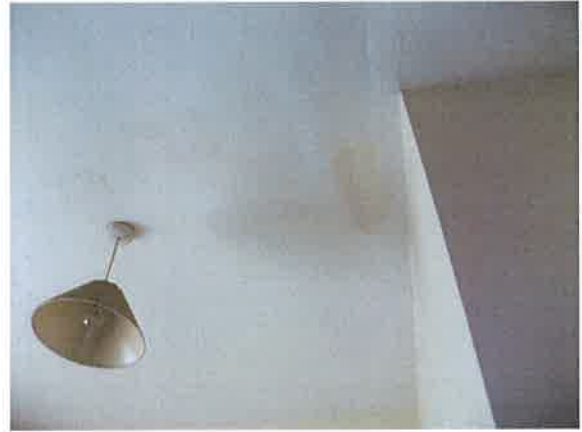
08 - Rear bedroom - dampness at ceiling
(On internal wall and possibly from the flat above)

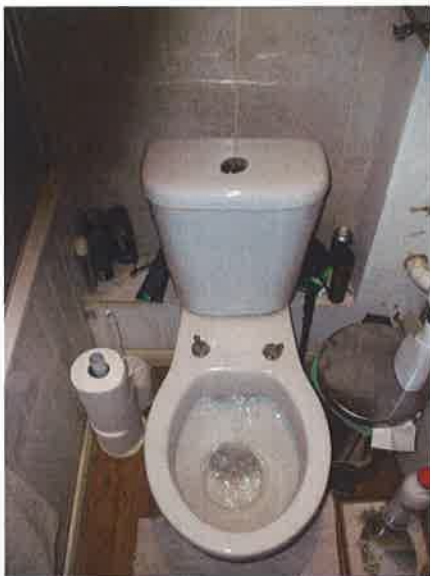
9. The tenant complained that the toilet cistern mechanism was faulty and that the cistern would continue to run after flushing. This was tested by the Committee members and was noted by them. The tenant also complained that the toilet seat was broken and again this was noted by the Committee members and observed by them. The tenant also complained that the bath was slow to drain. This was tested by the Committee and observations were made.

- (c) The flooring in the kitchen was defective. There was a hole in the vinyl and cracking in the vinyl.
 - (d) Within the toilet, the WC had no seat and the flush mechanism was malfunctioning.

09 - WC - no seat
(and flush mechanism malfunction)

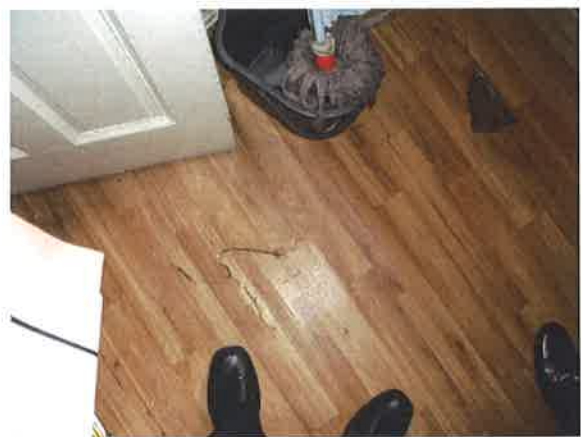
10. The tenant also complained that there was a hole in the floor covering in the kitchen. This was observed and noted by the Committee members.

10 - Kitchen - defective floor finish
(hole & cracking present in vinyl at inspection)
