Repairing Standard Enforcement Order Ordered by the First-tier Tribunal for Scotland (Housing and Property Chamber)

Chamber Ref: FTS/HPC/RT/24/0448

9 Cruden Terrace, Lockerbie, DG11 2HY being the subjects registered in the Land Register of Scotland under title number DMF32911 ('The Property')

Statement of Decision of the First-tier Tribunal for Scotland (Housing and Property Chamber) under Section 24 (1) of the Housing (Scotland) Act 2006.

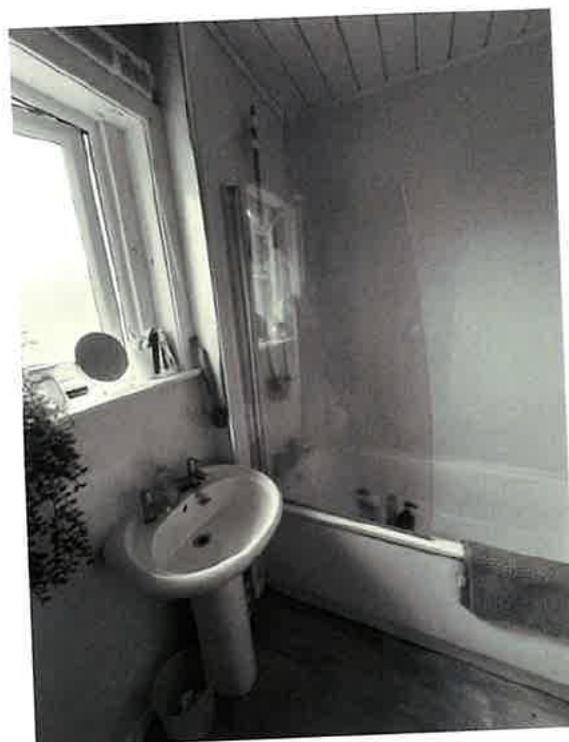
The Tribunal determine that the fact that (i) the Landlord has not produced a valid Gas Safety Certificate and EICR certificate and (ii) it is not possible to turn off the shower pull cord results is a breach of the Repairing Standard.

Photograph 14: Bathroom: Shower power switch
