**Statement of Decision of the First-tier Tribunal for Scotland (Housing and Property Chamber) under Section 24 (1) of the Housing (Scotland) Act 2006.**

**Tribunal Ref: HPC/RP/25/2433**

**Property: 5 Firwood Road, Newton Means, Glasgow G77 5PX**

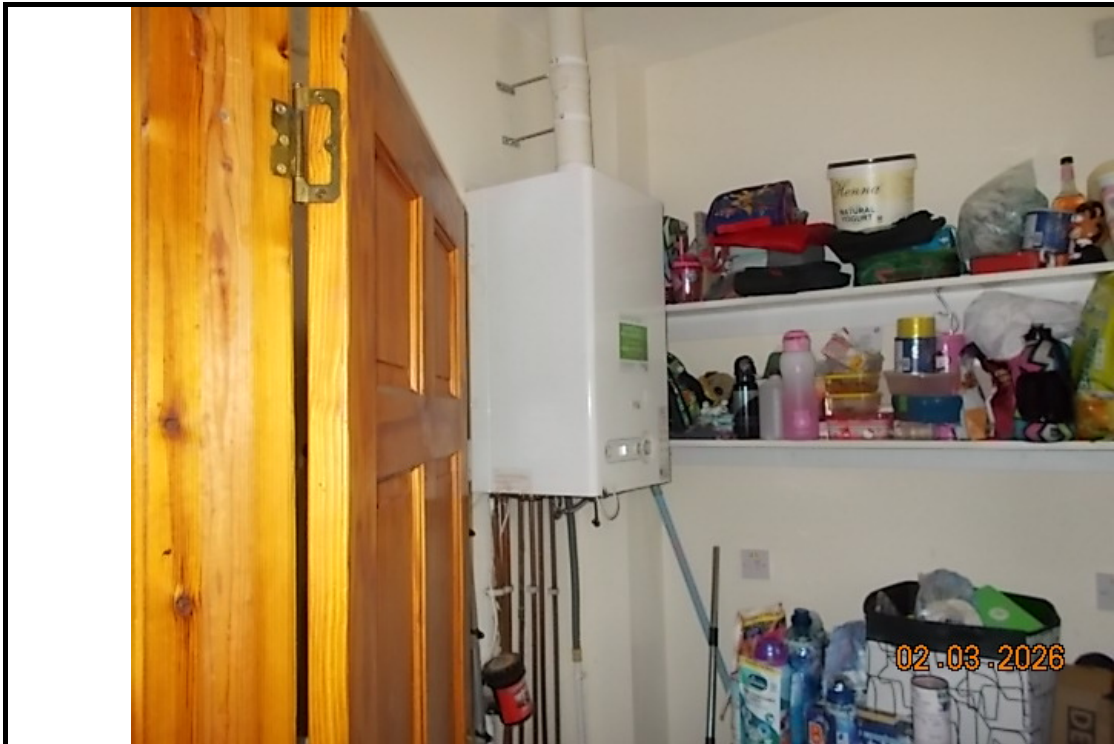
7. Utility Room with boiler

- i. While it did not form part of the application, the Tribunal noted there was an operational carbon monoxide detector and alarm. This, however, is located in kitchen rather than the utility room where the boiler is located. It should be relocated in accordance with Scottish Government statutory guidance.
- ii. The Tribunal noted there were interlinked smoke and heat alarms and that these were operational.

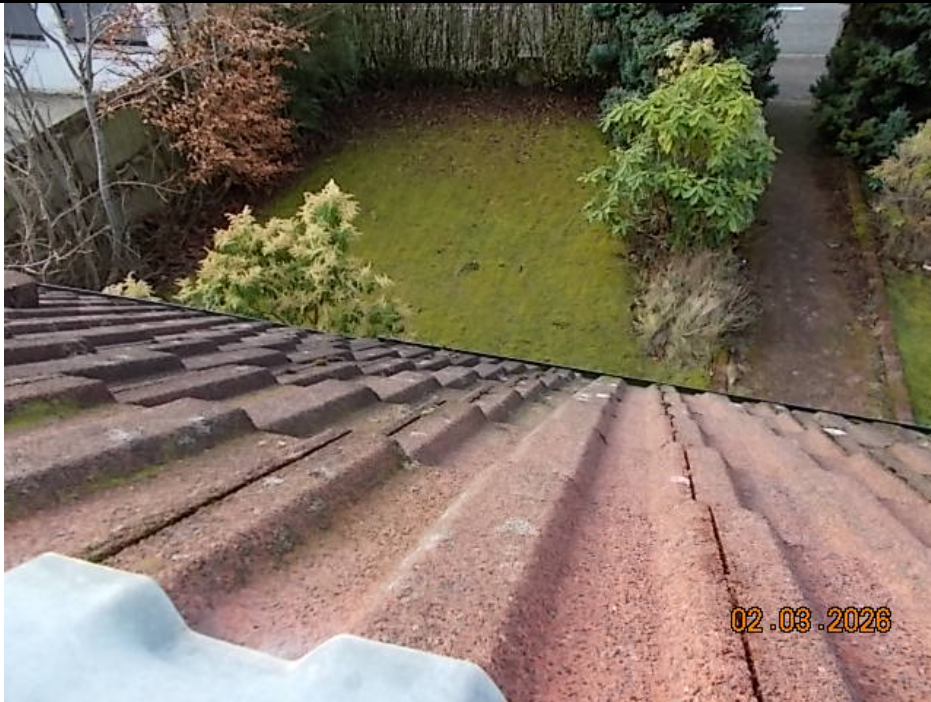
23. Front roof slope from First Floor Front Bedroom

There was no evidence of a roof leak in this area at time of inspection. The roof, generally, looks in reasonable condition with no widespread missing, loose or otherwise defective tiles.
