Statement of Decision of the First-tier Tribunal for Scotland (Housing and Property Chamber)

Case Reference Number: FTS/HPC/RP/19/2496

Re: 1/1 37 Barterholm Road, Paisley PA2 6PA (“the house”)

Schedule of Photographs taken during the
inspection by tribunal members on 29th
October 2019

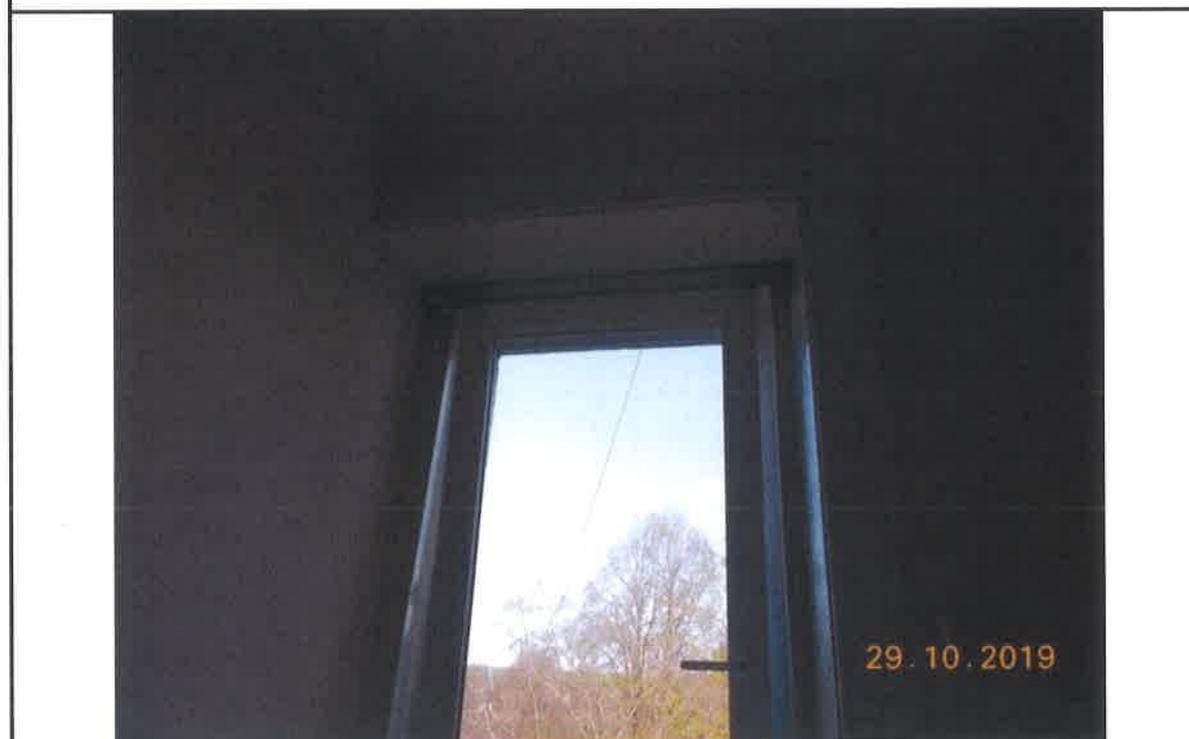
2. Kitchen window open

- 1) Resealing of 2 x bathroom tiles and grouting as required.
- 2) Supply and fit of adequate ventilation above gas cooker, or removal of mouldy, poorly positioned blind restricting use of window.

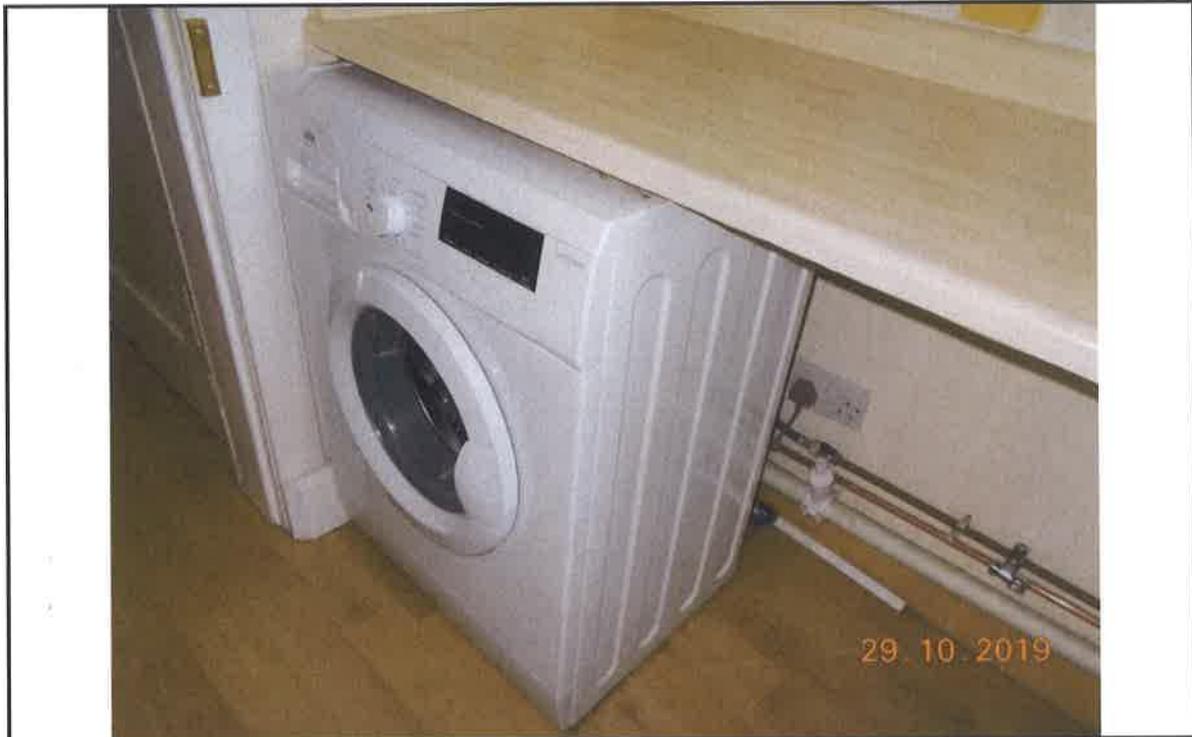
7. Washing machine in Kitchen

56. The tribunal determined on the basis of the information before it that on the balance of probabilities, the washing machine was in a reasonable state of repair and in proper working order.

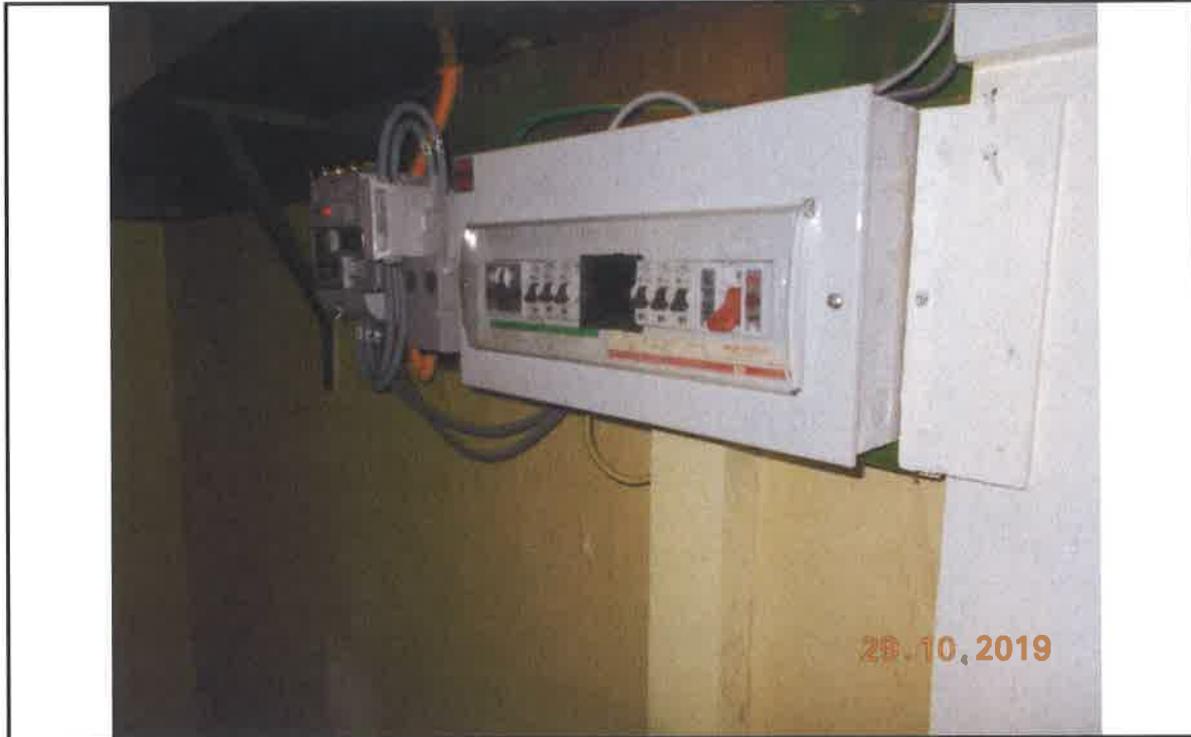
21. Electrical meter and switchgear

20. *No Electrical Installation Condition Report was provided upon letting out the property.*
53. While there is a requirement on landlords to provide an up to date EICR to a tenant at the start of the tenancy, this is not in itself a repairing standard requirement. The landlords had produced to the tribunal an EICR dated 27 September 2017 provided by M & F Electrical, Glasgow, which is an NICEIC registered contractor, which is attached to this decision. The tribunal noted that this report would have been current at the time the tenancy began in February 2018, and it was still current at the time of the hearing, as it was less than 5 years old. The EICR found that the electrical installation was satisfactory and made no category C1 or C2 observations. The tribunal determined that there was therefore no breach of the repairing standard, as the EICR showed that the electrical installation was in a reasonable state of repair and in proper working order.
