**STATEMENT OF DECISION OF THE PRIVATE RENTED HOUSING COMMITTEE
UNDER SECTION
26(1) OF THE HOUSING (SCOTLAND) ACT 2006 ("the Act")**

**Property at 39 Wallbrae Road, South Carbrain, Cumbernauld G67 2PD
(hereinafter referred to as "the house")**

Reference PRHP/RP/14/0168

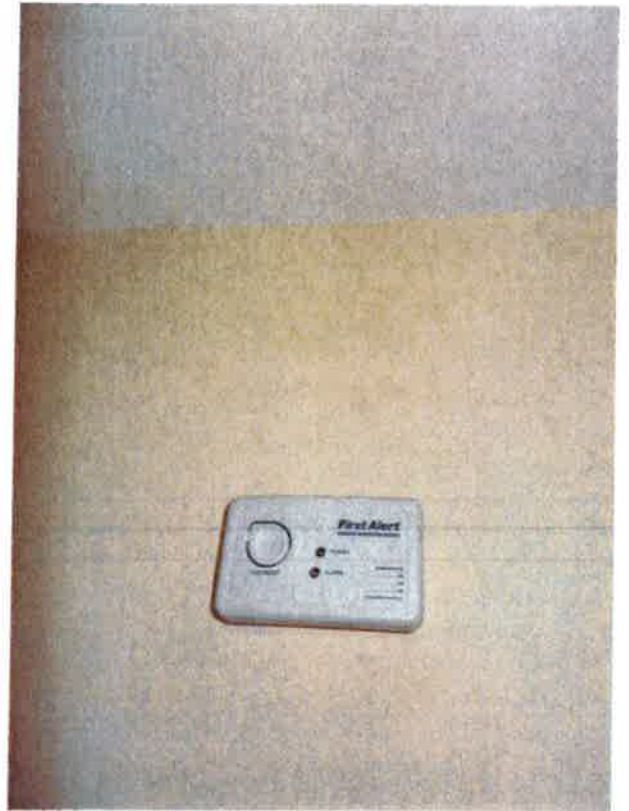
3. Carbon monoxide alarm - 1st Floor room left

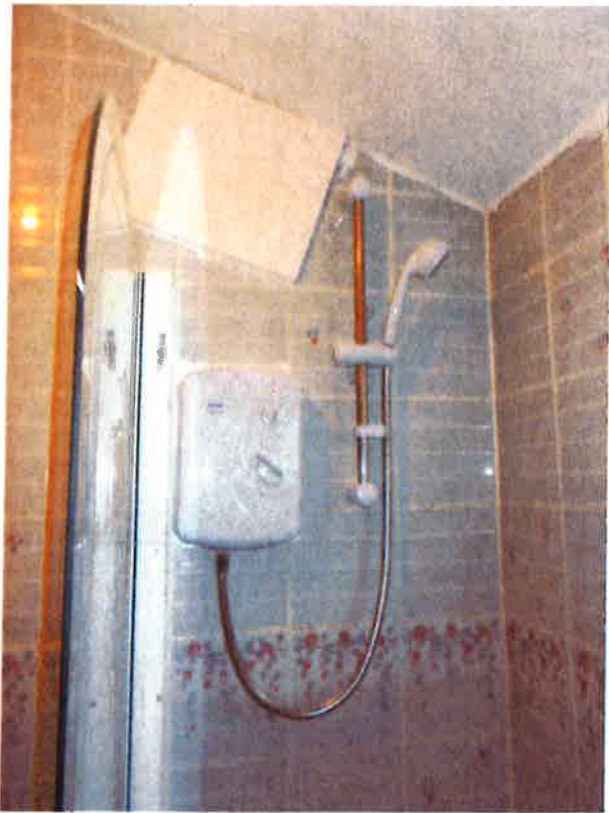
4. The replacement shower has been completed and was tested and appears to be in working order (photo marked 4).

4. Shower complete and functioning
