First-tier Tribunal for Scotland (Housing and Property Chamber)

STATEMENT OF DECISION: Housing (Scotland) Act 2006 Section 24 (1)

Chamber Ref: FTS/HPC/RP/20/1458

Pre-hearing inspection summary and schedule of photographs

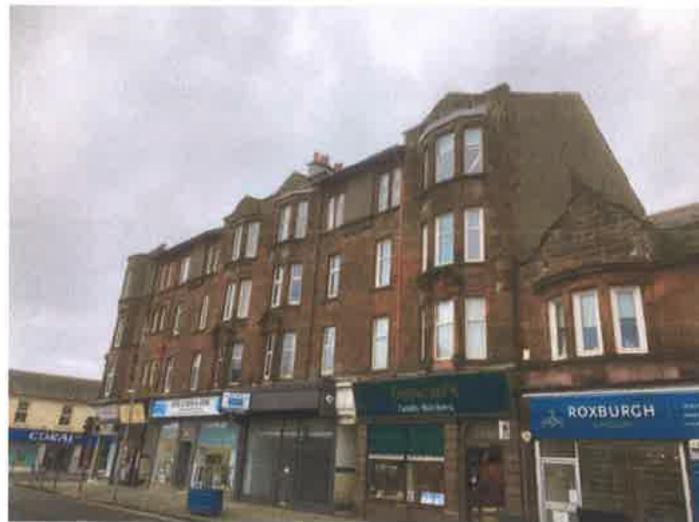
Photographs 1-3 illustrate recent repairs and renewal at the guttering, leadwork, bay window projections and chimneyhead.
