## **First-tier Tribunal for Scotland (Housing and Property Chamber)**

**STATEMENT OF DECISION:** in respect of an application Section 22(1) of the Housing (Scotland) Act 2006 (“the Act”)

**Chamber reference:** FTS/HPC/RP/17/0228

## Schedule of Photographs

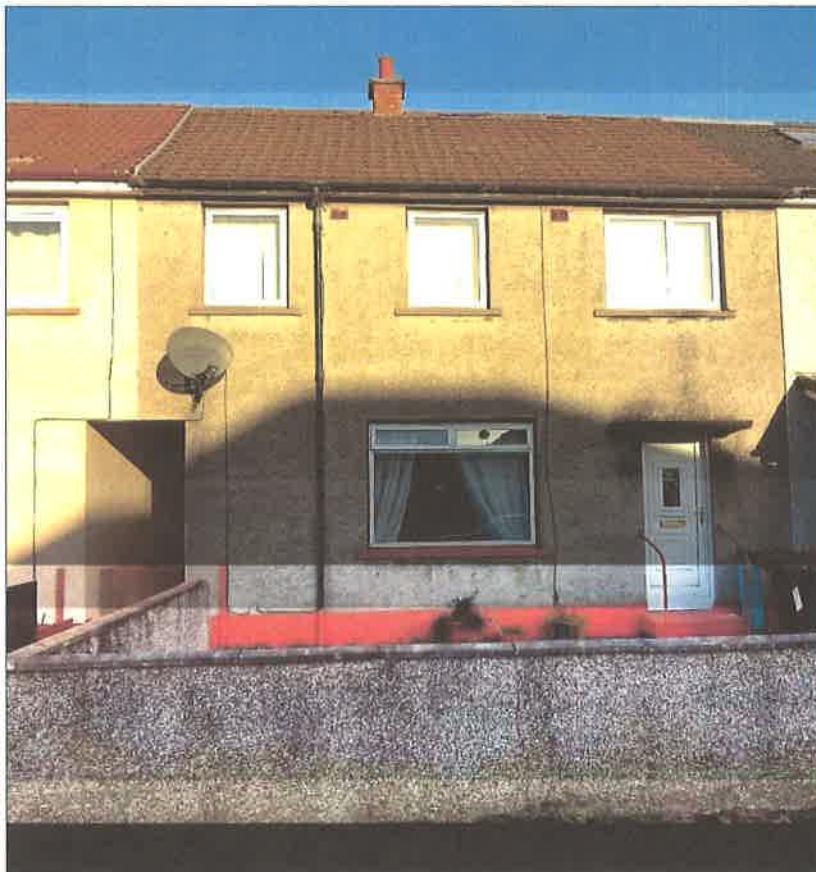
RP17/0228

Holes in roof - No evidence of missing or broken tiles – heavy covering of moss at the rear elevation. No evidence of bird's nest at rear bedroom window
