STATEMENT OF DECISION OF THE TRIBUNAL UNDER SECTION 24 (1) OF THE HOUSING (SCOTLAND) ACT 2006

Case Reference FTS/HPC/RP/24/2549

Wee Glen, Skyreburn, Gatehouse of Fleet, DG7 2HG being part of the subjects recorded in the General Register of Sasines for the County of Kirkcudbright in the Disposition by Trustees under the Deed of Trust by Claude Langrish Faber proprietor of the lands and farm of Glen extending to 1727 acres in the Parishes of Kirkmabreck and Anwoth referred to in the Disposition to James Robertson Robertson and another recorded 15 August 1960 (under exception of subjects in Disposition to Audrey Mildred Falkner or Surtees recorded 16 September 1965) (“the Property”)

Schedule of Photographs
Wee Glen, Skyreburn, Gatehouse of Fleet
FTS/HPC/RT/24/2549

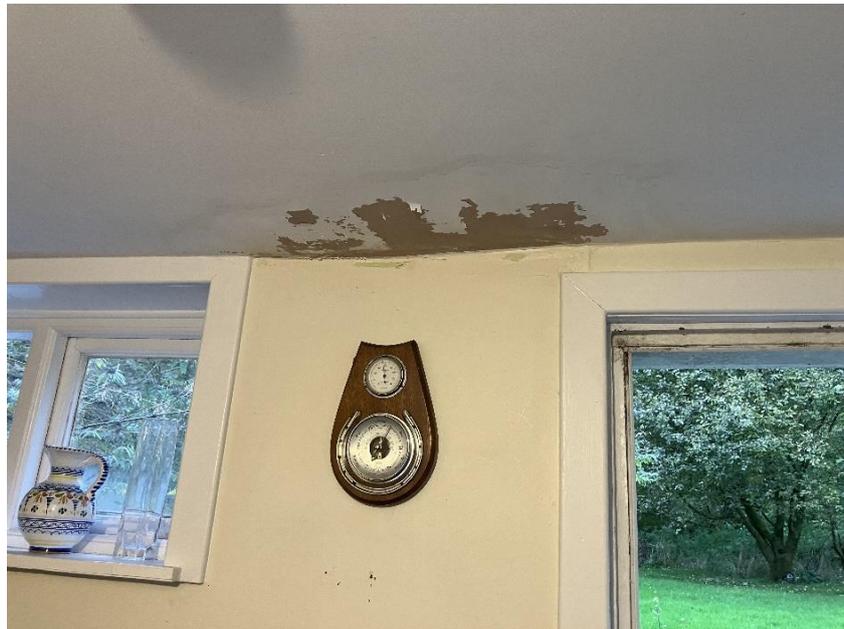
2. Utility room damp staining at ceiling

Photographs 2 & 3:- Damp staining and damp readings utility ceiling.

11. Damp staining and flaking paintwork was visible on the utility room ceiling adjacent to the rear external wall. Moisture readings taken at the affected area confirmed the presence of penetrating damp at a level likely to cause further deterioration to the internal fabric if left unrepaired. As viewed externally it was noted that there was defective roof slating, badly corroded and broken rainwater goods and choked valley gutters which were all likely to be a contributory source of water ingress.

35. The landlord did supply an electrical installation certificate dated 13 May 2024.
36. There is penetrating damp on the utility room ceiling adjacent to the rear external wall. Defective roof slating, badly corroded and broken rainwater goods and choked valley gutters are all likely to be a contributory source of water ingress.

50. The Tribunal found that there was damp in the ceiling at the utility room and consider that, specifically at this location, the property was not wind and watertight.

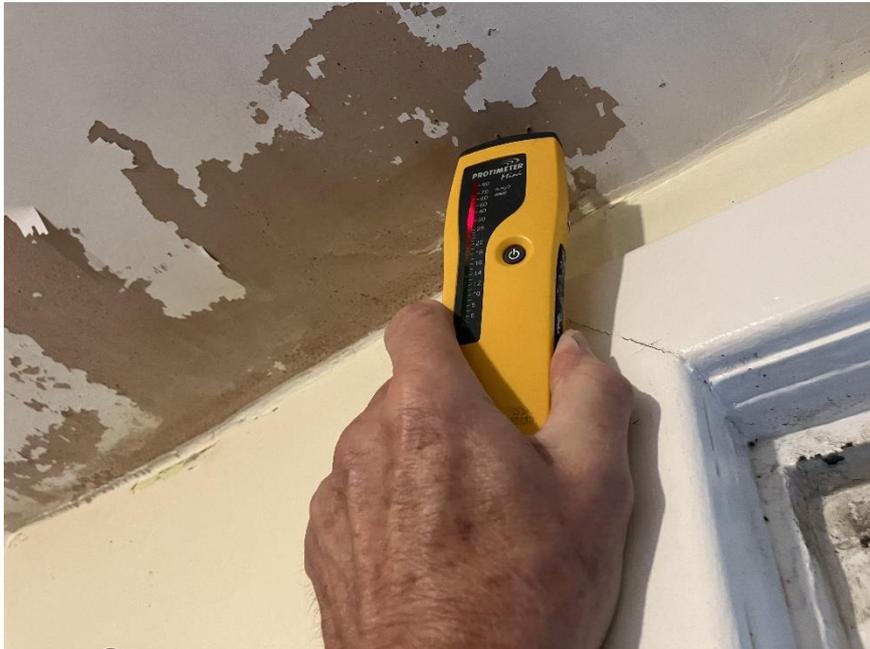
3. Damp readings at utility room ceiling

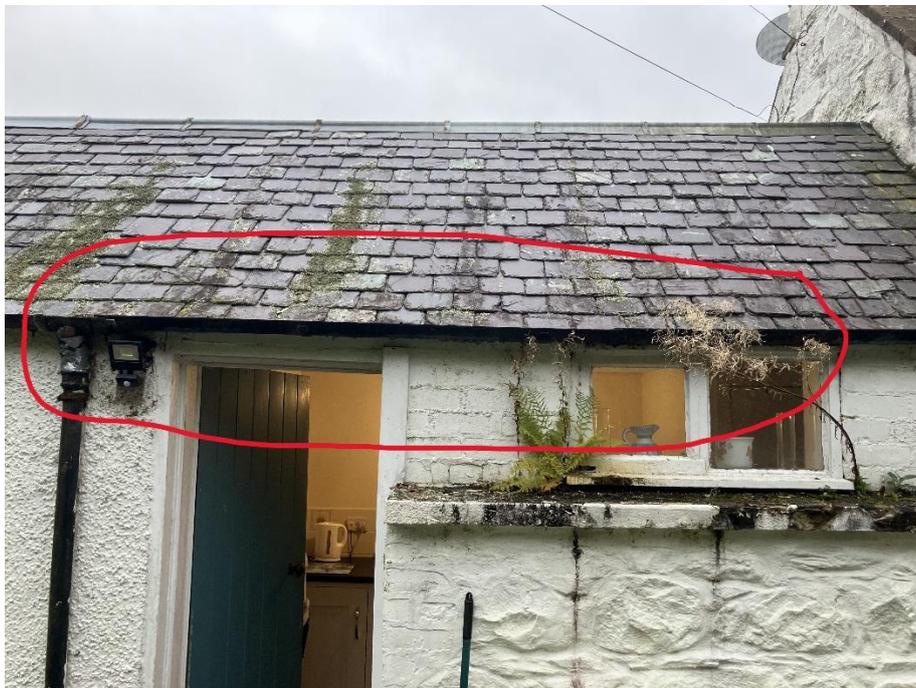
4.

Photograph 4:- Area circled in red highlights badly corroded and broken rainwater goods and chipped slates immediately above and outside the utility area.

51. Externally, the tribunal was concerned about the exterior of the house. It did not appear to be in a reasonable state of repair given that there was noted to be defective roof slating, badly corroded and broken rainwater goods and choked valley gutters. We find that they are all likely to be a contributory source

of water ingress. We find therefore that the structure and exterior of the property was not in a reasonable state of repair.

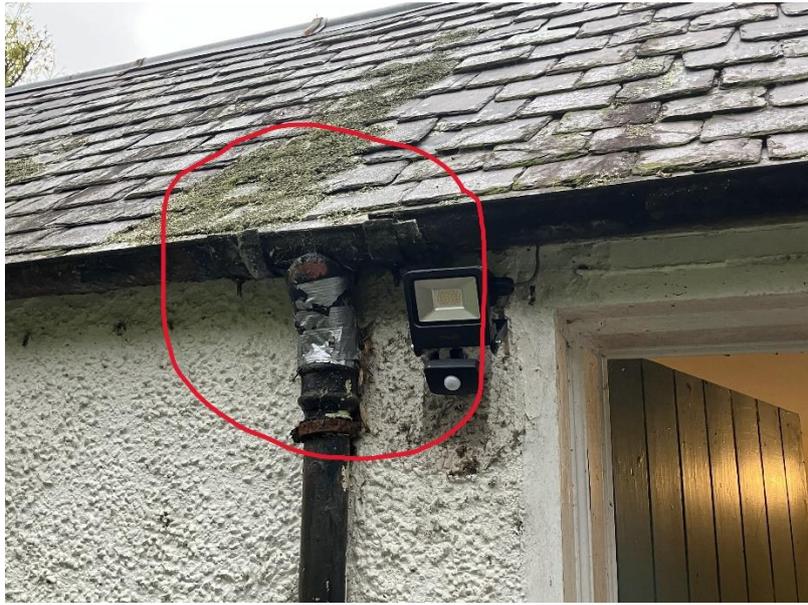
5.

Photograph 5:- Temporary repair between badly corroded downpipe and gutter outside the utility area.

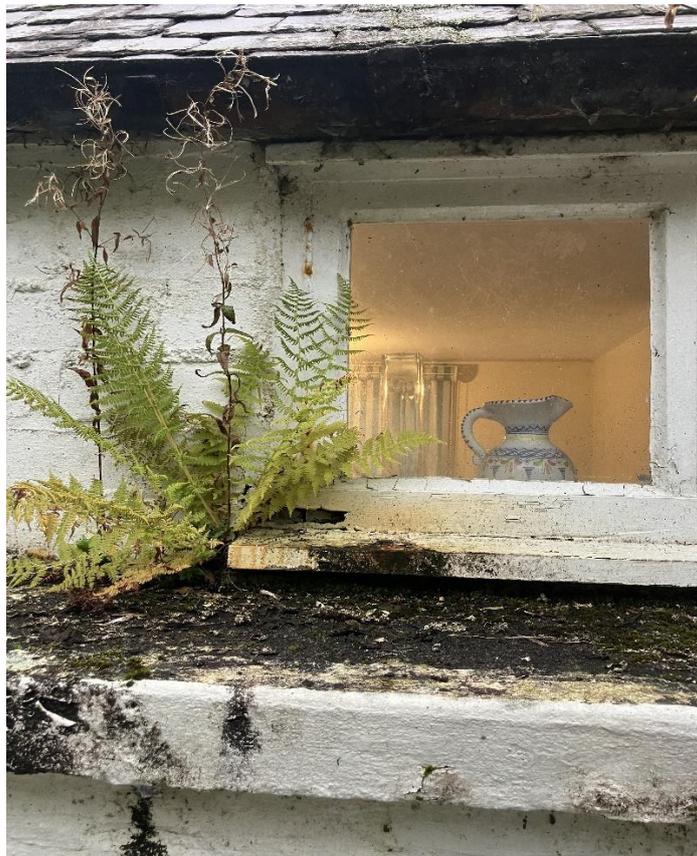
6.

Photograph 6:- Rot and vegetation growth at window and sill of utility room.

12. The external window frame on the rear wall of the utility room is decayed with significant vegetation growing on and around the stone sill, contributing to further deterioration.

37. The external window frame on the rear wall of the utility room is decayed with significant vegetation growing on and around the stone sill.
38. On the external front elevation of the property the bathroom, living room and kitchen windows, all show evidence of areas of localised rot, disrepair and flaking paint. Recent maintenance to these windows has not taken place. Internally there is no evidence of any penetrating damp corresponding with these areas.

49. In relation to the external windows. There were some concerns in relation to utility, bathroom, sitting room and kitchen windows within the property. They all showed signs of deterioration and required repair work to be carried out to maintain them. The tribunal did not consider that those windows were in a reasonable state of repair given the areas of localised rot and flaking paint noted and we consider that the landlord is in breach of their duty to repair and maintain.

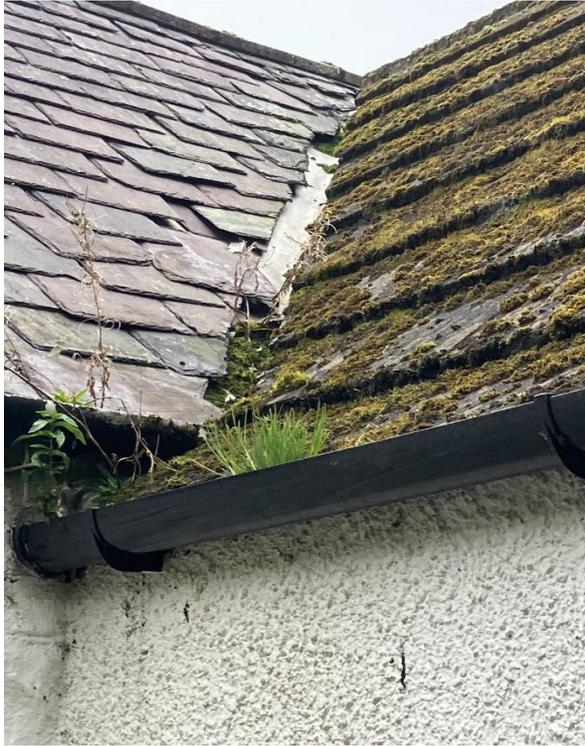
7.

Photograph 7:- Slipped, broken and missing roof slates in the rear left valley gutter between main property and rear projection and significant vegetation choking valley gutter specifically at junction with eaves gutter

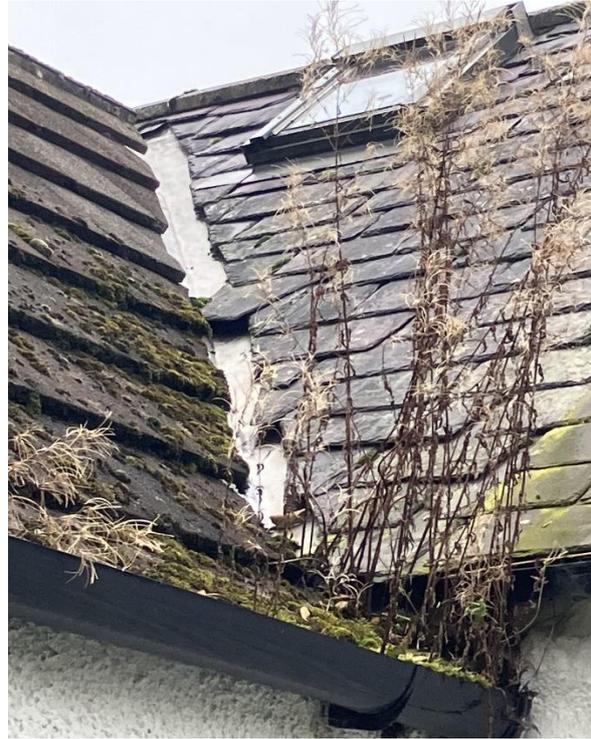
8.

Photograph 8:- Slipped, broken and missing roof slates in the rear right valley gutter between main property and rear projection and significant vegetation at eaves and valley gutter.

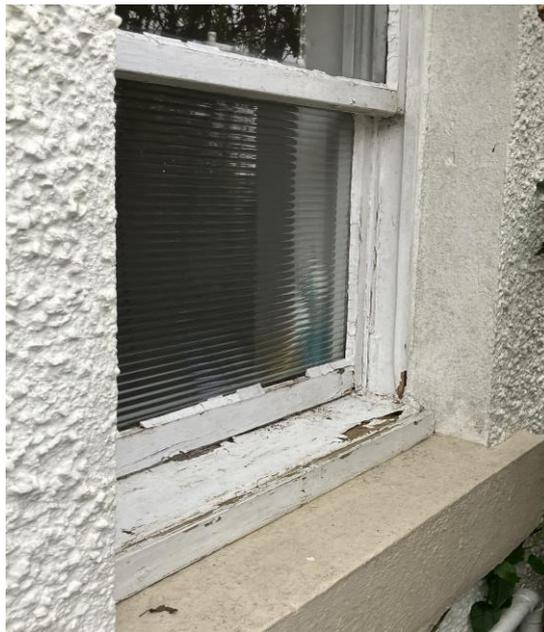
9.

Photograph 9:- Localised rot and flaking paint at bathroom window.

13. On the external front elevation at the bathroom, living room and kitchen windows, all of varying timber design, there was evidence of localised rot, disrepair and flaking paint, recent maintenance having been neglected. There were visible gaps between the base of the window frames and stone sills although when viewed internally there is no evidence of any penetrating damp corresponding with these areas.

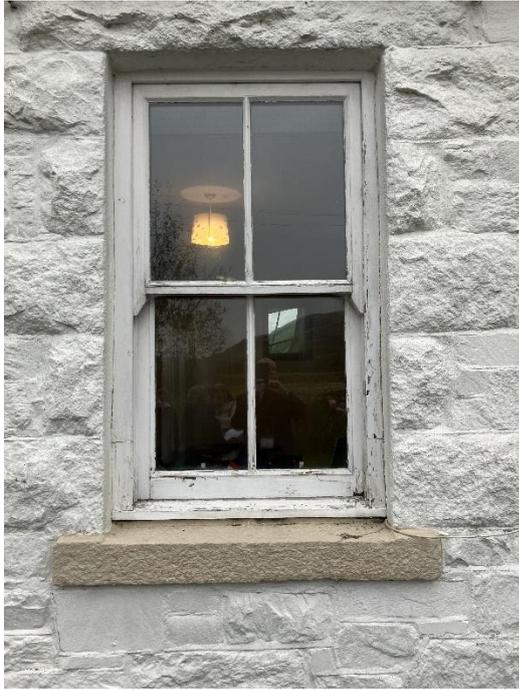
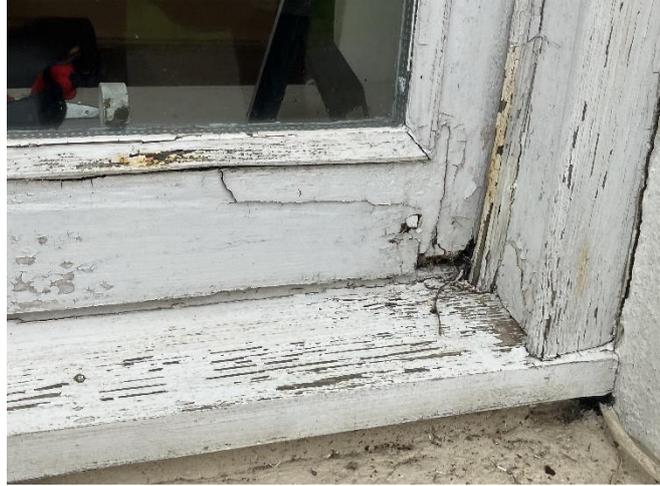
Photographs 10 & 11:- Localised rot and flaking paint at living room window.

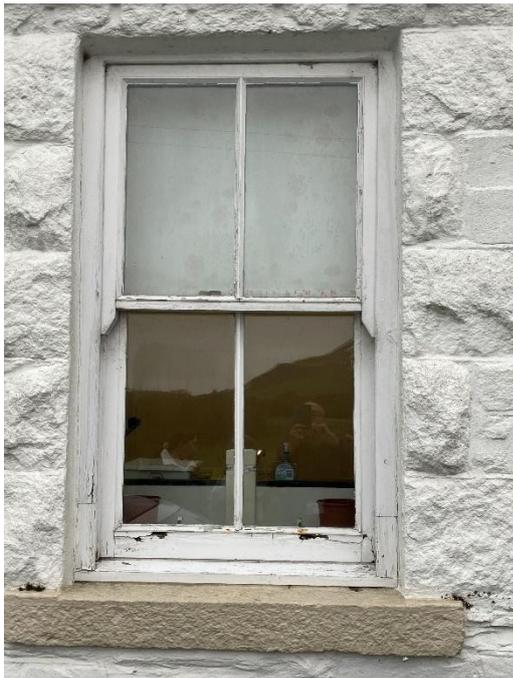
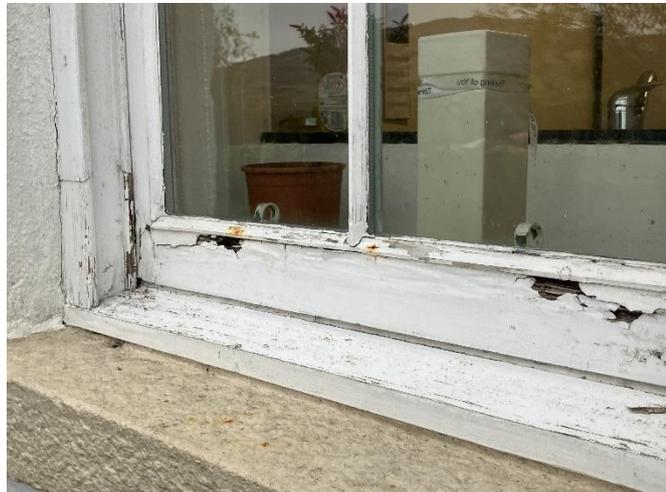
Photographs 12 & 13:- Localised rot and flaking paint at kitchen window.

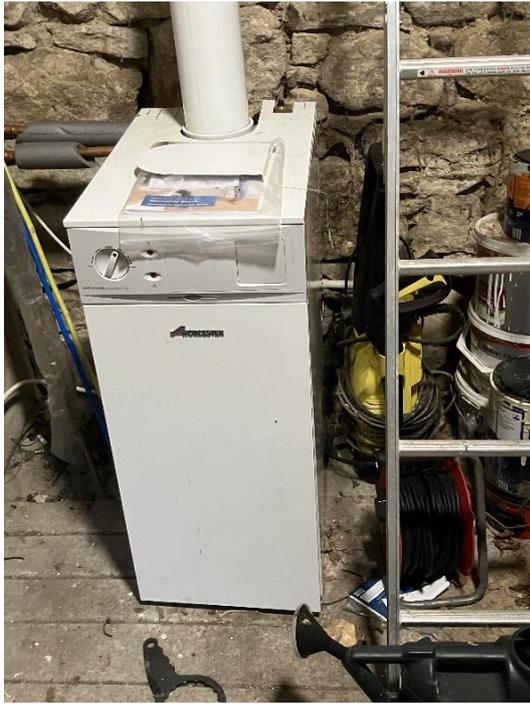
14.

Photograph 14:- Worcester Oil fired Boiler in outhouse installed circa May 2023

15. There was no current "satisfactory" Electrical Installation Condition Report (EICR) within the property and none was held by the tenant.
16. A floor standing "Worcester" oil fired boiler was located in an outbuilding accessed from the rear of the property. It was understood to have been installed around May 2023 although the tenant stated that it has been "broken"

57. OBSERVED The tribunal observes the oil boiler may not currently be in good working order. We do not however make any order in relation to the oil boiler, as it appears to have been in good working order when the application was made on 3 June 2024 and when the third-party inspection was carried out In April 2024. As the tenant raised the matter at the hearing that the oil boiler was not working, and as the tenant advised that she had contacted the landlord about this matter and asked for repairs to be carried out, then we would recommend that parties liaise with each other and make the necessary arrangements for the oil boiler to be looked at by a suitably qualified engineer and repaired as necessary. We do not consider that this matter is formally before the tribunal and we do not therefore determine this matter, it remains open to the tenant or the third party however to make a further application if the matter is not resolved.

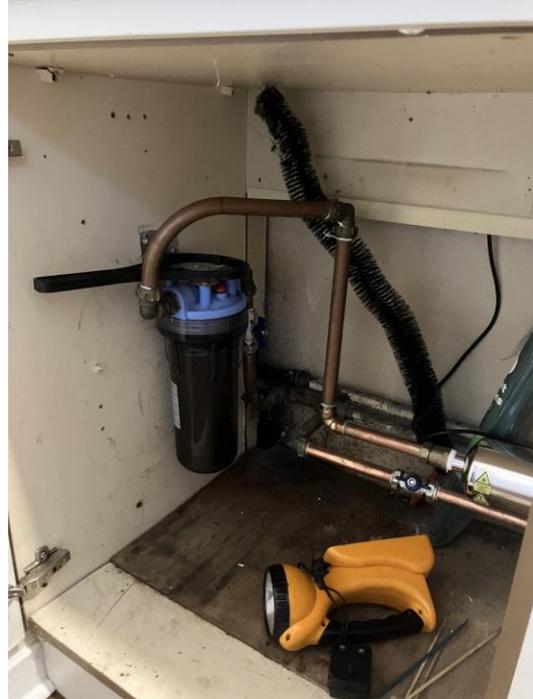
15.

Photograph 15:- Water filter below sink unit in utility room.
