**Decision with Statement of Reasons of the First-tier Tribunal for Scotland  
(Housing and Property Chamber) under sections 24 and 27 of Housing  
(Scotland) Act 2006**

**Chamber reference: FTS/HPC/RP/26/0318**

**Re: Property at Flat 1/L, 12 Boyd Street, Largs, KA30 8LD (“the Property”)**

**Schedule of Photograph**

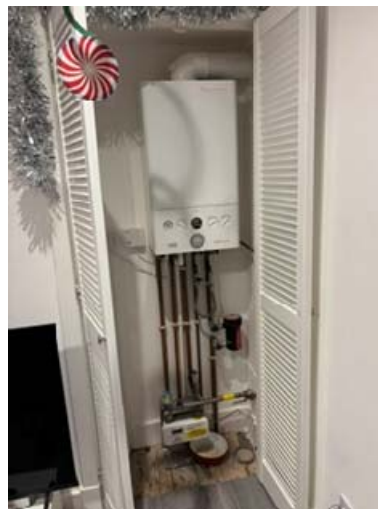
two bedrooms, living room, bathroom, and kitchen area off the hallway. The boiler is situated in a wall-press cupboard in the living room, which is a front-facing room. The flue for the boiler exits through the outside wall, and the flue terminal is visible from the street, slightly to the right of the living room window.

**General view of gas combination boiler in wall-press off livingroom**

- a) *To instruct an inspection by a suitably qualified heating engineer so as to establish the cause of apparent water escape around the boiler;*
- b) *Thereafter to undertake such works as deemed necessary by the engineer to remedy the water escape; and*
- c) *To report to the Tribunal and the Tenant as to the outcome of the said investigation and the steps undertake to remedy.*

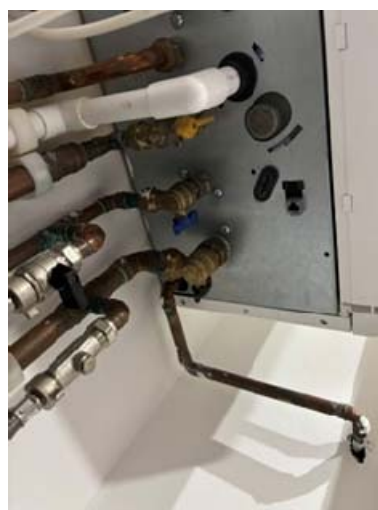
10. We noted no water escape from any part of the boiler during our visit (which was consistent with the Tenant's submissions at the hearing – referred to below – that the water escape occurs during periods of significant rain combined with wind).

**Underside of boiler- no indication of leakage at the time of the inspection**

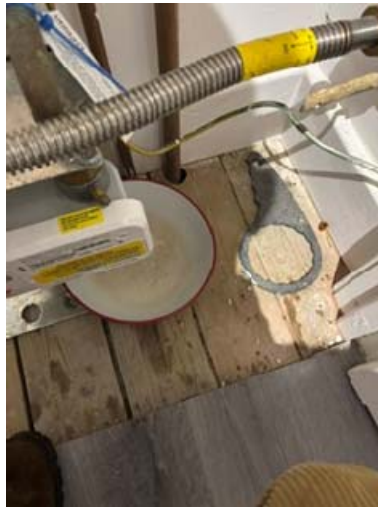
11. The Tenant had placed a bowl underneath the boiler but it was also dry at the time of the inspection. There was some marking or staining below the bowl (on wooden floor boards). We saw no evidence of rot or material water damage to the floor boards.

**Gas meter and bowl, placed by tenant, dry at the time of the inspection**

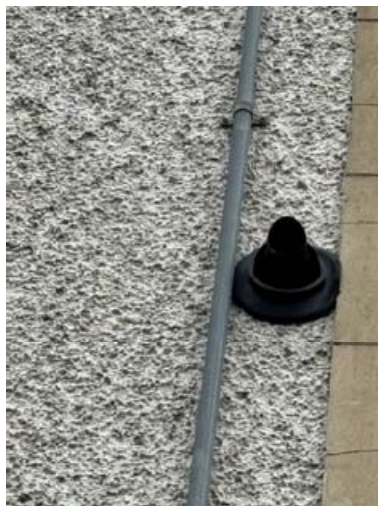
- 12.2 The flue terminal on the front elevation was one-storey up but we could only view it from ground level.
  - 12.3 The external seal around the flue terminal was not entirely flush to the surface of the wall, particularly where a raised stone detail interfered with the fit of the seal. A gap was visible.

**External-flue terminal and seal, showing part of seal not flush to wall surface, gaps visible**

As stated above, we allow two months from today for the Landlord to undertake this work. Though we do not specify any specific works to be undertaken, the Landlord would be well-advised to investigate both the angle of the pipe and the apparent lack of seal round the full diameter of the flue terminus, as well as instruct an internal inspection of the boiler. The Landlord should wish to ensure there is no water escape from within the boiler as well no rain penetration.

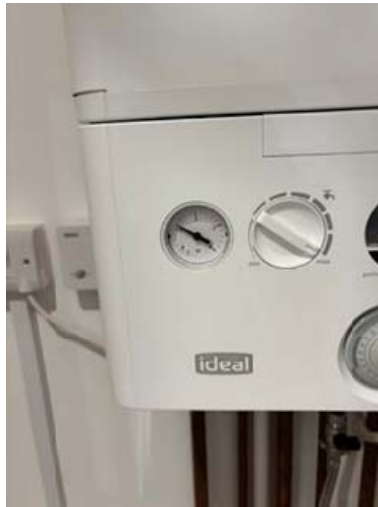
Boiler pressure guage, showing pressure within acceptable range

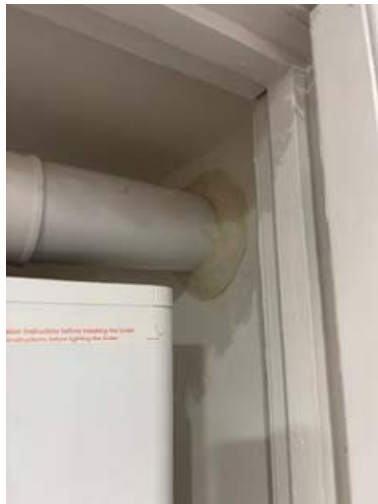
- 12.1 The flue pipe at the top of the boiler, which combines exhaust and air intake, did appear to rise at a slight angle as it exited through the outside wall.

Internal view of boiler flue, above boiler, passing through external wall
