Repairing Standard Enforcement Order (RSEO): Housing (Scotland) Act 2006, Section 24

House at Wallace View, Ferry Road, South Alloa, Falkirk, FK7 7LF
("The Property")

STATEMENT OF DECISION: Housing (Scotland) Act, Section 24(1)

Inspection - Photograph Schedule
Wallace View, Ferry Road, South Alloa, Falkirk, FK7 7LF

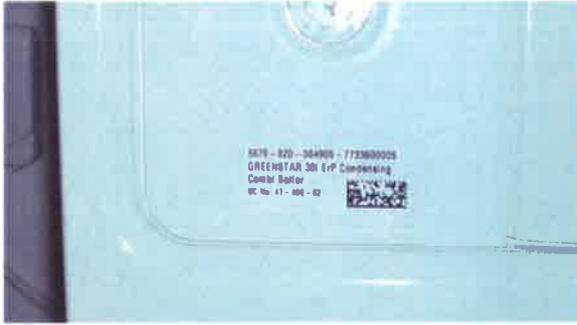
- (c) That with regard to the required repairs intimated by the Tenant:-
 - (i) That at the time of the tribunal's inspection a new boiler was found to have been installed in a cupboard located under the wooden stairs leading to the loft space but no Gas Safety Record relating thereto had been produced to the Tenant.

- (i) The boiler is located within a cupboard under stairs leading to the roof space. The boiler appeared to be a new Worcester boiler supporting the Tenant's statement that it had been installed on 3 May 2018. The Tenant reported that the central heating and hot water systems now appeared to be operating correctly but that no Gas Safety Record had been produced to them relative to the new boiler. The tribunal could not be satisfied that the boiler is in a reasonable state of repair and in proper working order and therefore meets the repairing standard.

Photo 2 – Recently installed combi boiler

- (a) (i) Engage a suitably qualified and Gas Safe registered heating engineer to carry out an inspection and report on the safety, suitability and effectiveness of the boiler.
- (ii) Follow the recommendations of the report referred to in paragraph (a)(i) above to ensure that the boiler is safe and in proper working order.
- (iii) To produce to the tribunal a valid Gas Safety Certificate.

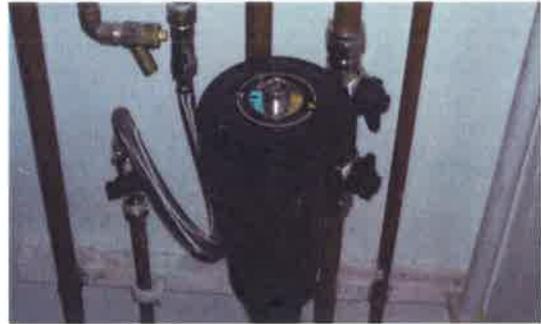
Photo 3 – Boiler components

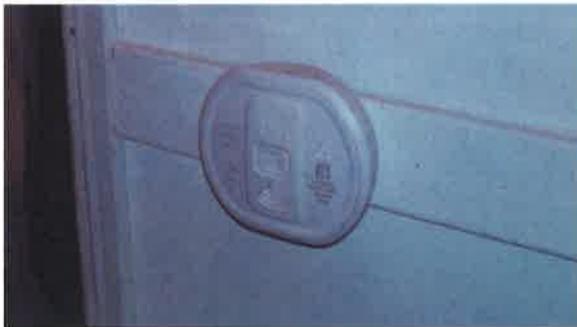
Photo 4 – Carbon Monoxide detector

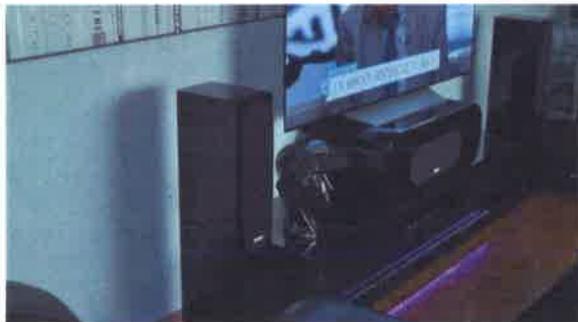
- (vi) That in the lounge the wall lights had been removed leaving loose cables, and that exposed wiring had been observed on the wall section behind the television.

Photo 6 – Wiring concern behind television

- (ii) To engage a suitably qualified and registered SELECT or NICEIC electrical contractor to carry out a certificated electrical condition check (EICR) on the electrical installations of the Property, and thereafter follow the recommendations of that report to ensure that the entire system is safe and in proper working order.

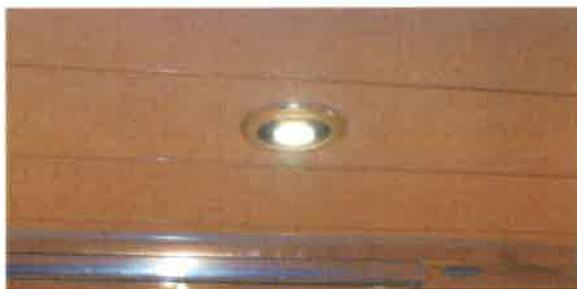
- (vi) That in the bathroom the extractor fan in-built into the spotlight in the ceiling above the shower does not operate.
 - (vii) That in the bathroom ceiling, one spotlight is missing and another is hanging down.

- (v) In the bathroom, the extractor fan within the light fitting located in the ceiling above the shower does not operate. In addition another spotlight in the ceiling is hanging down and a third spotlight is missing. The electrical installations in the bathroom are not in a reasonable state of repair and in proper working order.

Photo 8 – Broken extractor above shower

- (b) (i) To repair or replace the ceiling light fitting in the hall, the spotlights in the unused bedroom accessed from the utility room, the extractor fan and the ceiling spotlights in the bathroom, and to make safe the cabling serving the former wall lights located in the lounge.

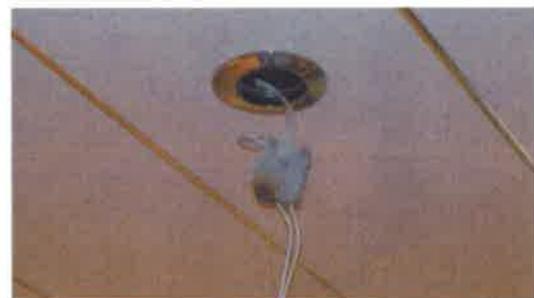
- (vii) That in the bathroom, the extractor fan within the light fitting located in the ceiling above the shower does not operate.
- (viii) That in the bathroom, one spotlight in the ceiling is hanging down and another spotlight is missing.

Photo 9 – Exposed wiring in bathroom

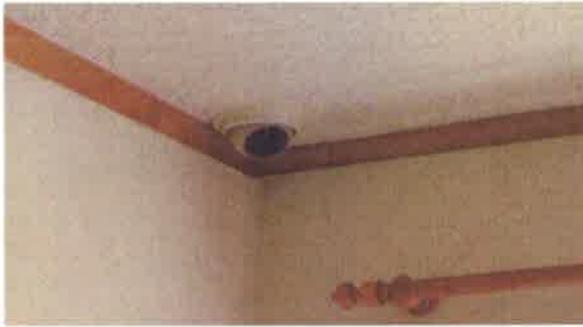
- (iv) That in the bedroom accessed from the utility room and presently unoccupied, the two spotlights located in two of the corners of the bedroom do not operate due to a switch to operate the lights not being capable of being found.

- (iii) The spotlights located in two of the corners of the unoccupied bedroom accessed from the utility room cannot be used as there is no switch with which to turn the lights on or off. The tribunal could not locate a switch. In the absence of a switch the electrical installations in the bedroom are not in a reasonable state of repair and in proper working order.

Photo 10 – Defective light in spare bedroom

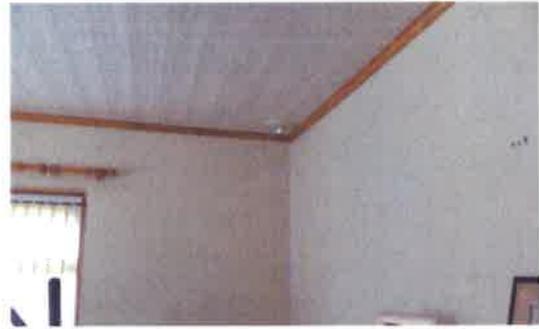
Photo 11 – 2nd defective ceiling light

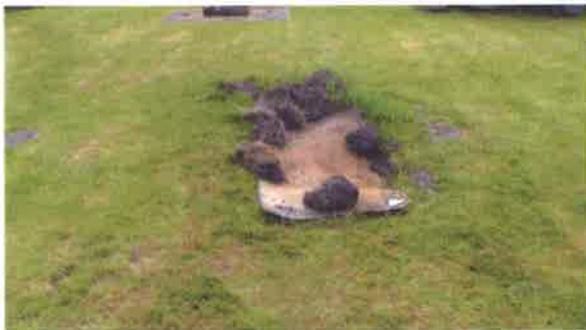
- (i) That the septic tank is not operating correctly in that the contents backfill into the toilet and the shower.
- (ii) That the septic tank has not operated correctly for 7 months.
- (iii) That the septic tank has required to be emptied on 4 occasions since the Tenant and his family moved into the Property.
- (iv) That the Landlord's agents, Martin & Co., instructed a contractor to investigate the position and whose camera became stuck in associated pipework which is understood to have collapsed.
- (v) That the Tenant has involved the Environmental Health Department of the local authority.

- (vi) The tribunal found a hole in the lawn to the rear of the Property dug to locate the septic tank and from which investigations had been carried out by both a contractor employed by the Landlords' letting agent and the Environmental Health Department of the local authority. The septic tank is not operating

correctly in that the contents backfill into the toilet and the shower. The septic tank has not operated correctly for 7 months and has required to be emptied on 4 occasions since the Tenant and his family moved into the Property. The septic tank and the associated pipework is not in a reasonable state of repair and in proper working order.

Photo 12 – Location of septic tank

- (d) To instruct a reputable contractor to carry out an investigation of and prepare a report on the septic tank and all associated underground pipework, to identify the reasons for the septic tank not operating correctly and to repair or replace the septic tank and any associated underground pipework to ensure the septic tank and the associated underground pipework is in a reasonable state of repair and in proper working order and to make safe the hole in the lawn to the rear of and make good any other damage caused to the Property.
