### **Repairing Standard Enforcement Order (RSEO): Housing (Scotland) Act 2006 Section 24**

**Chamber Ref: FTS/HPC/RT/17/0076**

**Property at 26 Thistle Drive, Portlethen, Aberdeen, AB12 4QH  
("The Property")**

**Photographs of 26 Thistle Drive, Portlethen, AB12 4QH**

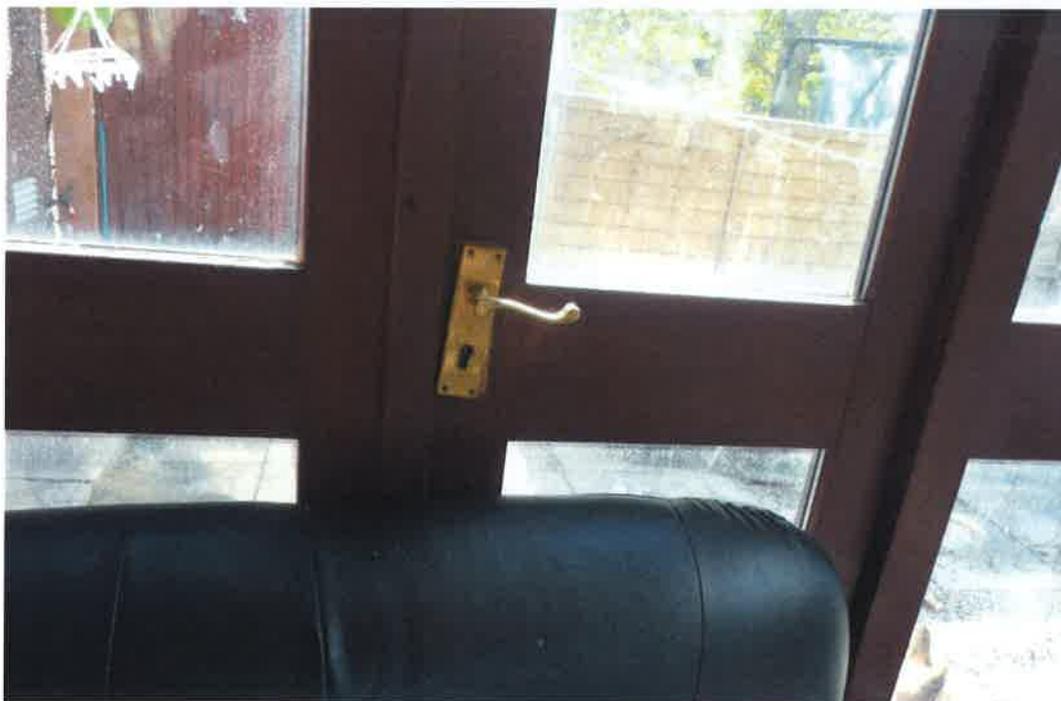
- (i) That the external door from the conservatory to the rear garden does not operate correctly in that the handle and locking mechanism is loose.
- (ii) That the two windows of the conservatory do not open and close correctly and the handles of the windows are loose.
- (iii) That one of the lower panes of glass is cracked and requires replaced.

**Conservatory door – loose and un-lockable**

- (i) To repair or replace the handle and lock on the external door from the conservatory to the rear garden to ensure that the door opens, closes and locks correctly and is in a reasonable state of repair and in proper working order.
- (ii) To repair or replace the handles of the two windows in the conservatory to ensure that the windows open, close and lock correctly and are in a reasonable state of repair and in proper working order.
- (iii) To replace the lower pane of glass that is cracked and to ensure that the replacement pane is wind and watertight, in a reasonable state of repair and in proper working order.

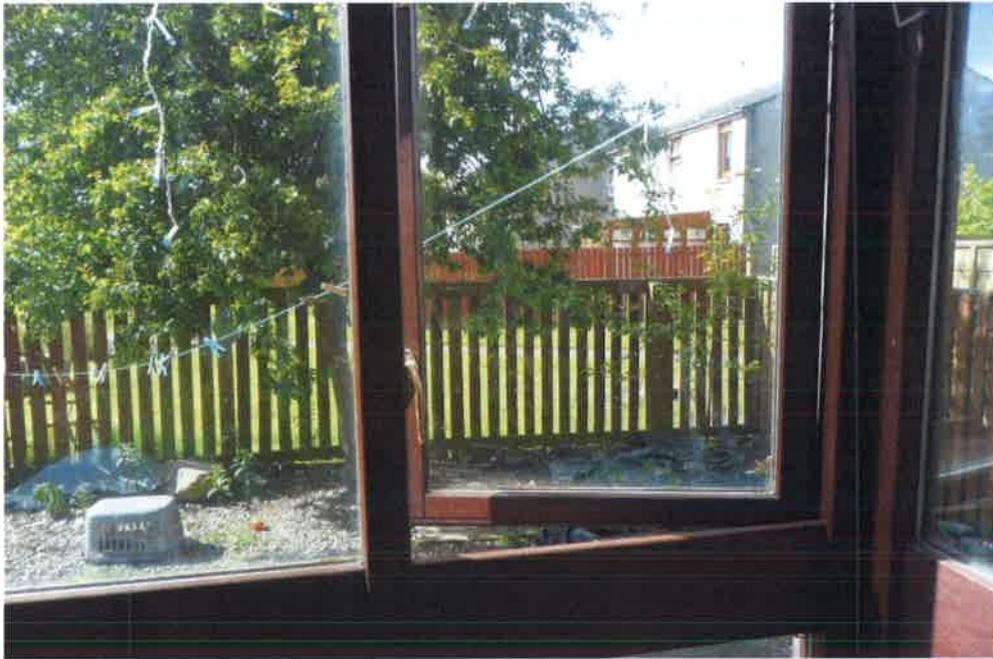
Conservatory window in open position. – does not close properly

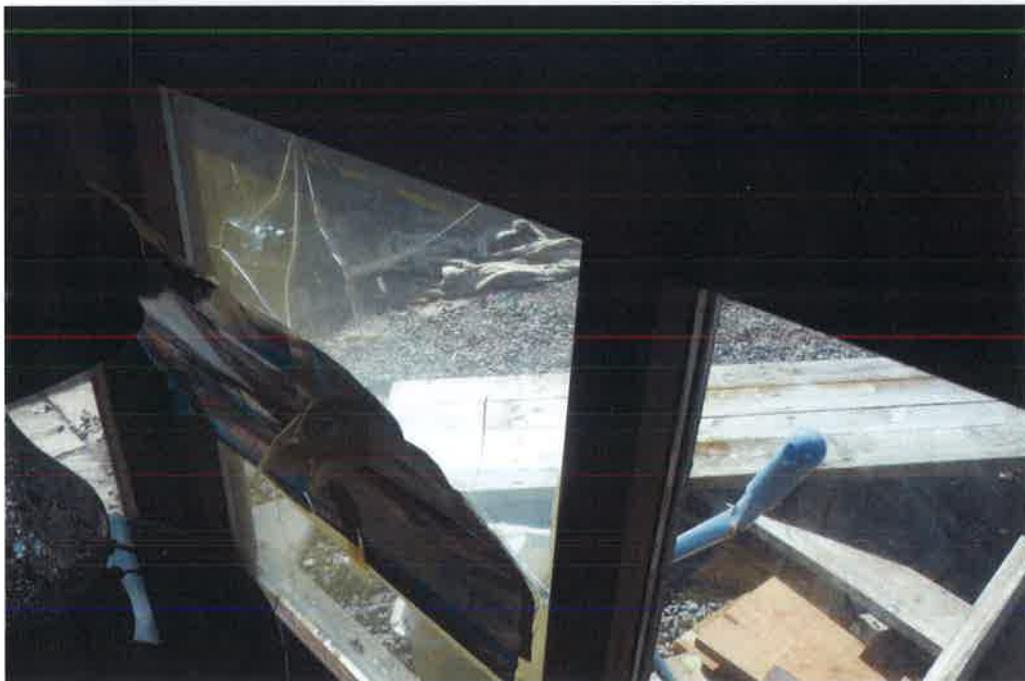
Conservatory – cracked pane of glass covered by cereal packet

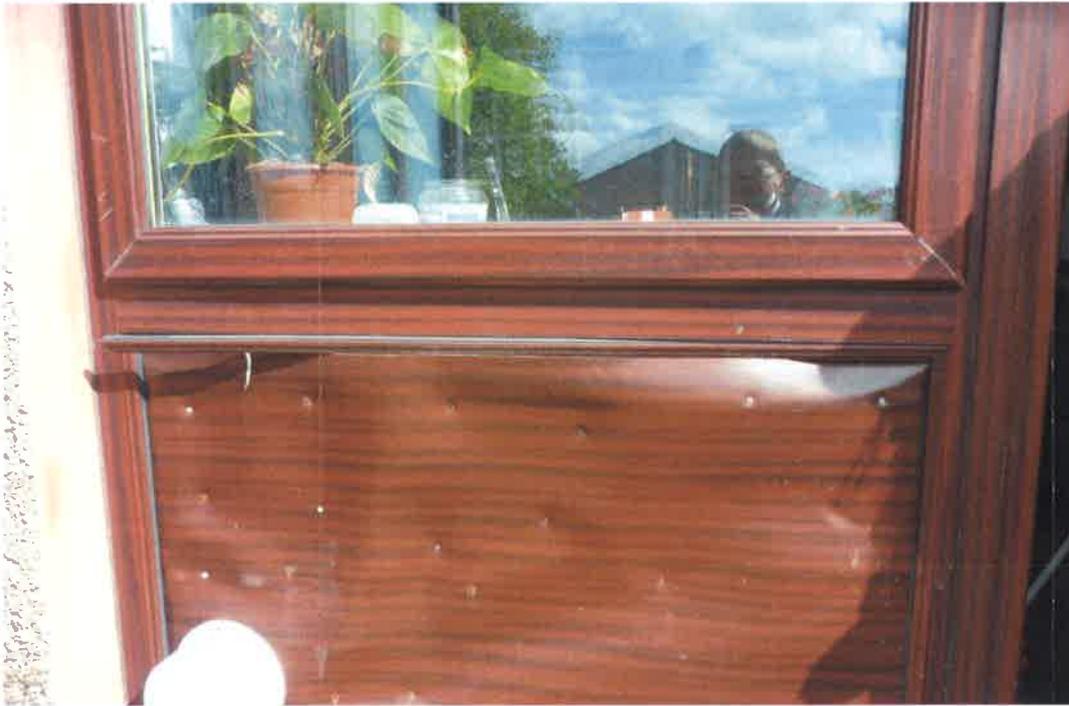
The rear exterior door of the Property is set into a UPVC frame along with the adjacent kitchen window and a panel beneath. When a modest amount of pressure was applied to the frame of the open exterior door, the entire UPVC frame incorporating the door, window and panel flexed considerably. The tribunal noted in particular the panel beneath the window to have failed entirely as a consequence of which the tribunal concluded that the UPVC frame had lost structural integrity. The tribunal was satisfied that the entire arrangement of the rear exterior door, window and panel within the UPVC frame was not in a reasonable state of repair and in proper working order.

**Damaged UPVC panel beneath kitchen window**

- (iii) To repair or replace the handle of the rear exterior door of the Property leading from the kitchen to the garden to ensure that the door opens, closes and locks correctly and is in a reasonable state of repair and in proper working order.
- (iv) To repair or replace the UPVC frame including the rear exterior door from the kitchen to the garden, adjacent window and panel beneath the window to ensure that the combined structure is in a reasonable state of repair and in proper working order.

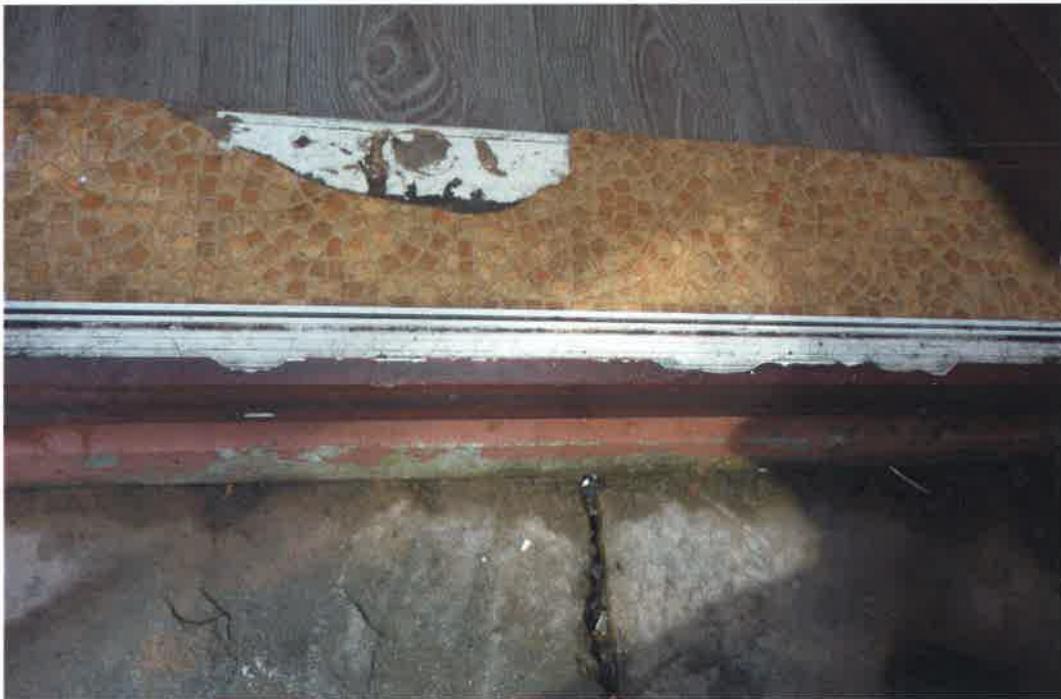
The tribunal examined the exterior door leading from the kitchen to the back garden. Again the sill was found to be damaged and the Tenant reported that during periods of heavy rain water would leak into the kitchen. The handle of the rear door was also found not to operate correctly in that whilst the handle would lock the operating mechanism was broken. The tribunal was satisfied that both exterior doors were not wind and water tight and were not in a reasonable state of repair and in proper working order.

**Kitchen door to garden showing damaged sill which leaks**

- (i) To repair or replace the damaged sill to the front exterior door of the Property to ensure that the door is wind and watertight and in a reasonable state of repair and in proper working order.
- (ii) To repair or replace the damaged sill to the rear exterior door of the Property leading from the kitchen to the garden to ensure that the door is

wind and watertight, in a reasonable state of repair and in proper working order.

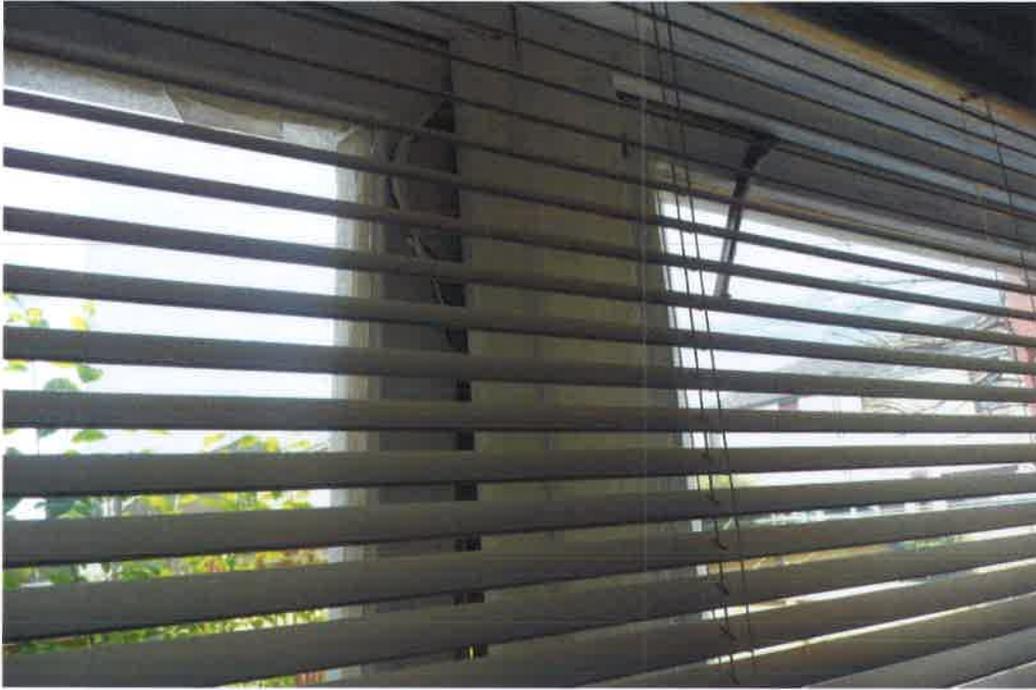
The tribunal examined the windows throughout the Property. In the livingroom the Tenant had replaced the two window handles to allow the windows to open and close securely. However, the seals of the windows were hanging down. The window on the upper landing of the Property would not open or close at all and no key to the lock of the handle had been provided. Elsewhere and throughout the Property the window handles were loose and the windows did not open and close correctly. The tribunal concluded that the windows throughout the Property do not meet the repairing standard in that they are not in a reasonable state of repair and in proper working order.

Living room window showing loose draughtproofing strips

- (i) Under exception of the window on the upper landing, to repair or replace the handles of the windows of the Property to ensure that they open, close and lock correctly and are in a reasonable state of repair and in proper working order.
- (ii) Within the livingroom, to repair or replace the seals around the windows to ensure that the windows are wind and watertight and in a reasonable state of repair and proper working order.
- (iii) On the upper landing to provide a key to allow the window to be unlocked and opened, and thereafter if required to repair or replace the window handle to ensure that it opens, closes and locks correctly and is in a reasonable state of repair and in proper working order.

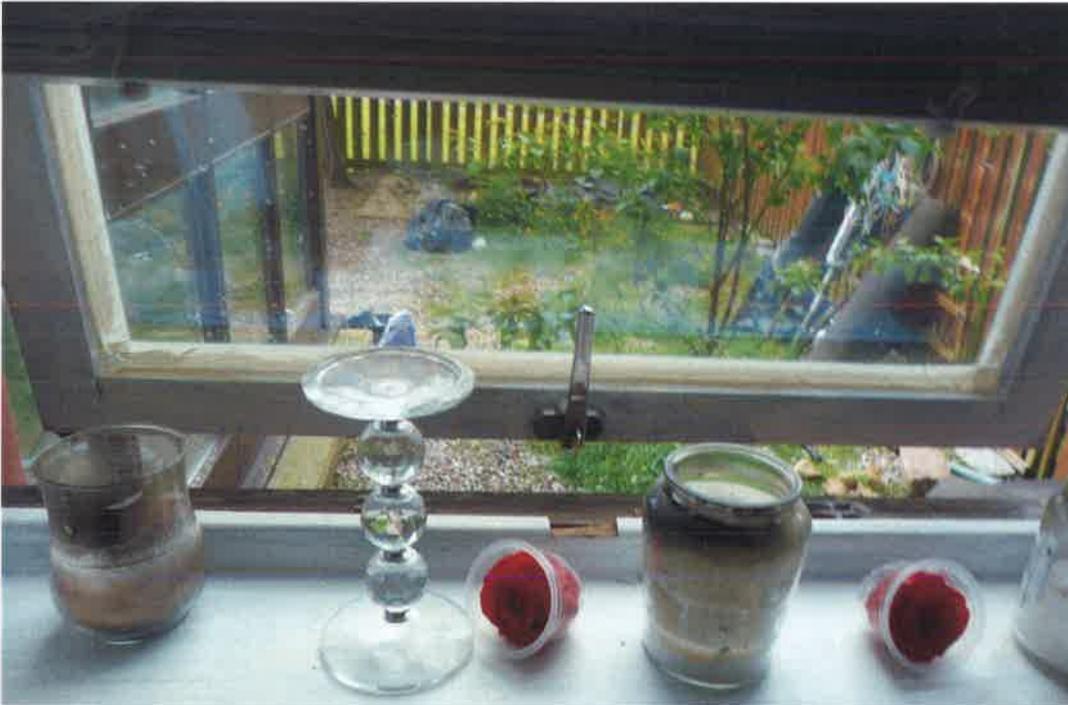
Living room window – replacement locks fitted by tenant

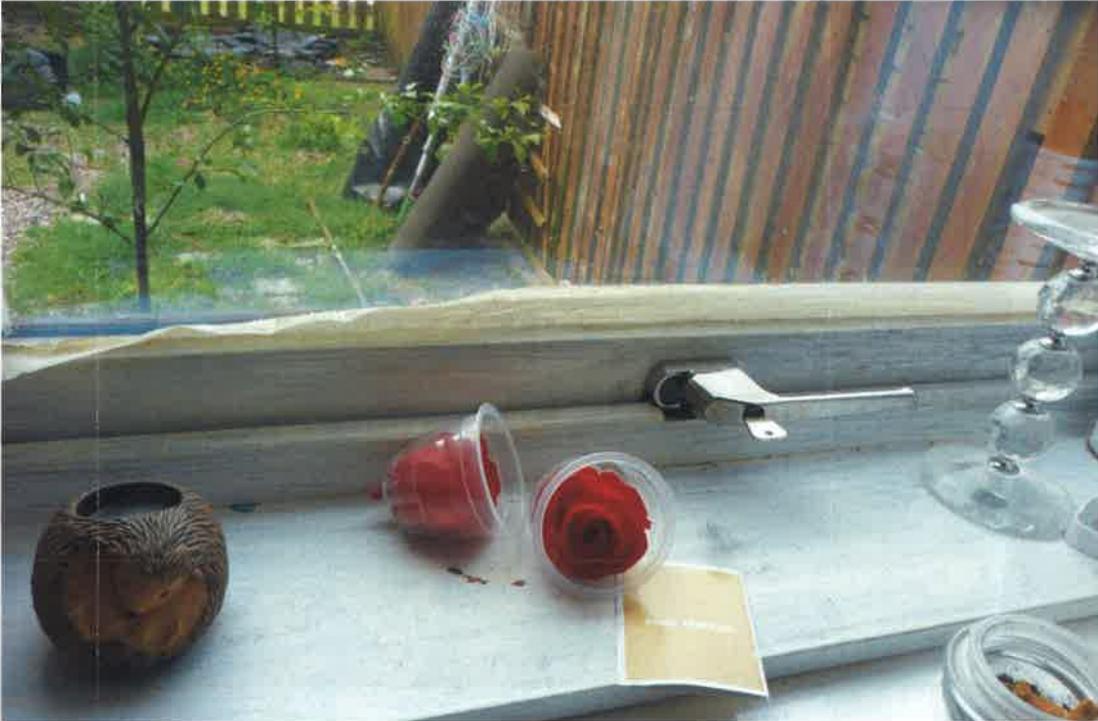
Living room window – replacement locks

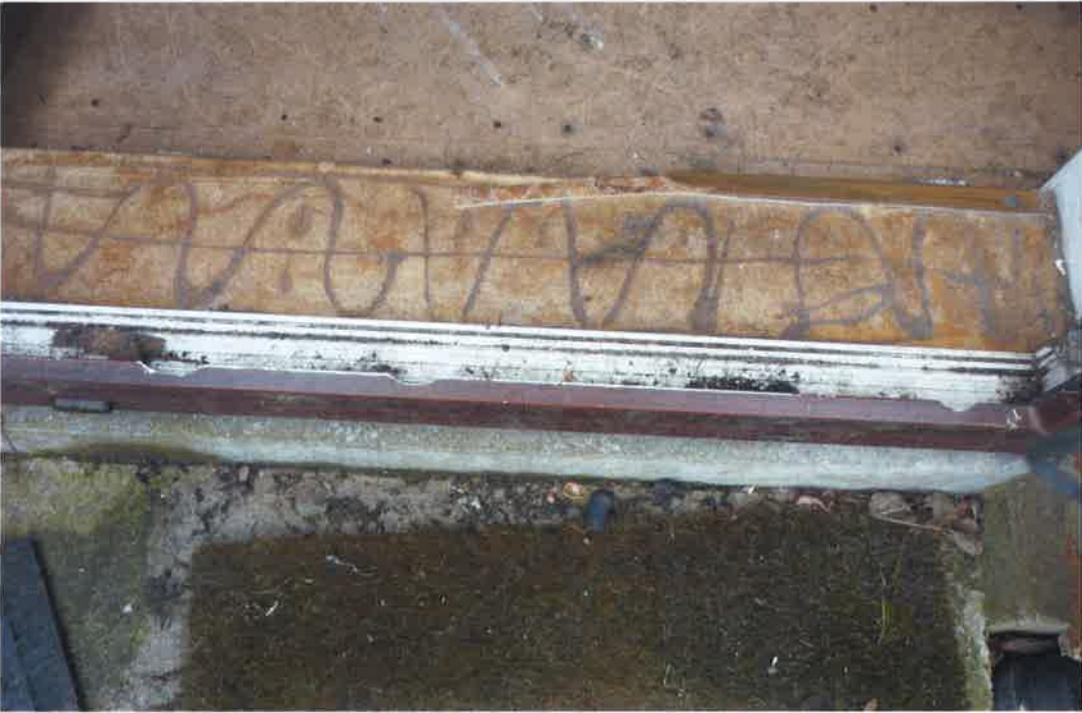
The tribunal examined the front exterior door into the Property. The sill of the door was found to be damaged and the Tenant reported that water leaked into the hallway during periods of heavy rain.

Front door – damaged sill which leaks

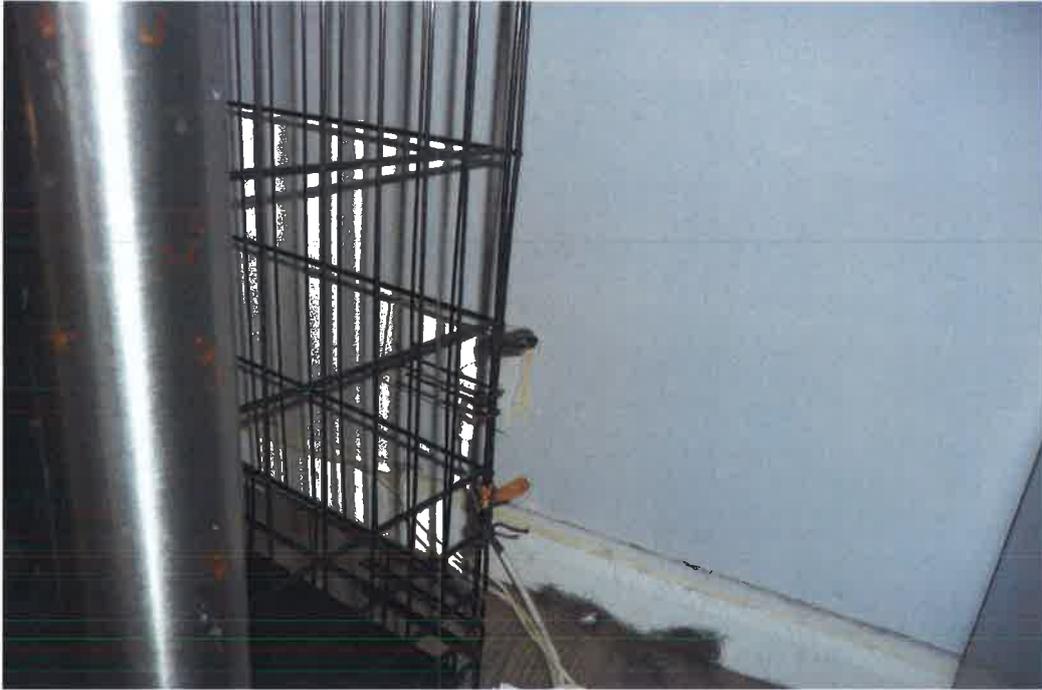
Loose socket in kitchen to left of fridge

- (i) To repair or replace the loose sockets within the kitchen namely to the left of the fridge freezer and to the left of the external door to the rear garden to ensure that they are in a reasonable state of repair and in proper working order.

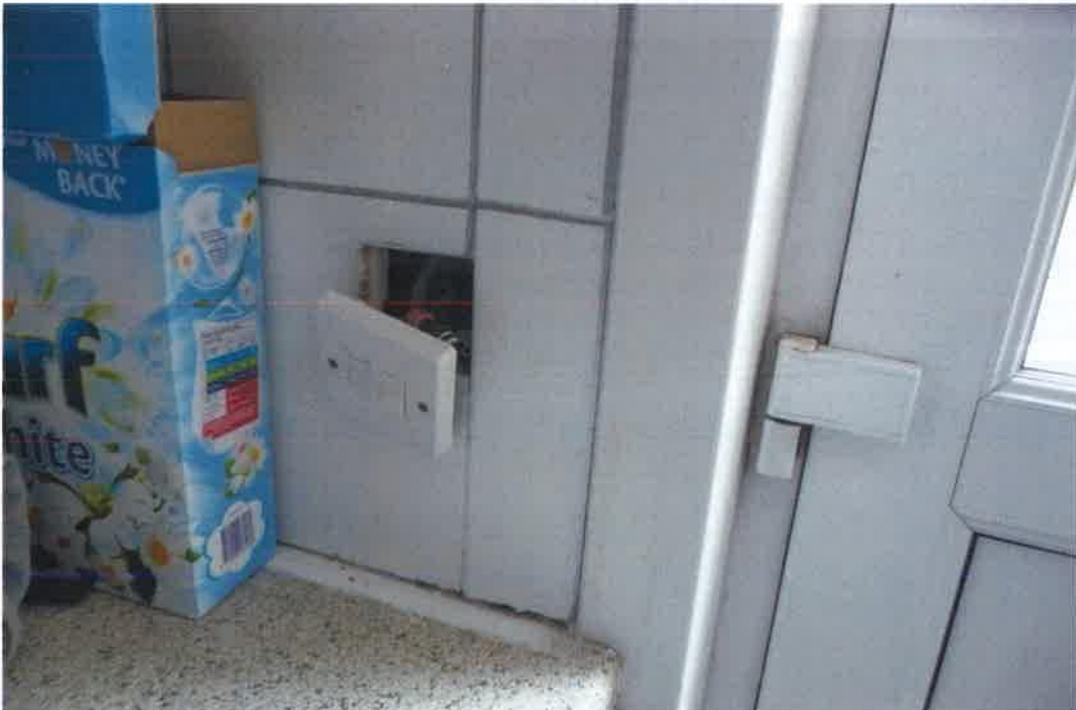
Loose and dangerous socket in kitchen to left of door

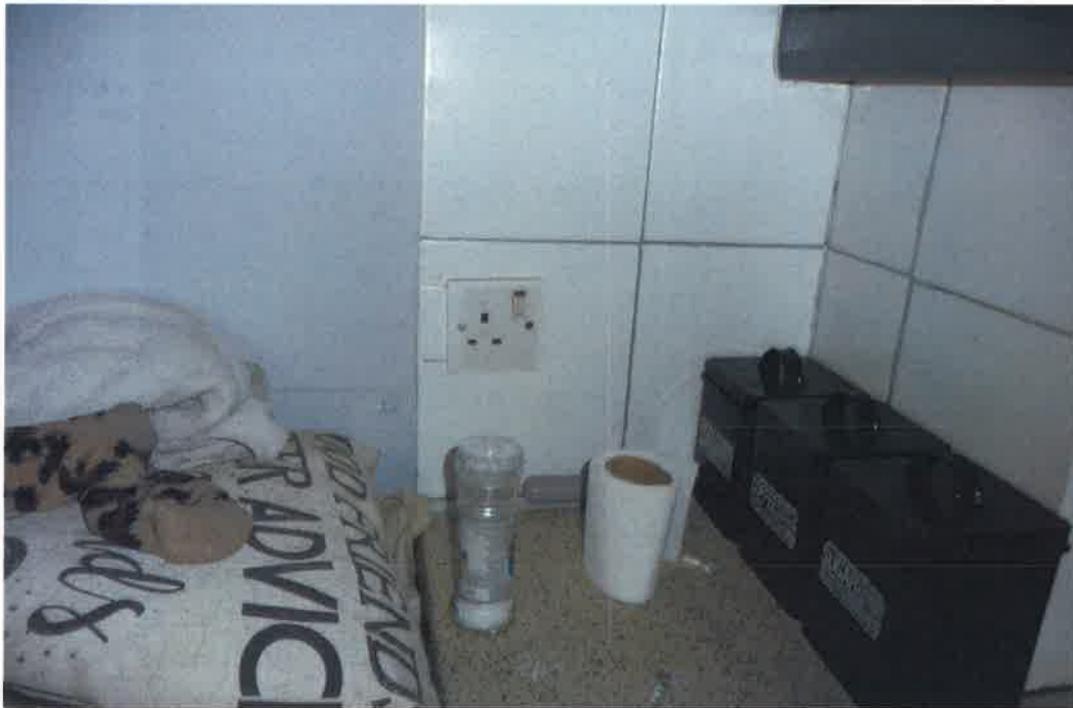
Kitchen socket to right of door which does not work

- (iii) In the kitchen to repair or replace the switch to the right of the door from the hall to ensure that it is in a reasonable state of repair and in proper working order.

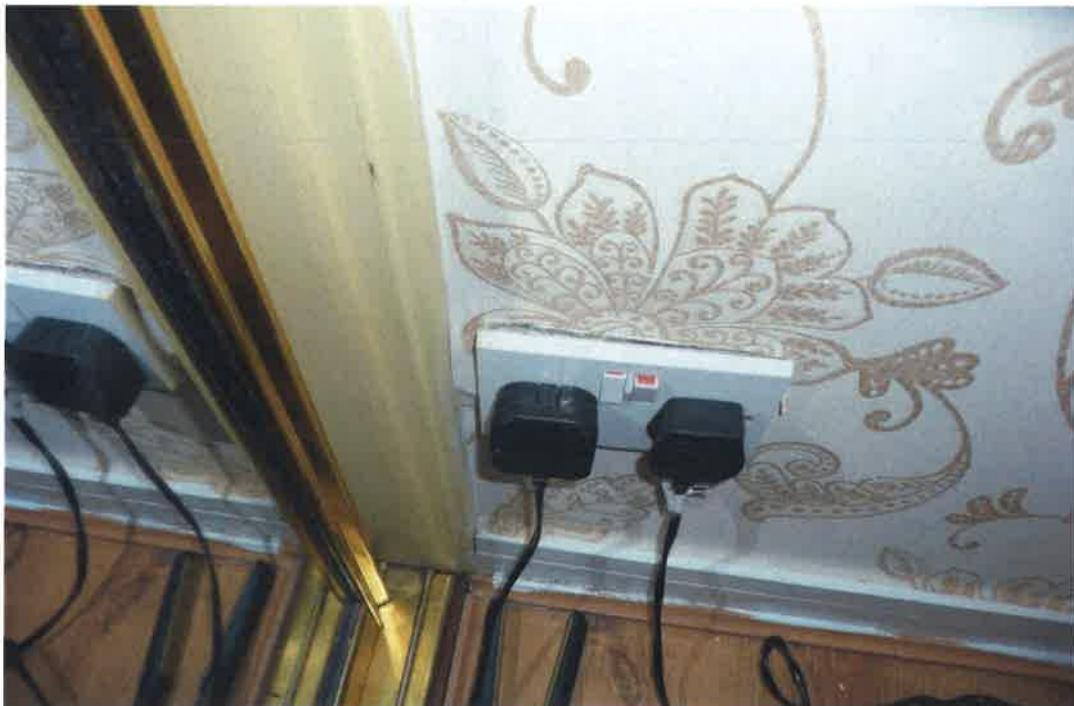
Loose socket in bedroom

- (ii) To repair or replace the loose socket in the main bedroom (situated upstairs to the right of the bathroom) to the right of the window to ensure that it is in a reasonable state of repair and in proper working order.

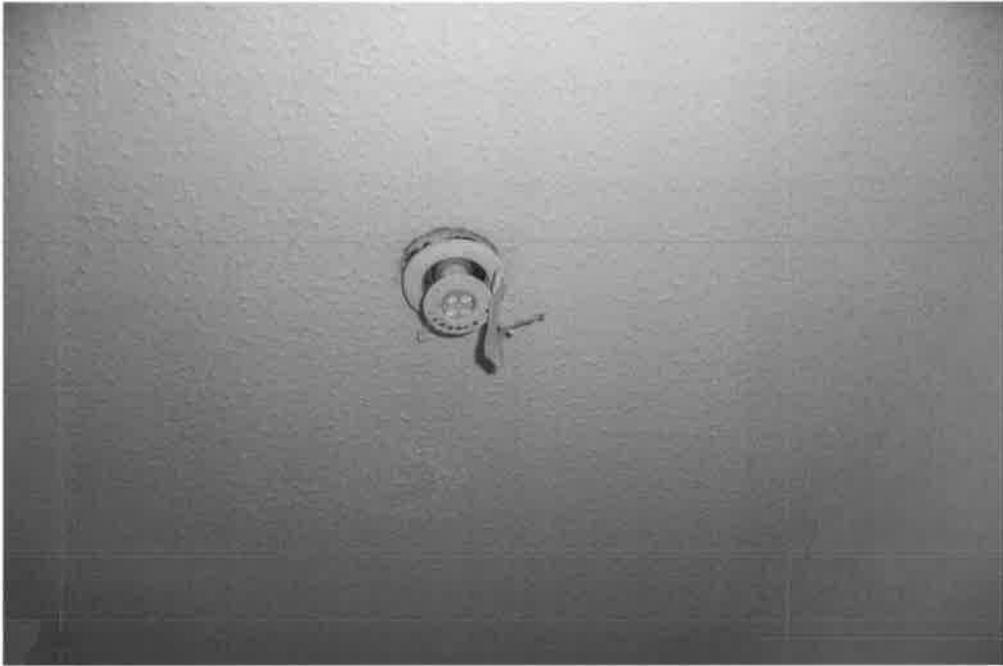
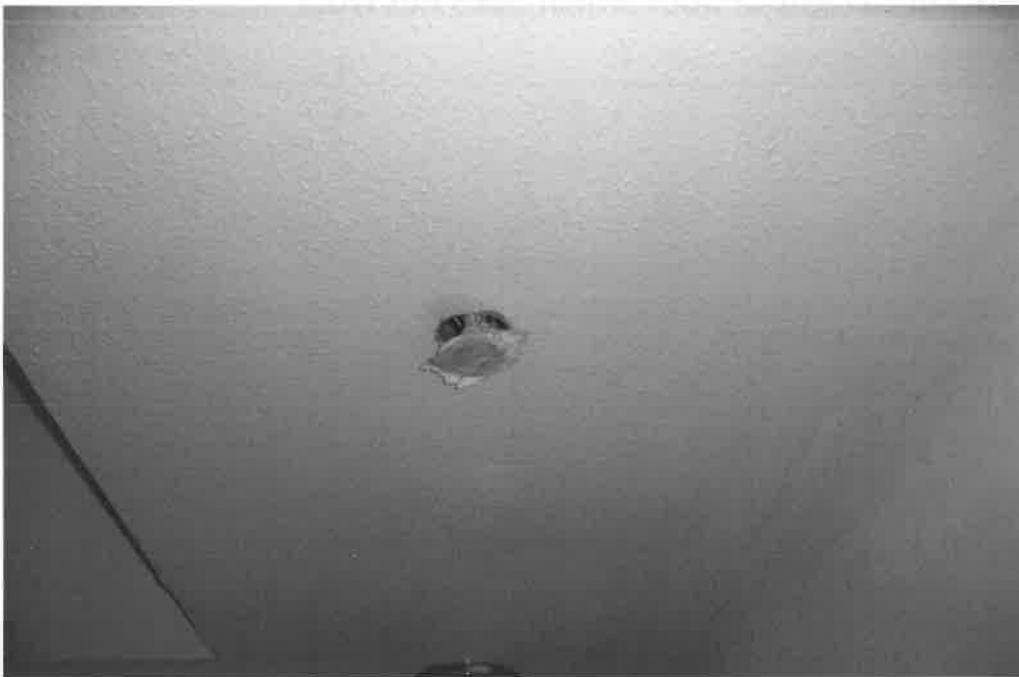
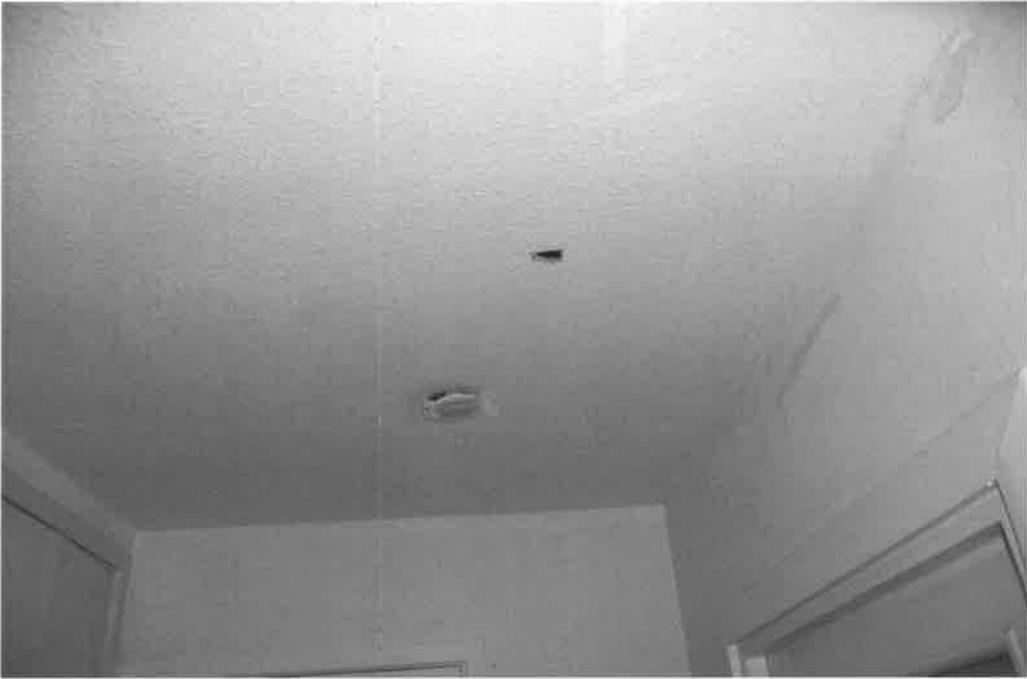
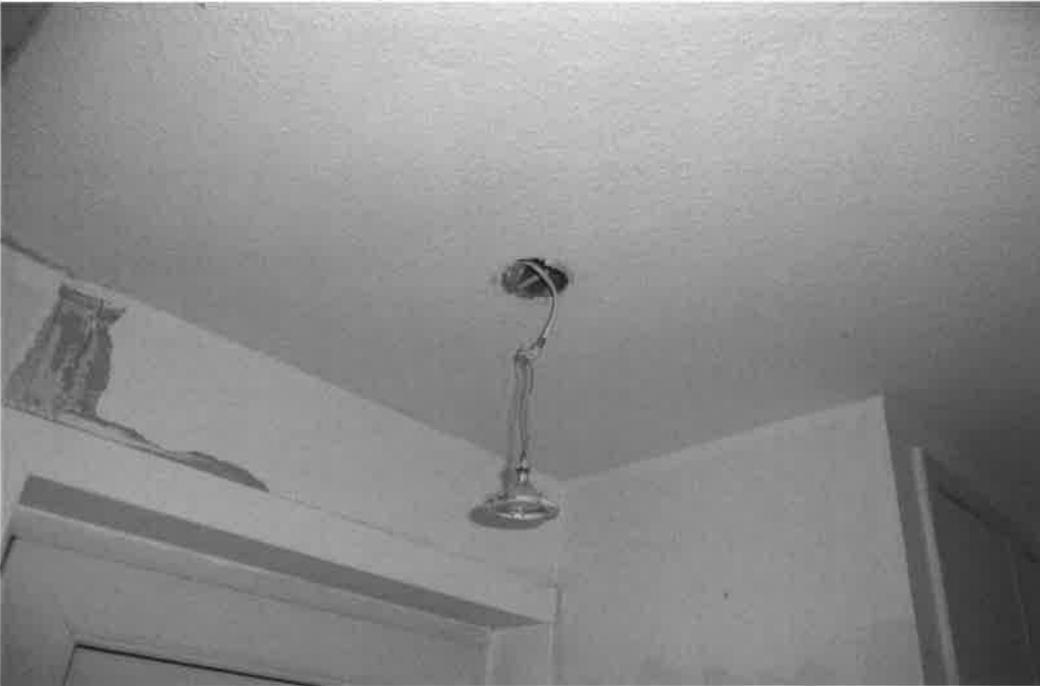
Loose ceiling downlight in hallway

2<sup>nd</sup> loose ceiling light in hallway

**3<sup>rd</sup> loose ceiling light in hallway**

**4<sup>th</sup> loose ceiling light in hallway**

- (vi) To repair or replace the spotlights in the lower hall to ensure that they are in a reasonable state of repair and in proper working order.
- (vii) To install sufficient smoke alarms and heat detectors that are mains wired and interlinked and otherwise comply with the requirements of the relevant fire legislation.

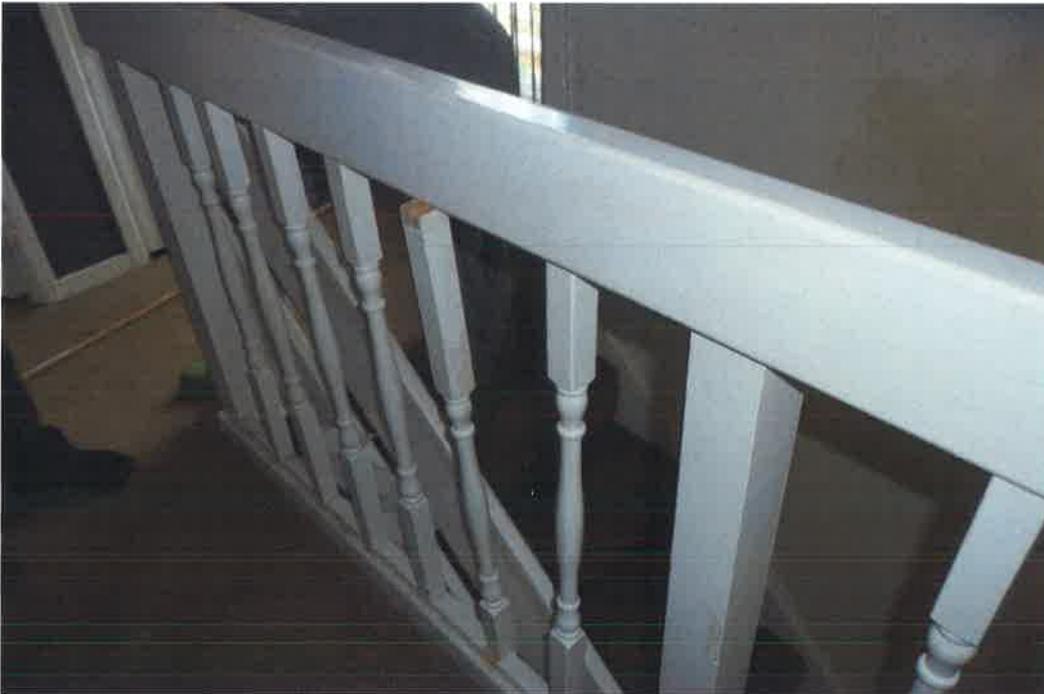
In the upper hall the spindles of the banister were loose and could readily be removed. In addition the tribunal identified that the spindles are centred too far apart. They ought to be no more than 100mm apart to comply with building regulations. The tribunal was satisfied that the banister in the upper hall is not in a reasonable state of repair or in proper working order.

**Bannister rail on landing showing loose spindles and wide centres**

To repair or replace the spindles of the banister on the upper landing to ensure that they are in a reasonable state of repair and at a maximum distance apart of 100mm.

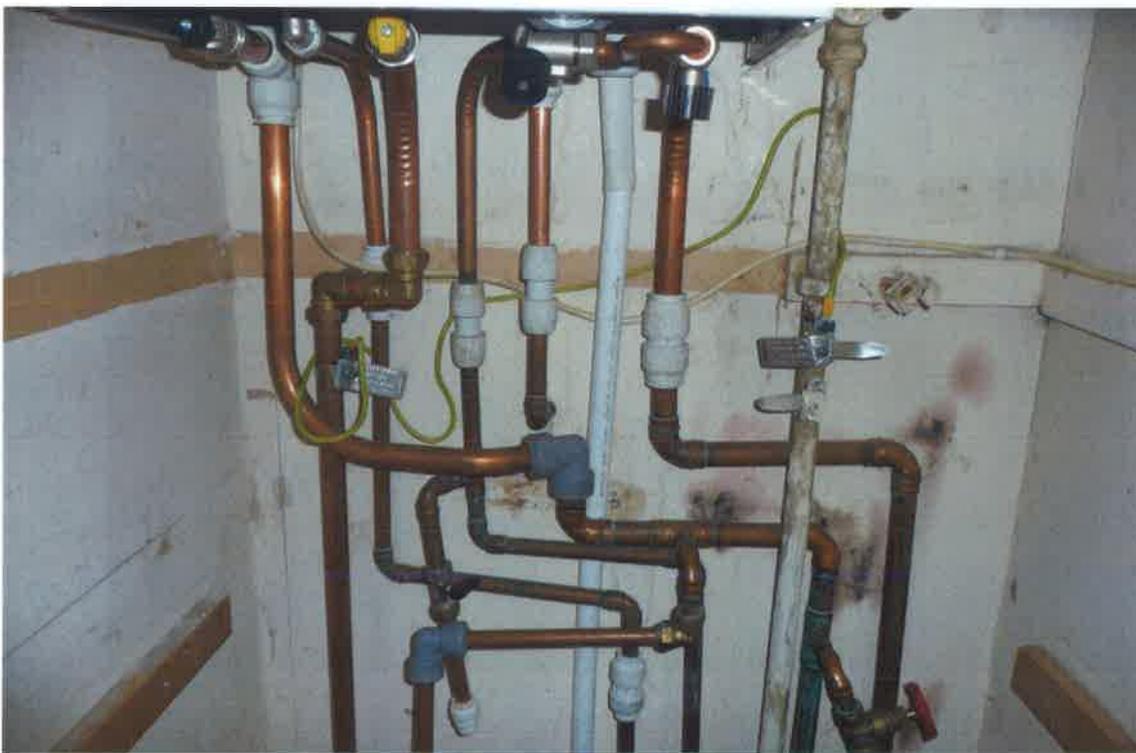
The Tenant explained that prior to her reporting the boiler leaking a few days before Christmas 2016 the central heating system worked only intermittently. Despite her reporting the boiler having leaked no repairs had been carried out and the plumber who had looked at the boiler had condemned it. No repairs have been effected. The tribunal noted the terms of the previous RSEO with regard to the boiler. However, the tribunal noted there to be a wider concern with regard to the operation of the central heating system itself. The tribunal was not satisfied that the central heating system is in a reasonable state of repair and in proper working order.

**Pipework beneath boiler showing mix of copper pipes and plastic couplings**

To engage a reputable specialist to investigate the cause of the central heating system failing to operate correctly and to carry out any works recommended by that specialist to ensure that the central heating system is in a reasonable state of repair and in proper working order and safe to use, and without prejudice to the foregoing generality, the tribunal requires the Landlords to have the specialist prepare a report on any faults affecting the central heating system and to exhibit this report to the tribunal.

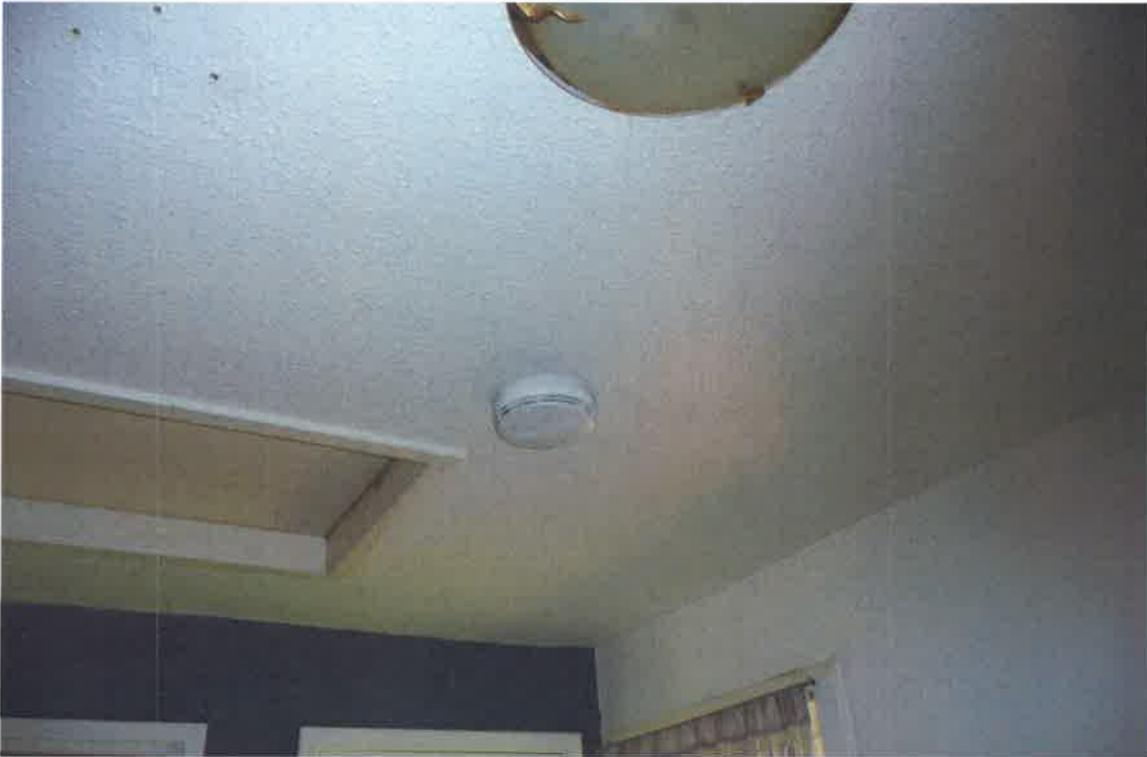
The tribunal observed only one mains wired smoke alarm within the upper hall of the Property. The tribunal noted the terms of the previous RSEO requiring two mains wired and interlinked smoke alarms to be installed or repaired as appropriate in the ground and first floor halls. Despite that previous RSEO being outstanding, the tribunal determined that an additional mains wired and interlinked smoke alarm is required within the livingroom and a heat detector within the kitchen.

**Single smoke alarm on landing**
