**First-tier  
Tribunal for  
Scotland (Housing and Property Chamber)**

**Decision and Statement of Reasons: Housing (Scotland) Act 2006  
Section 24**

**Chamber Ref: FTS/HPC/RP/19/1600**

**50 Ravenscraig Road, Dundee DD2 4ND (“The House”)**

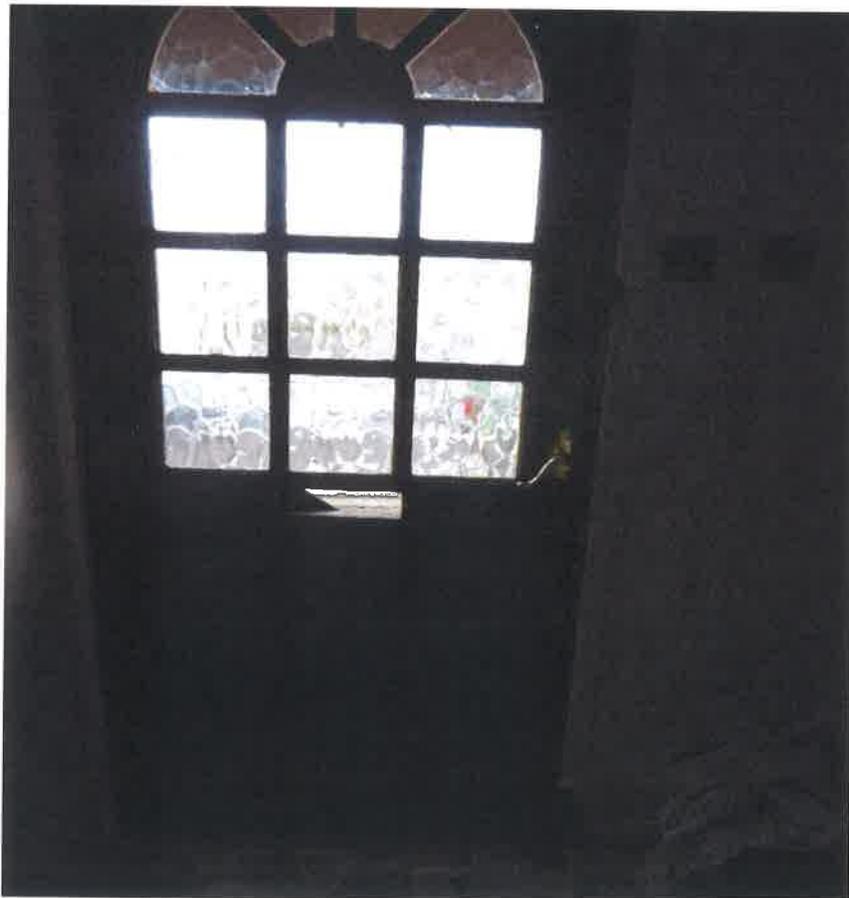
18. The front door was discussed first. The Ordinary member noted that there were areas of rot on the door. The letterbox was hanging off the door. The door was not wind proof with nothing stopping the wind going through the letterbox. The door also did not fit the frame. It was also noted that the wood was going soft. The Ordinary member noted that it may be possible to repair the door but it maybe expensive and would be prudent to replace the door. Neither party had any comments on this point.

Front door seen from inside. No letterbox cover, loose handle, deteriorating woodwork to base.

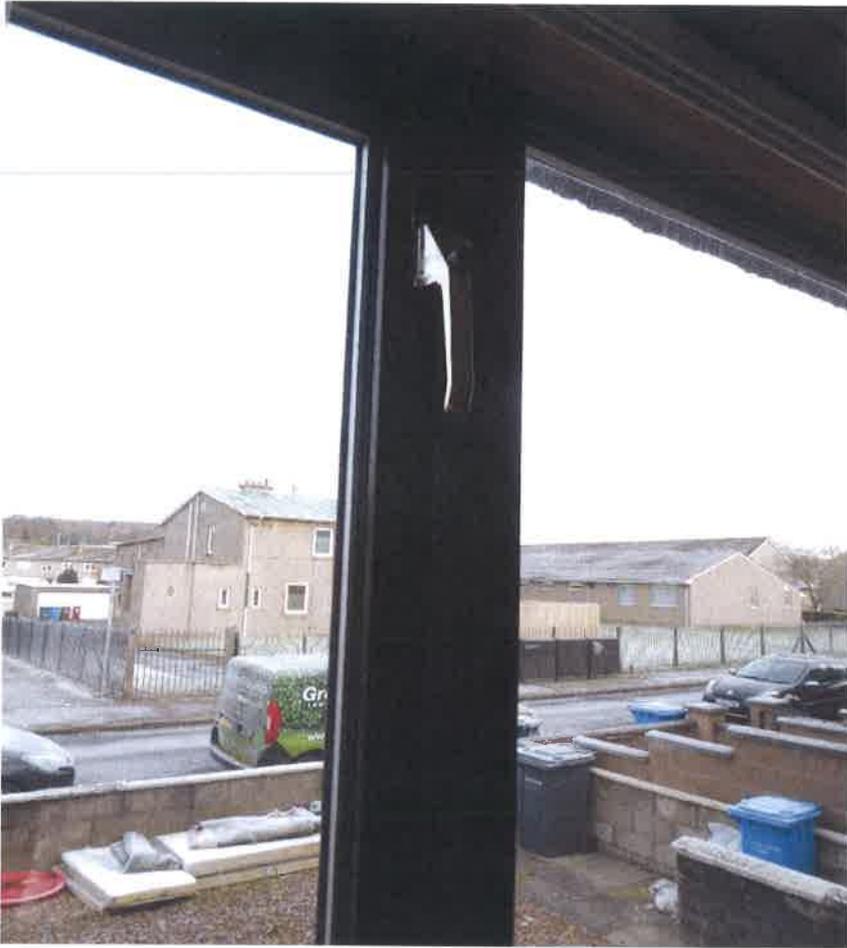
19. The living room window was discussed next. The Ordinary Member noted that the window was in such poor state that it should be repaired or replaced. The window was very loose. When the window was open the frame was quite jelly like with very little substance to it. The window can close but left a small gap. The window has no resistance which it would be expected to have had. It was noted that the rubber seals could be replaced as opposed to replacing the window but that this would not be a repair that would last for long. The Landlord queried if she completed the lower cost repair then would she be able to sell the House. It was confirmed to her that on the point of sale the new owner would take over all obligations. However, the Landlord informed that a failure to carry out the repairs to a standard that would meet the repairing standard could result in a failure to comply being lodged. It is at that point that the case would be referred to the police for prosecution with criminal charges.

Handle to opening section of living room window. Poor fitting, flexible upvc material allows draughts to enter in windy conditions.

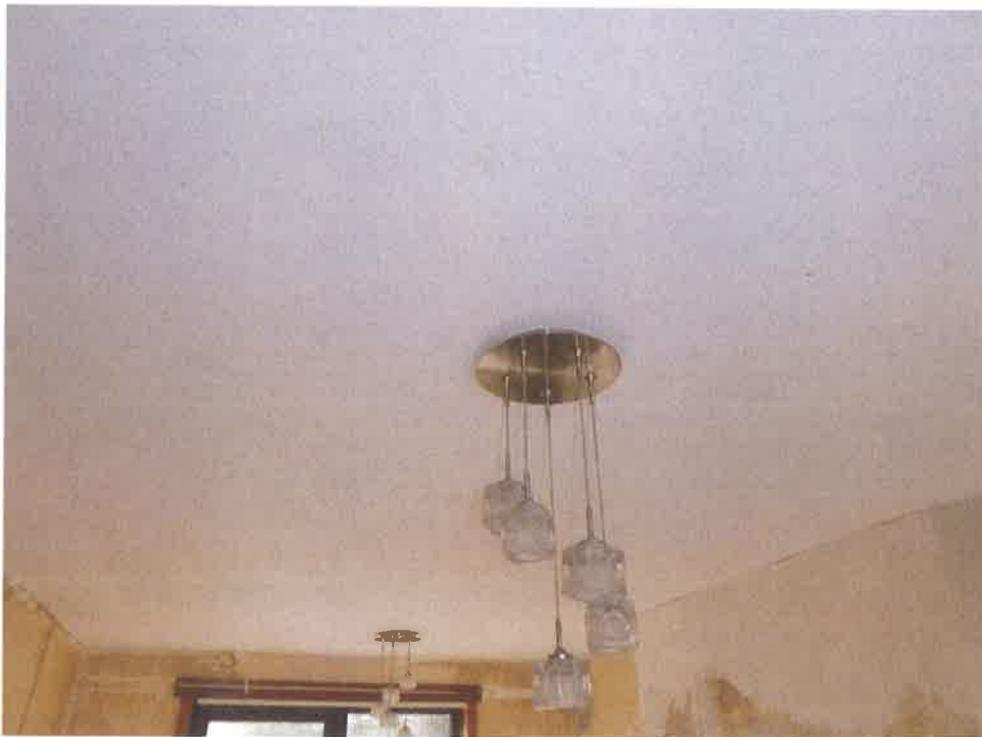
21. The main light in the living room was discussed next. The Ordinary Member noted that the electricity was no on during the inspection. It could not be determined if was working or not. Given that there is currently an RSEO in place for the case FTS/HPC/RP/19/0779 requiring an up to date EICR the Tribunal was of the view that the first RSEO would cover this point. The

Tribunal noted that the earlier inspection under the above referred to case had found the light not to be working. Neither party commented on this.

Living room lights (could not be tested because power off)

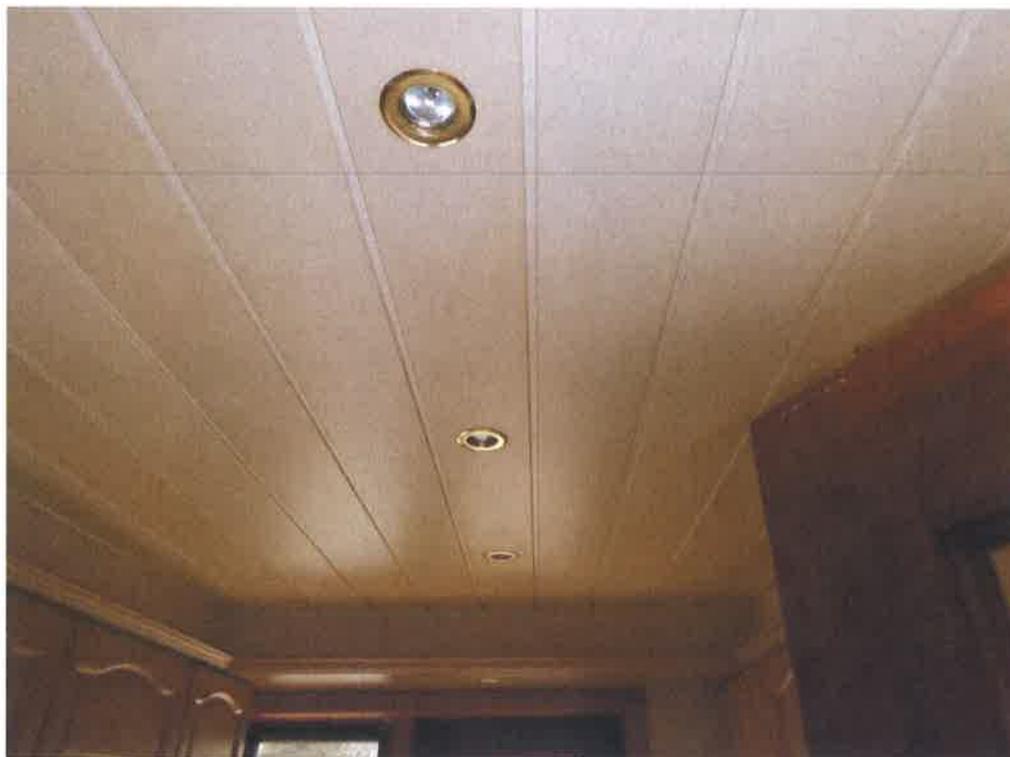
22. The down lights in the kitchen were discuss next. The Tribunal were of the same view as of that in point 21 above that this would be covered by the RESO under case FTS/HPC/RP/19/0779. Neither party commented on this.

Kitchen spotlights (could not be tested because power off)

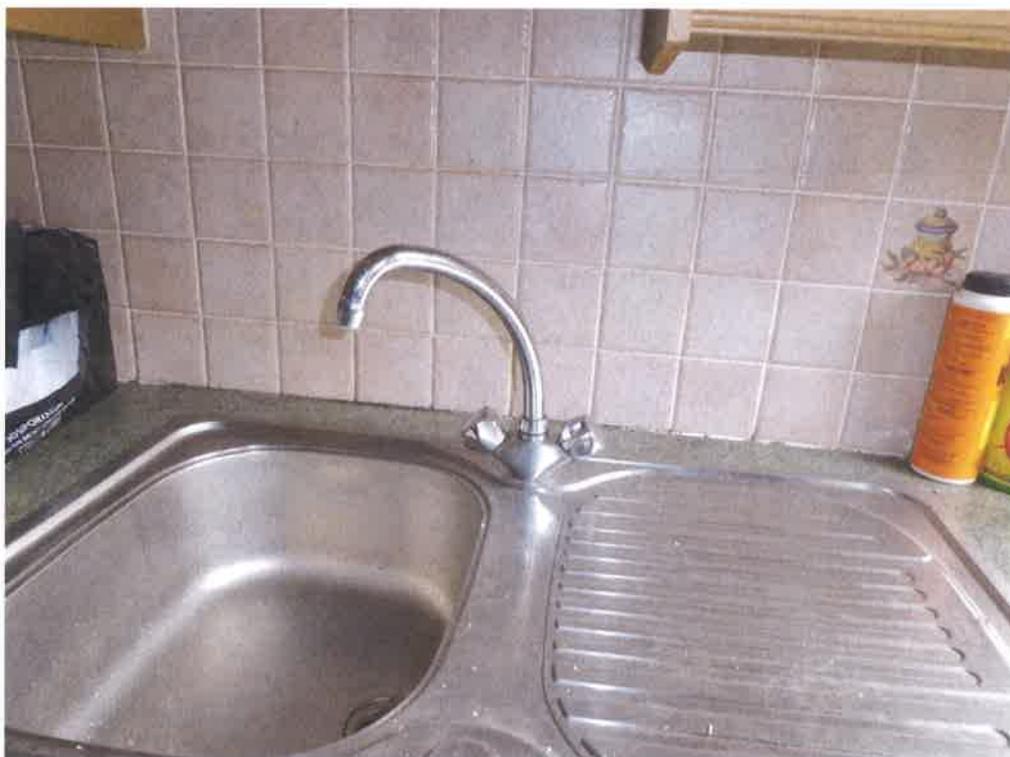
23. The Kitchen tap was discussed next. The Ordinary Member noted that the tap was not working. It will need to be repaired by a plumber. Neither party commented on this point.

Kitchen hot tap. Does not work on hot side (Cold ok)

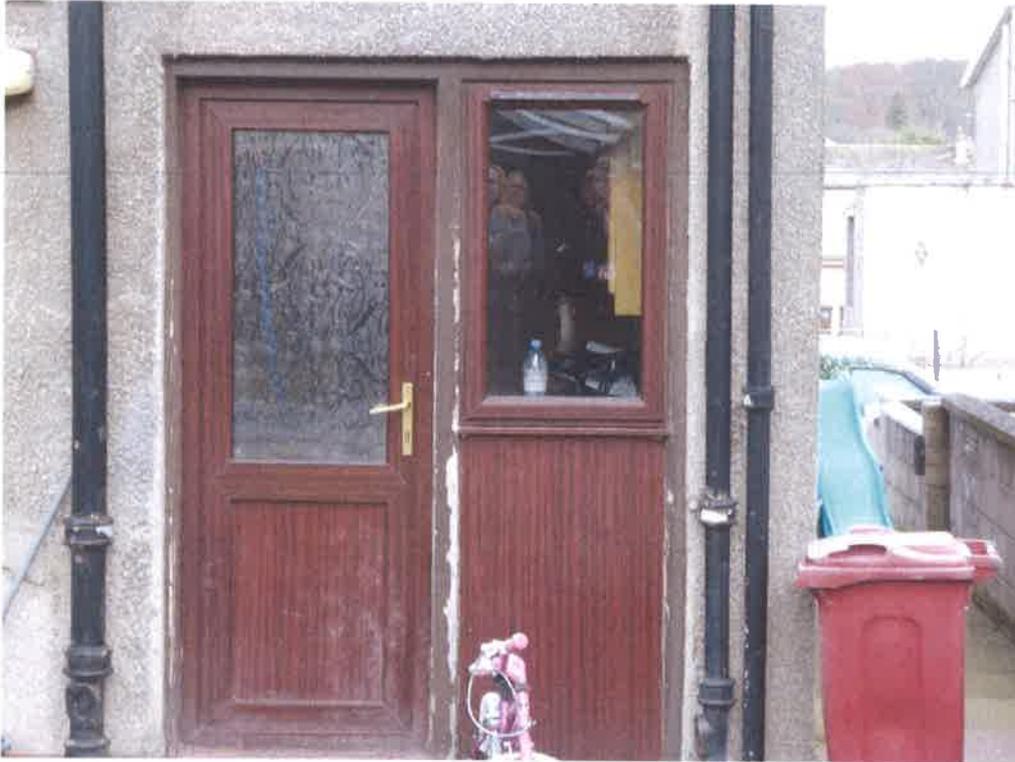
24. The door to the garden from the kitchen was discussed next. The Ordinary member noted that the door was old but that it closed when pushed shut and kept on the latch. This met the repairing standard. Neither party commented on this point.

Kitchen door from exterior. Handle slightly loose but does hold door shut.

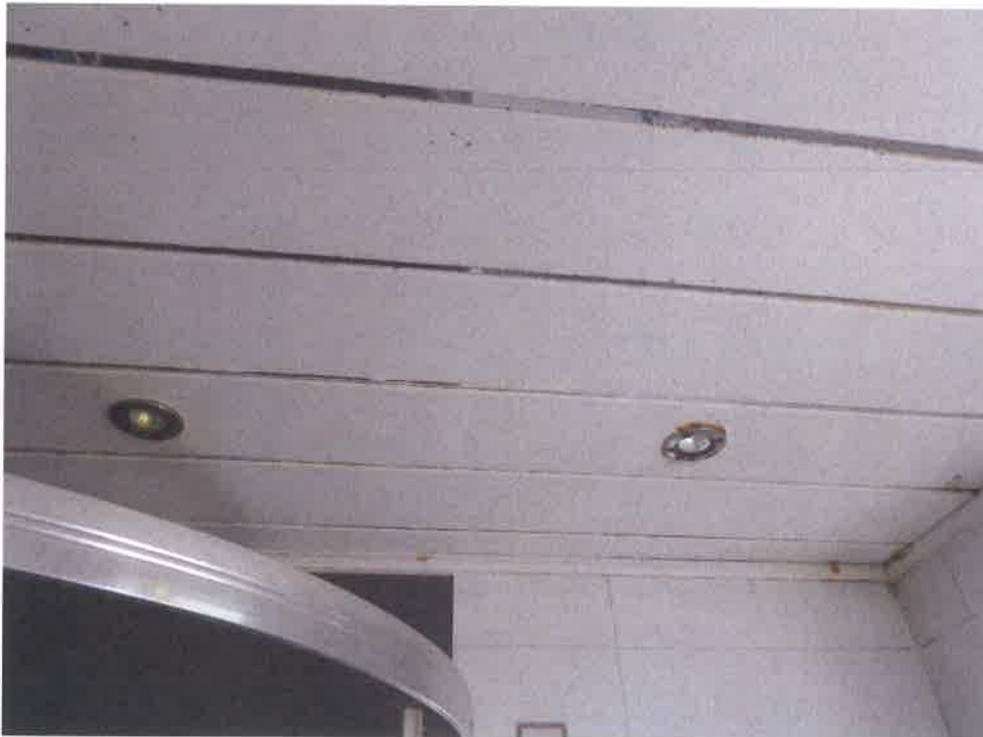
25. The bathroom lights were discussed next. At the earlier inspection the Tribunal had noted the poor condition of the bathroom lights and that they did not work. Although the Tribunal were of the same view as of that in point 21 above that this would be covered by the RESO under case FTS/HPC/RP/19/0779 it was considered that the lights would not be capable of repair and would have to be replaced. Neither party commented on this point.

Bathroom lights rusty and not working

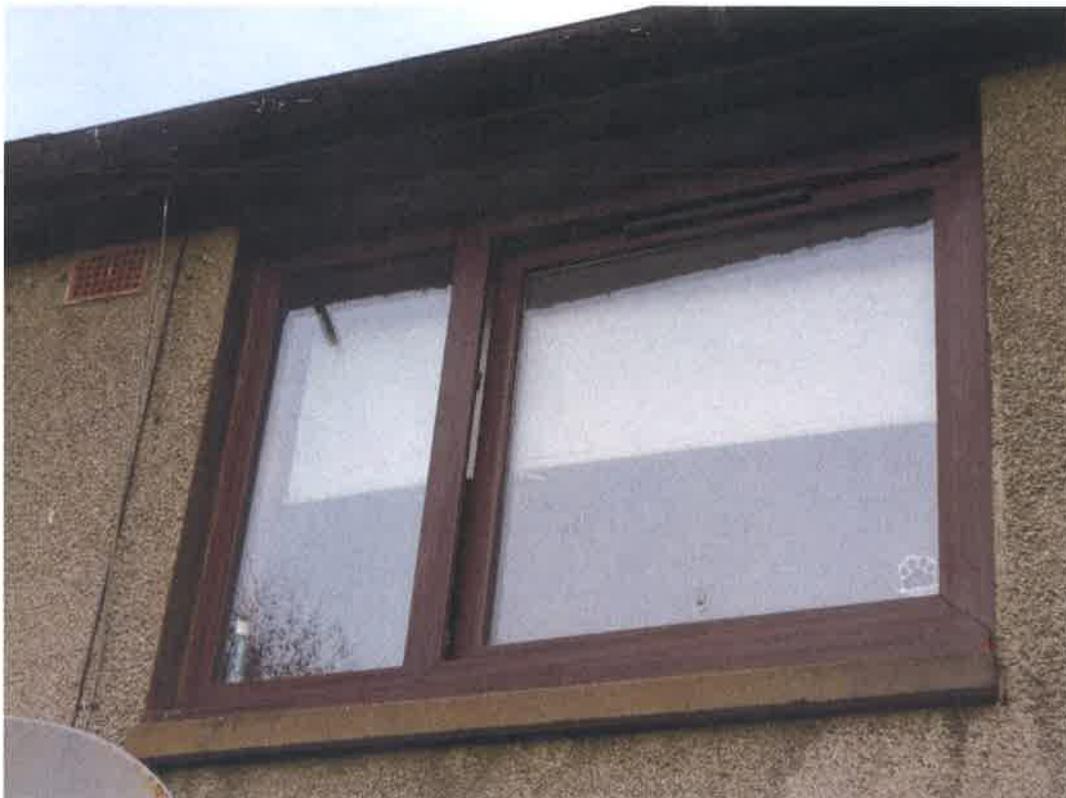
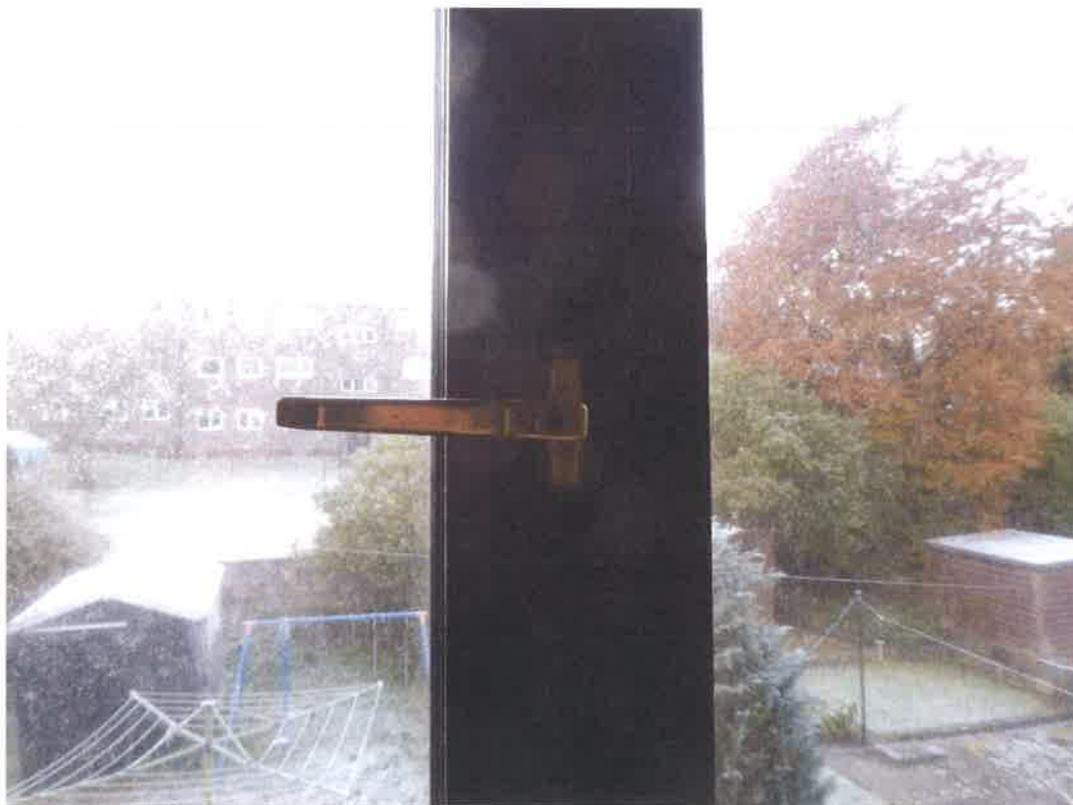
26. The rear bedroom window was discussed next. The Ordinary member noted that the window tilted inwards and did not close properly. The frame was seen to be insubstantial and not long lasting. The window will need to be replaced. Neither party commented on this point.

Rear bedroom window from exterior – does not close properly

Rear bedroom window handle does not work properly and window does not close

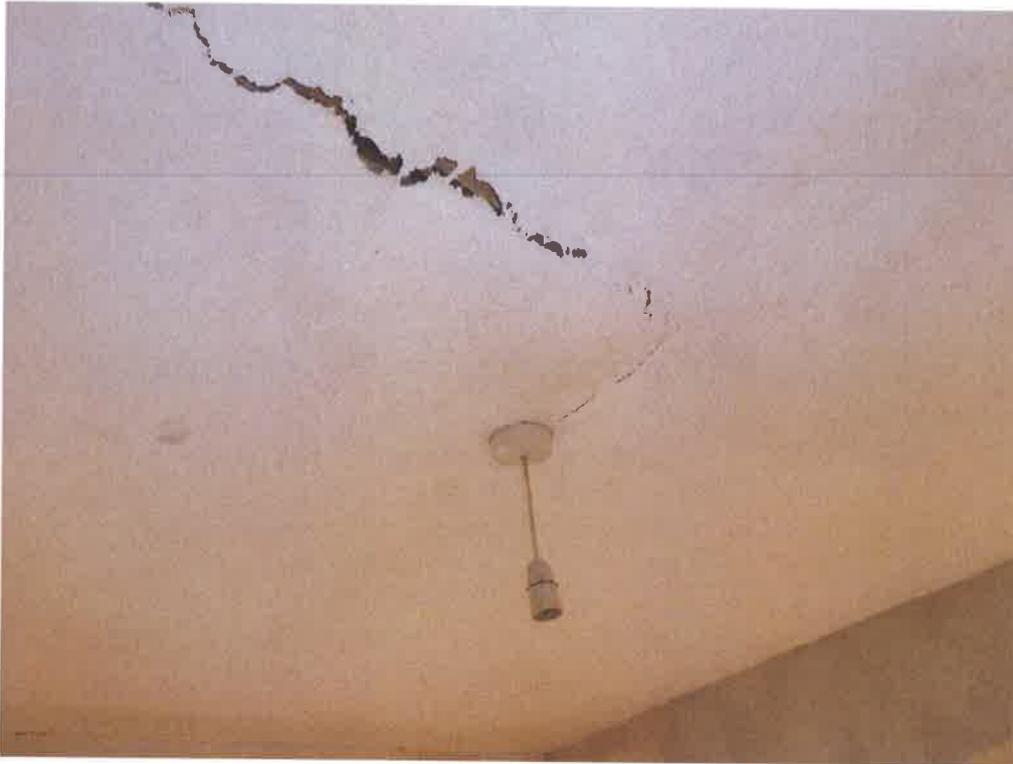
32. It was not listed on the complaints but the Tribunal observed that the rear bedroom ceiling was bowed and showing signs of dampness. The Landlord commented that the attic window had been left open to cause rain to come in. It was now drying out. The Tribunal was of the view that it remained dangerous as it could collapse at any point.

44. The ceiling in the rear bedroom needs repaired as it is bulging as a result of rain coming in through the skylight being open in the attic room above. There is a serious and significant risk that the ceiling will collapse.
45. There are a number of miscellaneous items discarded in the front garden. These items should be removed.
46. The chimney stack in poor condition. The brickwork to the chimney stack and the concrete chimney slab is defective and needs to be repaired.

Rear bedroom ceiling light. Ceiling in dangerous condition (may fall at any moment) due to leak in attic above

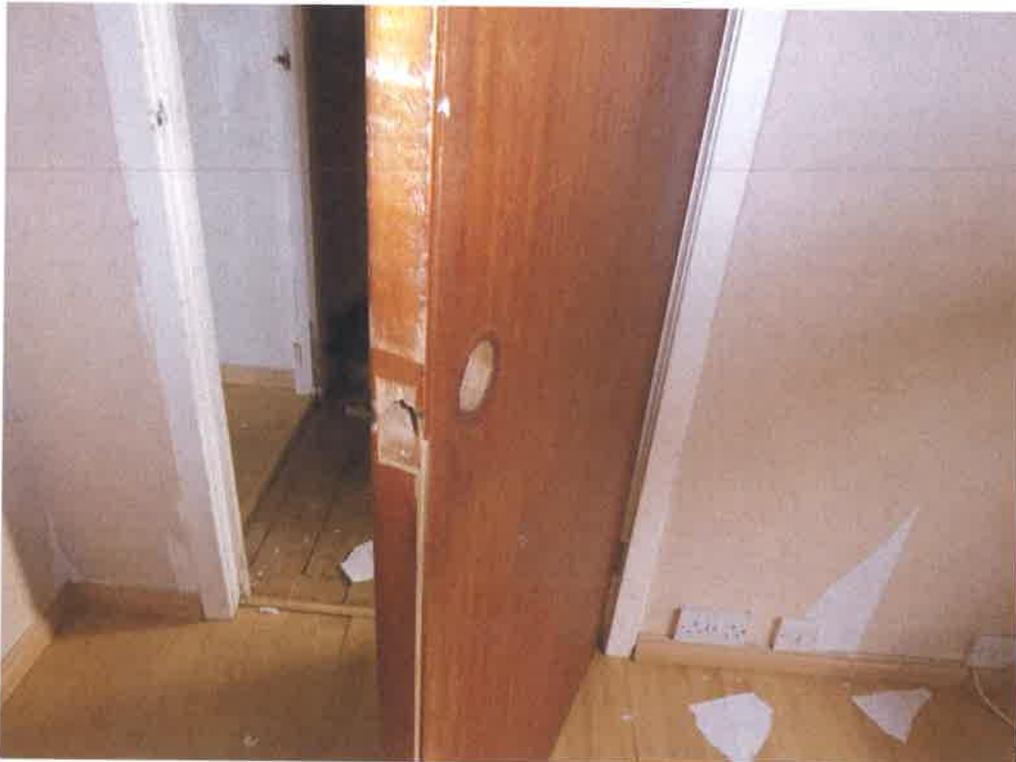
Rear bedroom door

28. The rear bedroom door was discussed next. The Ordinary Member noted that the handle was missing. The door needs to be replaced. Neither party commented on this.

– no door furniture (handles and catch)

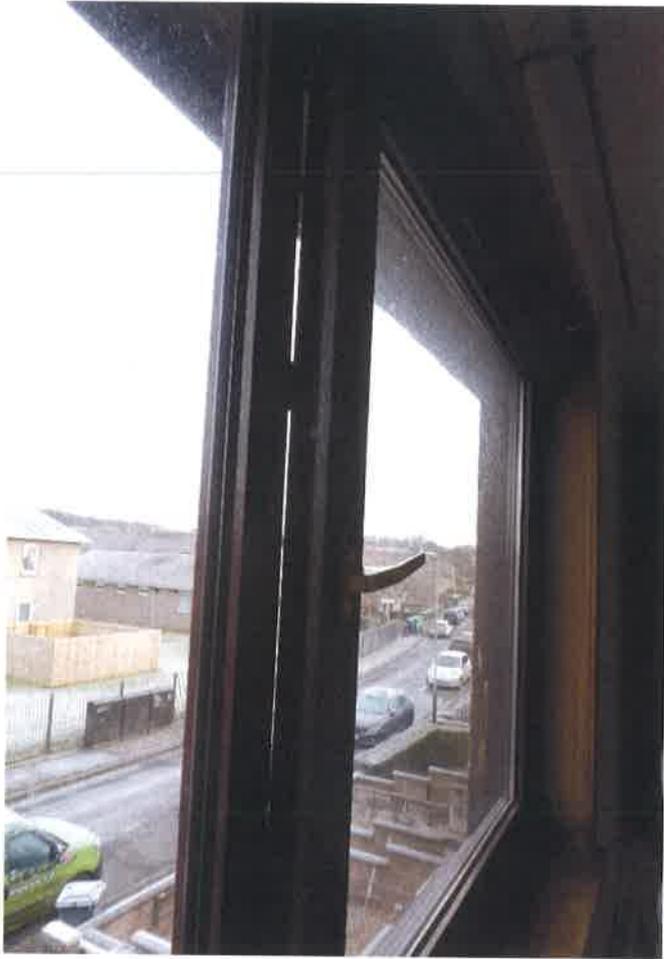
29. The front bedroom window was discussed next. The Ordinary Member noted that the window would not close at all and tilted inwards. The top system for closing was out of place and would not go back in place to shut it. The window was clearly needed replaced as it was too old to repair. Neither party made comment on this point.

Front bedroom window does not close properly – No further than this possible.

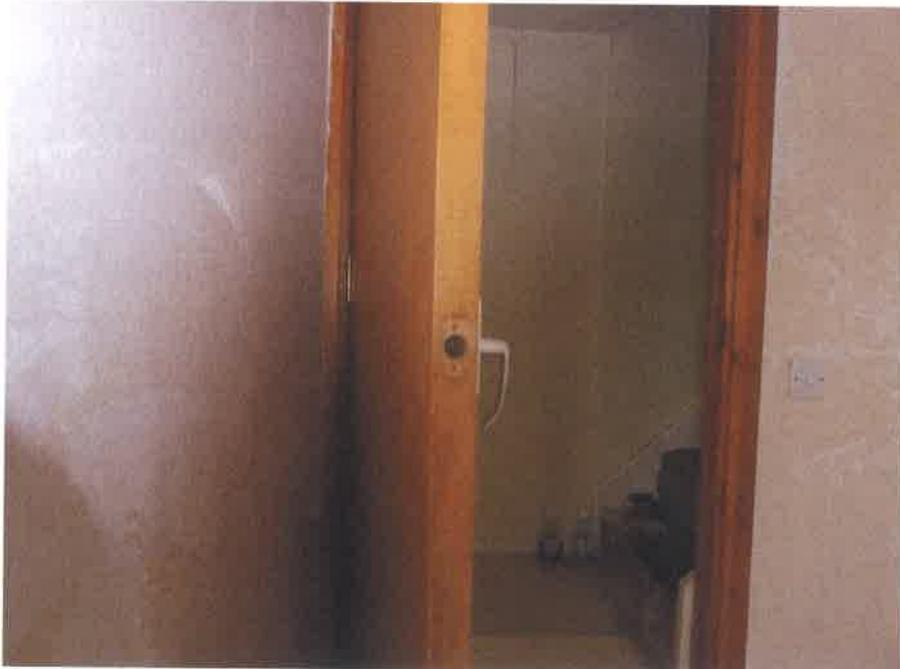
30. The attic door was discussed next. The Ordinary Member noted that the handle was missing. This needs to be replaced. Neither party made comment on this point.

Door to attic – only one handle and no catch

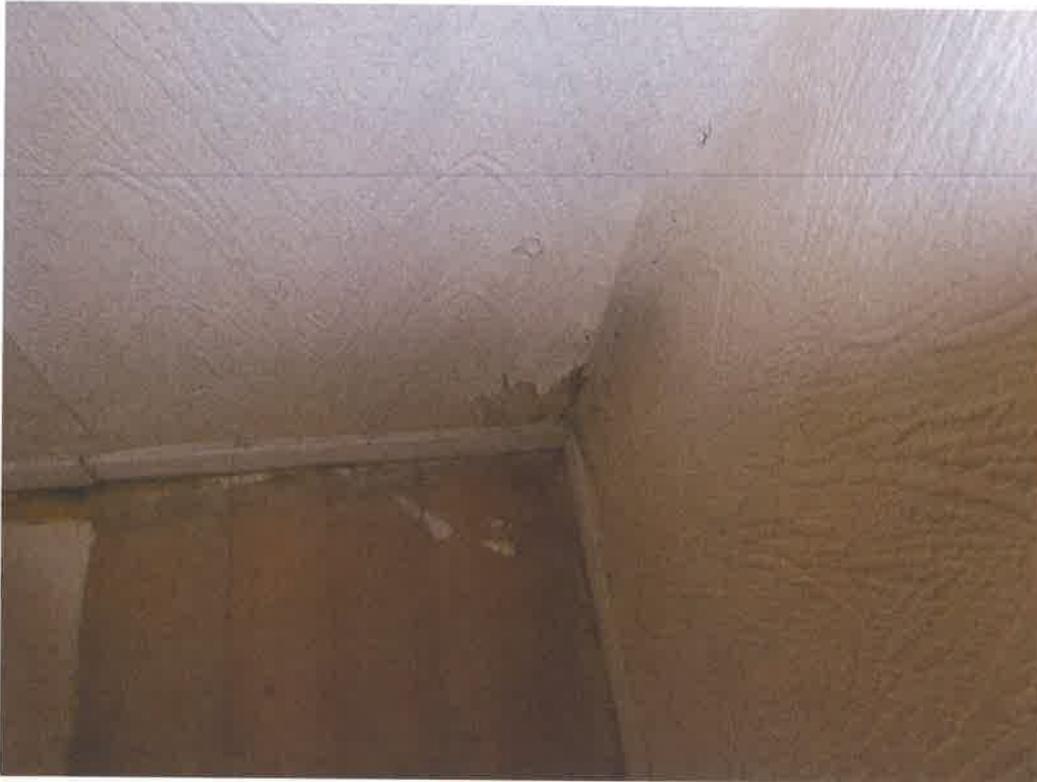
31. The wall in the staircase leading to the attic was discussed next. The Ordinary Member noted that that there was damp clearly present in the corner at the bottom step. This area should be investigated and the

Plasterwork at base of attic stairs is defective / damp and requires investigation to establish cause and then repaired

appropriate action to ensure that the damp is reduced to within an acceptable level or eliminated. Neither party made comment on this point.

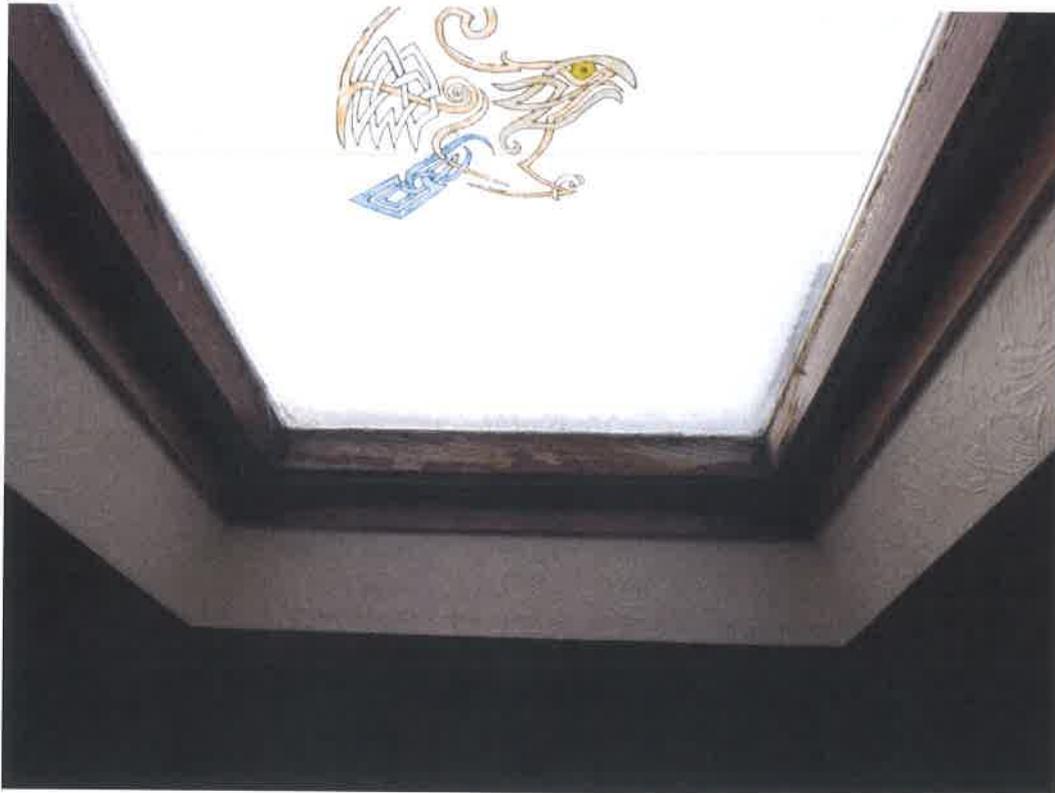
35. The frame of the attic window was discussed next. It was raised as a separate issue from the skylight itself. The Ordinary Member noted that the frame was in poor condition and needed to be redecorated. Neither party commented on this.

Attic 'velux' skylight. Requires re-decoration

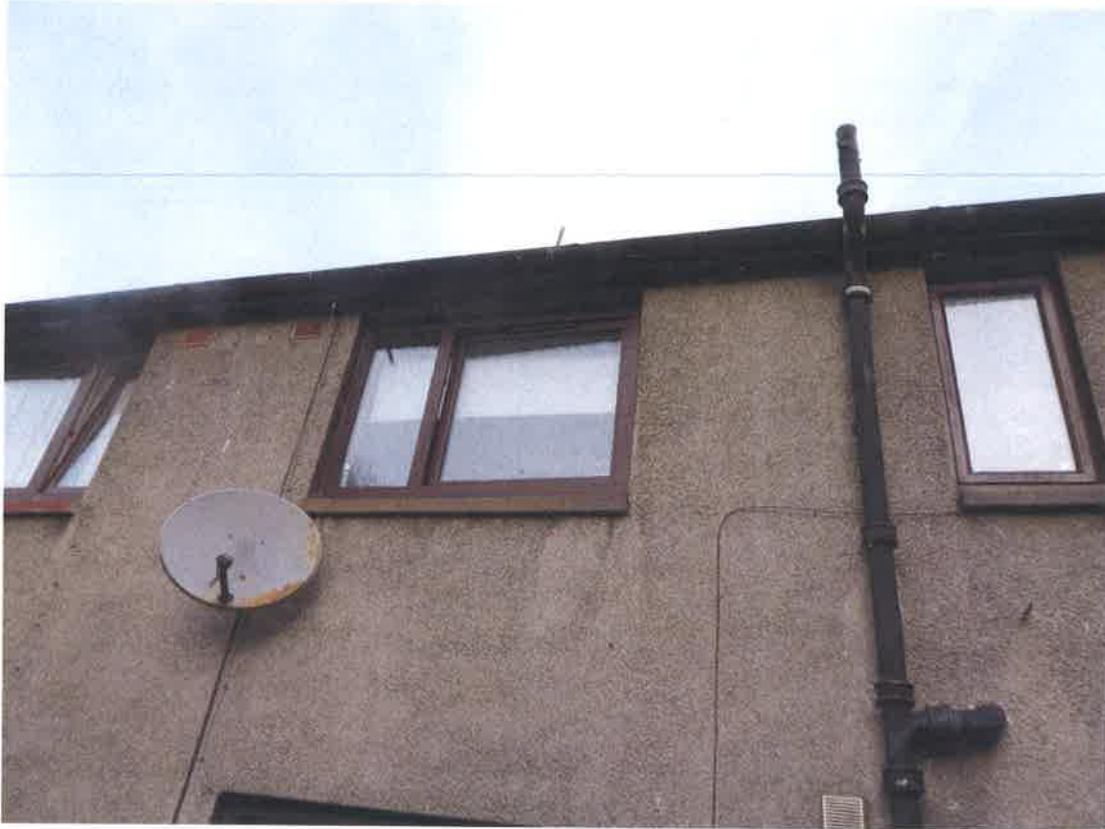
36. The rhones and downpipes were discussed next. The Ordinary Member noted that they were in good condition and in a similar condition to those at the houses located in close proximity to the House. The Tribunal considered that the repairing standard had been met. Neither party commented on this.

Rear gutters and downpipes in reasonable decorative order

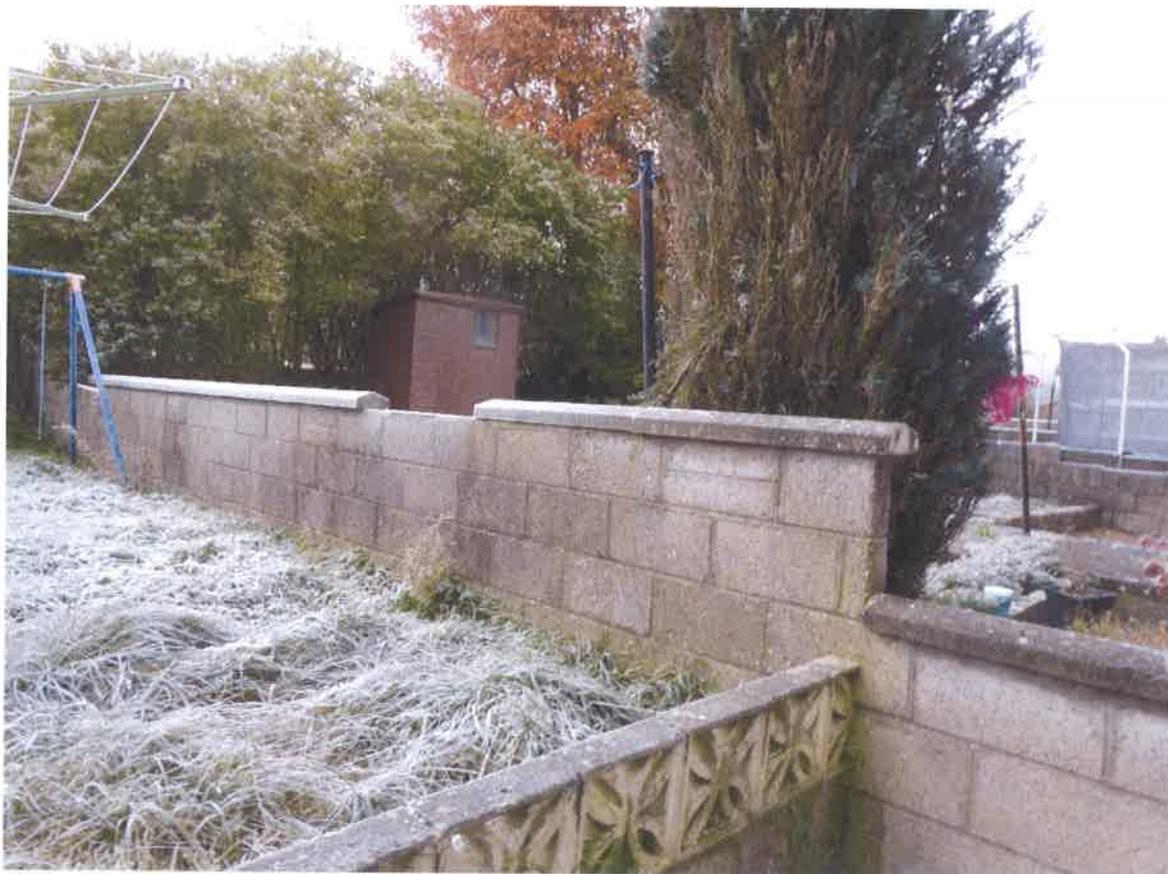
37. The coping stones in the back garden were discussed next. The Ordinary Member noted that right boundary wall had coping stones that were missing and needed to be replaced. Neither party commented on this.

Missing coping stone to be re-set and all others checked

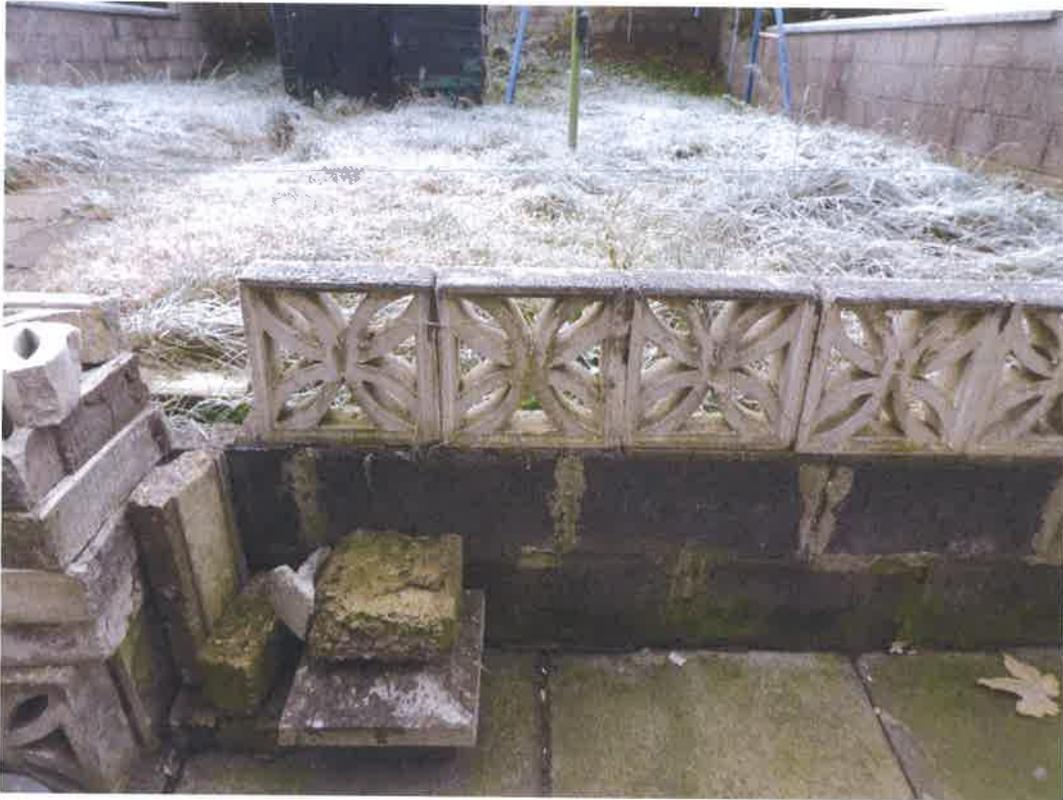
38. The coping stones on the decorative wall within the garden were discussed. The Ordinary Member noted that the stones to the left and right of the steps were not secure and at risk of falling off the wall. They needed to be removed or made safe and secure. Neither party commented on this.

Decorative coping stones – ensure these are properly fixed to base and sides (lack of cement between blocks at present)

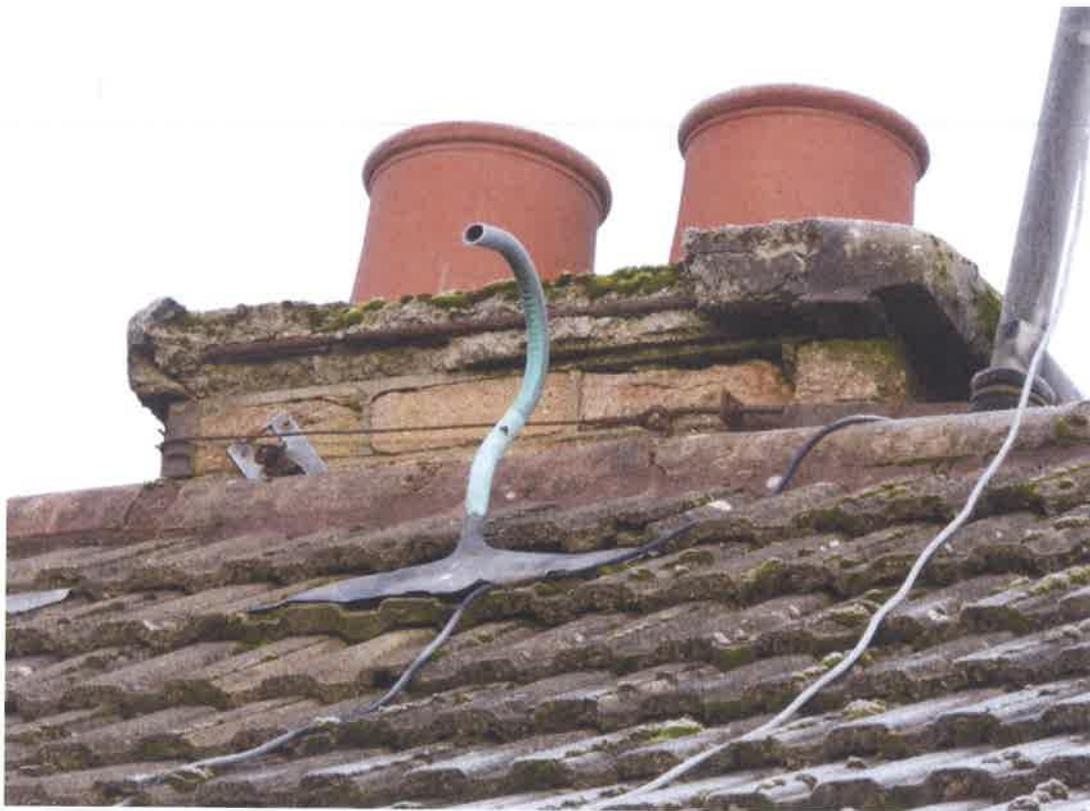
Observation – Brickwork to chimney stack and concrete chimney slab (shared) defective and requires repair.
