**STATEMENT OF DECISION OF THE PRIVATE RENTED HOUSING COMMITTEE
UNDER SECTION
26(1) OF THE HOUSING (SCOTLAND) ACT 2006 ("the Act")**

**Property at 39 Wallbrae Road, South Carbrain, Cumbernauld G67 2PD
(hereinafter referred to as "the house")**

Reference PRHP/RP/14/0168

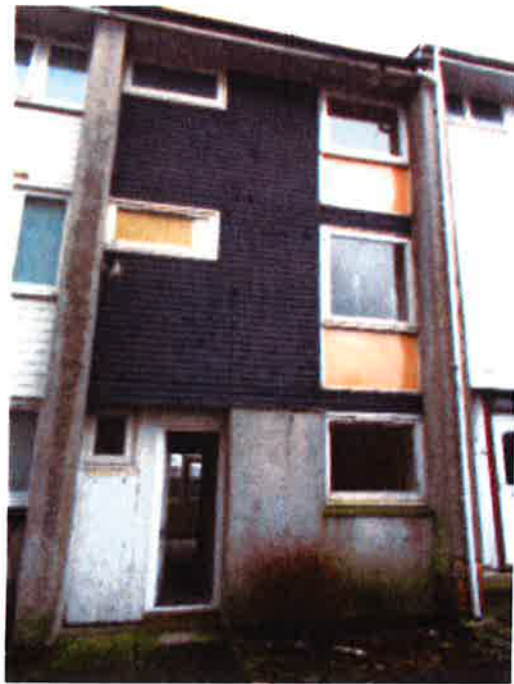
External view - Front elevation of property

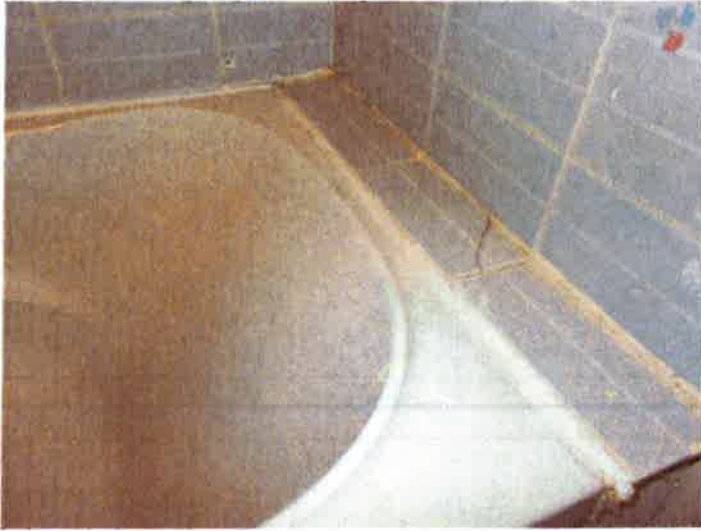
1. (b) Bath

b) To repair the source of water leak in the bathroom; to repair the damage to the flooring under the bath, and the adjoining skirting and to replace the ceiling and make good the plasterwork in the first floor room left; to ensure that the bath is securely fixed to the floor; and all existing sealant at the bath removed and replaced, all the foregoing to a reasonable state of repair.

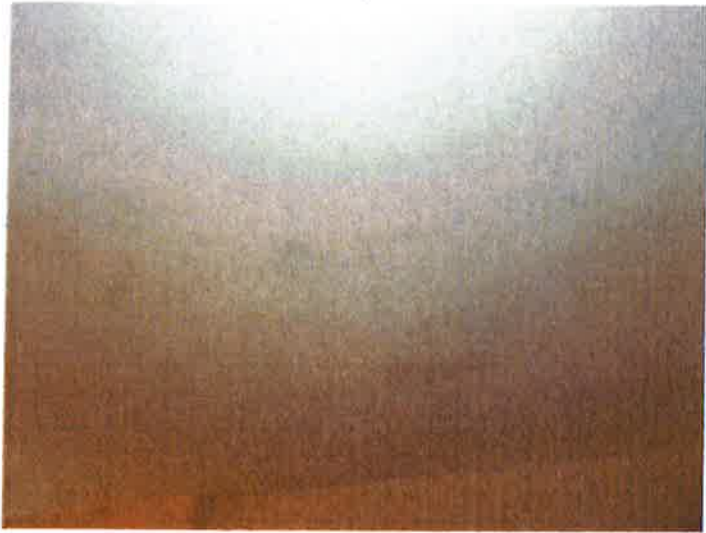
1. (b) 1st floor left room ceiling

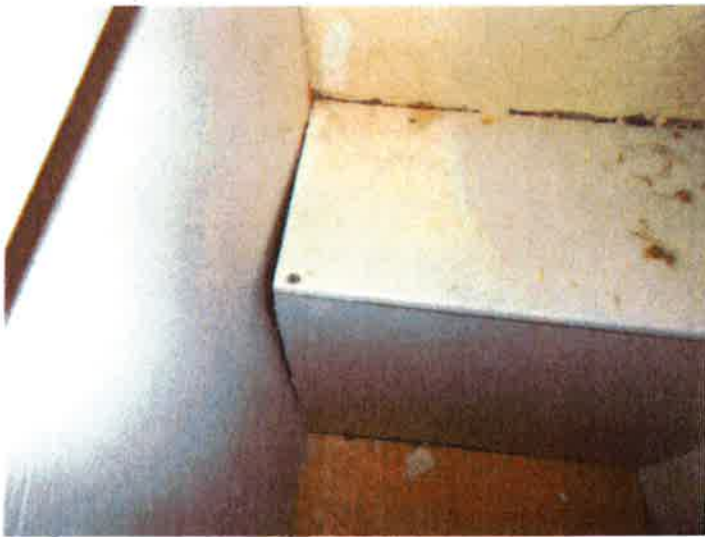
1. (d) Bathroom

d) To secure the upstairs toilet so that it does not move, repair the laminate in the bathroom to ensure no gaps and it is readily able to be cleaned and to box in the exposed pipes to a reasonable state of repair.

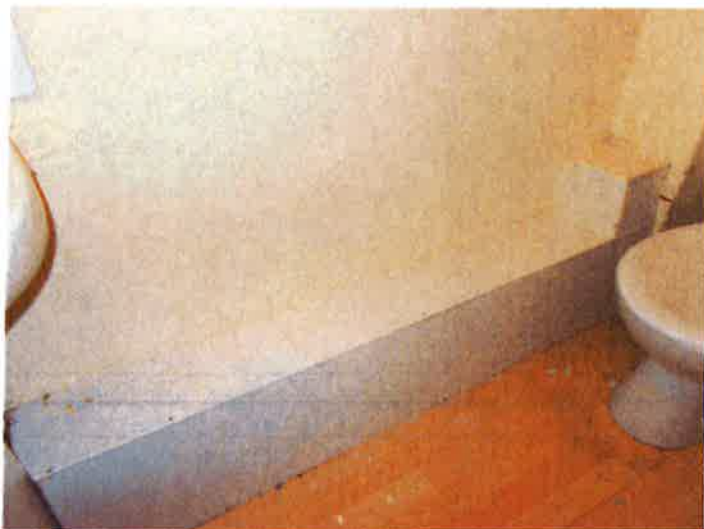
1. (d) Bathroom

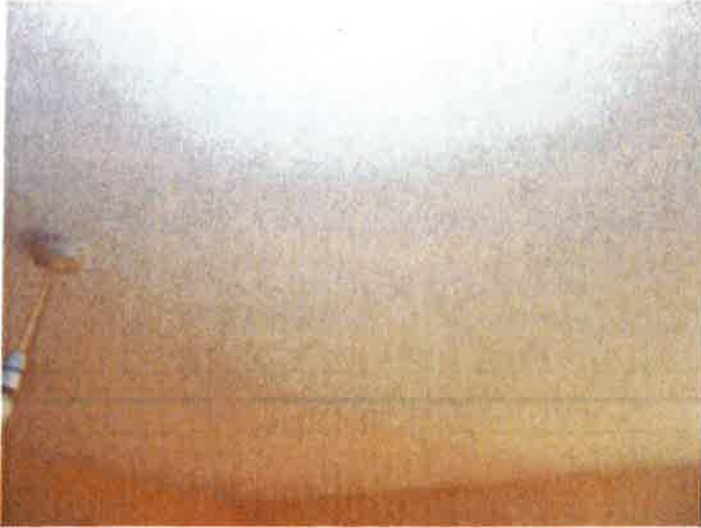
1. e) This requirement was part satisfied prior to the re-inspection on 6 August 2015 and detailed in the Decision dated 25 November 2015. The landlord has now painted the new plasterboard ceiling in the first floor bedroom left and installed a new plasterboard ceiling in the adjoining cupboard off the landing, he has also boxed in the pipework in this cupboard and re-painted. The associated water damage to most areas including the ground floor has now been rectified although there is still some damage at the base of the wall in the first floor cupboard (photos marked 1. (e)).

1. (e) New ceiling in 1st floor room left

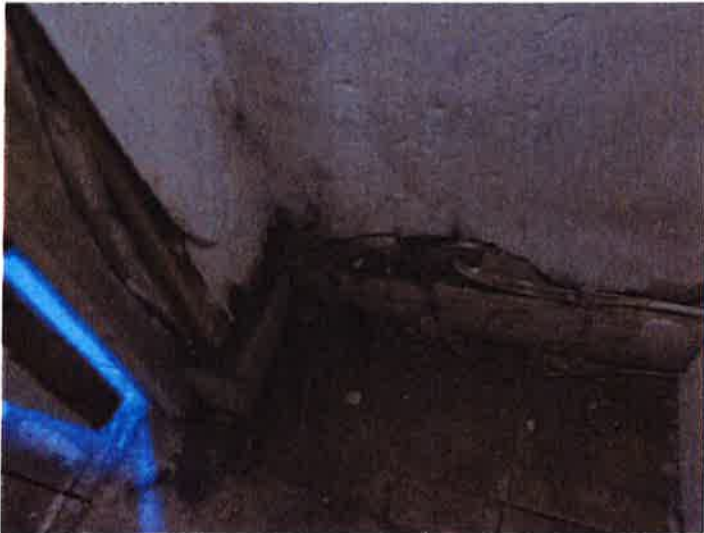
1. (e) Cupboard 1st floor landing - adjacent to room with boiler

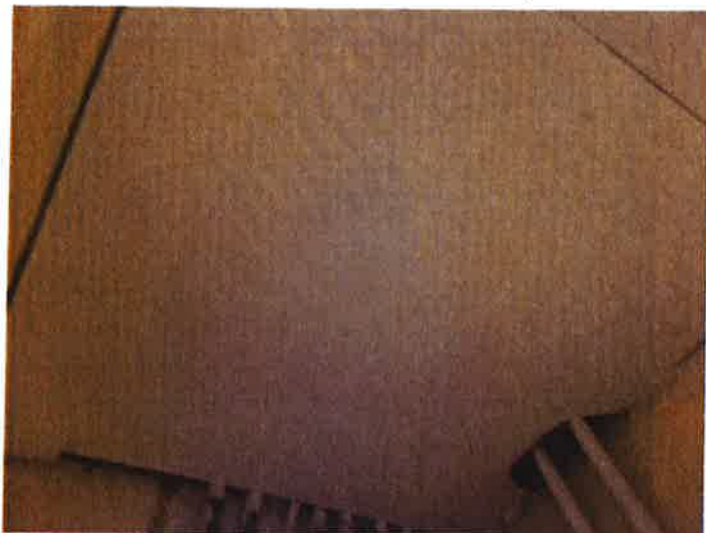
1. (e) Ceiling in cupboard off landing on 1st floor

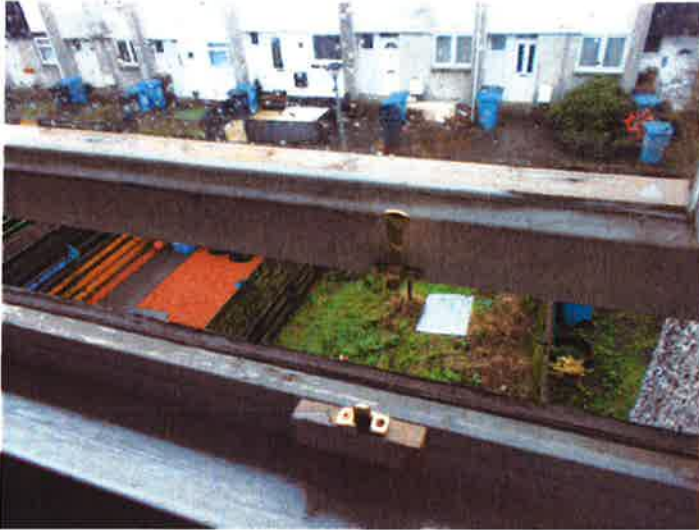
1. f) The glazing to the broken window in the second floor bedroom right was replaced before the re-inspection on 6 August 2015 but the new section of external timber remains unpainted. A number of new handles have been fitted to several windows throughout the property and most of them open and close satisfactorily. However, the left hand side window in the first floor room to the right cannot be opened, it appears to have a defective restrictor. The handle to the ground floor toilet window which is not easily accessed due to its awkward position at height remains broken and there is no other means of ventilation in this room (photos marked 1. (f)).

1. (f) 2nd floor room right - window on right - external timber unpainted

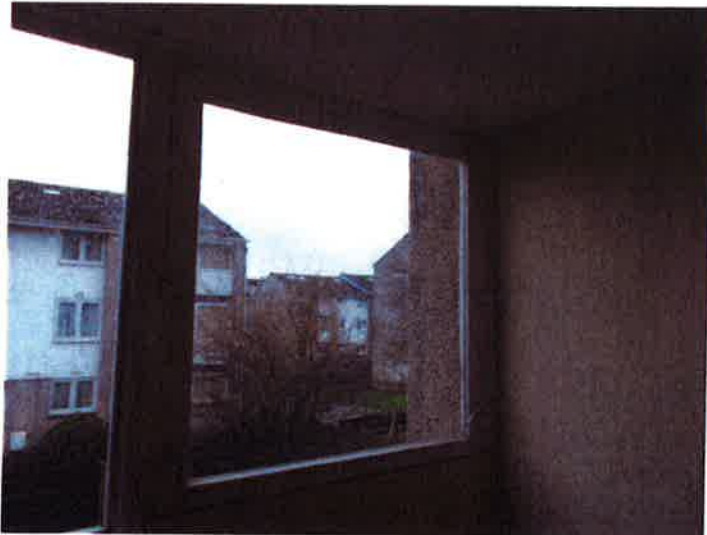
1. (f) 1st floor room on right - right window original handle satisfactory

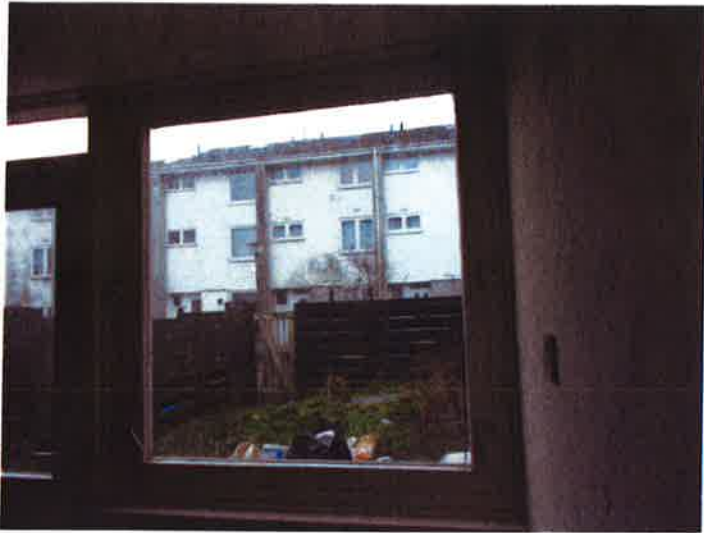
1. (f) Kitchen window on right original handles satisfactory

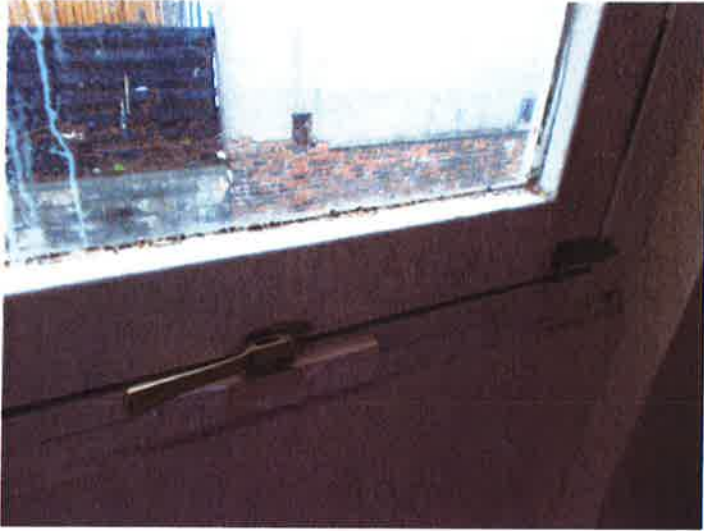
1. (g) 1st floor room left

g) To repair the window in the first floor bedroom left to ensure that the window is secure and can be opened and closed properly and is in a reasonable state of repair and in proper working order.

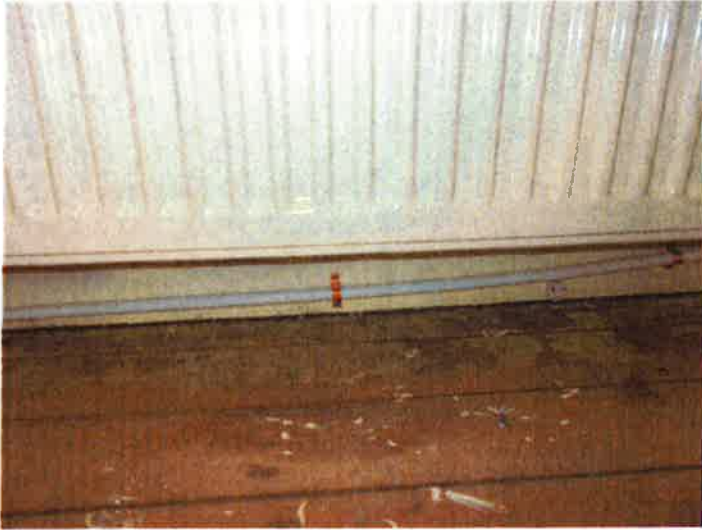
2. 2nd floor room right

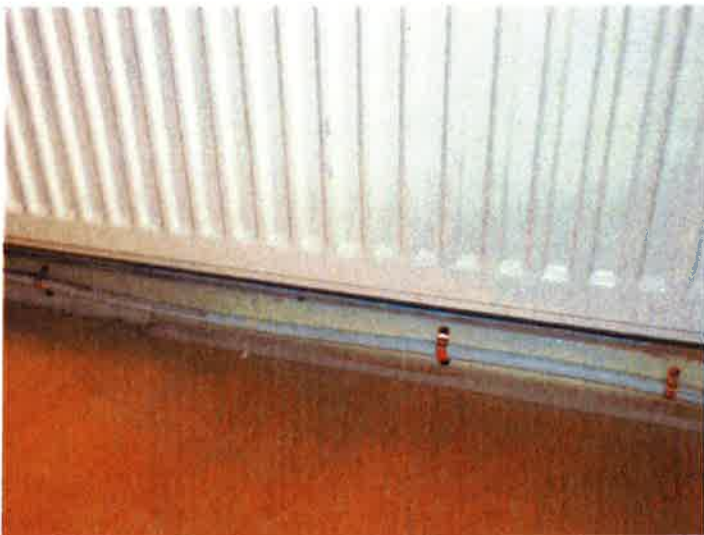
2. 2nd floor room left

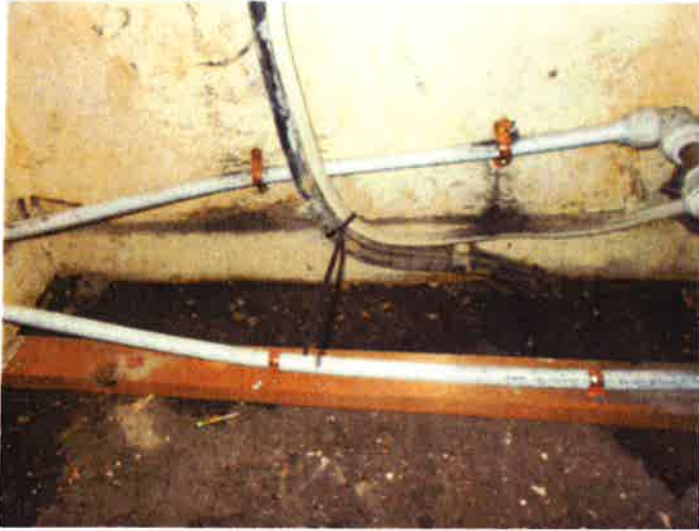
2. Ground floor meter cupboard

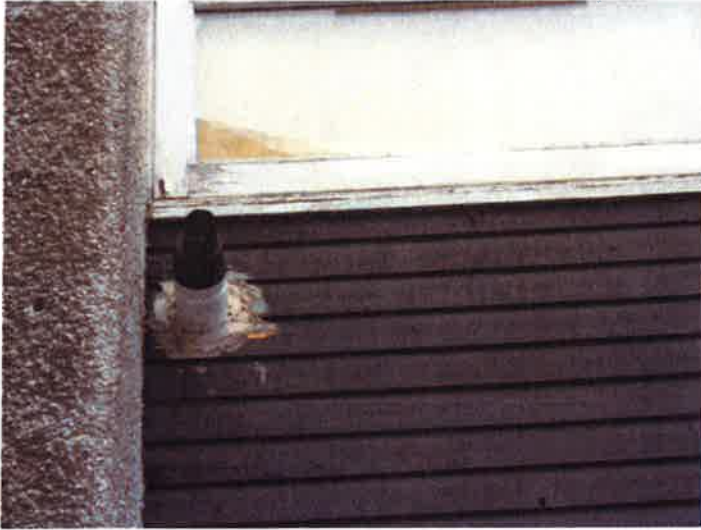
3. Boiler flue - external front elevation

3. The RSEO to include a requirement on the Landlord to either provide written verification that the boiler appliance/ flue as fitted in the house does not require a shield as described in the Gas Safe Register inspector's report dated 22 September 2015 or fully comply with the requirements as detailed at clause 2. on page 2 of the report; the other issues relating to the identified defects in the said report to be rectified as described to ensure compliance with the repairing standard so that the installation in the house is in a reasonable state of repair and in proper working order, all to the satisfaction of the Committee; the type and location of the carbon monoxide detector in the house must comply with the Scottish Government Statutory Guidance issued in relation to the Provision of Carbon Monoxide Alarms in Private Rented Housing.

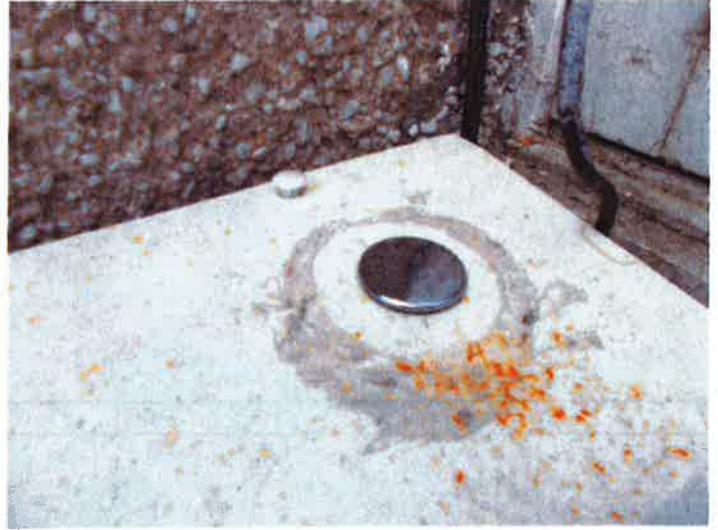
3. Top of meter box to rear

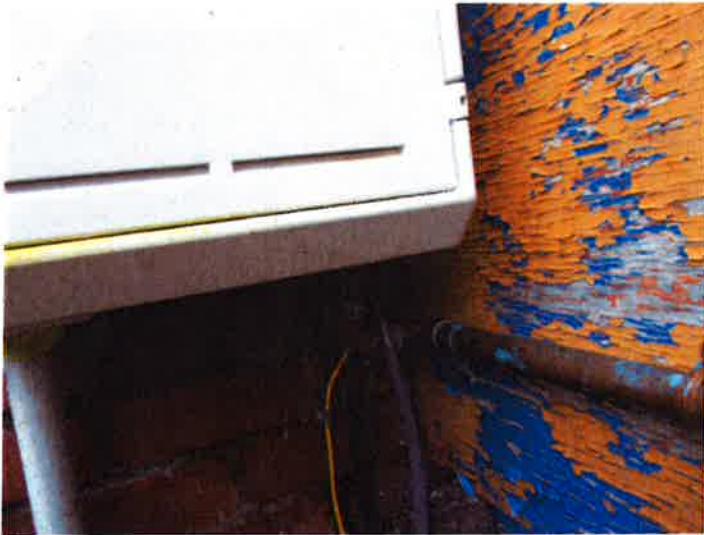
3. Base of gas meter box to rear

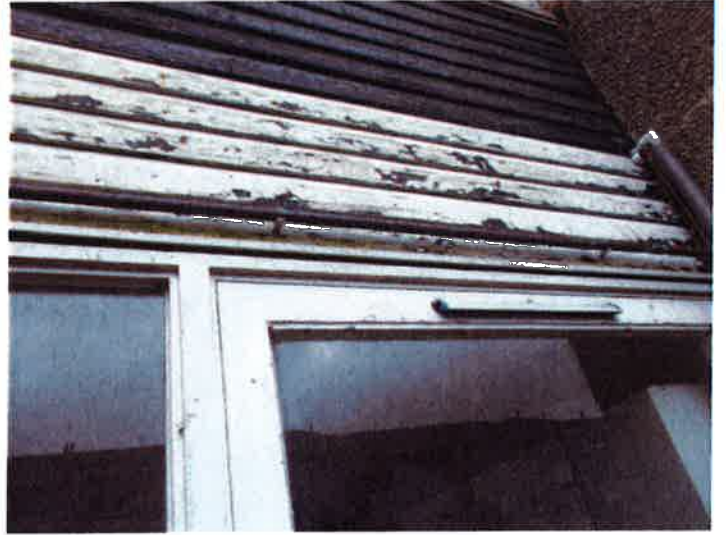
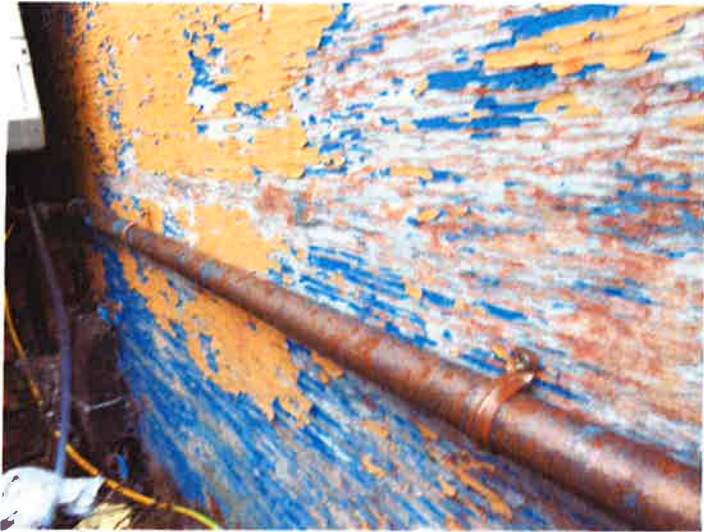
3. Rear elevation - copper gas installation pipe

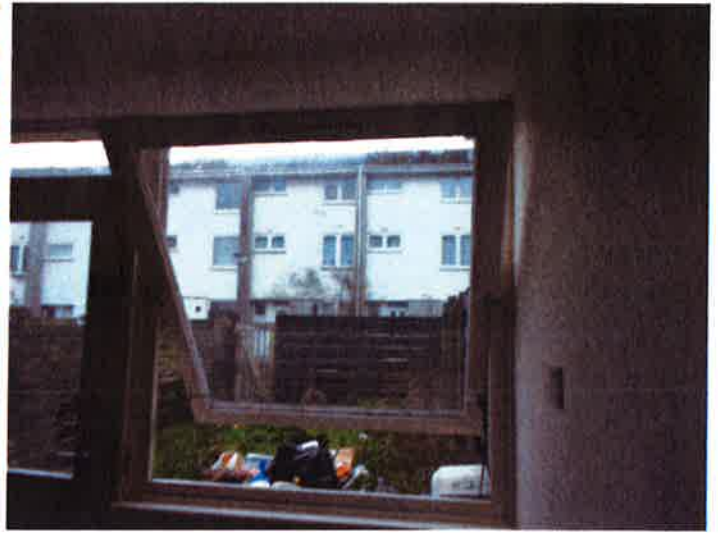
3. Kitchen Window - Unobstructed opening

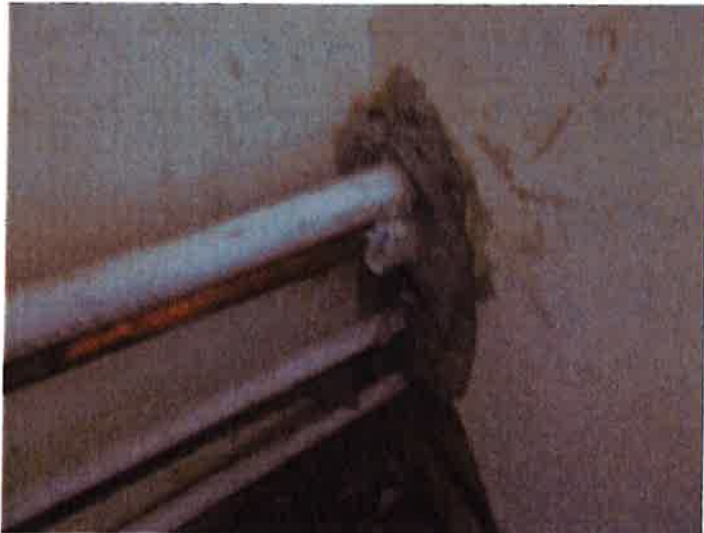
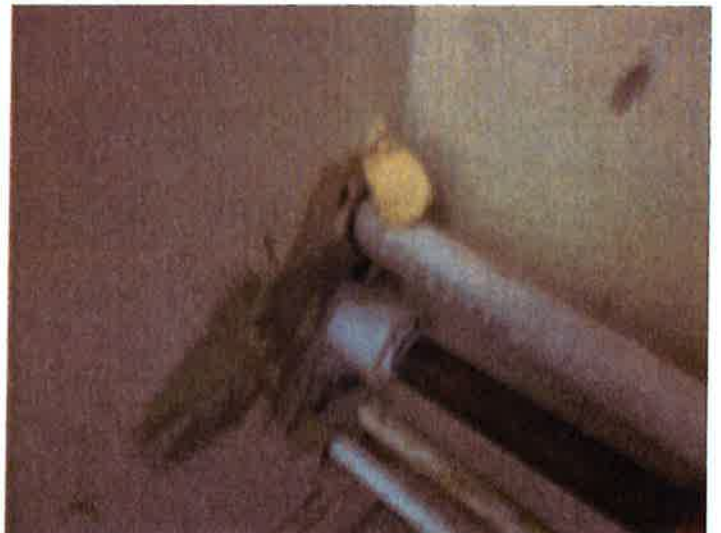
3. Copper pipe sleeved where it passes through the wall - 1st floor cupboard

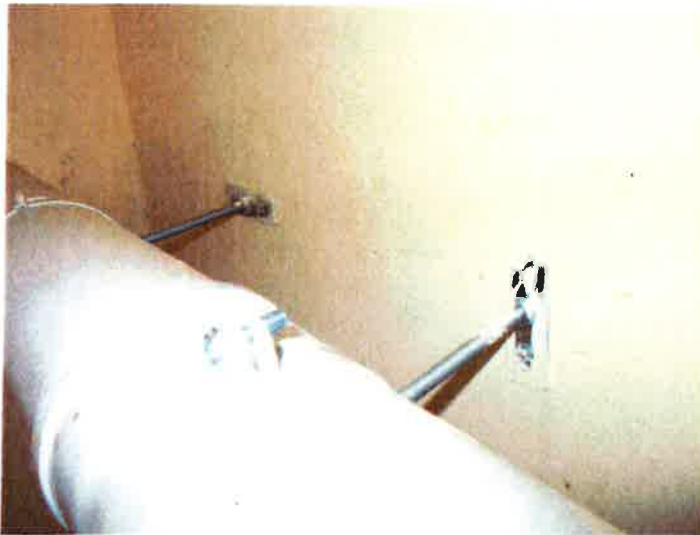
3. Flue duct brackets fitted

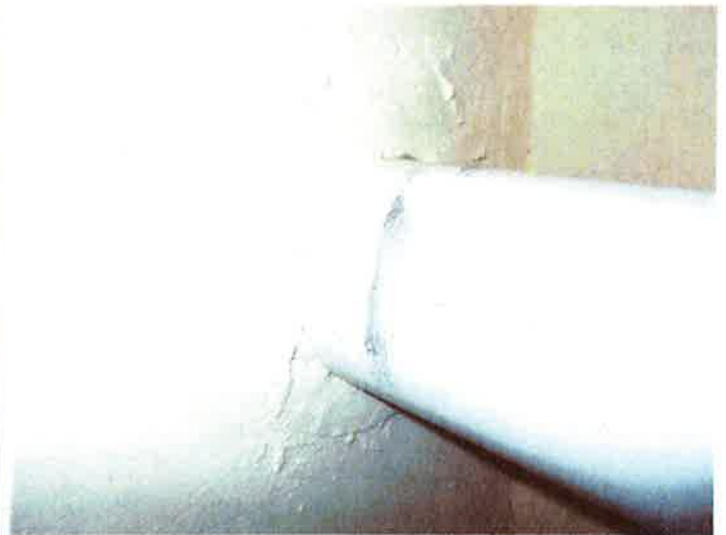
3. Flue at front wall - 1st floor room left

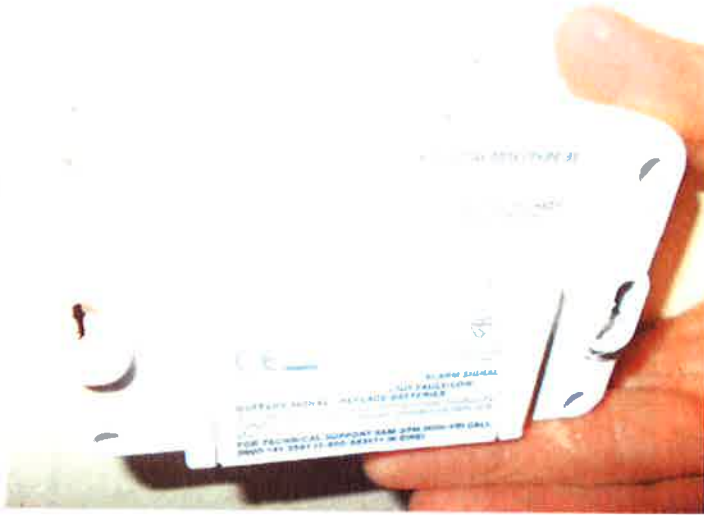
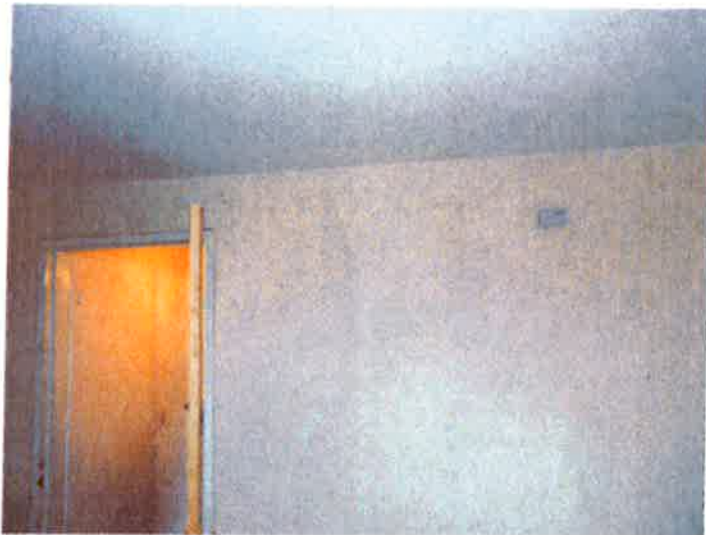
3. Carbon monoxide alarm - 1st Floor room left

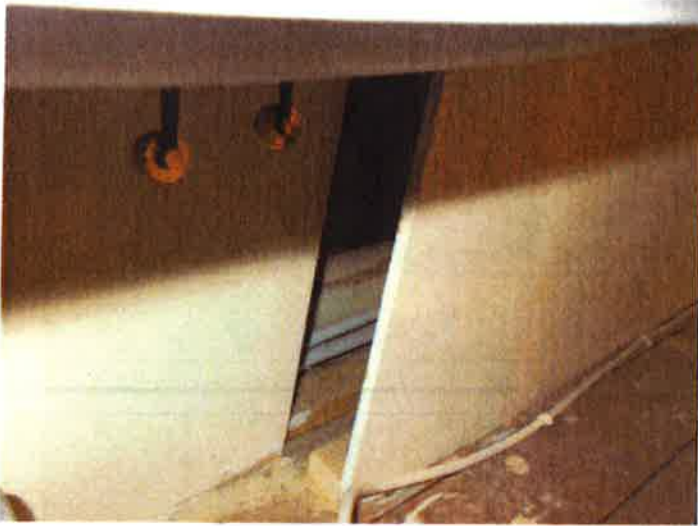
1. a) The central heating system has been completed and Mr Matthews tested the system at the time of this re-inspection. The radiators all appear to be functioning. It was however noted that during recent works in this property that a number of sections of boxed pipework have been dismantled and not re-instated to a safe and secure state (see also section below relating to "making good" damage and photos 5 - 10).

5. 1st floor room left large gap at Boxing under boiler

The landlord is reminded that it is a requirement of the RSEO that he must make good damage caused by the carrying out of any work for the purpose of complying with the repairing standard duty. This includes such matters as filling in holes and making good affected areas, and redecoration of these affected areas.

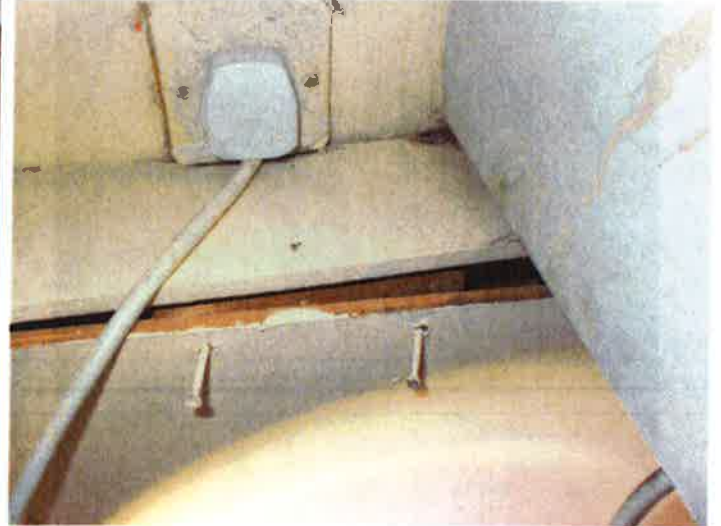
6. 1st floor room left Boxed pipes under boiler

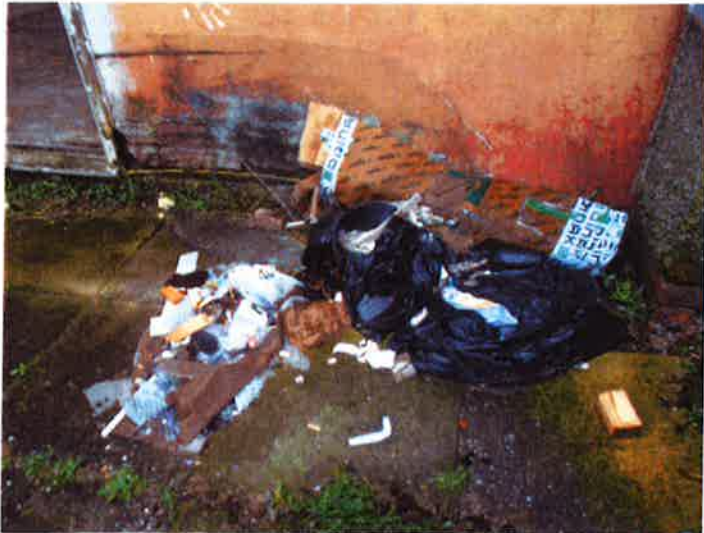
24. Rear Garden - Rubbish

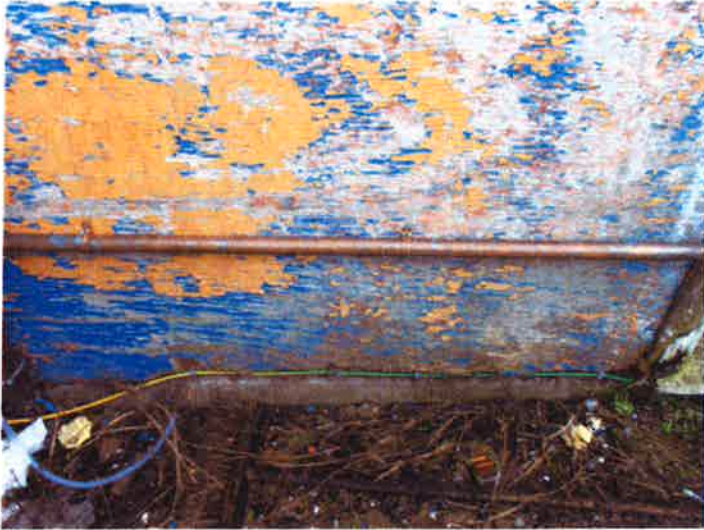
26. Timber external cladding - rotten - Rear elevation at base
